FIRE SAFETY INSPECTION REPORT

**FOUR H LINGERIE LTD.
BRTC BUS DEPOT, BALUCHARA, CHITTAGONG**

ACCORD
on Fire and Building Safety in Bangladesh

August 23, 2014

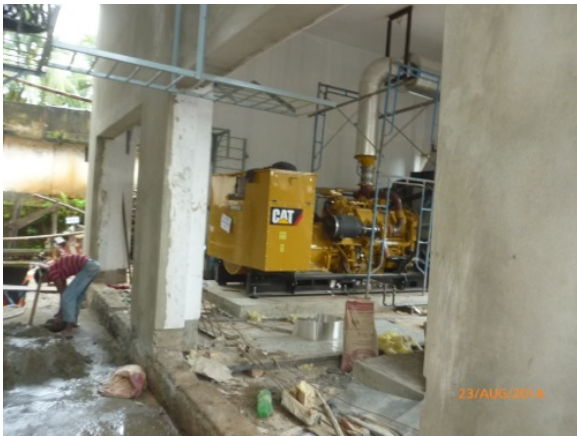
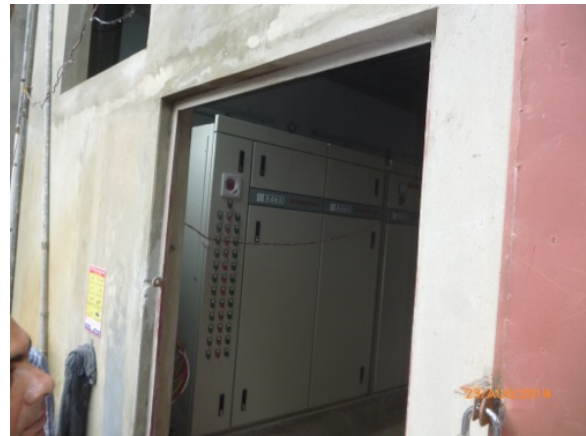
No.	Category	Finding	Recommendation	Remediation Timeframe
F-1	Fire Rated Construction	The generator and electrical rooms are not separated by fire-rated construction (openings, non-rated doors, penetrations).	Separate the generator and electrical rooms by a minimum 2-hr fire-rated construction. Seal and/or protected all openings to maintain the required fire separations	Within 3 months

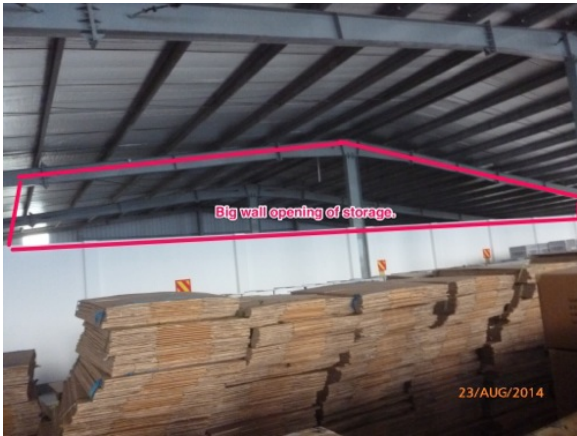
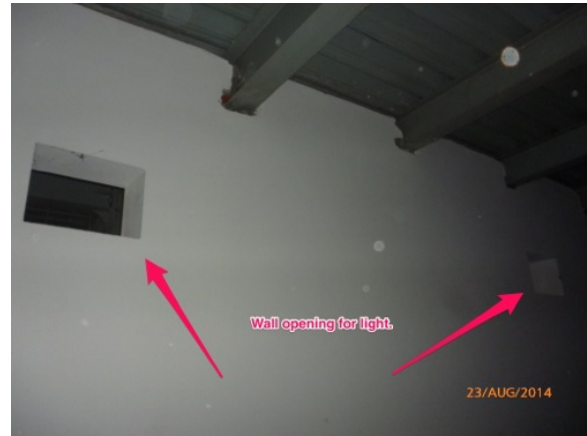
F-2	Fire Rated Construction	Rooms used for combustible storage are not separated by fire-rated construction. (No fire rated door, wall opening.) Ground and Mezzanine storage.	Provide dedicated storage rooms separated by minimum 1-hr fire-rated construction.	Within 3 months
-----	----------------------------	---	--	--------------------

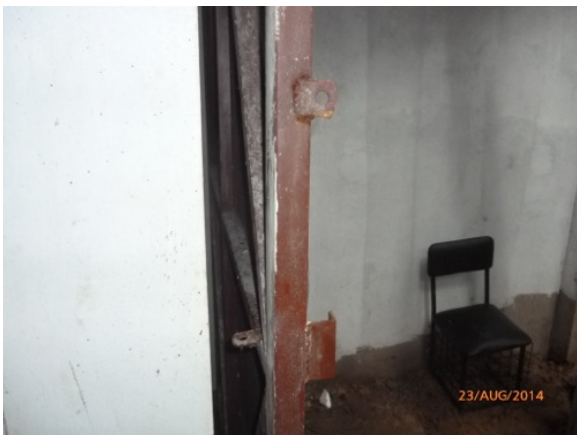
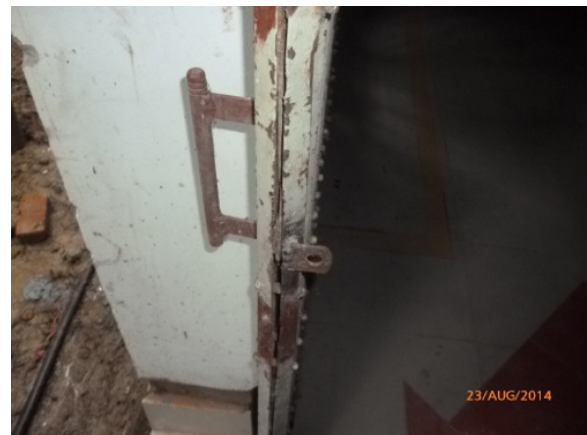
F-3 Egress

Egress doors and gates with locking features are provided at building exits and along egress routes.

All gates/doors were open and unlocked during the inspection.

Remove locking features from all egress doors / gates.

If locks are required for security reasons, utilize special door locking features complying with NFPA 101.

Immediate

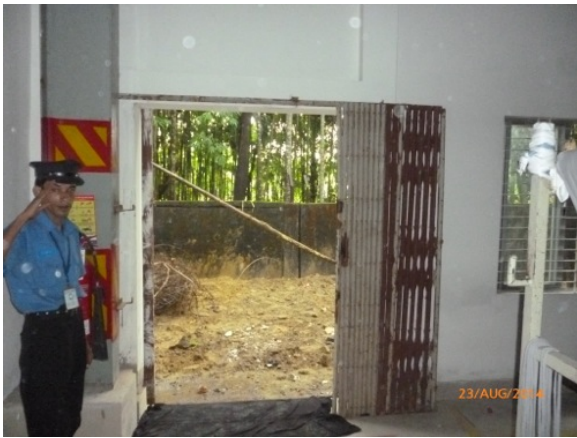
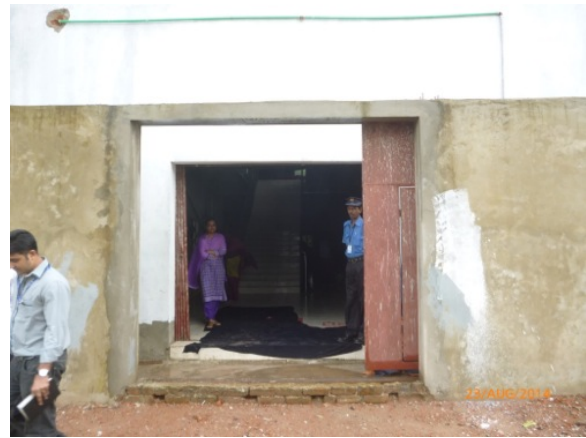
F-4	Egress	Sliding doors and gates are provided at building exits and along egress routes.	Replace all gates and sliding doors along the means of egress with side-hinged, swinging egress doors. If locks are required for security reasons, utilize special door locking features complying with NFPA 101.	Within 1 month
-----	--------	---	--	----------------

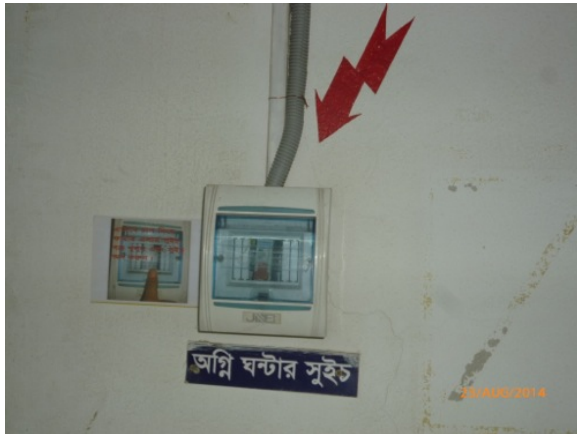
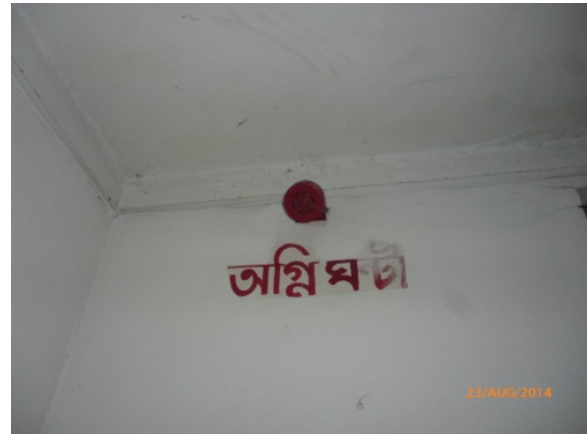
F-5	Fire Protection	The fire alarm system is antiquated, not a listed system, and does not provide alarm and notification features consistent with acceptable standards.	Replace the fire alarm system with a new, listed addressable fire alarm system in accordance with NFPA 72.	Design within 4 months, install within 9 months
-----	-----------------	--	--	---

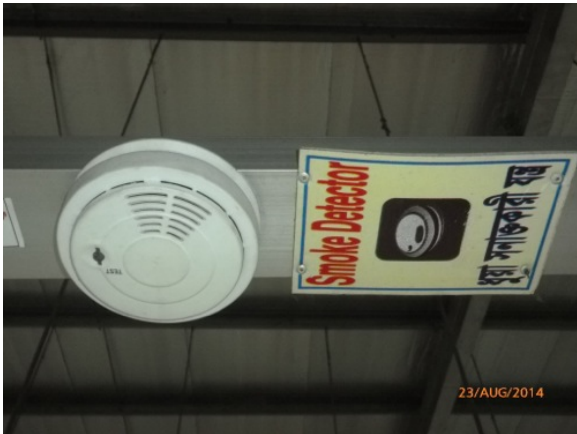
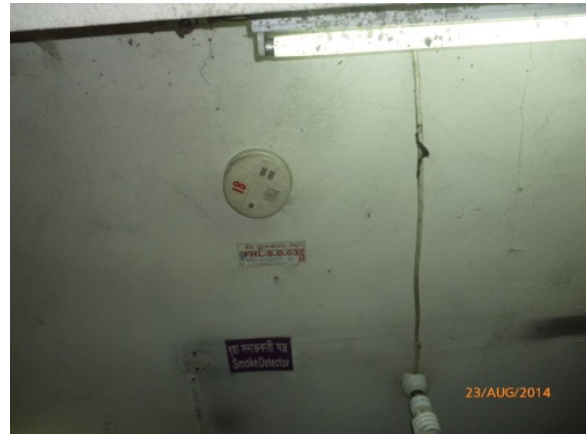
F-6	Fire Protection	Inspection, testing, and maintenance of the fire alarm system is not in accordance with NFPA 72.	Inspect, test and maintain the fire alarm system, and keep written records on-site, in accordance with NFPA 72.	Within 3 months
F-7	Fire Protection	The building is equipped with single-station smoke alarms. Smoke alarm activation sounds only a local alarm and does not provide automatic fire alarm notification of occupants.	Remove single-station smoke alarms. Provide automatic smoke detection throughout the building, tied into the fire alarm system, in accordance with NFPA 72.	Within 6 months

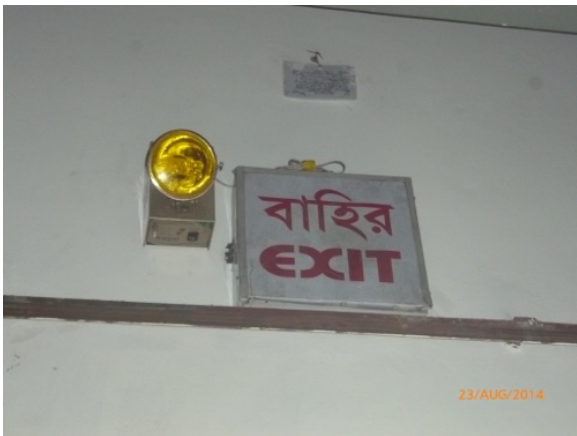
F-8	Egress Lighting	Several exit signage not illuminated (burned out, broken, etc.).	Regularly inspect all exit signage and replace/install lights as needed to illuminate signs.	Within 1 month
-----	-----------------	--	--	----------------

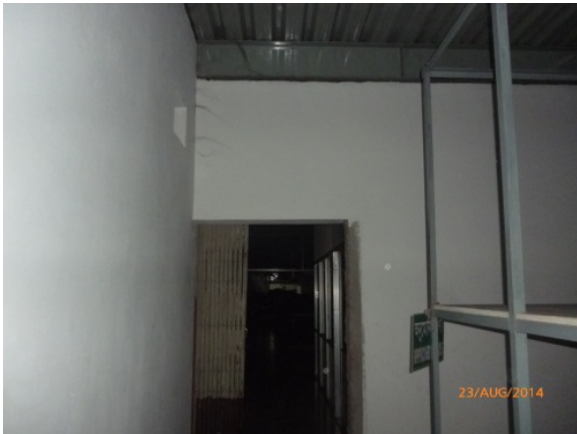
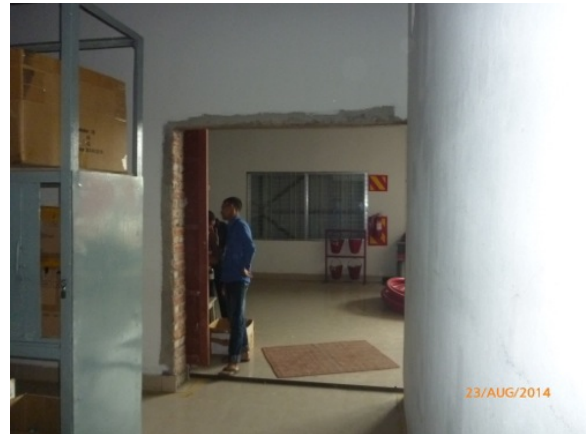
F-9	Egress Lighting	Exit sign not provided at exit on storage area.	Provide exit signs above all exits to the exterior and all doors to the exit stairs.	Within 1 month
-----	-----------------	---	--	----------------
