# **FIRE SAFETY INSPECTION REPORT**

**ISLAM KNIT DESIGNS LTD**

**ZARUN, KONABARI, GAZIPUR SADAR, GAZIPUR**

August 24, 2014

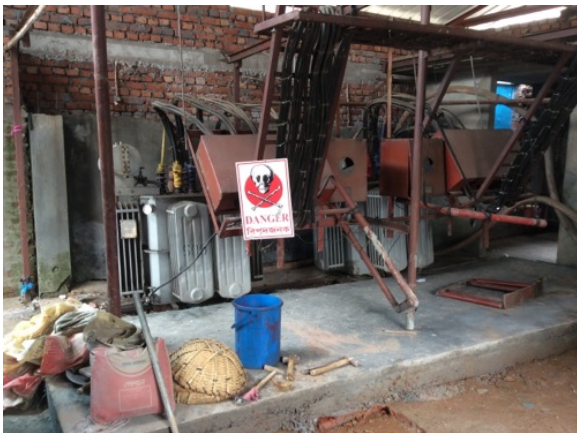
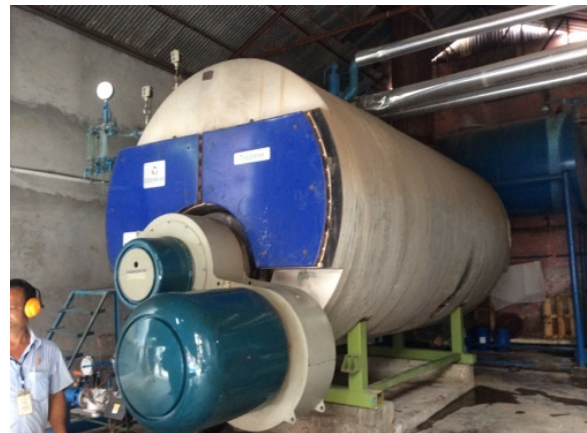
No.	Category	Finding	Recommendation	Remediation Timeframe
F-1	Fire Rated Construction	The boiler, generator, and transformer room located on the ground floor, is not separated by fire-rated construction, openings, non-rated doors, and penetrations.	Separate the boiler, generator, and transformer room by a minimum 2-hr fire-rated construction. Seal and/or protected all openings to maintain the required fire separations	Within 3 months

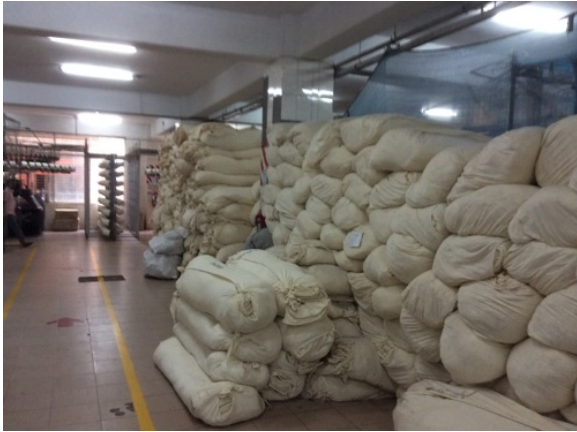
F-2	Fire Rated Construction	Areas used for combustible storage on the first, second, third, fourth and eighth floors are not separated by fire-rated construction.	<p>Provide dedicated storage rooms separated by minimum 1-hr fire-rated construction.</p> <p>Where separate storage rooms are not feasible, provide defined storage areas and limit the storage arrangement as follows:</p> <ul style="list-style-type: none"><li>- Maximum height of 2.4m and maximum area of 23m<sup>2</sup></li><li>- If sprinkler protected: maximum height of 3.66m and maximum area of 93m<sup>2</sup></li></ul> <p>Separate areas of unenclosed combustible storage by a minimum clear distance of 3m.</p>	Within 3 months
-----	-------------------------	--	---	-----------------

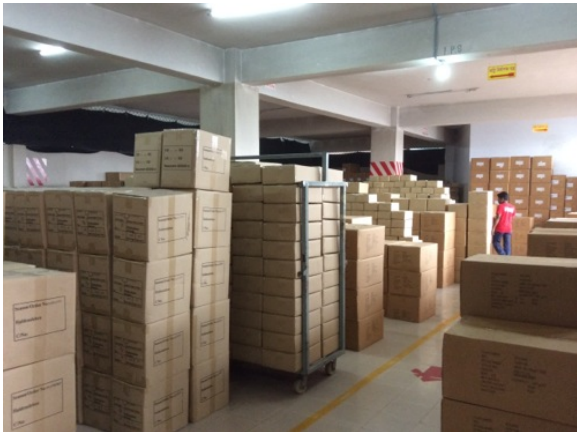
F-3	Fire Rated Construction	Storage rooms used for combustible storage on the ground, first and second floors are not separated by fire-rated construction.	Provide dedicated storage rooms separated by minimum 1-hr fire-rated construction.	Within 3 months
-----	-------------------------	---	--	-----------------

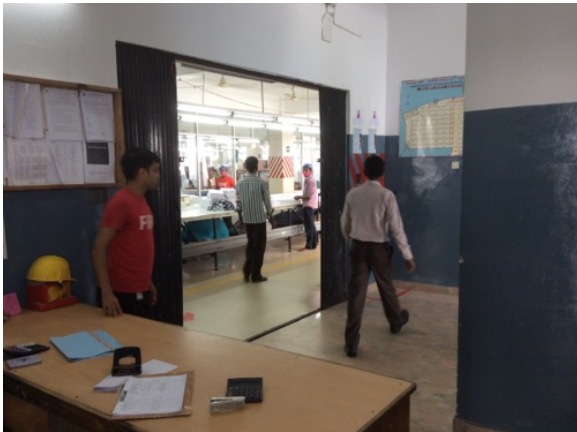
F-4	Fire Rated Construction	The exit stairs are not separated from work areas, and other spaces on each floor by fire-rated construction. This was reflected throughout the building on all floors.	Provide minimum 1.5-hr fire rated doors and seal all unprotected openings to separate the exit stairs from work areas and other building spaces on all floor levels. Ensure that the fire doors are self-closing and positive latching and that they are provided with fire exit (panic) hardware where serving production floors.	Within 3 months
			If fire doors are required to be held open for functional reasons, provide automatic-closing devices tied to the fire alarm system.

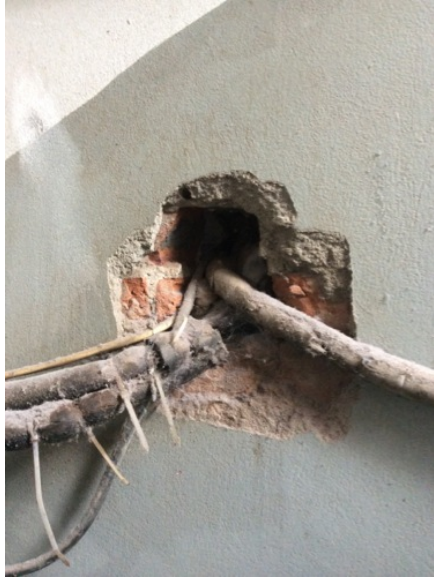
F-5	Fire Rated Construction	Unsealed penetrations and openings on all floors are located in each exit stair enclosures.	Seal all penetrations and openings in exit stair enclosure walls to maintain the fire separation.	Within 3 months
-----	-------------------------	---	---	-----------------

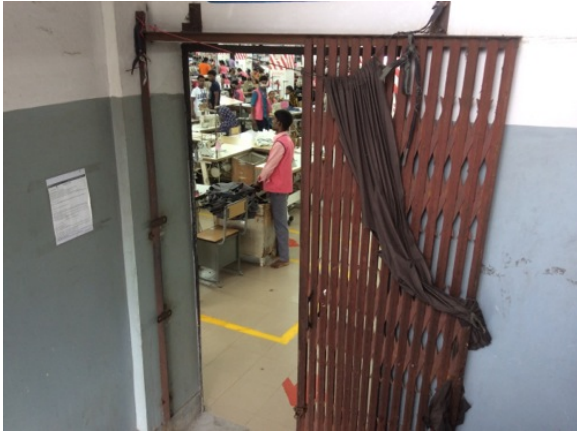
F-6	Fire Rated Construction	The exit discharge path serving all exits is less than 10 ft wide and is not separated from the building interior.	Seal all penetrations and openings to the interior of the building along the discharge path, up to a height of 10 ft., to provide a minimum 1-hr fire separation.  Alternatively, provide a second remote discharge path to the public way (only include this if feasible).	Within 6 months
F-7	Egress	Egress doors / gates with locking features are provided at building exits, exit stairs, along egress routes, and exit discharge. This was reflected throughout the building on all floors.	Remove locking features from all egress doors / gates.  If locks are required for security reasons, utilize special door locking features complying with NFPA 101.	Immediate

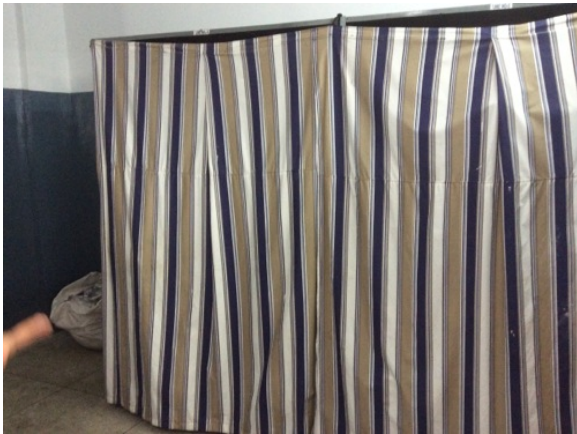
F-8	Egress	Storage was located in all exit stairs, on each floor.	Remove all storage from exit stairs and egress paths.	Immediate
-----	--------	--	---	-----------

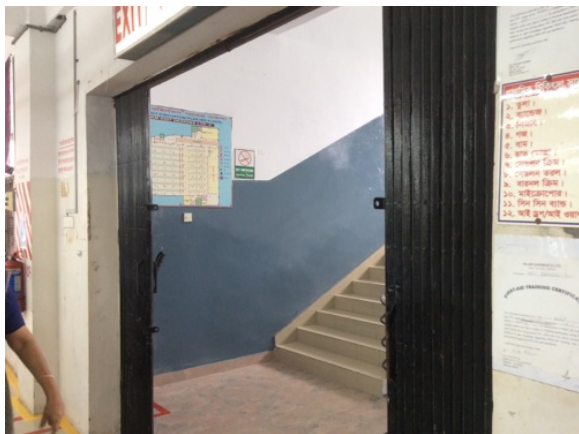
F-9	Egress	Collapsible gates / sliding doors are provided at building exits, exit stairs, along egress routes, and exit discharge. This was reflected throughout the building on all floors.	<p>Replace all gates / sliding doors along the means of egress with side-hinged, swinging egress doors.</p> <p>If locks are required for security reasons, utilize special door locking features complying with NFPA 101.</p>	Within 1 month
-----	--------	---	---	----------------

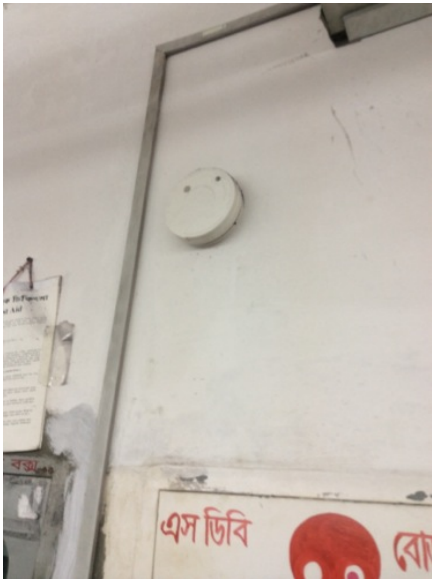
F-12	Fire Protection	In addition to having conventional type smoke detectors the building is also equipped with single-station smoke alarms. Smoke alarm activation sounds only a local alarm and does not provide automatic fire alarm notification of occupants.	Remove single-station smoke alarms.	Within 6 months
------	-----------------	---	-------------------------------------	-----------------

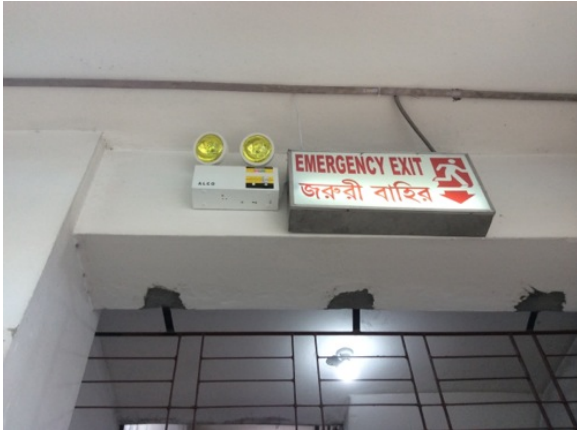
F-13	Egress Lighting	Exit signage not illuminated (burned out, broken, etc.). This was reflected throughout the building on various floors.	Regularly inspect all exit signage and replace/install lights as needed to illuminate signs.	Within 1 month
F-14	Egress Lighting	Manual on-off switch is provided for emergency lighting units. This was reflected throughout the building in various locations.	Remove manual on/off switches from emergency lighting units to prevent them from being switched off.	Within 1 month
