Sigma Fashions Ltd (10597)

Sigma Washing Ltd

17.May.2014

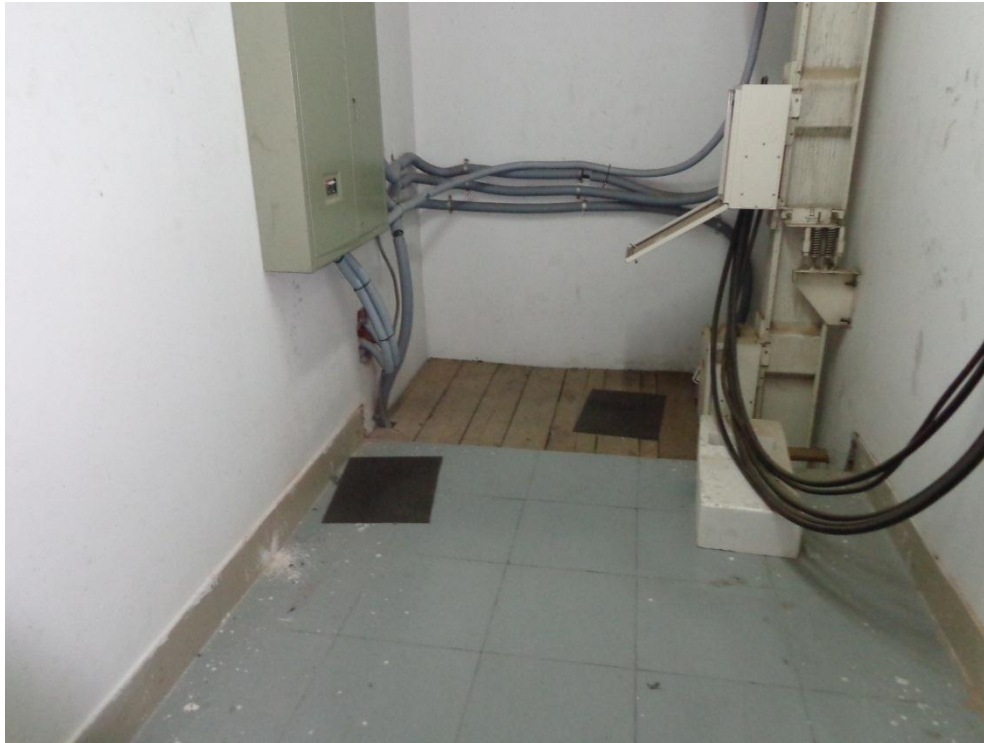
1st Priority 3 Concern

At the Main Production Building, precisely in the T.I. Room, inappropriate wooden floor infilling of unused slab openings. This must be checked by the Factory Engineer immediately. Until then, restrict the floor use locally on all floors. The areas must be cordoned off to prevent use.

Item No.	Observation	Recommended Action Plan	Recommended Timeline
1	Main Production Building - Wood floor infilling at the T.I. room.	Carry out a verification of this structure by the Factory Engineer of the infilling and carry out remedial works as necessary.	6-weeks
2	Main Production Building - Wood floor infilling at the T.I. room.	Complete the correct infilling construction work.	6-months
3	Main Production Building and Washing Building - Lightweight structural steel roof.	Carry out a Detailed Engineering Assessment by the Factory Engineer of this lightweight structural steel roof.	6-weeks
4	Main Production Building and Washing Building - Lightweight structural steel roof.	If it is necessary, carry out any remedial works recommended.	6-months
5	Medical and day care Building - Reinforcing steel at the roof.	Factory engineer to provided details to remediate at this situation and provide adequate waterproofing.	6-weeks

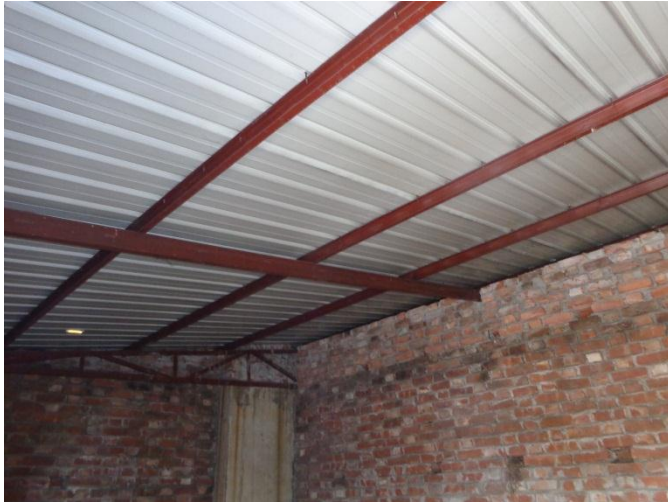
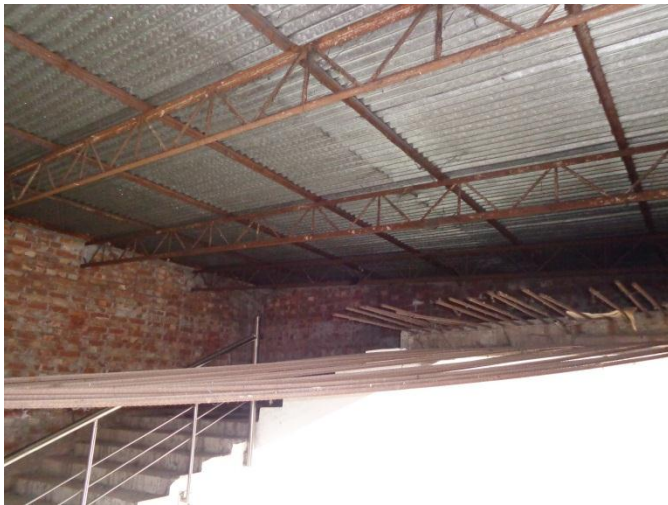
2nd Priority 3 Concern

At the Main Production Building and the Washing Plant, there is a lightweight structural steel roof at the stair cases and elevator shafts. A review of these structures by the Factory Engineer is required, especially as regards its resistance to lateral and uplift loads caused by wind.

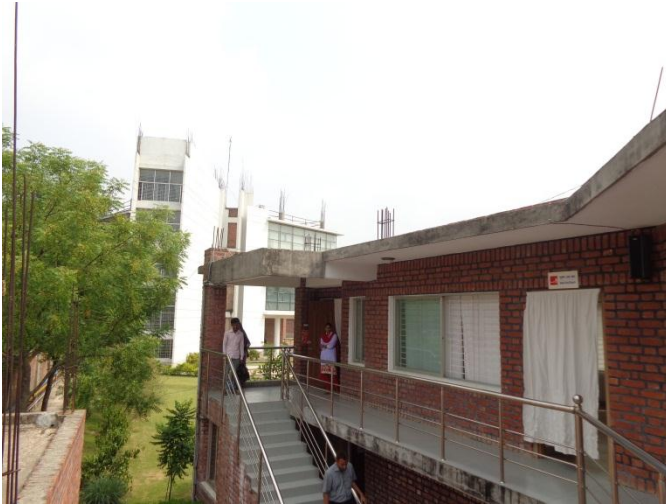
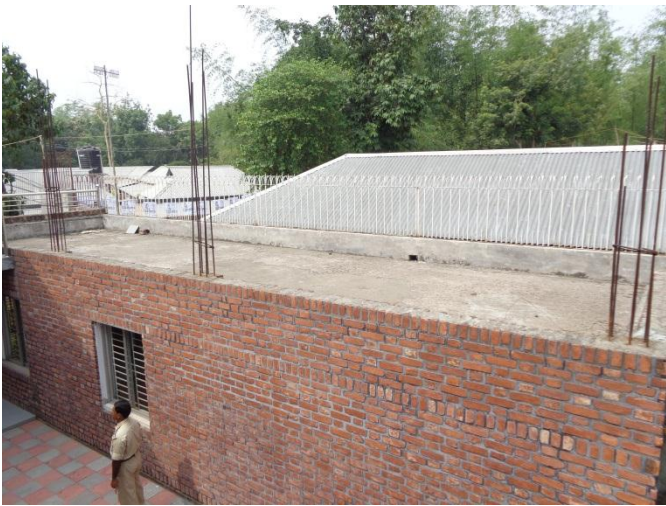
3rd Priority 3 Concern

At the Medical and day care center Building, the reinforcing steel bars of the columns are extended over the roof slab even though no future construction is planned. This situation will allow water to seep into the concrete slab and cause long-term soaking of the slab. We recommend that the Factory Engineer remedy this problem.

6	Medical and day care Building - Reinforcing steel at the roof.	Carry out remedial works to protect slab rebar.	6-months

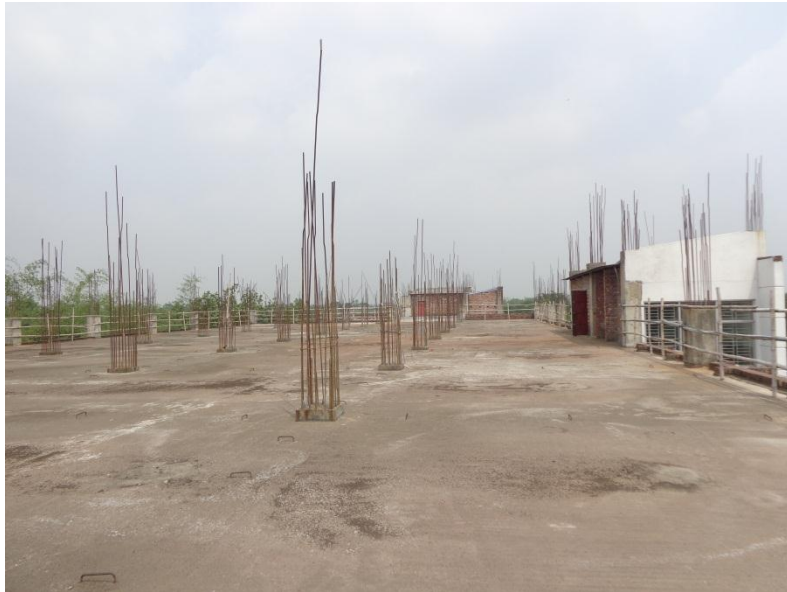
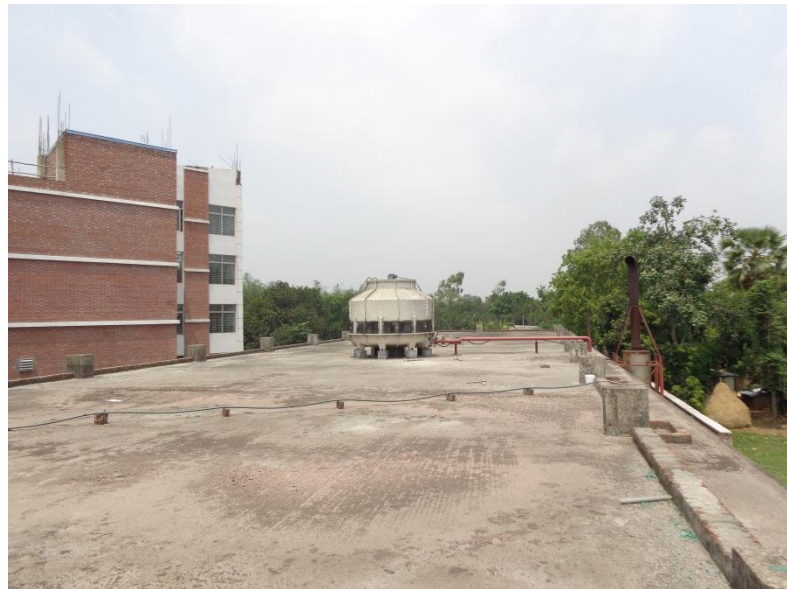
Water Ingress at Roof Level

At the Main Production Building, Washing Plant and the Utility Building, no waterproofing membrane was visible on these roofs. This means that any cracks in the surface finishes on the roof will allow water to seep into the concrete slab and cause long-term soaking of the slab causing corrosion of the reinforcement and deterioration of the brick chip concrete.
