FIRE SAFETY INSPECTION REPORT

Fin Bangla Apparels Ltd

ACCORD ID: 12893

Date: 31 July, 2017

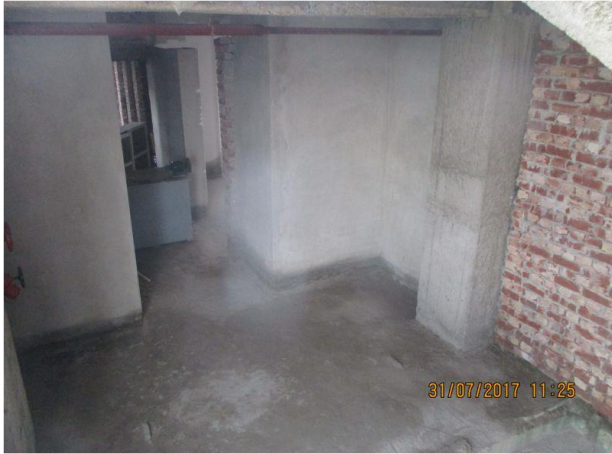
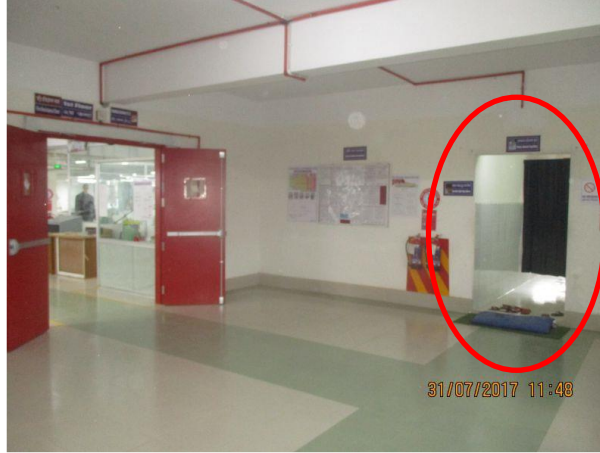
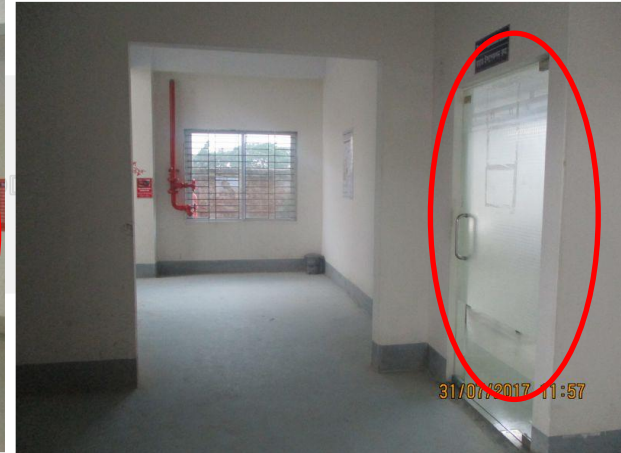
SI No.	Category	Findings	Required Action	Remediation Time Frame
1	Fire Rated Construction	The exit stairs are not separated from work areas and other spaces on each floor by fire-rated construction(Fire door parts were missing for installed doors, corrugated metal roof, toilet facilities at stair landing etc.).	Provide minimum 1-hr rated doors for buildings with 3 or fewer stories and 1.5-hr fire rated doors for buildings that are 4 or more stories. Seal all unprotected openings to separate the exit stairs from work areas and other building spaces on all floor levels. Ensure that the fire doors are self-closing and positive latching and that they are provided with fire exit (panic) hardware where serving production floors. If fire doors are required to be held open for functional reasons, provide automatic closing devices tied to the fire alarm system. Once fire doors are installed, every door in a stair enclosure serving more than 5 stories shall be provided with re-entry unless it meets. (Factory shall ensure that all the door parts are installed and function properly)	Within 3 months

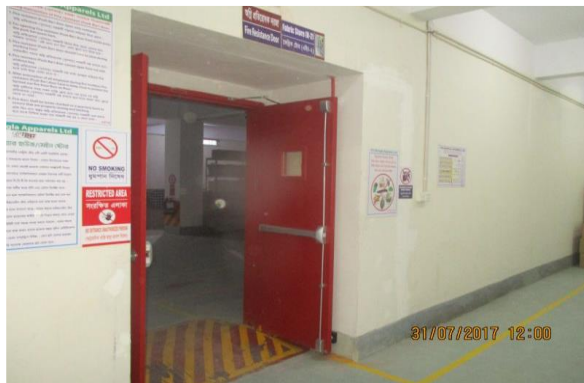
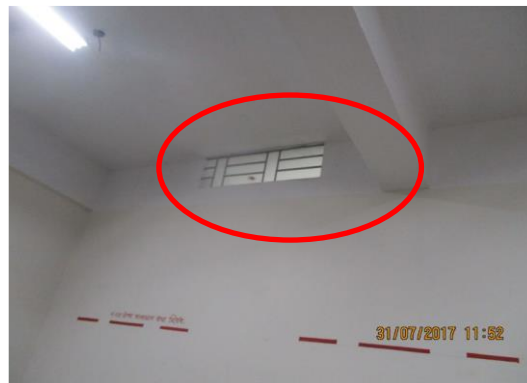
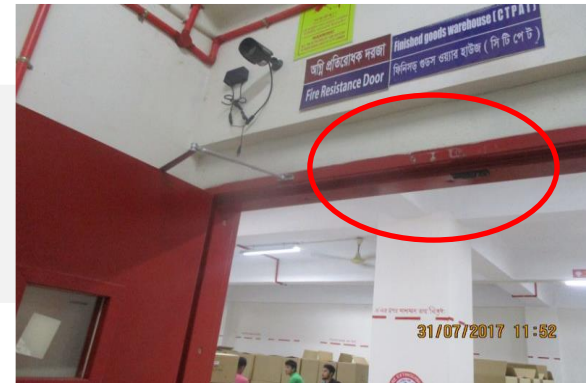
2	Fire Rated Construction	<p>Rooms used for combustible storage are not separated by fire rated construction properly. (Fire door parts like smoke seal, door coordinators were missing)</p> <p>Location: Finished good and fabric store on ground floor.</p>	<p>Provide dedicated storage room separated by minimum 1-hr fire-rated construction. Seal all the unseal penetrations. (Factory shall ensure that all the door parts are installed and function properly)</p>	Within 3 months
---	-------------------------	--	---	-----------------

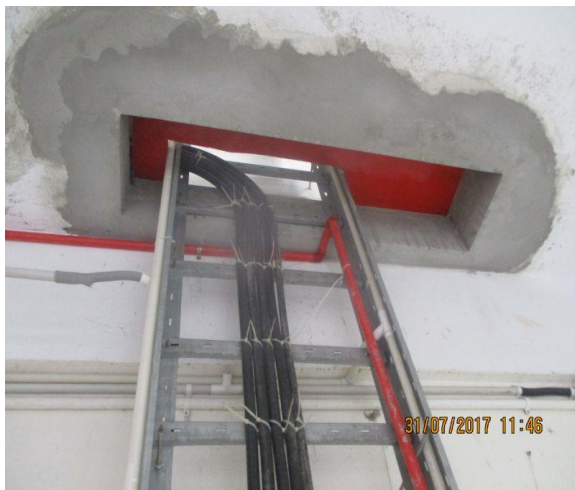
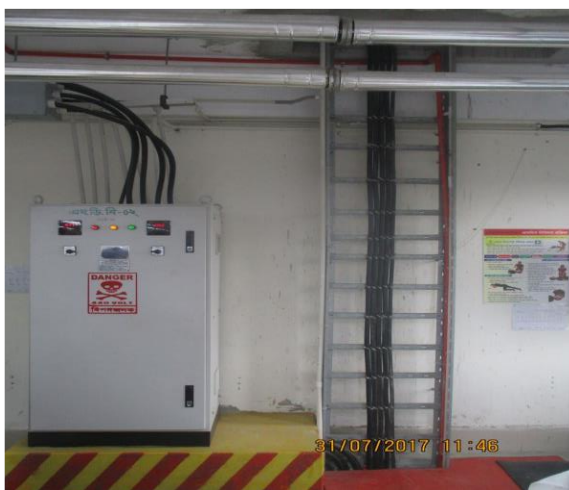
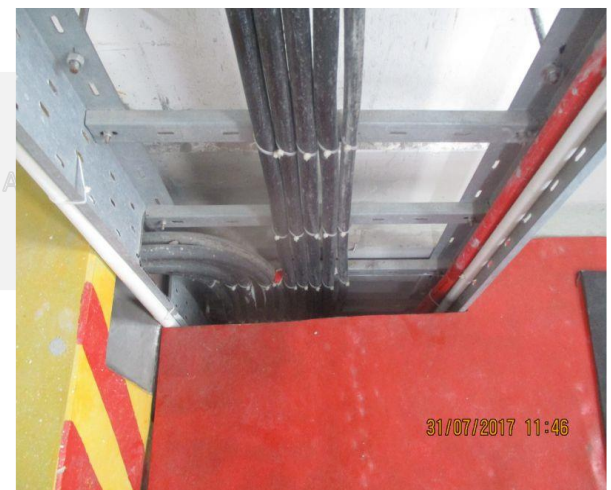
3	Fire Rated Construction	<p>Unsealed penetrations and openings are located in the fire rated floor/ceiling assemblies. Location: electrical cable riser penetration at south-east corner of the building.</p>	<p>Provide a minimum 2-hr fire rated shaft to separate the utility risers from each floor level. Seal all penetrations and openings in floors/ceiling assemblies to maintain the fire separation.</p>	Within 3 months
---	-------------------------	--	--	-----------------

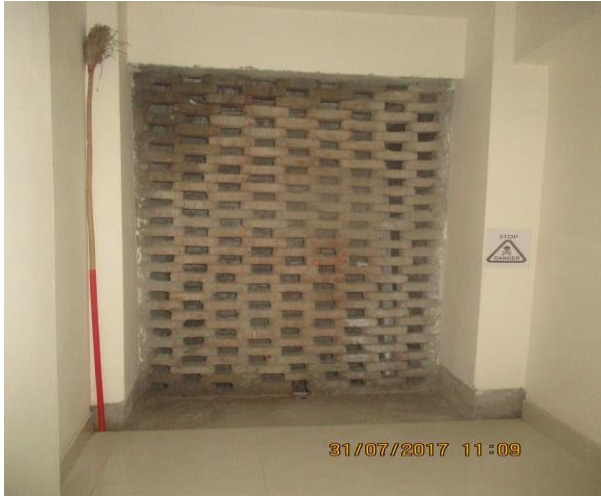
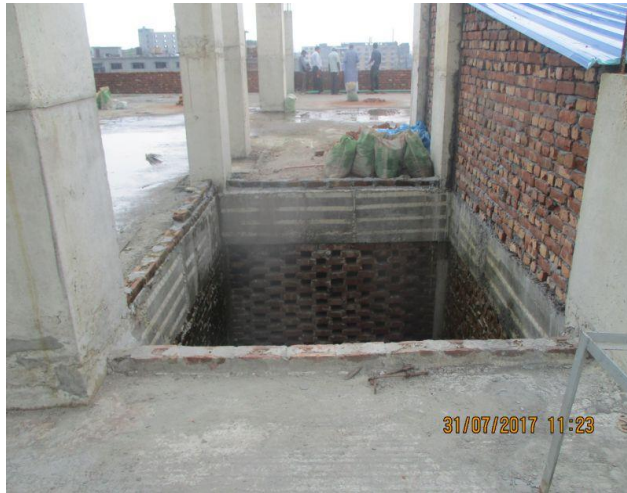
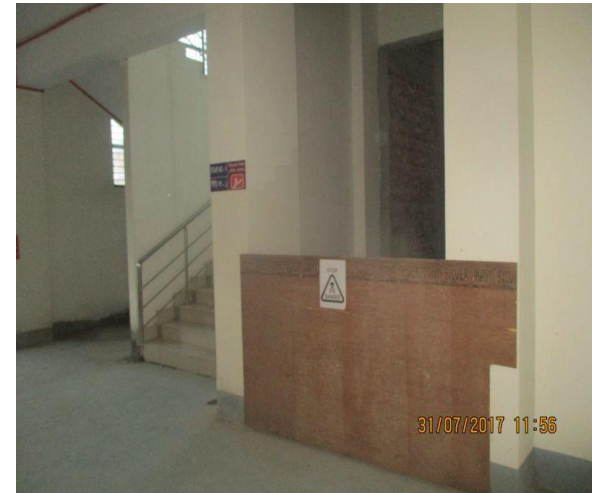
4	Fire Rated Construction	<p>Unsealed penetrations and openings are located in the exit stair enclosures. Location: Elevator shaft at stair-3 and 1.</p>	<p>Seal all penetrations and openings in exit stair enclosure walls to maintain the fire separations.</p>	Within 3 months
---	-------------------------	---	---	-----------------

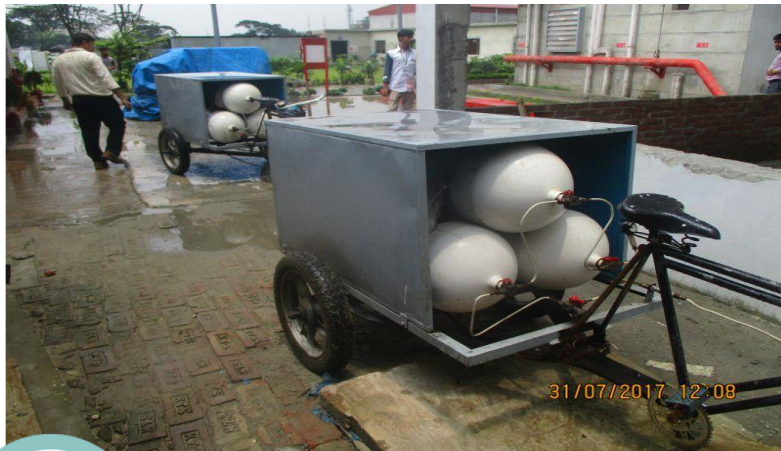
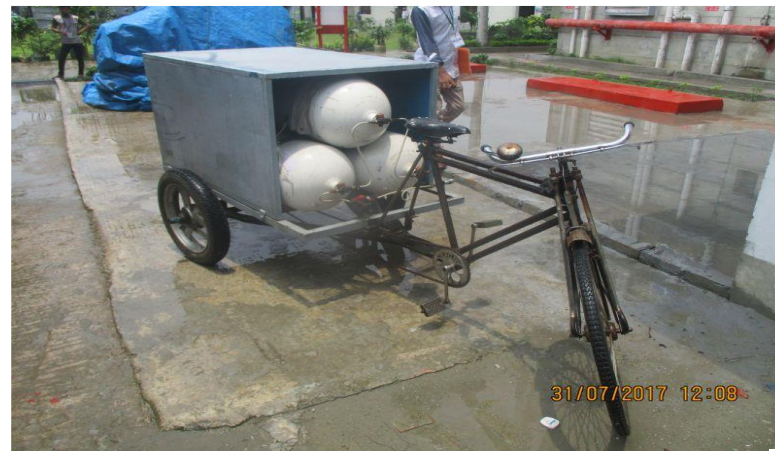
5	Fire Rated Construction	<p>[Hazardous materials / flammable liquid storage] area is not separated by fire-rated construction (openings, non-rated doors, penetrations). Location: Gas cylinder in front of compressor room</p>	<p>Separate the hazardous materials / flammable liquid storage room by a minimum 2-hr fire-rated construction. Seal and/or protect all openings to maintain the required fire separations</p>	Within 3 months
---	-------------------------	--	---	-----------------

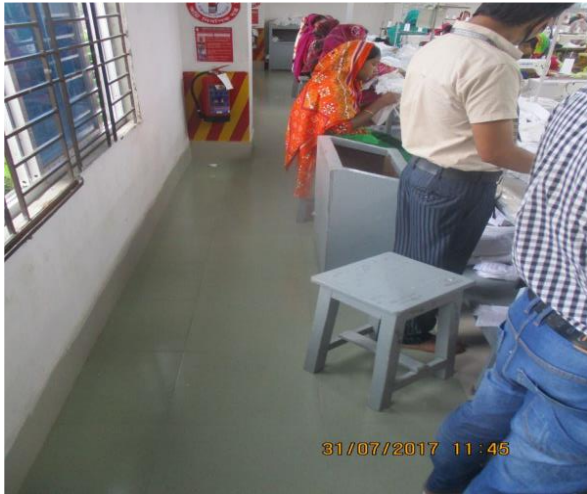
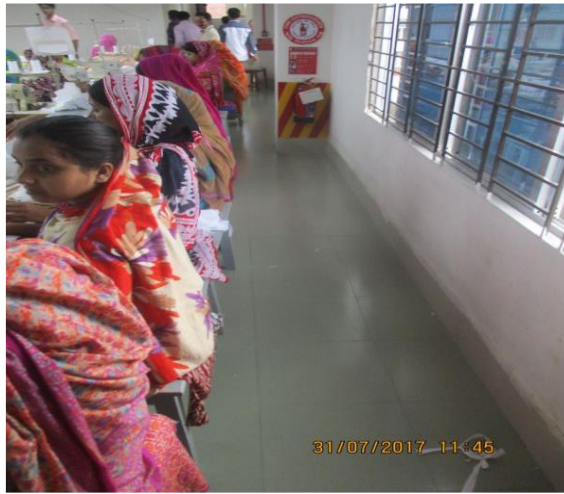
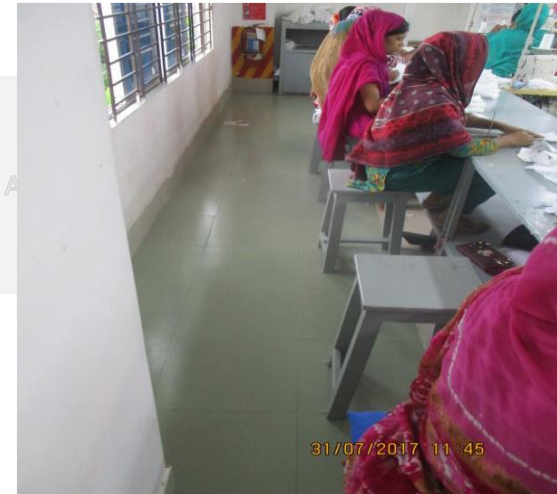
6	Egress	The width of egress aisles is less than 36-inch.	Provide minimum aisle widths of 36-inch. All the aisles shall be free from any kind of obstruction.	Within 3 months
---	--------	--	---	-----------------

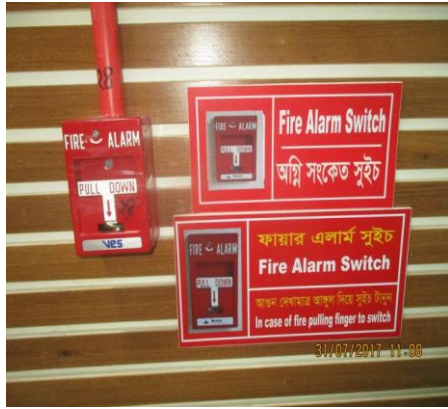
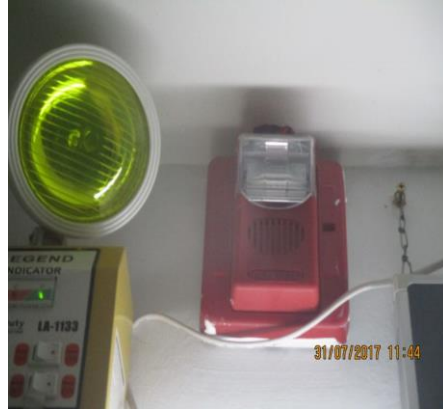
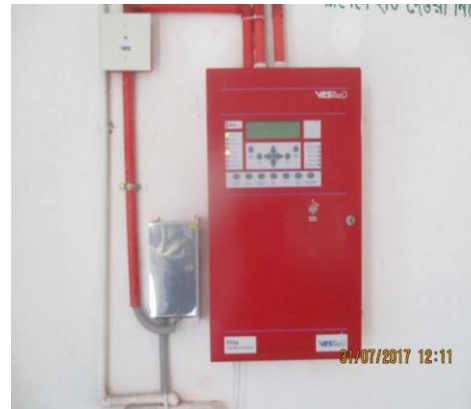
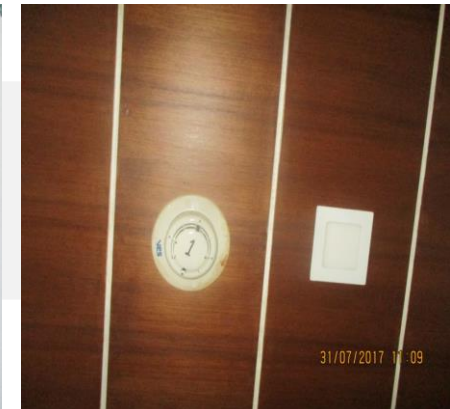
7	As Built Fire Detection System	Fire detection system installation requires modification and detailed review to confirm compliance with NFPA 72 and ACCORD standards	Submit as-built drawings, testing records, equipment certification and other relevant documentation to the ACCORD for review and approval	Design 1 month, modification within 5 months
---	--------------------------------	--	---	--

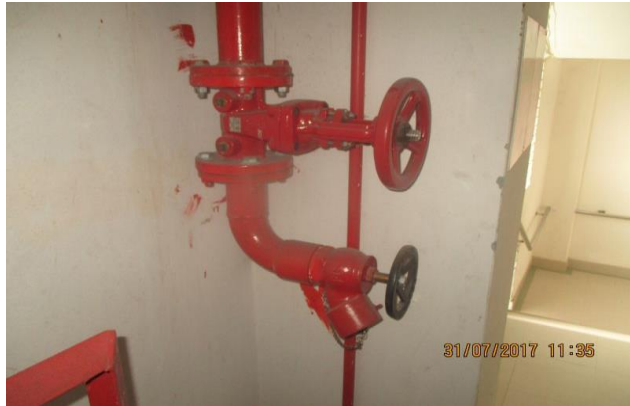
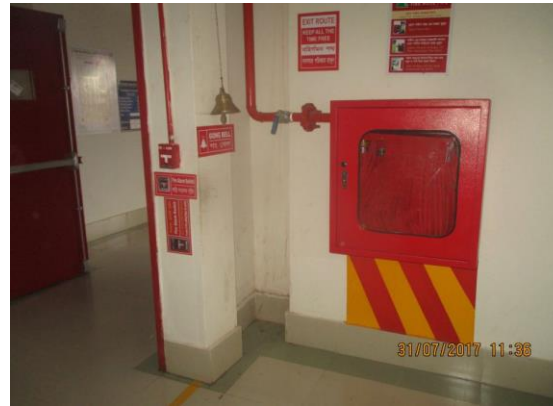
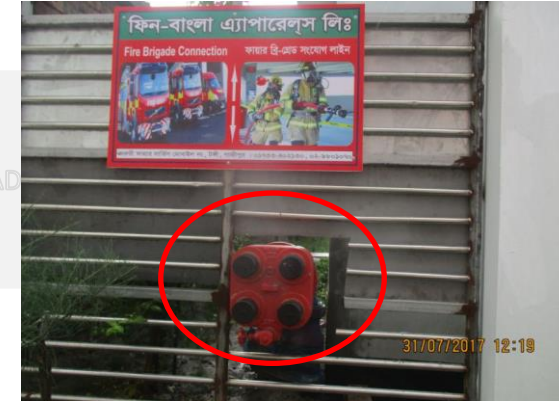
8	Fire Detection ITM	Inspection, testing, and maintenance for the fire detection system is not in accordance with NFPA 72.	Inspect, test and maintain the fire detection system, and keep written records on-site, in accordance with NFPA 72.	Within 3 months
9	Standpipe System	The existing building has an occupied floor greater than 10 meter (33 feet) and a system was found which is not fully installed requires modification and detailed review to confirm compliance with NFPA 14 and ACCORD standards.	Submit as-built drawings, testing records, equipment certification and other relevant documentation to the ACCORD for review and approval	Design within 1 months, Install within 6 months

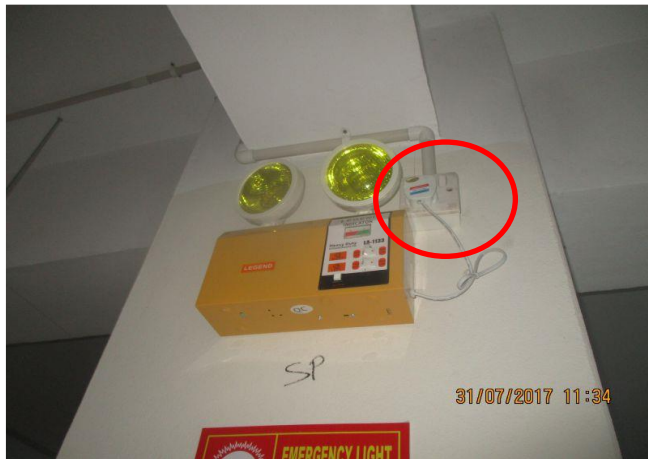
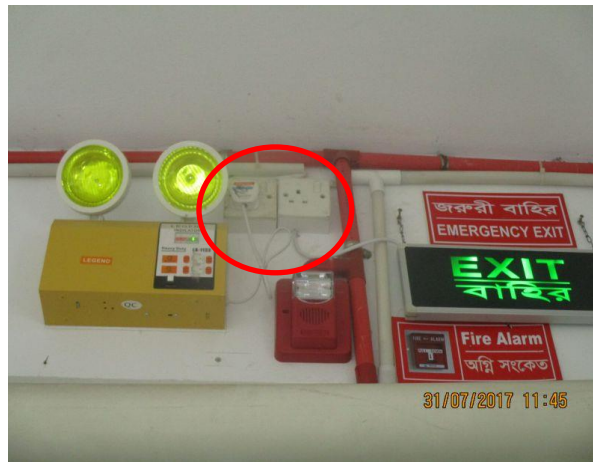
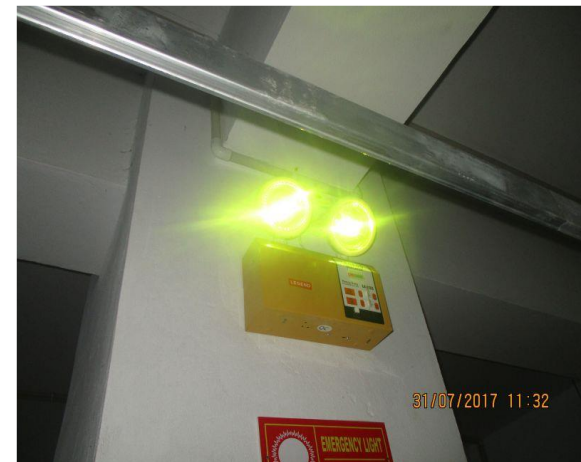
12	On/Off Switch	Manual on-off switch is provided for [emergency lighting / exit signage] units.	Remove manual on/off switches from [emergency lighting / exit signage] units to prevent them from being switched off	Within 1 month
----	---------------	---	--	----------------

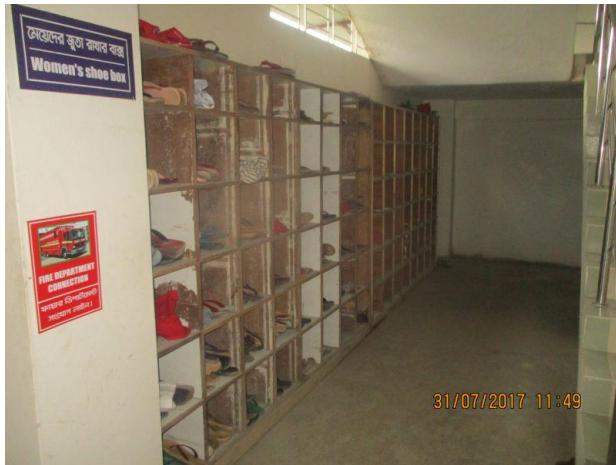
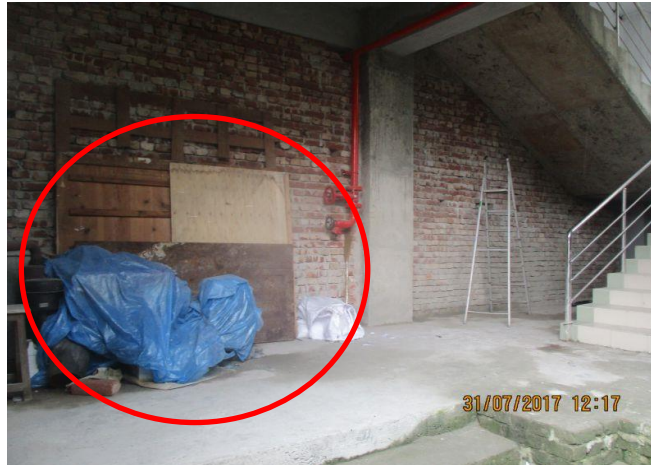
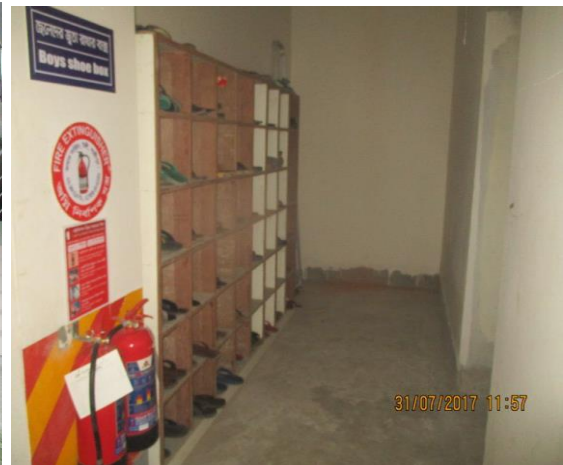
13	Emergency Lighting ITM	Inspection, testing, and maintenance for the emergency lighting system was not in accordance with The ACCORD standard.	Inspect, test and maintain the emergency lighting system in the accordance with The ACCORD standard. Keep written records on-site.	Within 3 months
14	Egress	Storage was located under exit stair on ground floor.	Remove storage from the exit stairs and egress path	Immediate

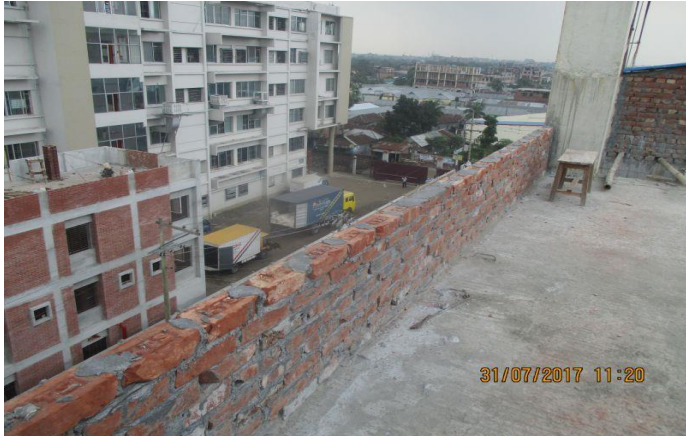
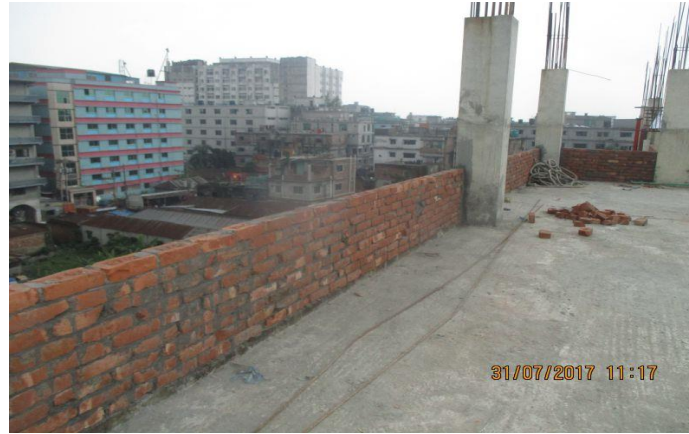
15	No Parapets or Guards	Parapets or guards are provided in occupied roof which is less than 1067mm (42 inch.).	Provide parapets or guards with a minimum height of 1067mm (42 inch.).	Within 3 months
----	-----------------------	--	--	-----------------

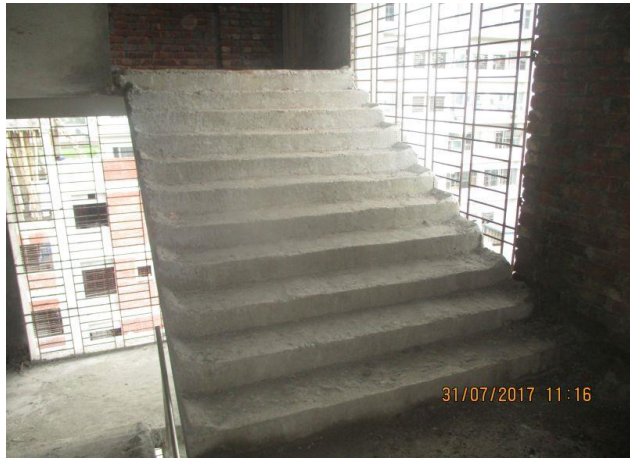
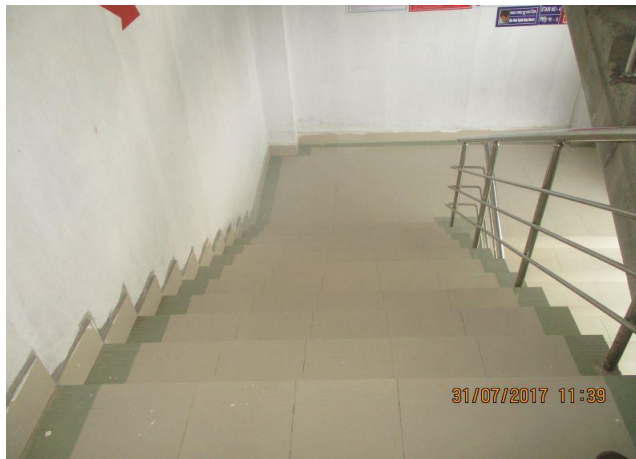
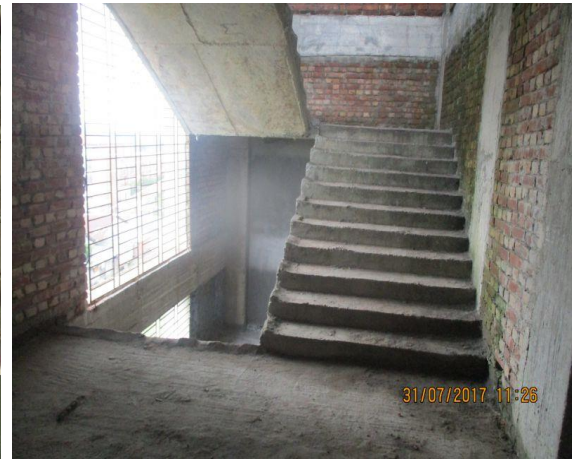
16	No Handrails	Handrails are not provided on both sides of each exit stairs on all floors. Having handrails on one side of said staircase, may pose as a falling hazard during evacuation.	Provide handrails on both sides of the exit stair. New handrails shall have a minimum height of 865 mm (34 in.) and a maximum height of 965 mm (38 in.) as measured from the leading edge of the tread. Intermediate handrails shall be provided when the stair width exceeds 2.2 m (87 in.)	Within 3 months
----	--------------	---	--	-----------------

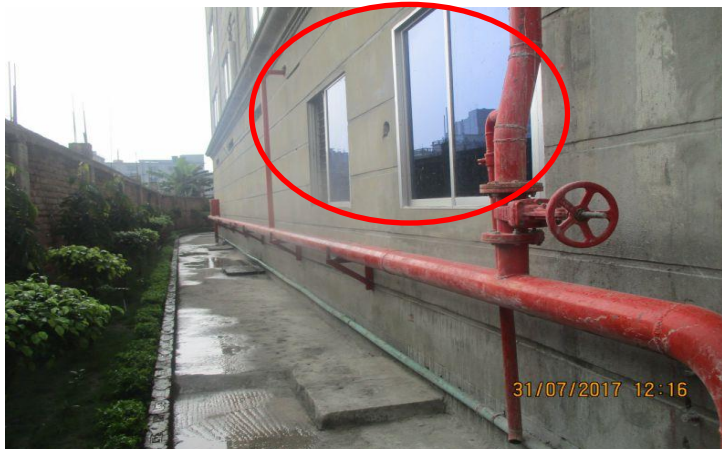
17	Unprotected Exterior Discharge Path	The exit discharge path serving stair-4 is less than 10 ft. wide and is not separated from the building interior.	Seal all penetrations and openings to the interior of the building along the discharge path, up to a height of 10 ft., to provide a minimum 1-hr fire separation.	Within 3 months
----	-------------------------------------	---	---	-----------------
