# **FIRE SAFETY INSPECTION REPORT**

## **CA KNITWEAR LIMITED (RELOCATION)**

**ACCORD ID: 12871**

**Date: 20 June, 2017.**

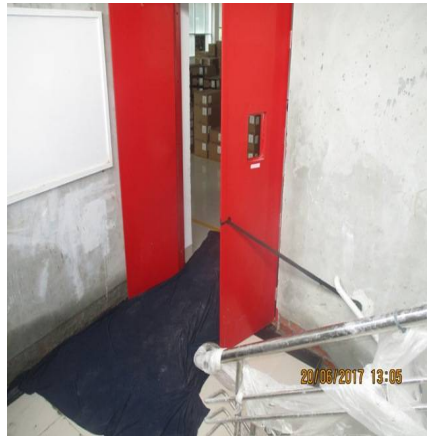
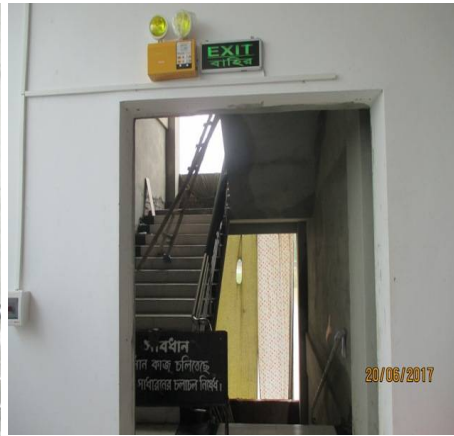
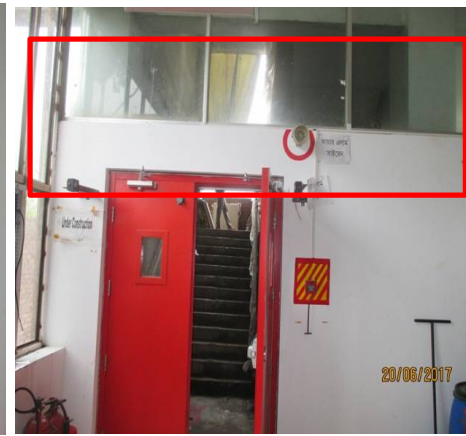
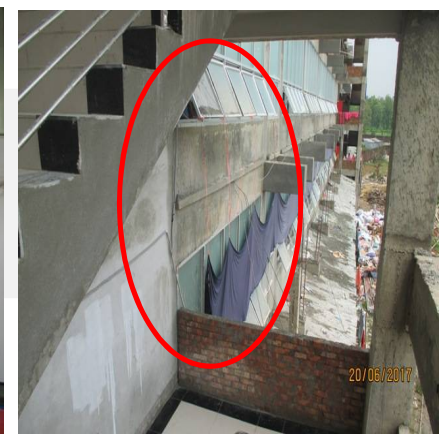
| Sl No. | Category | Findings | Required Action | Remediation Time Frame |
|---|---|---|---|---|
| 1 | Fire Rated Construction (Building 1 & 2) | The exit stairs enclosures are not separated from work areas and other spaces on each floor by fire-rated construction(Non rated doors, unsealed penetrations and openings etc.). | Provide minimum 1-hr rated doors for buildings with 3 or fewer stories and 1.5-hr fire rated doors for buildings that are 4 or more stories. Seal all unprotected openings to separate the exit stairs from work areas and other building spaces on all floor levels. Ensure that the fire doors are self-closing and positive latching and that they are provided with fire exit (panic) hardware where serving production floors. If fire doors are required to be held open for functional reasons, provide automatic closing devices tied to the fire alarm system. Once fire doors are installed, every door in a stair enclosure serving more than 5 stories shall be provided with re-entry unless it meets. Seal all penetrations and openings to the interior of the building up to a height of 10 ft. to provide proper fire rated separation. | Within 3 months |

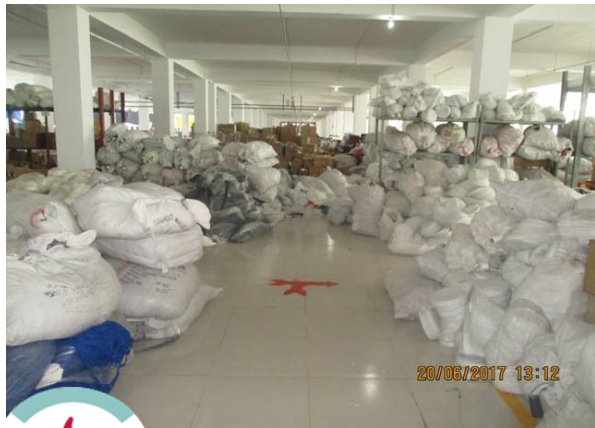
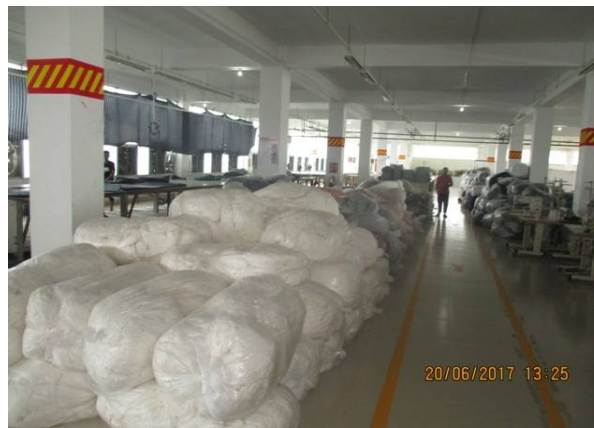
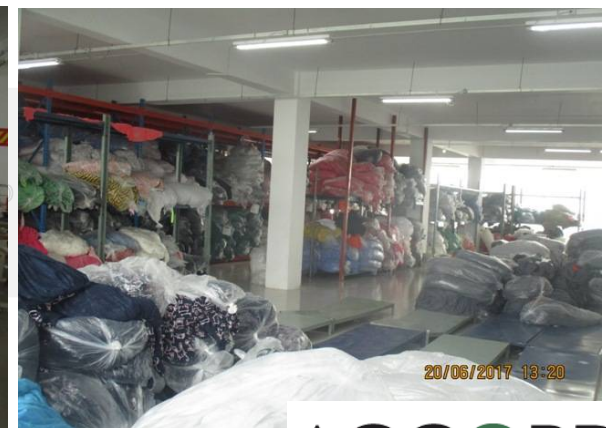
| 2 | Fire Rated Construction (Building 1) | <p>Areas used for combustible storages are not separated by fire rated construction.</p> <p><b>Location:</b> Throughout 2nd floor with cutting section, Middle &amp; South side of 1st floor packing section &amp; Metal free zone on GF.</p> | <p>Provide dedicated storage rooms separated by minimum 1-hr fire-rated construction. Where separate storage rooms are not feasible, provide defined storage areas and limit the storage arrangement as follows:</p> <ul style="list-style-type: none"> <li>- Maximum height of 2.4m and maximum area of 23m<sup>2</sup></li> <li>- If sprinkler protected: maximum height of 3.66m and maximum area of 93m<sup>2</sup></li> </ul> <p>Separate areas of unenclosed combustible storage by a minimum clear distance of 3m.</p> | Within 3 months |

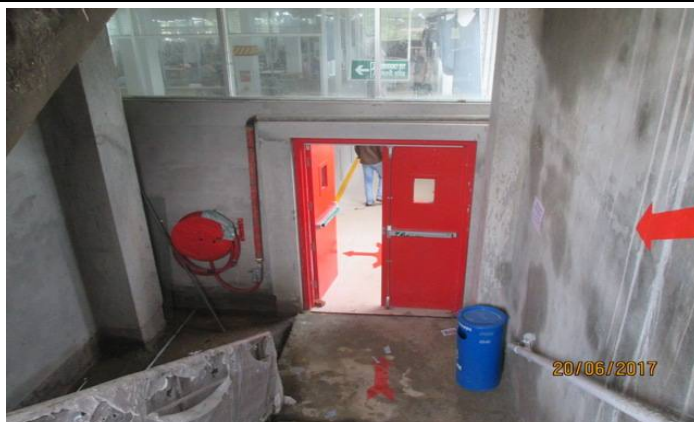
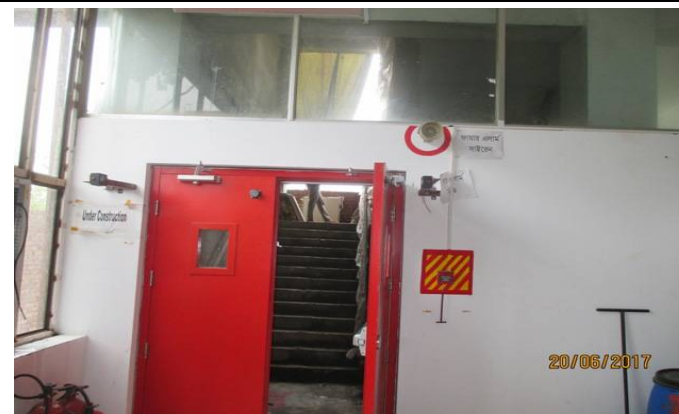
| 3 | Interior Exit Discharge | Exit stairs discharge the occupants inside the building.<br>Location: East & South-east stairs. (Stair: 5 & 6) | 1. Modify stair to discharge directly outside.<br>Or<br>2. Provide 2-hr fire-rated exit passageway leading directly outside (vestibules to separate any storage areas). | Within 3 months |

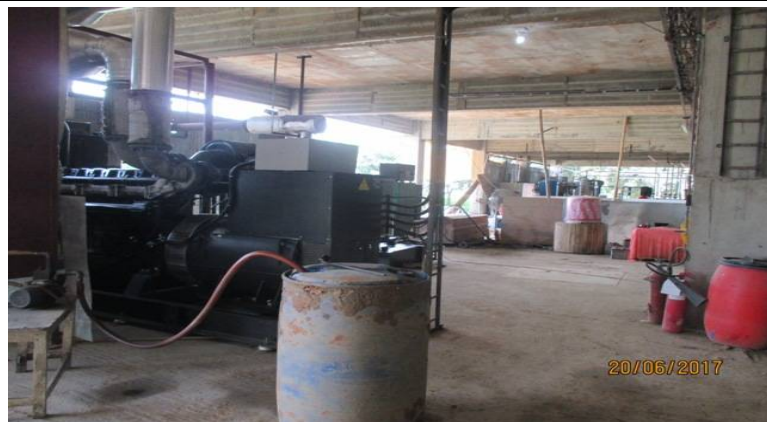
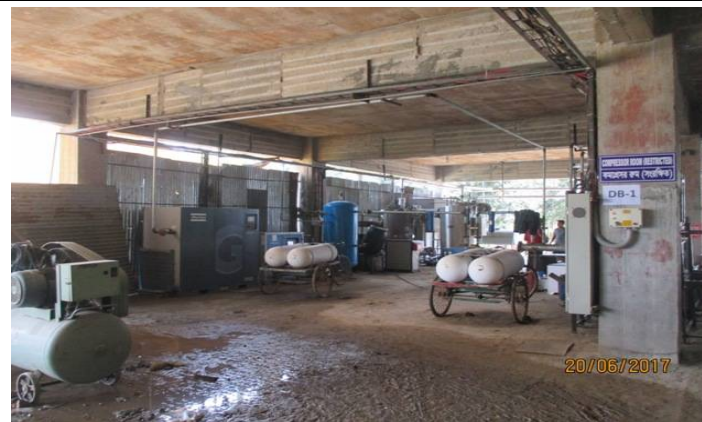
| 4 | Fire Rated Construction | <p>Boiler, Generator, Compressor &amp; CNG Cylinders are not properly separated from each other by fire rated construction.</p> <p>Location: Ground Floor, Building 2.</p> | <p>1. Boilers or other heat producing equipment shall be separated from other occupancies by a minimum 1-hr (2-hr for highrise building) fire rated construction (wall, floor, slab etc.). Seal all penetrations and openings (door, window etc.) should be protected by 0.75-hr (45 min) fire rated materials to maintain the fire separation if required. All exhaust systems shall discharge to the exterior of the building in a safe location. Or, Relocate it to exterior of the building and maintain a minimum 3m (10 ft.) spatial separation distance from the building.</p> <p>2. Generator, Compressor &amp; CNG room shall be separated from other occupancies by a minimum 2-hr fire rated construction (wall, floor, slab etc.). Seal all penetrations and openings (door, window etc.) should be protected by 1.5-hr fire rated materials to maintain the fire separation if required. All exhaust systems shall discharge to the exterior of the building in a safe location. Or, Relocate to exterior of the building and maintain a minimum 3m (10 ft.) spatial separation distance from the building.</p> | Within 3 months |

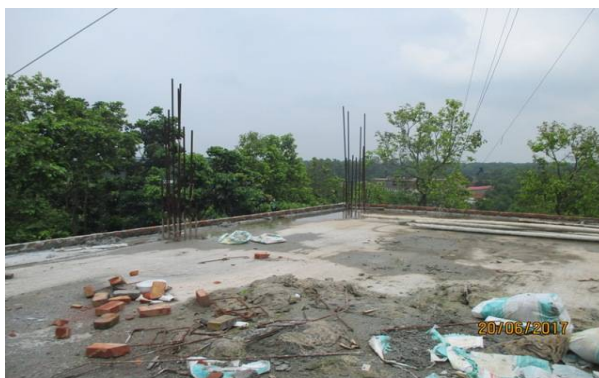
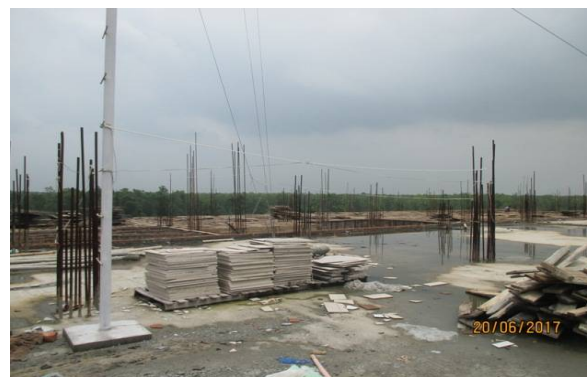
| 5 | Parapets or Guards | Parapets or guards are not provided in occupiable roof. | Provide parapets or guards with a minimum height of 1067mm (42 inch.). | Within 3 months |

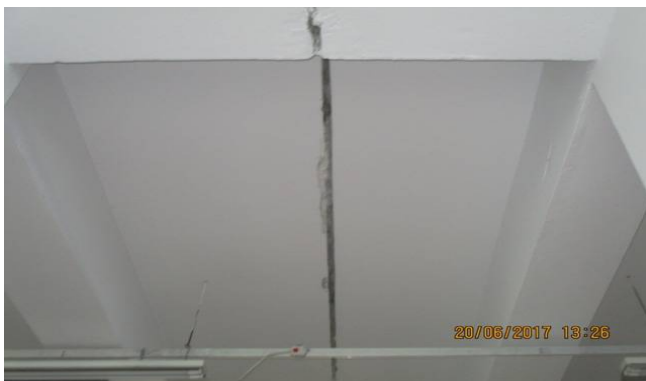
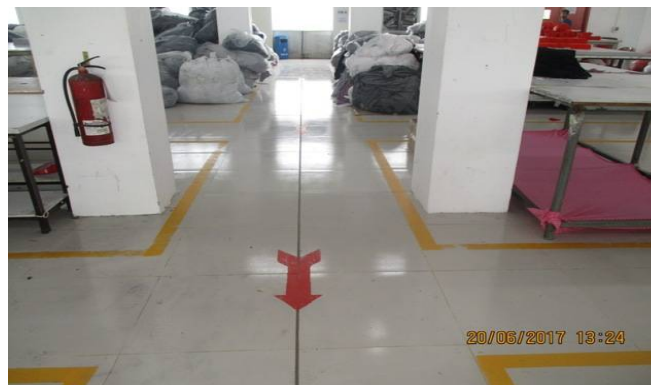
| 6 | Fire Rated Construction | Unsealed penetrations (Building joint) & openings are located in the fire rated floor/ceiling assemblies. | Seal all penetrations and openings in floors/ceiling assemblies to maintain the fire separation. | Within 3 months |

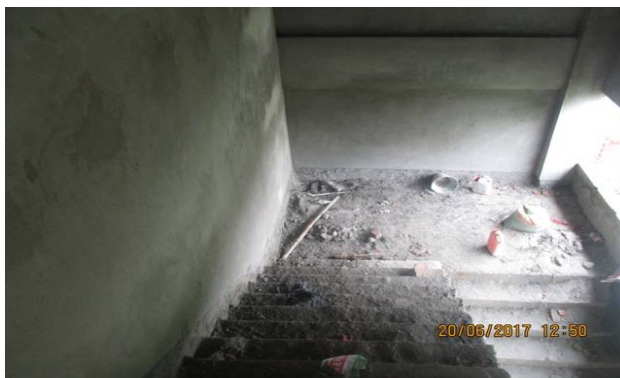
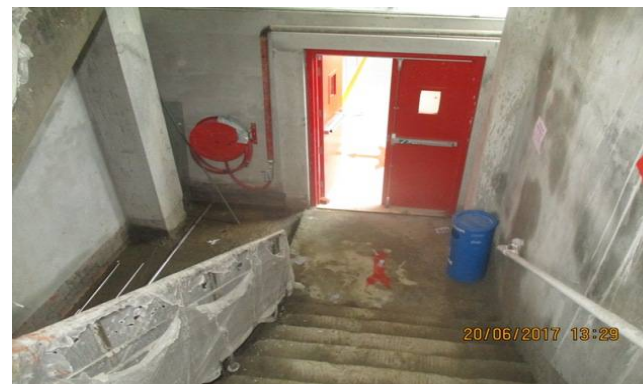
| 7 | Handrail | Handrails are not provided on both sides of the exit stairs. | Provide handrails on both sides of the exit stair. New handrails shall have a minimum height of 865mm (34 in.) and a maximum height of 965 mm (38 in.) as measured from the leading edge of the tread. Intermediate handrails shall be provided when the stair width exceeds 2.2 m (87 in.) | Within 3 months |

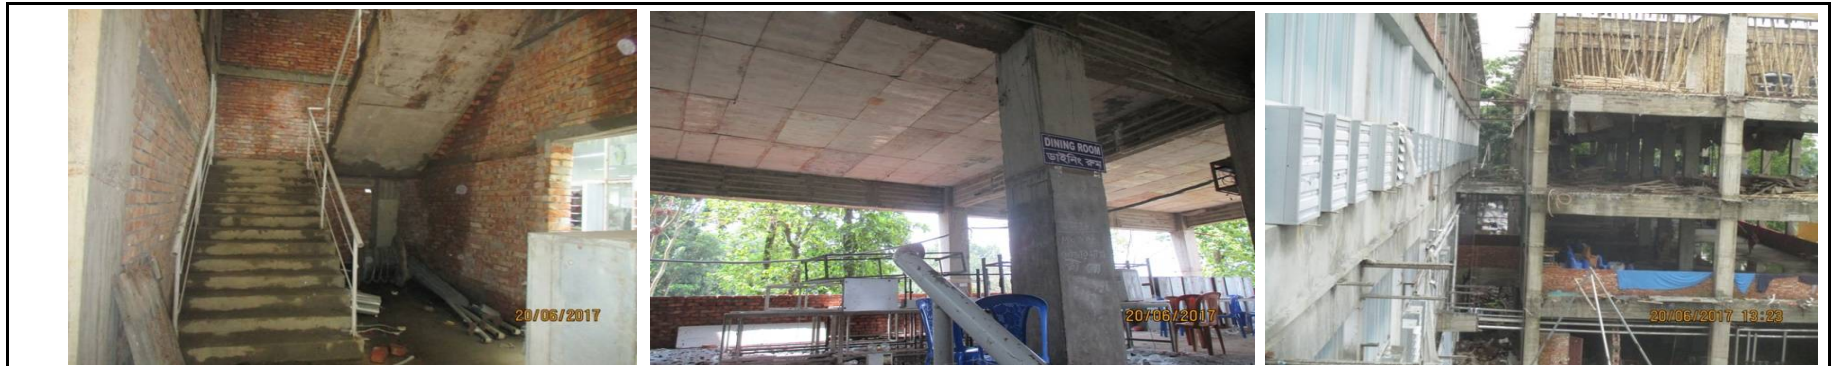
| 11 | Occupant load/ Exit capacity & Fire rated construction | A single means of egress/stair is provided from dining area on 1st floor (Building: 2) where the occupant load is 800. | Relocate the Dinning & Prayer room to ground floor Or,<br>Provide additional means of egress/ exit stair in accordance with Accord Standard 6.6.1 & as per occupant. Provide all exit stair width minimum of 2 meters.<br>and provide minimum 2 hours fire rated separation between assembly occupancy & other facilities. | Within 3 months |

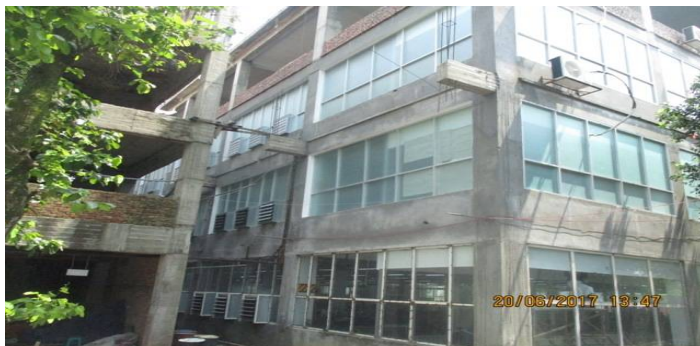
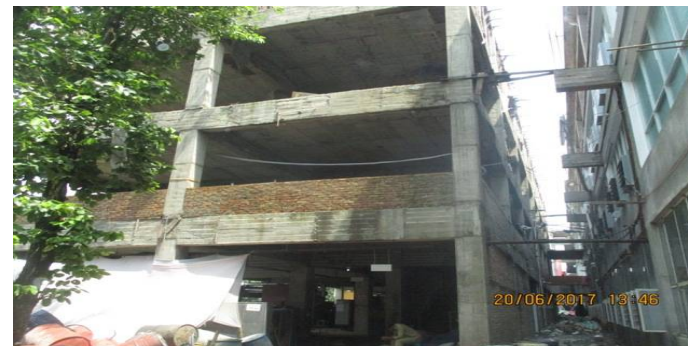
| 13 | Fire Protection System (Building 1 & 2) | The existing building has an occupied floor greater than 10 meter (33 feet) and is not provided with proper standpipe protection. | Install a new standpipe system, fire pump & fire department connection in accordance with NFPA 14,20,22 & 24. A class I system shall be permitted in buildings protected throughout by an automatic sprinkler system. | Design within 4 months, Install within 9 months |

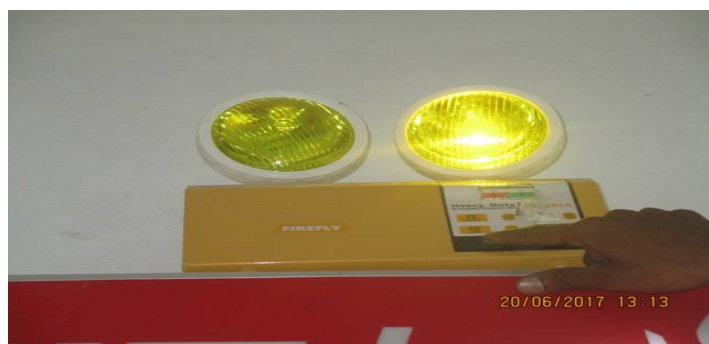
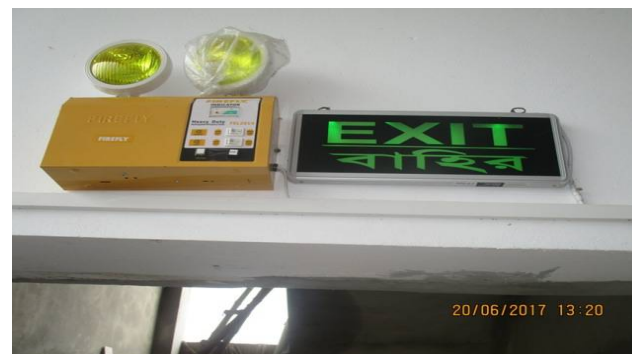
| 17 | Egress Lighting | Manual on-off switch facility available for emergency lights/exit signs. | Remove manual on/off switches from emergency lighting units/ exit signs to prevent them from being switched off. | Within 1 month |

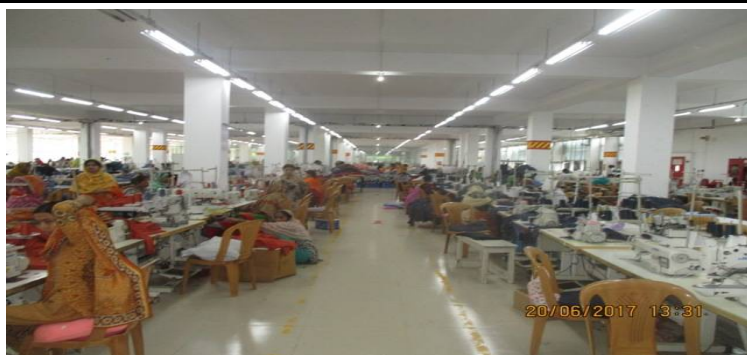
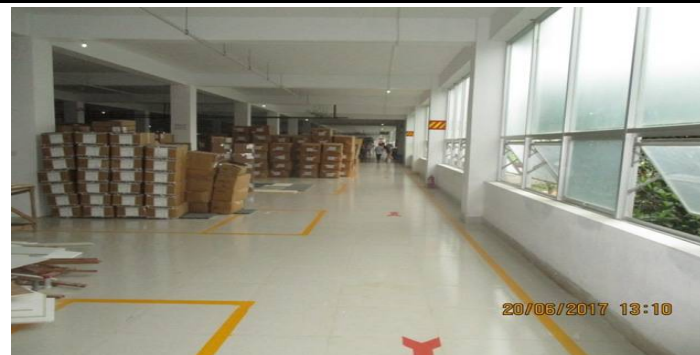
| 19 | Egress Lighting | The directional signs are not provided where there is a change in direction and where the continuation of the egress path is not obvious. | Install illuminated directional sign where there is a change in the direction of the path of travel. | Within 1 month |

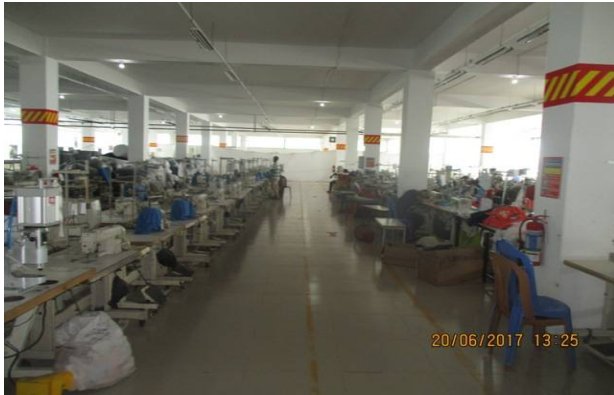
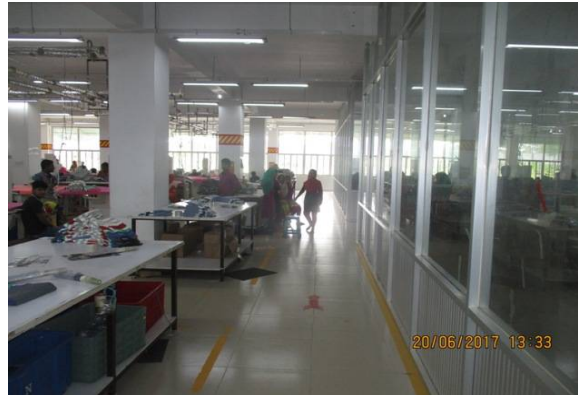
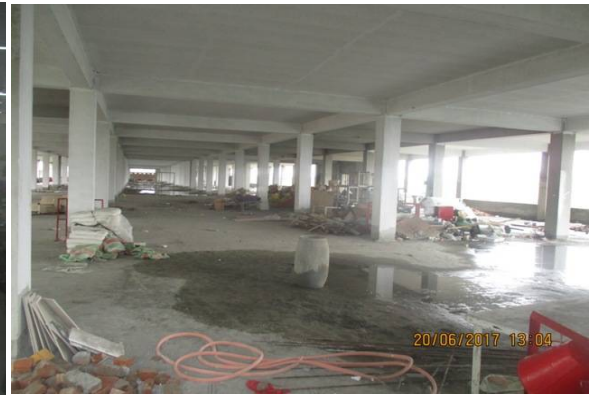
| 20 | Egress Lighting | Based on the number and location of emergency lights/exit signs observed, adequate illumination levels are not anticipated along egress routes.<br><b>Location:</b> All through the building. | Test the emergency lighting system on each floor and provide additional emergency fixtures to provide adequate illumination along the means of egress. Provide a minimum illumination of 10 lux at the floor level within exit stairs and exit discharge paths and minimum 2.5 lux along exit access aisles. | Within 3 months |
