# **FIRE SAFETY INSPECTION REPORT**

**SF Sweaters Ltd. Building - 2**

**ACCORD ID: 12844**

**Date: 17 May, 2017**

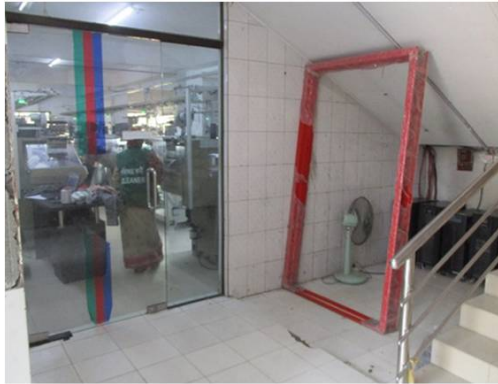
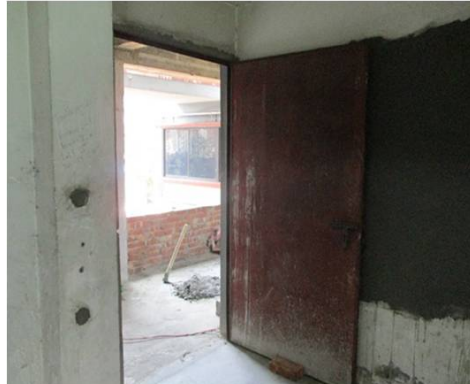
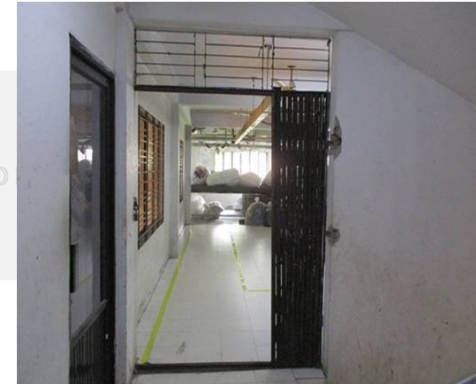
| Sl No. | Category | Findings | Required Action | Remediation Time Frame |
|---|---|---|---|---|
| 1 | Fire Rated Construction | The exit stairs enclosures are not separated from work areas and other spaces on each floor by fire-rated construction(Non rated doors, unsealed penetrations and openings etc.). | Provide minimum 1-hr rated doors for buildings with 3 or fewer stories and 1.5-hr fire rated doors for buildings that are 4 or more stories. Seal all unprotected openings to separate the exit stairs from work areas and other building spaces on all floor levels. Ensure that the fire doors are self-closing and positive latching and that they are provided with fire exit (panic) hardware where serving production floors. If fire doors are required to be held open for functional reasons, provide automatic closing devices tied to the fire alarm system. Once fire doors are installed, every door in a stair enclosure serving more than 5 stories shall be provided with re-entry unless it meets. | Within 3 months |

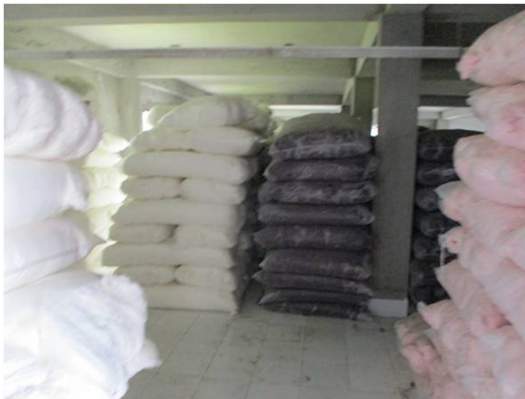
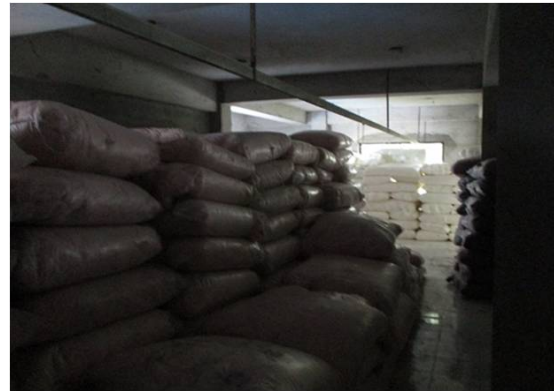
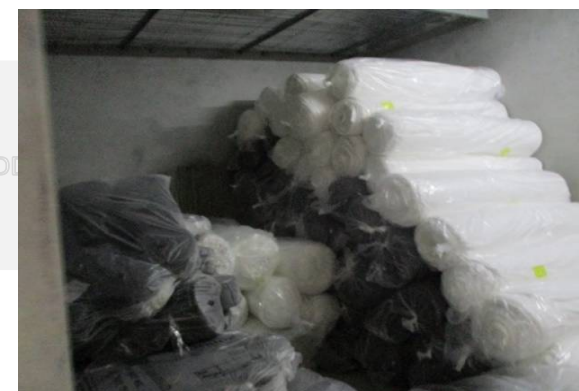
| 2 | Fire Rated Construction | Rooms used for combustible storage are not separated by fire rated construction properly. | Provide dedicated storage room separated by minimum 1-hr fire-rated construction. | Within 3 months |

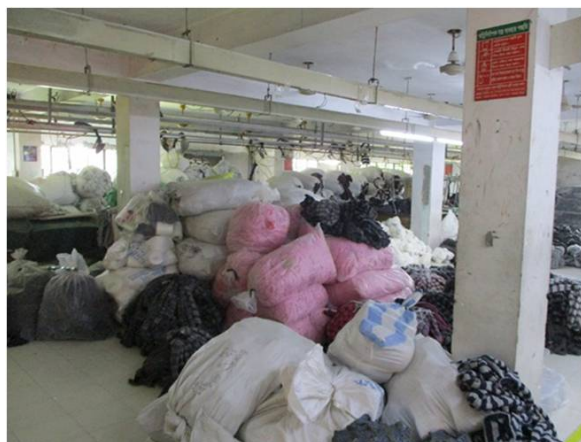
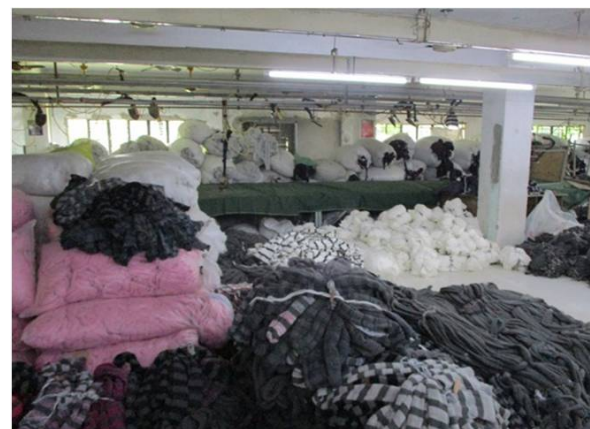
| 3 | Fire Rated Construction | <p>Areas used for combustible storage are not separated by fire rated construction.</p> <p><b>Location:</b> 1st floor (finishing) cutting section.</p> | <p>Provide dedicated storage rooms separated by minimum 1-hr fire-rated construction.</p> <p>Where separate storage rooms are not feasible, provide defined storage areas and limit the storage arrangement as follows:</p> <ul style="list-style-type: none"> <li>- Maximum height of 2.4m and maximum area of 23m<sup>2</sup></li> <li>- If sprinkler protected: maximum height of 3.66m and maximum area of 93m<sup>2</sup></li> </ul> <p>Separate areas of unenclosed combustible storage by a minimum clear distance of 3m.</p> | Within 3 months |

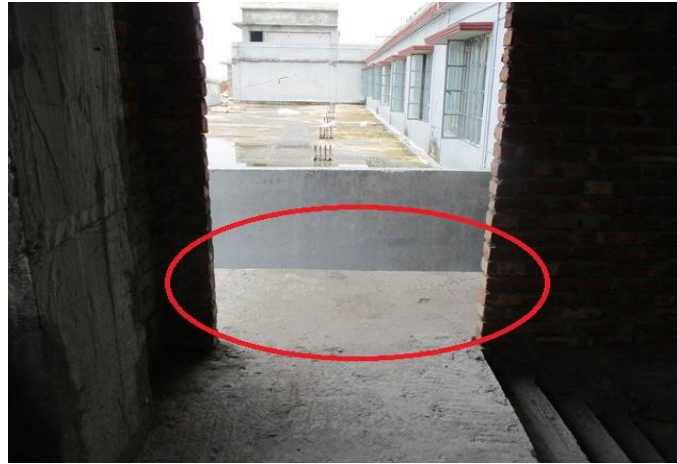
| 4 | Guard rail | <p>The occupiable roof was not provided with an adequate guard rail.</p> | <p>All occupiable roofs shall be provided with parapets or guards with a minimum height of 1067 mm (42 in.)</p> | Within 3 months |

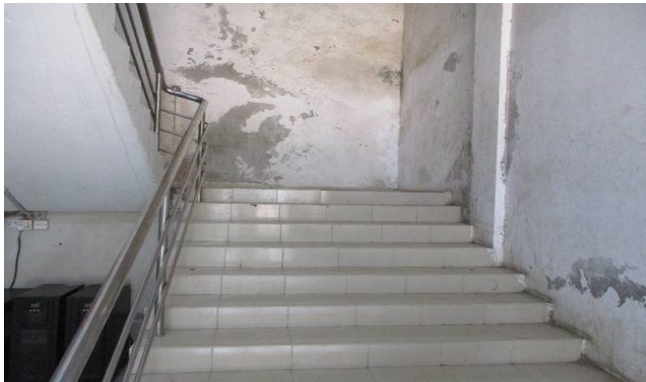
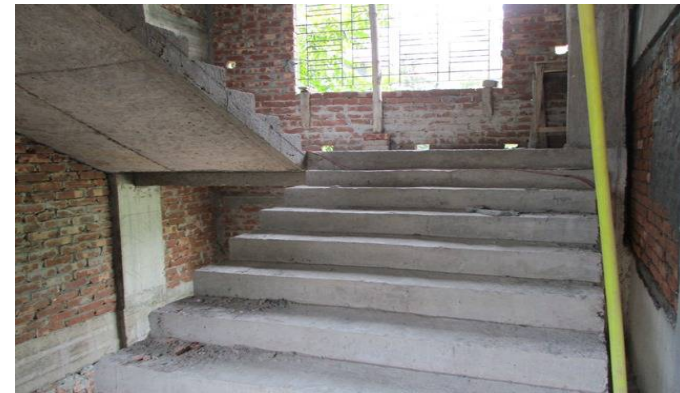
| 5 | Handrail | <p>Handrails are not provided on both sides of each exit stairs on all floors. Having handrails on one side of said staircase, may pose as a falling hazard during evacuation.</p> <p>Or, Handrails are not provided at exit stairs.</p> | <p>Provide handrails on both sides of the exit stair. New handrails shall have a minimum height of 865 mm (34 in.) and a maximum height of 965 mm (38 in.) as measured from the leading edge of the tread.</p> <p>Intermediate handrails shall be provided when the stair width exceeds 2.2 m (87 in.)</p> | Within 3 months |

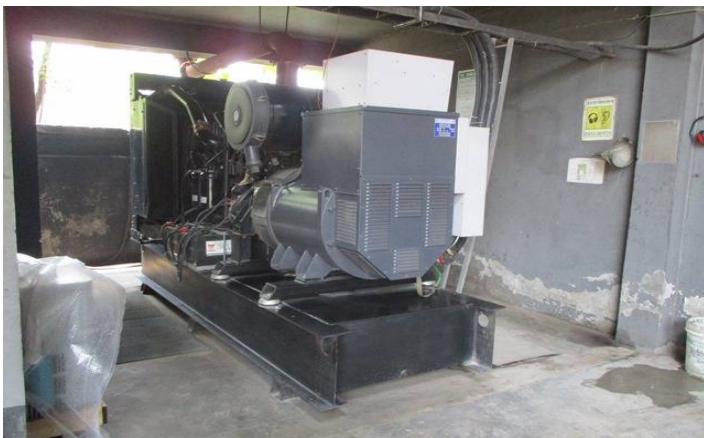
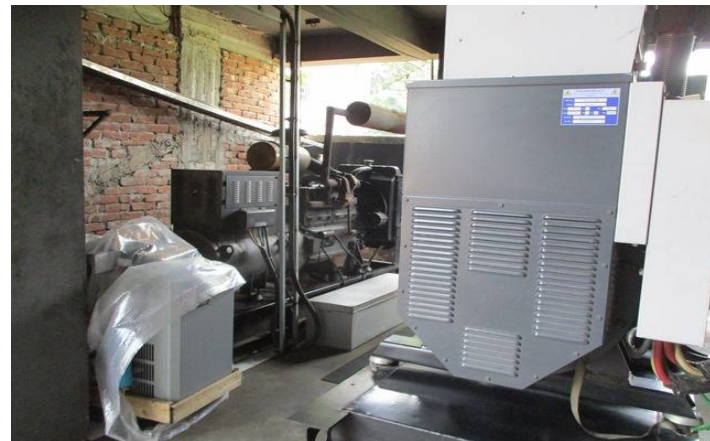
| 6 | Fire Rated Construction | Generator room is not properly separated by fire rated construction with other Occupancies/Areas | Generator room shall be separated from other occupancies by a minimum 2-hr fire rated construction (wall, floor, slab etc.). Seal all penetrations and openings (door, window etc.) shall be protected by 1.5-hr fire rated materials to maintain the fire separation if required. All exhaust systems shall discharge to the exterior of the building in a safe location. | Within 3 months |

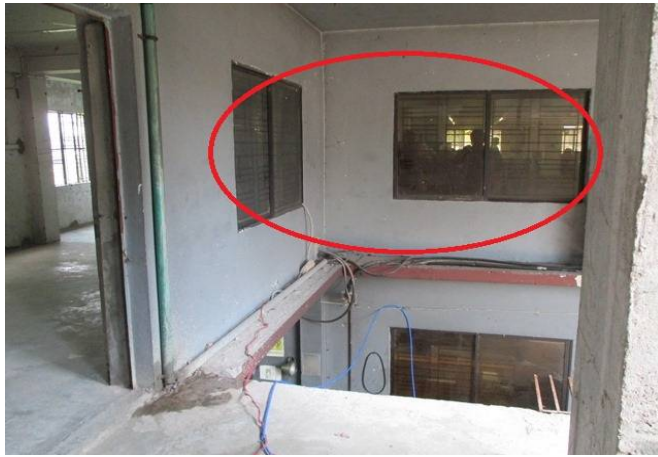
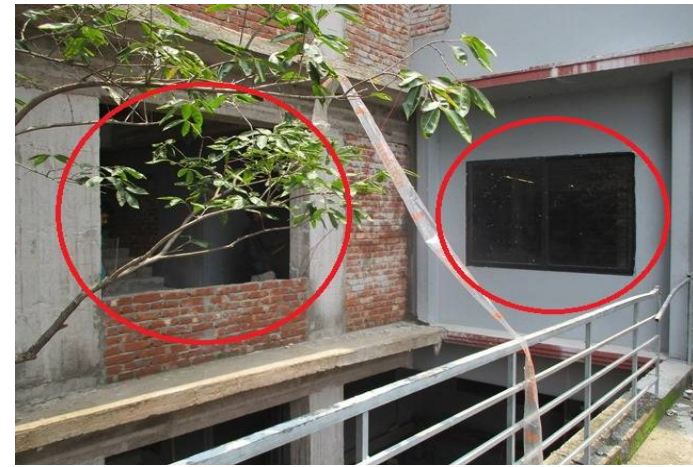
| 7 | Stair case separation | The southeast exit stair is not properly separated from the building. | Exterior exit stairs shall be separated from the building with a rating requirement of 1 hr. fire rating for 3 or fewer stories or 2 hr. fire rating for 4 or more stories. The rating of the exterior wall shall extend 3.05 m (10ft) beyond the ends of the stair structure. | Within 3 months |

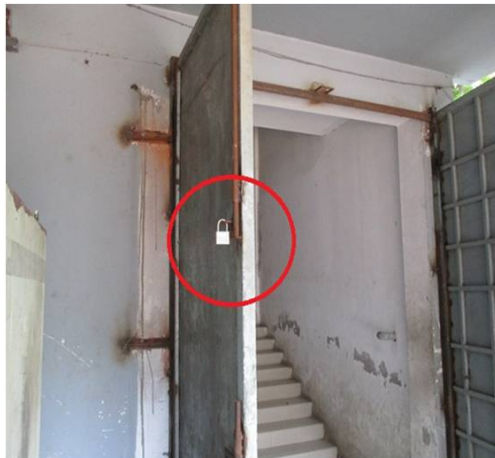
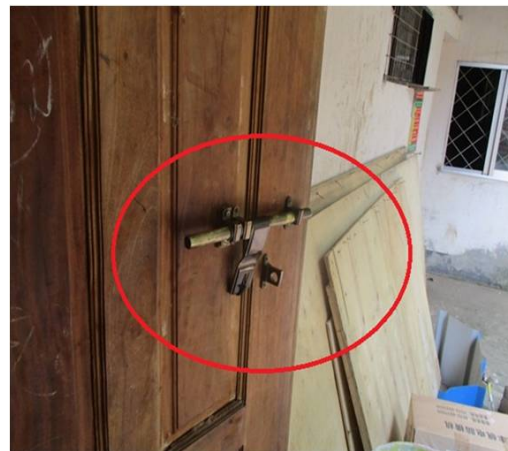
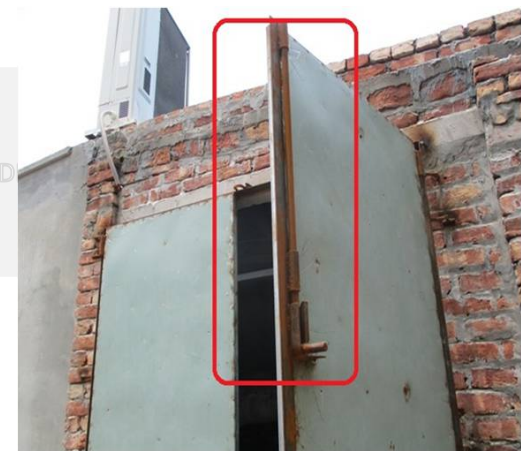
| 8 | Egress | <p>Egress doors/gates with locking features not complying with NFPA101 are provided at building.</p> <p><b>Location:</b> Ground floor middle &amp; N-W main exit gates.</p> | <p>Remove locking features from all egress doors/gates. If locks are required for security reasons, utilize specialized door locking features complying with NFPA101.</p> | Immediate |

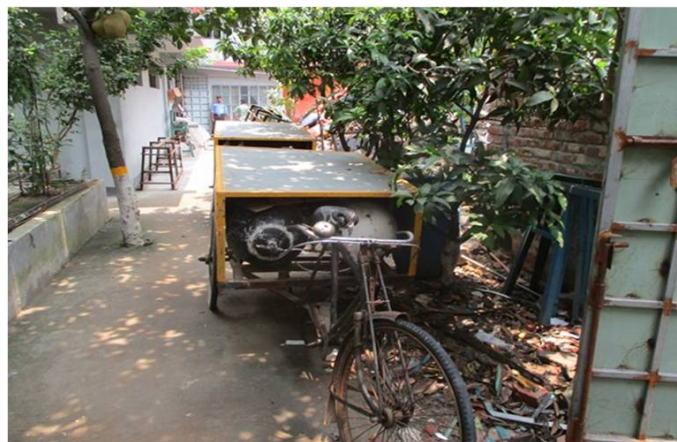
| 9 | Gas Cylinder | Flammable gas storage area is not separated by fire-rated construction (openings, non-rated doors, penetrations) from shed building exit discharge path. | Separate the flammable gas cylinder storage area by a minimum 2-hr fire-rated construction. Seal and/or protect all openings to maintain the required fire separations. | Within 1 month |

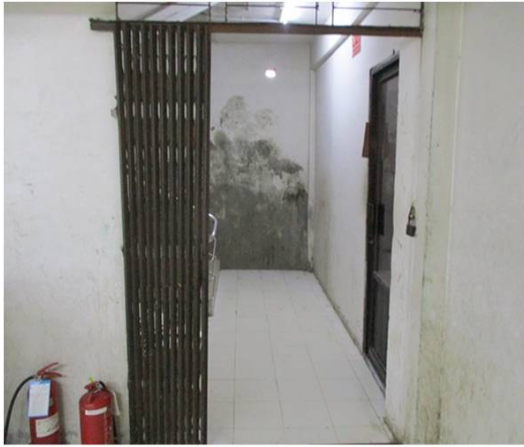
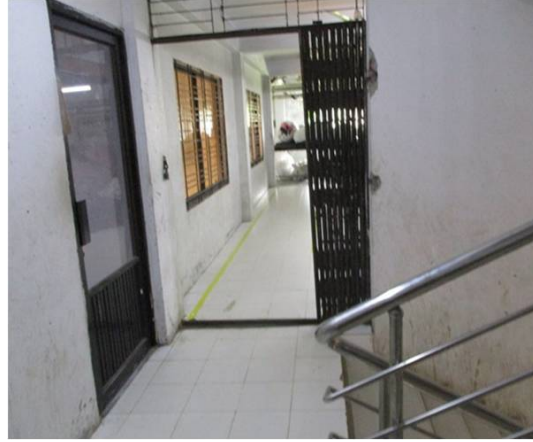
| 10 | Egress | Rolling shutter/Collapsible gates are provided at building exits.<br><b>Location:</b> Ground floor Middle & S-W main gates. | Replace all collapsible gates/ sliding doors/ rolling shutter doors along the means of egress with side-hinged, swinging egress doors.<br>If locks are required for security reasons, utilize specialized door locking features complying with NFPA101. | Within 1 month |

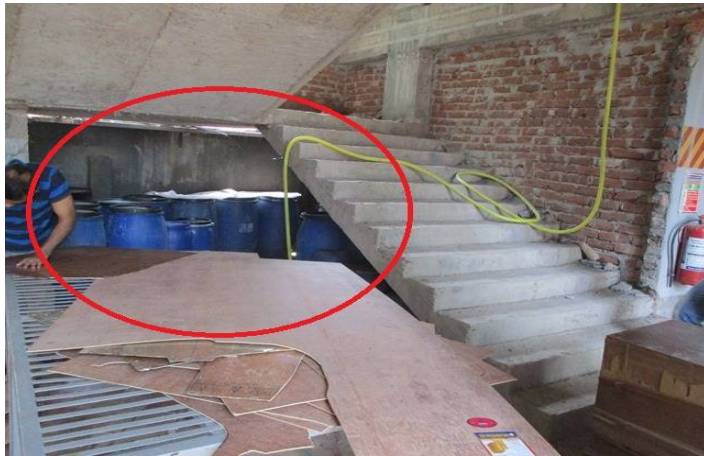
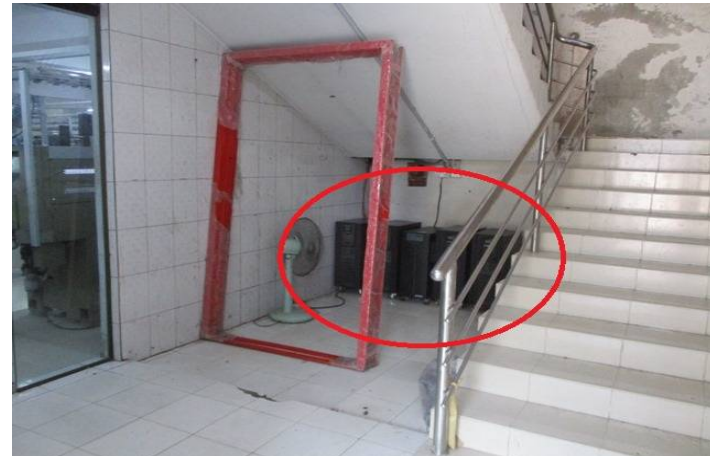
| 11 | Egress | Storage was located in all exit stairs.<br><b>Location:</b> Ground floor N-W exit stair enclosure. | Remove storage from the exit stairs and egress path | Immediate |

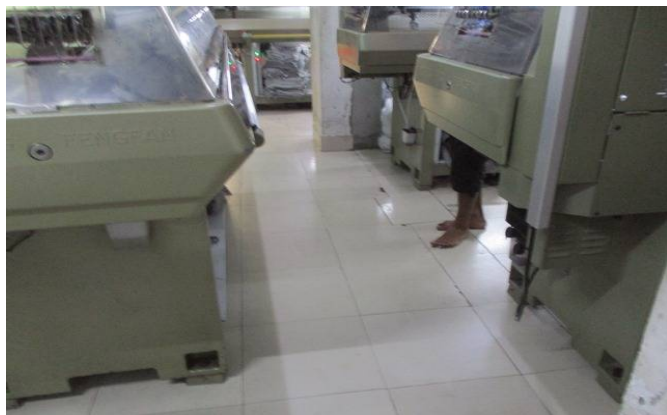
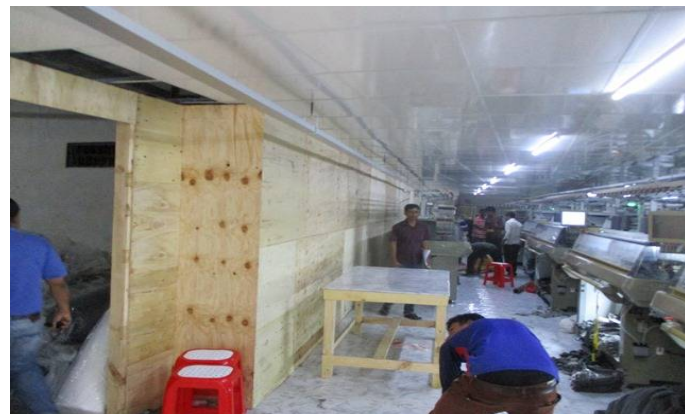
| 12 | Egress | The width of egress aisles is less than 36-inch.<br><b>Location:</b> Ground floor and shed building | Provide minimum aisle widths of 36-inch. | Within 3 months |

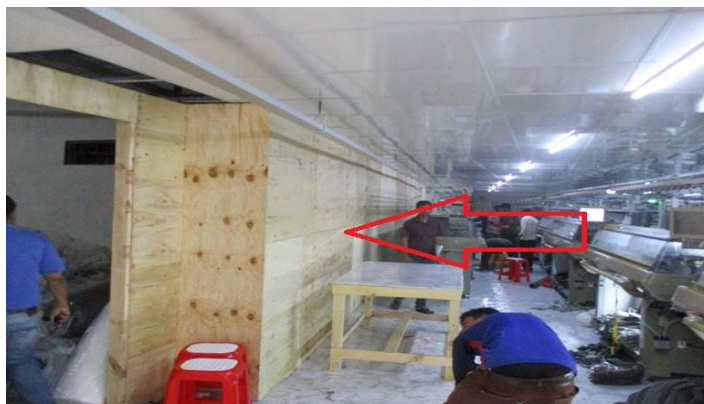
| 21 | Partition wall | Combustible materials are used for partition wall between the storage & production floor.<br>Location: shed building. | Remove all combustible materials and provide minimum 2-hr fire rated construction wall. | Within 3 months |

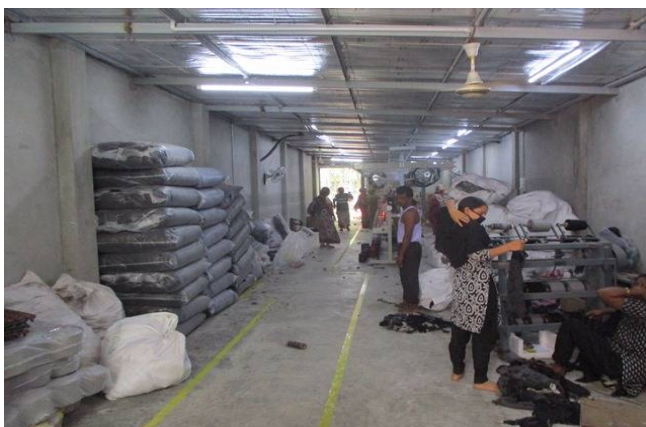
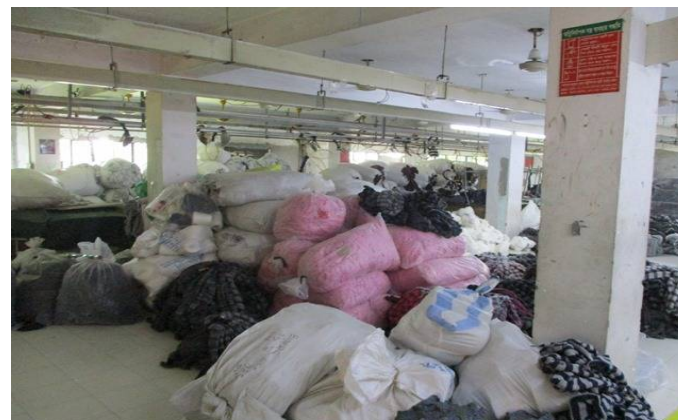
| 22 | Egress Lighting | Based on the number and location of emergency lights/exit signs observed, adequate illumination levels are not anticipated along egress routes.<br><b>Location:</b> All through the building. | Test the emergency lighting system on each floor and provide additional emergency fixtures to provide adequate illumination along the means of egress. Provide a minimum illumination of 10 lux at the floor level within exit stairs and exit discharge paths and minimum 2.5 lux along exit access aisles. | Within 3 months |
