FIRE SAFETY INSPECTION REPORT

**ABONI KNITWEAR LTD.
169-171, TATULZHORA HEMAYETPUR**

ACCORD
on Fire and Building Safety in Bangladesh

September 6, 2014

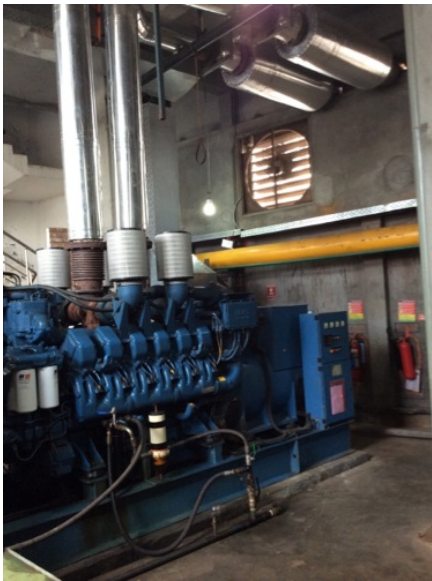
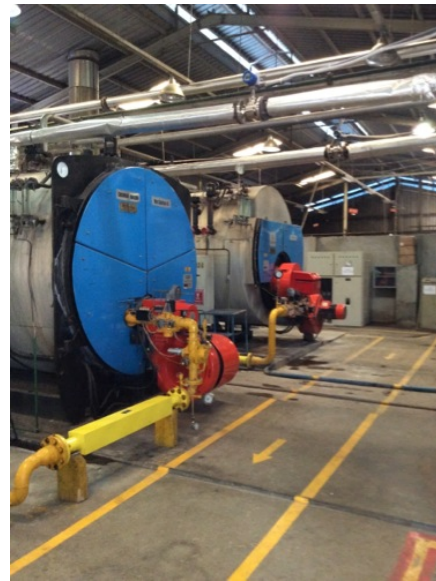
F-1	Fire Rated Construction	The boiler and generator rooms are not separated by fire-rated construction that is openings, non-rated doors and penetrations on ground and 2nd floors	Separate the boiler and generator room by a minimum 2-hr fire-rated construction. Seal and/or protected all openings to maintain the required fire separations	Within 3 months
-----	-------------------------	---	--	-----------------

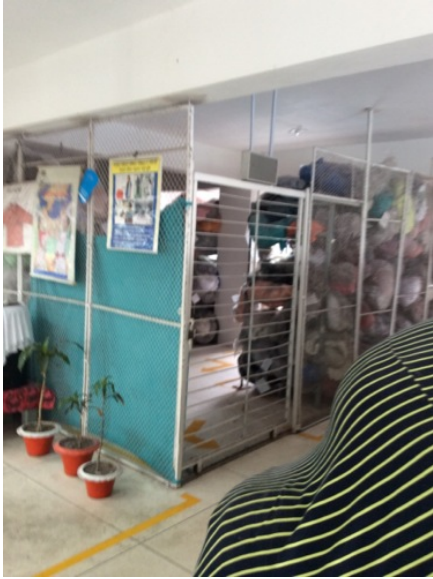
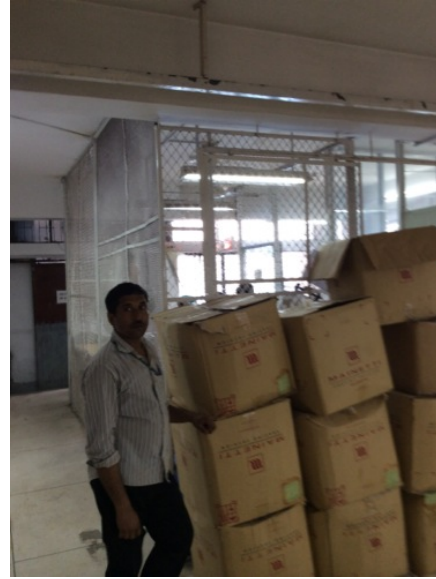
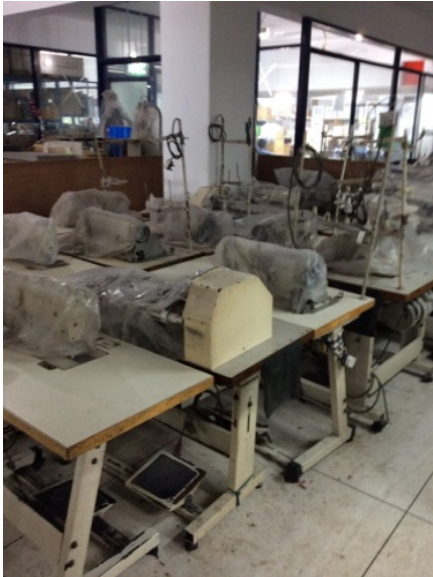
F-2	Fire Rated Construction	Rooms used for combustible storage are not separated by fire-rated construction on ground, 1st, 2nd, 3rd, 4th, 5th, 6th and 7th floors.	Provide dedicated storage rooms separated by minimum 1-hr fire-rated construction.	Within 3 months
-----	-------------------------	---	--	-----------------

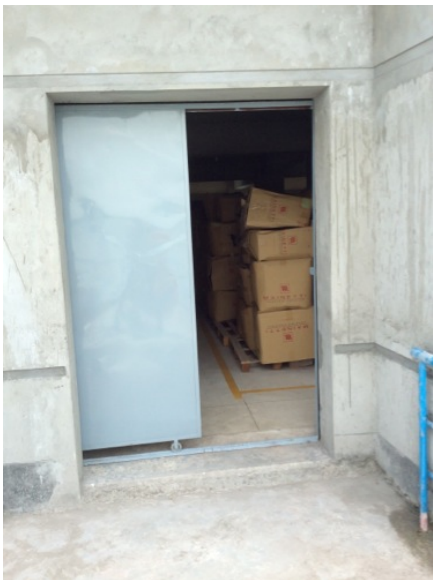
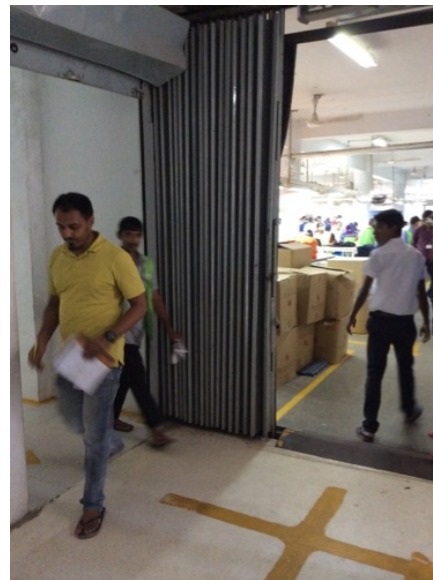
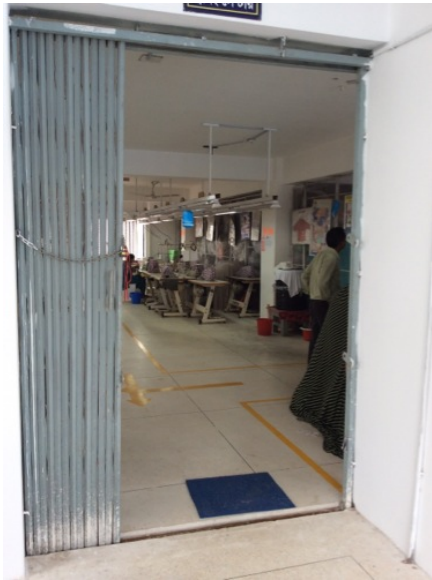
F-3	Fire Rated Construction	The exit stairs are not separated from work areas and other spaces on each floor by fire-rated construction.	Provide minimum 1.5-hr fire rated doors and seal all unprotected openings to separate the exit stairs from work areas and other building spaces on all floor levels. Ensure that the fire doors are self-closing and positive latching and that they are provided with fire exit (panic) hardware where serving production floors.	Within 3 months
-----	-------------------------	--	--	-----------------

If fire doors are required to be held open for functional reasons, provide automatic-closing devices tied to the fire alarm system.

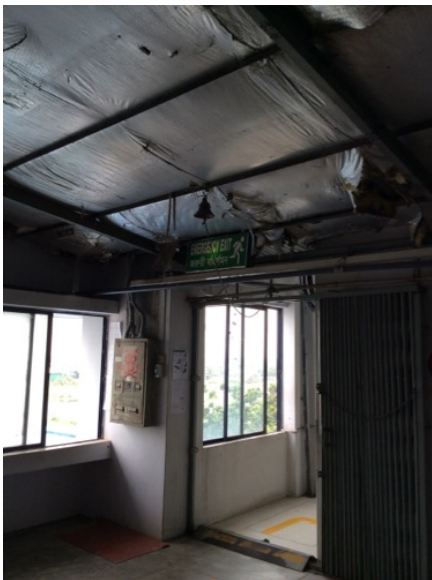
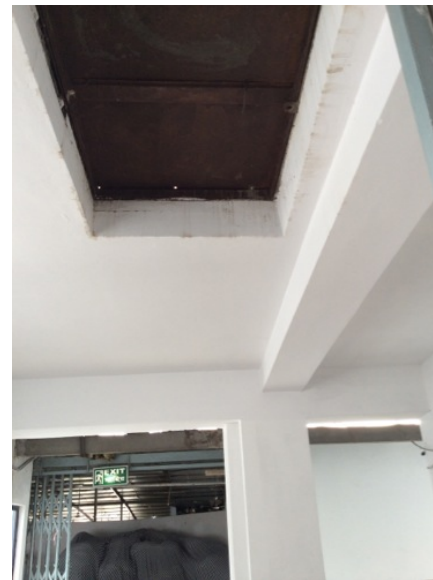
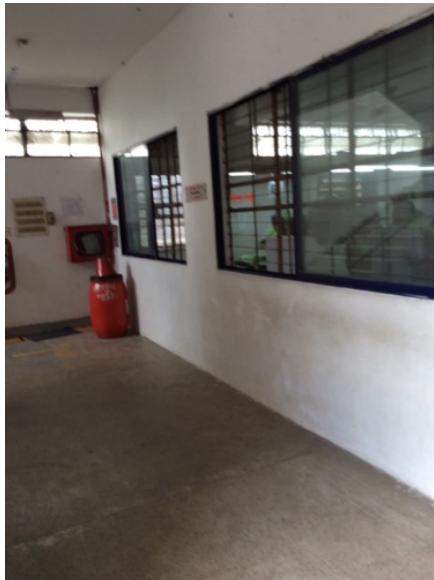
F-4	Fire Rated Construction	Unsealed penetrations and openings are located in exit stair enclosures.	Seal all penetrations and openings in exit stair enclosure walls to maintain the fire separation.	Within 3 months
-----	-------------------------	--	---	-----------------

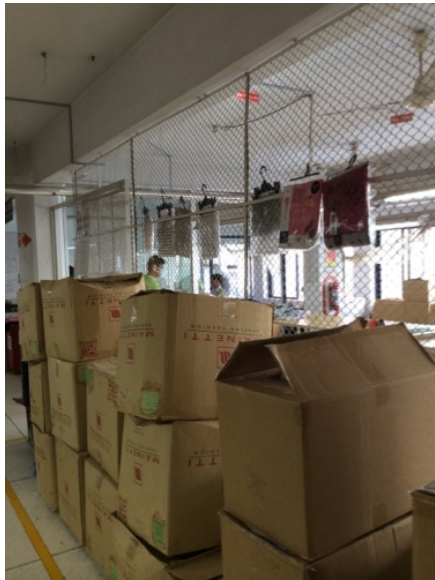
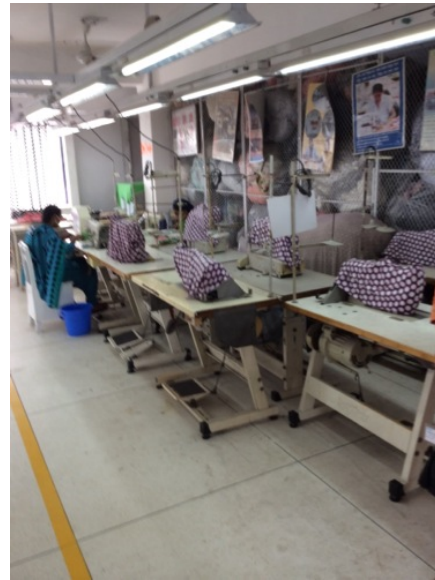
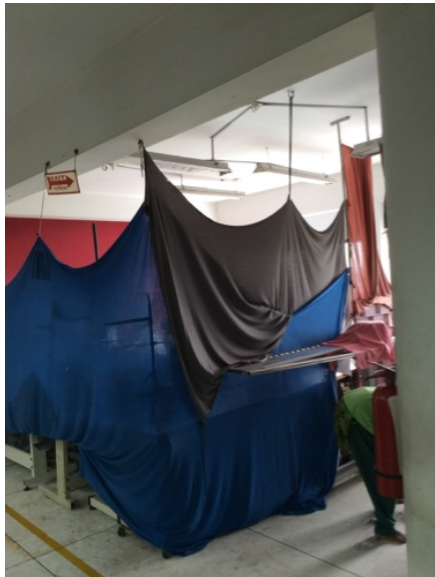
F-5	Fire Rated Construction	Areas used for combustible storage are not separated by fire-rated construction on ground 1st, 2nd, 3rd, 4th, 5th and 6th floors.	<p>Provide dedicated storage rooms separated by minimum 1-hr fire-rated construction.</p> <p>Where separate storage rooms are not feasible, provide defined storage areas and limit the storage arrangement as follows:</p> <ul style="list-style-type: none">- Maximum height of 2.4m and maximum area of 23m²- If sprinkler protected: maximum height of 3.66m and maximum area of 93m² <p>Separate areas of unenclosed combustible storage by a minimum clear distance of 3m.</p>	Within 3 months
-----	-------------------------	---	---	-----------------

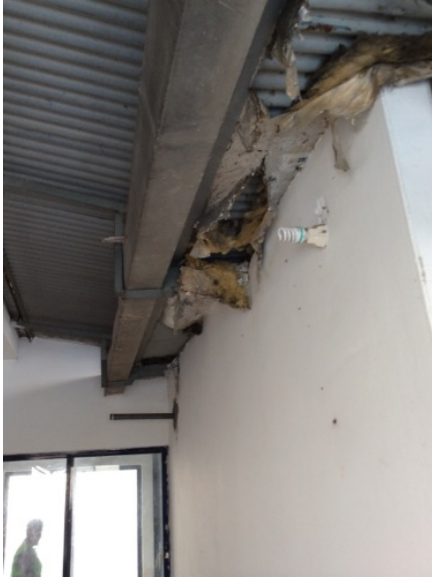
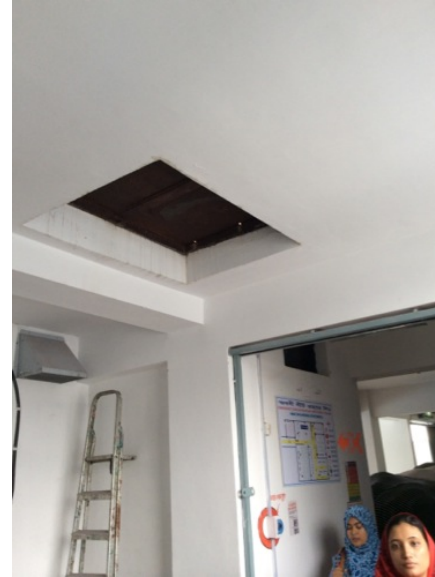
F-6	Fire Rated Construction	Unsealed penetrations and openings are located in the fire-rated floor/ceiling assemblies.	Seal all penetrations and openings in floor/ceiling assemblies to maintain the fire separation.	Within 3 months
-----	-------------------------	--	---	-----------------

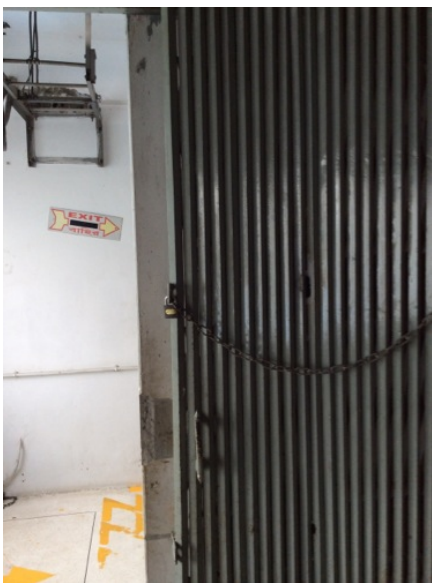
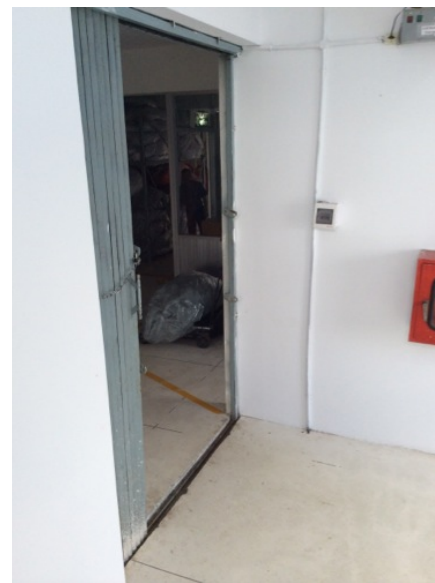
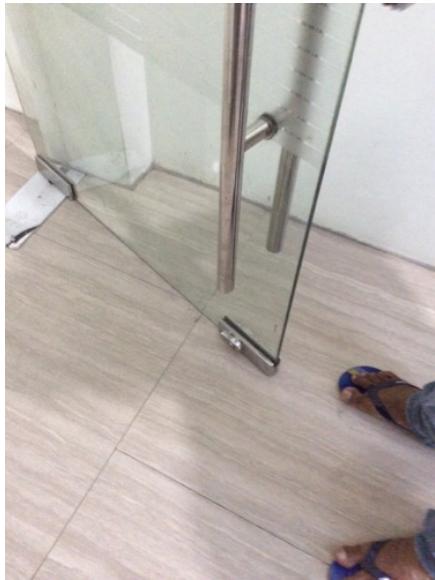
F-7 Egress

Egress doors / gates with locking features are provided at building exits, exit stairs, along egress route and exit discharge on all floors. All gates/doors were open and unlocked during the inspection.

Remove locking features from all egress doors / gates.

If locks are required for security reasons, utilize special door locking features complying with NFPA 101.

Immediate

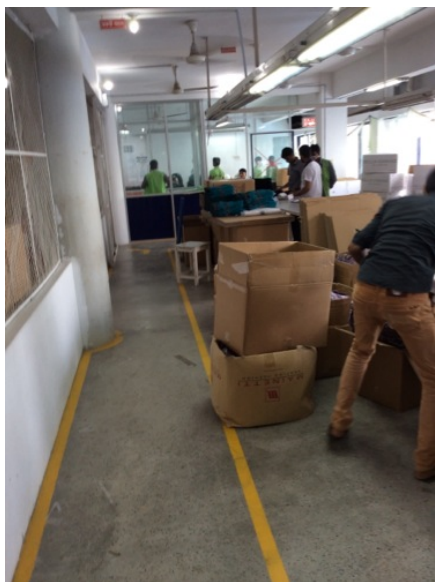
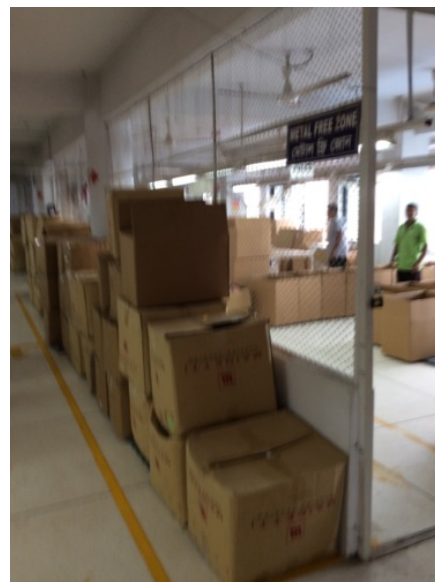
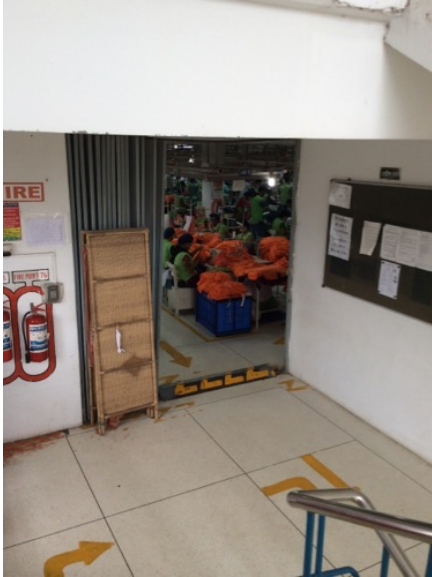
F-8	Egress	Storage was located in the egress path on ground, 1st, 2nd, 3rd 4th, 5th and 6th floors.	Keep egress paths and stairs clear of storage.	Immediate
-----	--------	--	--	-----------

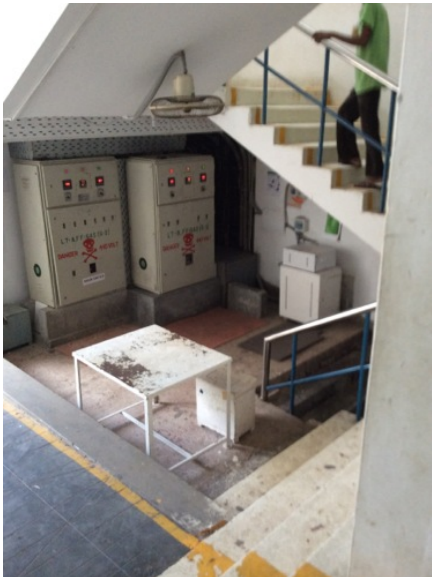
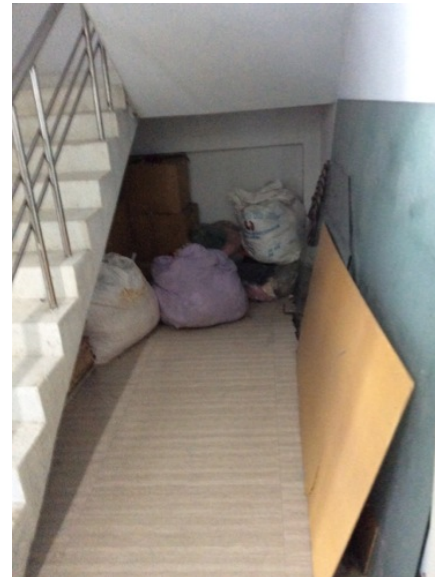
F-9	Egress	Storage was located in the exit stair on ground floor.	Remove all storage from exit stairs and egress paths.	Immediate
-----	--------	--	---	-----------

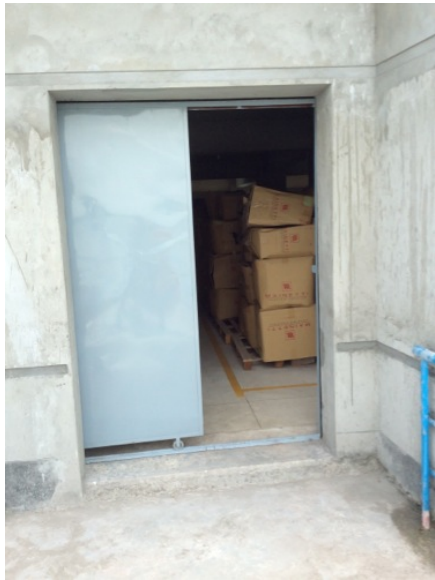
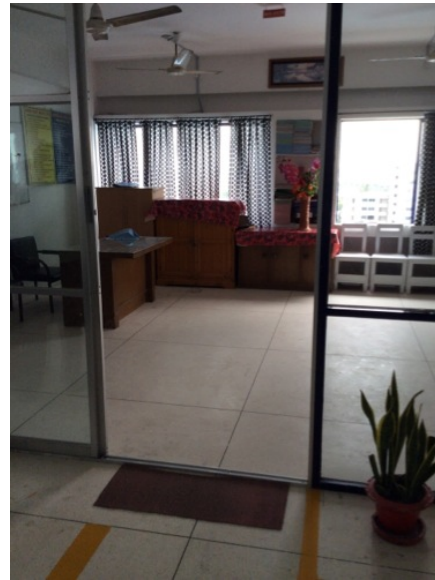
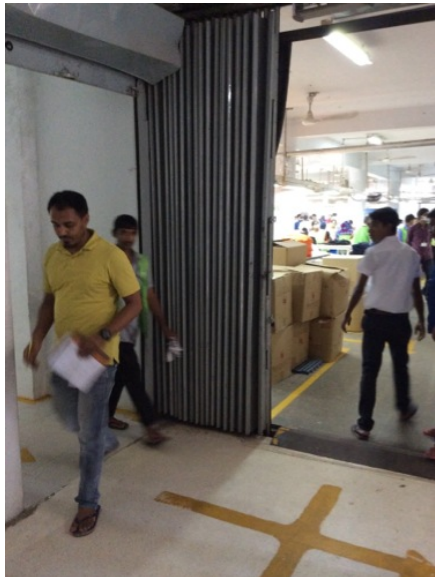
F-10	Egress	Collapsible gates / sliding doors are provided at building exits, exit stairs, along egress routes and exit discharge on all floors.	Replace all gates / sliding doors along the means of egress with side-hinged, swinging egress doors. If locks are required for security reasons, utilize special door locking features complying with NFPA 101.	Within 1 month
------	--------	--	--	----------------

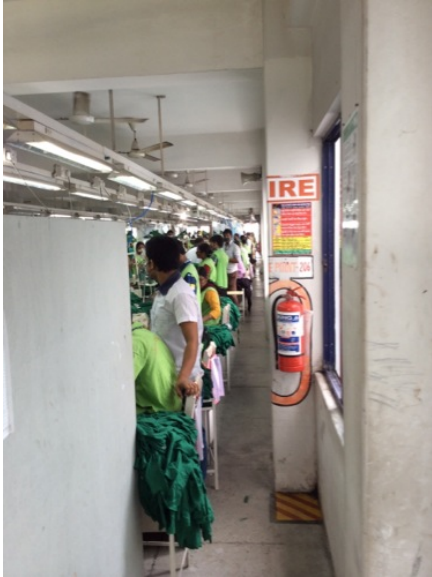
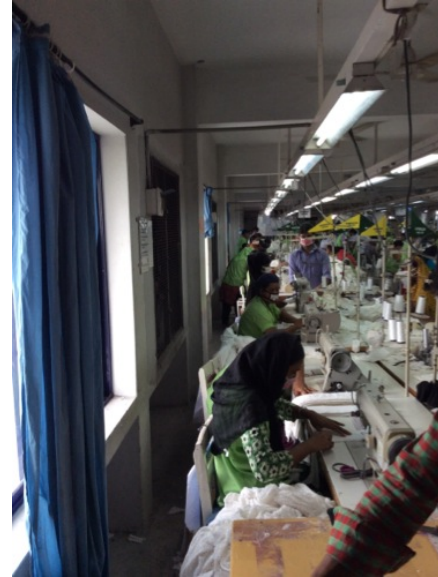
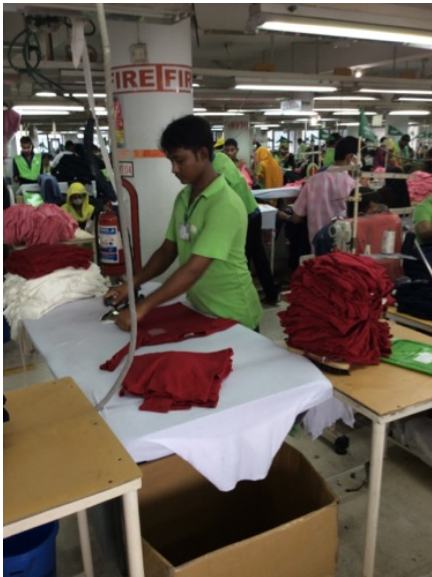
F-11 Egress

The width of egress aisles is less than 36-in. on ground, 1st, 2nd, 3rd, 4th and 5th floors.

Provide minimum aisle widths of 36-in.

Within 3 months

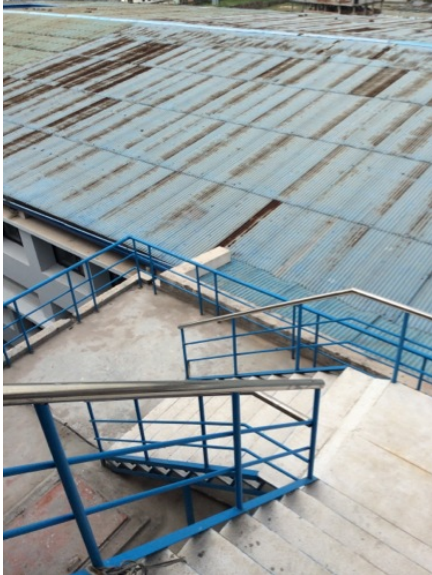
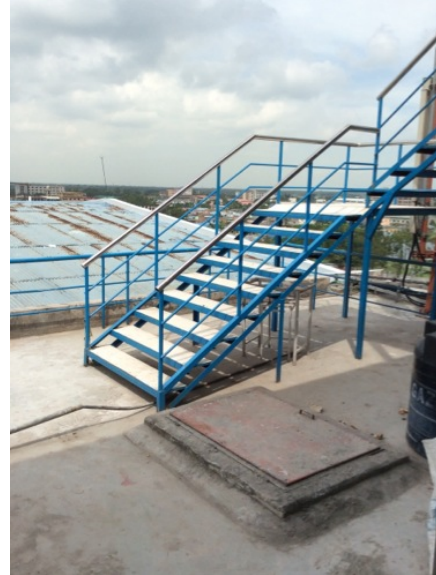
F-13	Egress	Exit stairs discharge inside the building on 7th floor discharge to roof of 6th floor and on 8th floor discharge to 7th floor.	Provide 2-hr fire-rated exit passageway leading directly outside (vestibules to separate any storage areas).	Within 6 months
------	--------	--	--	-----------------

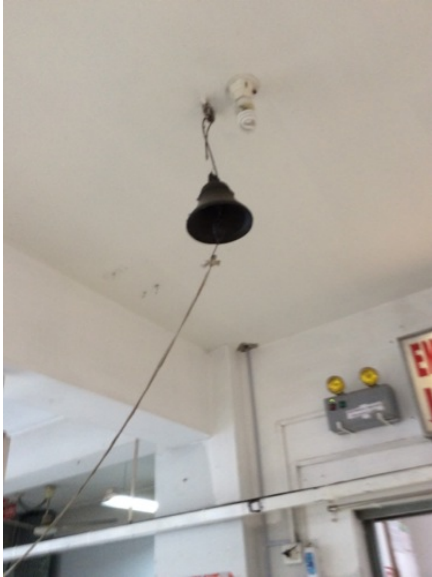
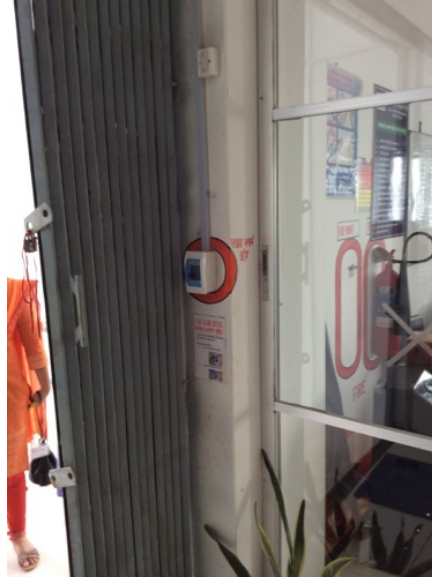
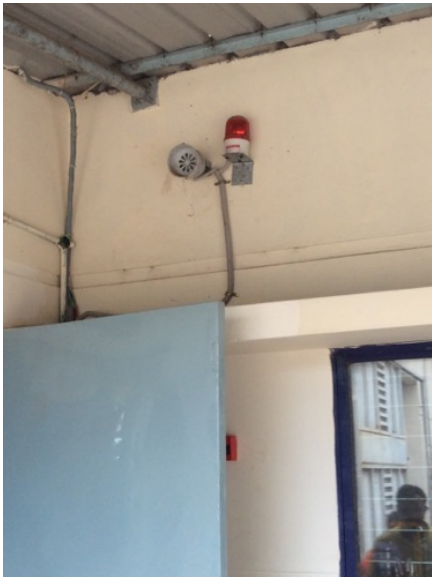
F-14	Fire Protection	The fire alarm system is antiquated, not a listed system, and does not provide alarm and notification features consistent with acceptable standards.	Replace the fire alarm system with a new, listed addressable fire alarm system in accordance with NFPA 72.	Design within 4 months, install within 9 months
------	-----------------	--	--	---

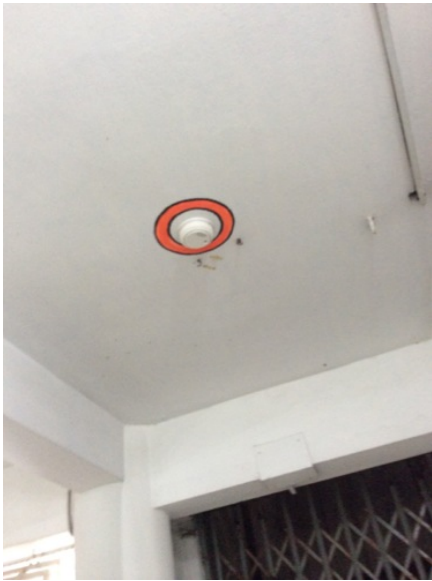
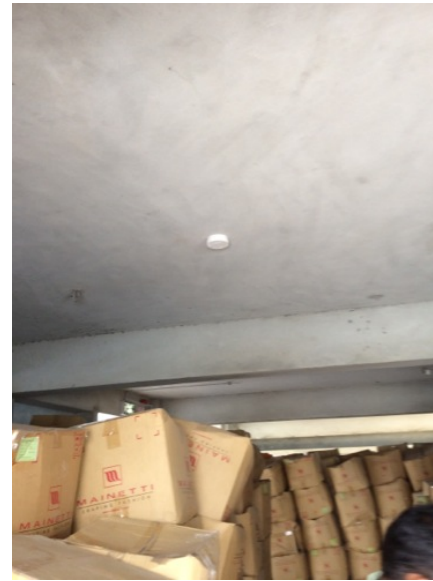
F-16	Fire Protection	Inspection, testing, and maintenance of the fire alarm system is not in accordance with NFPA 72.	Inspect, test and maintain the fire alarm system, and keep written records on-site, in accordance with NFPA 72.	Within 3 months
F-17	Fire Protection	The building is equipped with single-station smoke alarms. Smoke alarm activation sounds only a local alarm and does not provide automatic fire alarm notification of occupants.	Remove single-station smoke alarms. Provide automatic smoke detection throughout the building, tied into the fire alarm system, in accordance with NFPA 72.	Within 6 months
