# **FIRE SAFETY INSPECTION REPORT**

**THE SHANIN CORPORATION LTD.**  
**12 TO 1 HOSSAIN UDDIN KHAN, 1ST LANE LALBAGH**

**ACCORD**  
on Fire and Building Safety in Bangladesh

September 10, 2014

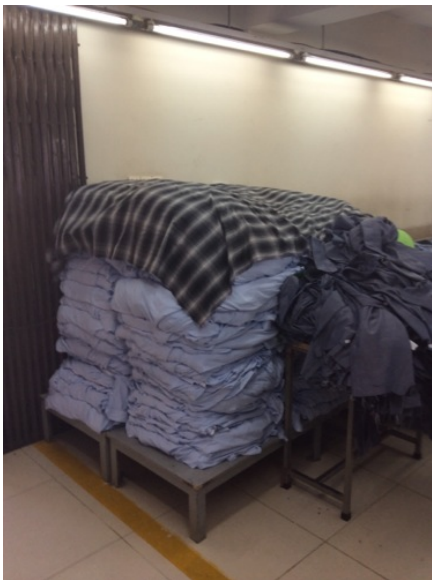
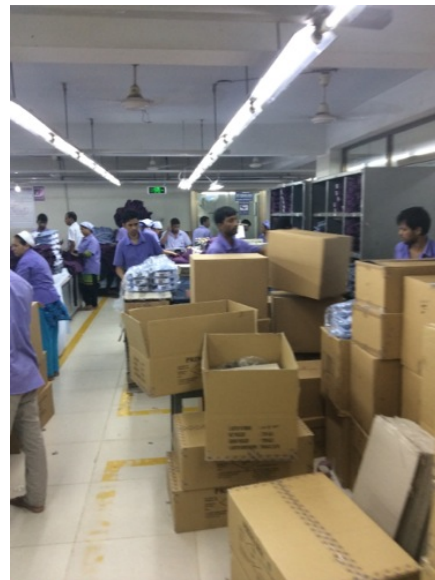
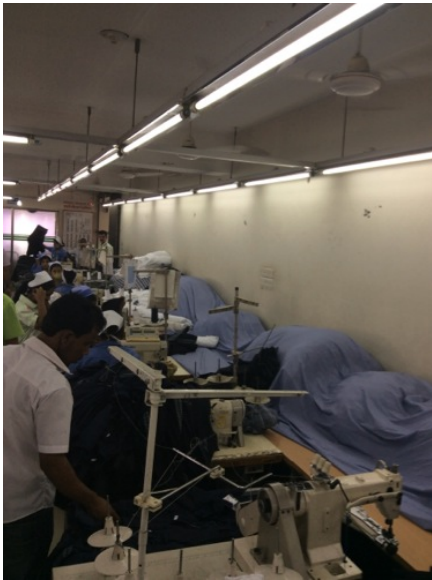
| F-2 | Fire Rated Construction | <p>Areas used for combustible storage are not separated by fire-rated construction.</p> <p>Locations:<br/>All Floors</p> | <p>Provide dedicated storage rooms separated by minimum 1-hr fire-rated construction.</p> <p>Where separate storage rooms are not feasible, provide defined storage areas and limit the storage arrangement as follows:</p> <ul style="list-style-type: none"><li>- Maximum height of 2.4m and maximum area of 23m<sup>2</sup></li><li>- If sprinkler protected: maximum height of 3.66m and maximum area of 93m<sup>2</sup></li></ul> <p>Separate areas of unenclosed combustible storage by a minimum clear distance of 3m.</p> | Within 3 months |

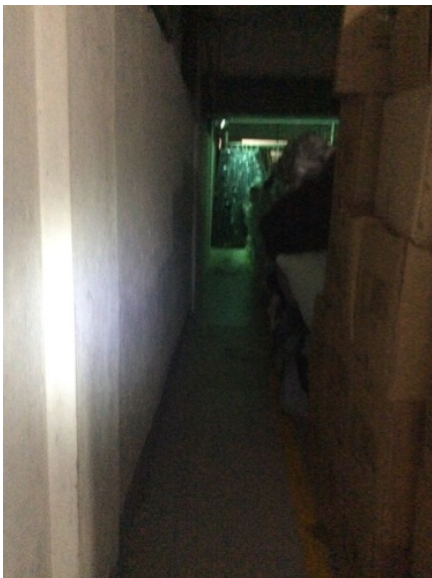
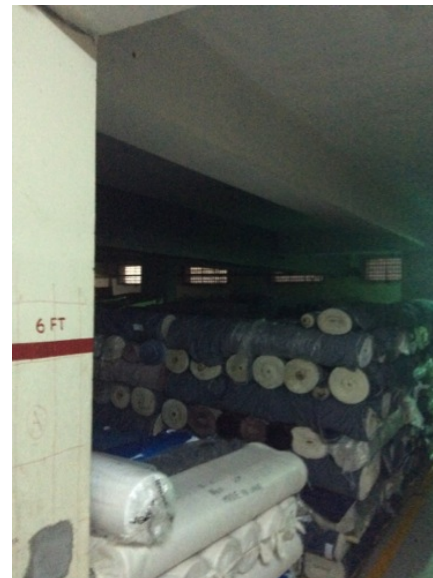
| F-3 | Fire Rated Construction | Rooms used for combustible storage are not separated by fire-rated construction. | Provide dedicated storage rooms separated by minimum 1-hr fire-rated construction. | Within 3 months |
| | | Location:<br>Basement | | |

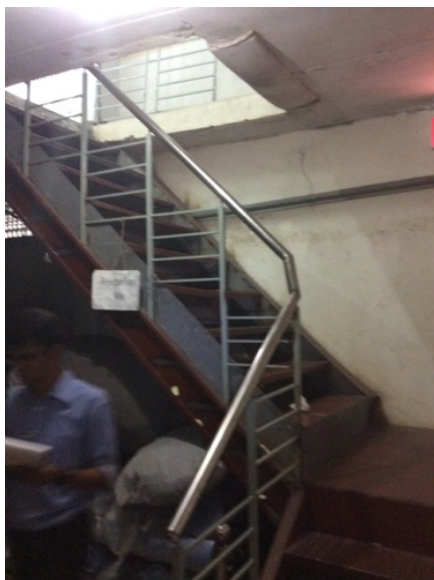
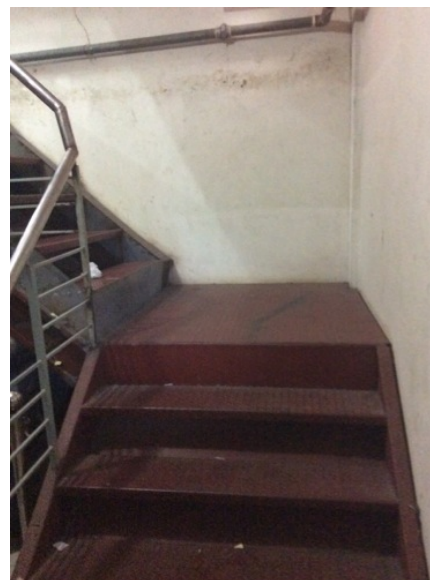
| F-4 | Fire Rated Construction | The exit stairs are not separated from work areas in the basement by fire-rated construction. | <p>Provide minimum 1.5-hr fire rated doors and seal all unprotected openings to separate the exit stairs from work areas and other building spaces on all floor levels. Ensure that the fire doors are self-closing and positive latching and that they are provided with fire exit (panic) hardware where serving production floors.</p> <p>If fire doors are required to be held open for functional reasons, provide automatic-closing devices tied to the fire alarm system.</p> | Within 3 months |

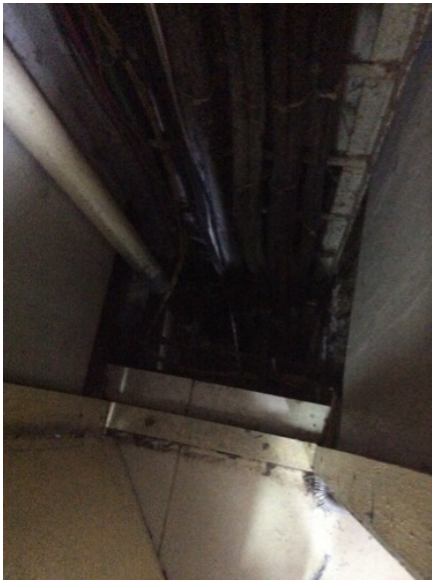
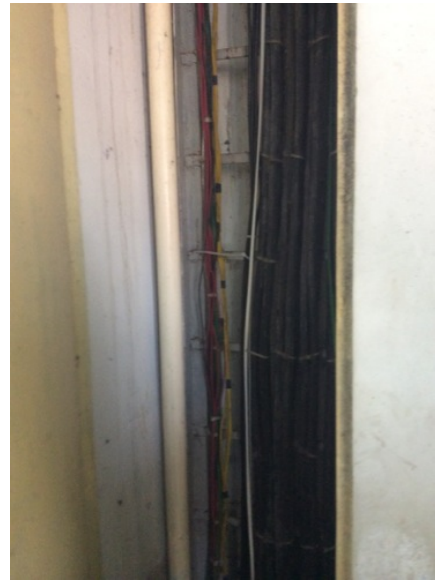
| F-5 | Fire Rated Construction | Unsealed penetrations and openings are located in the fire-rated floor/ceiling assemblies. | Provide a minimum 2-hr fire-rated shaft to separate the utility risers from each floor level. | Within 3 months |

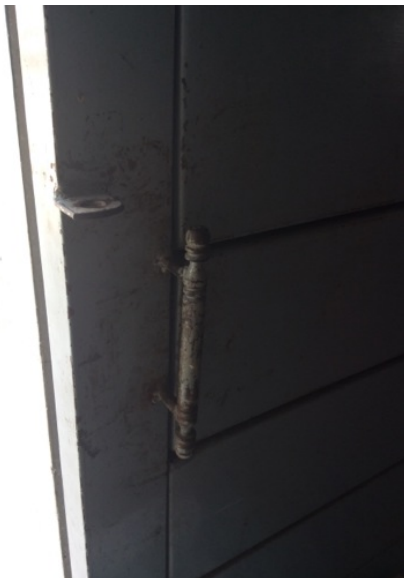
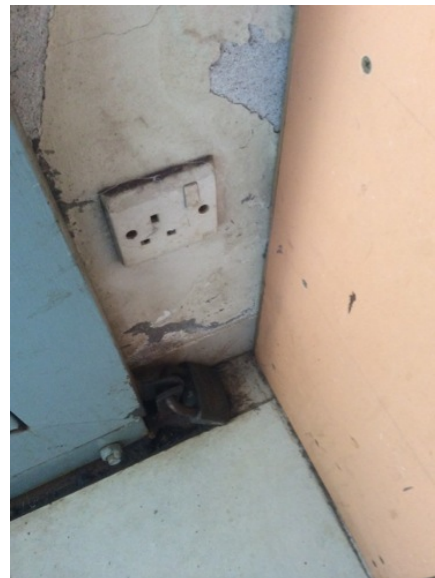
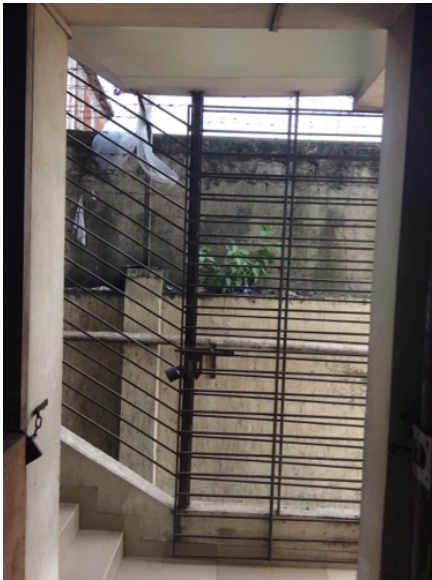
| F-6 | Egress | Egress doors / gates with locking features are provided at building exits, exit stairs, along egress routes and exit discharge. | Remove locking features from all egress doors / gates.<br><br>If locks are required for security reasons, utilize special door locking features complying with NFPA 101. | Immediate |

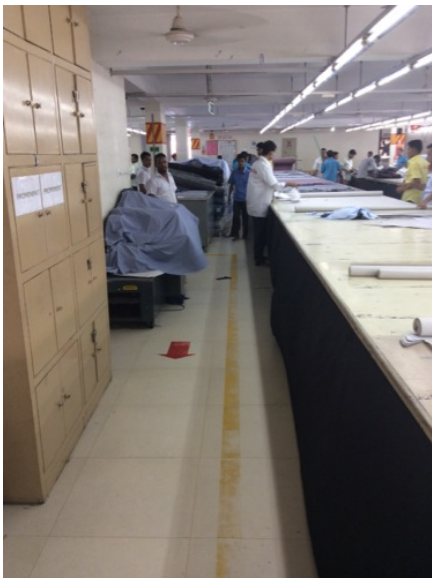
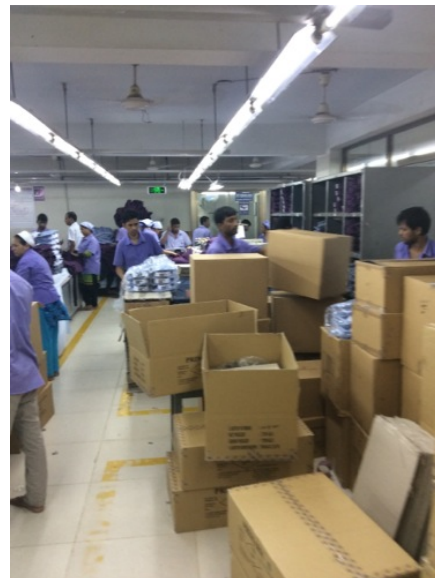
| F-7 | Egress | Storage was located in the egress path. | Keep egress paths and stairs clear of storage. | Immediate |

Located on all the floors except the third floor and roof.

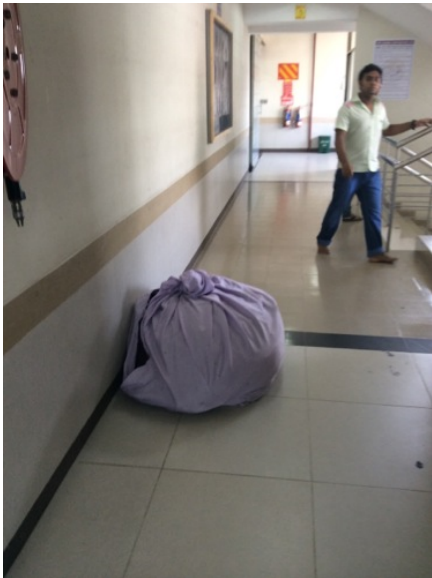
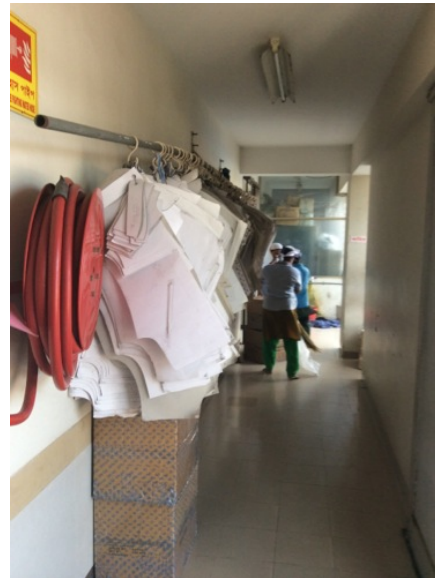
| F-8 | Egress | Storage was located in the exit stair. | Remove all storage from exit stairs and egress paths. | Immediate |

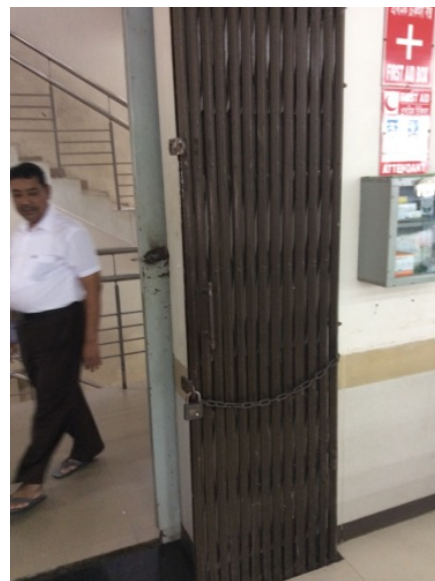
| F-9 | Egress | Collapsible gates / sliding doors are provided at building exits, exit stairs, along egress routes and exit discharge. | Replace all gates / sliding doors along the means of egress with side-hinged, swinging egress doors.<br><br>If locks are required for security reasons, utilize special door locking features complying with NFPA 101. | Within 1 month |

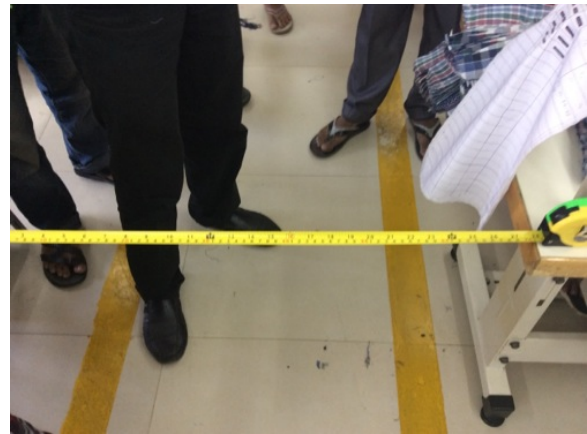
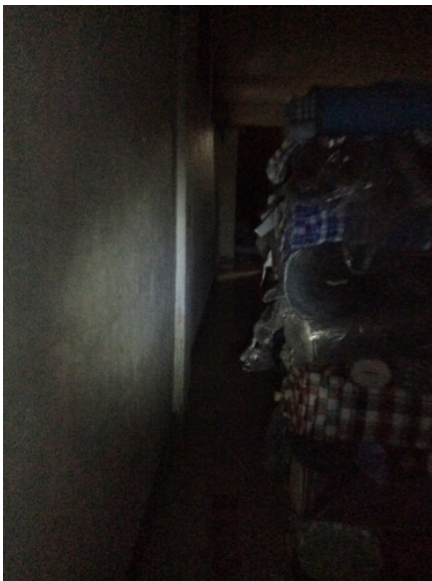
| F-10 | Egress | The width of egress aisles is less than 36-in. | Provide minimum aisle widths of 36-in. | Within 3 months |

Locations:  
Basement  
Ground Floor  
Third Floor  
Roof

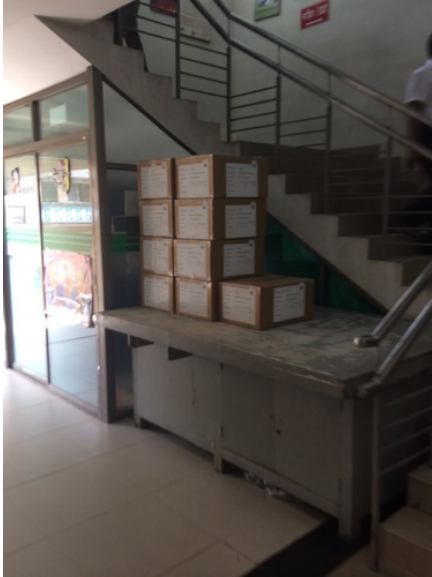
| F-11 | Egress | The day-care room is located in an exit stair.<br><br>Location:<br>Ground Floor | Relocate the day-care so it is not located in the exit stair on the ground floor with direct accesses to an exit. | Within 3 months |

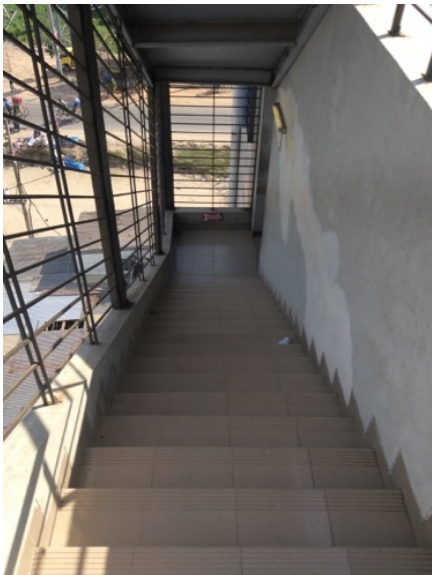
| F-12 | Egress | Handrails are not provided in the East exit stair. | Provide handrails on at least one side of the East exit stair. | Within 3 months |

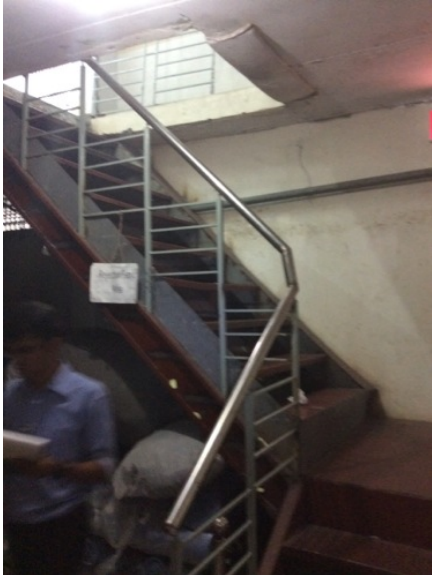
| F-13 | Egress | The East basement stair did not have adequate headroom (56 in). | Provide an adequate headroom height of 80 in. minimum from the East basement stair. | Within 3 months |

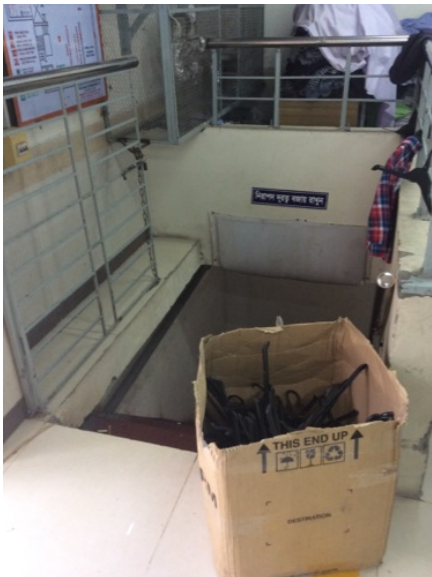
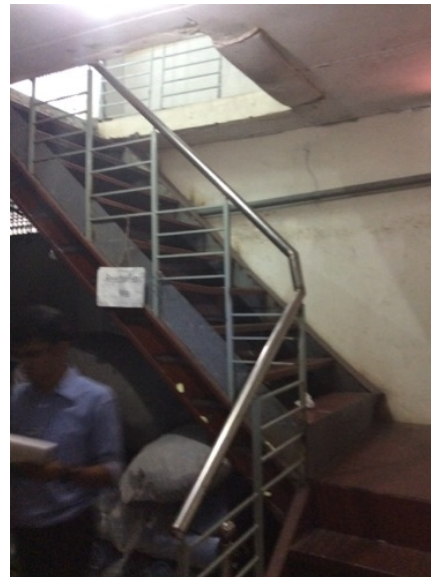
| F-14 | Egress | Exit stairs from the basement discharge inside the building. | Provide 2-hr fire-rated exit passageway leading directly outside (vestibules to separate any storage areas). | Within 6 months |

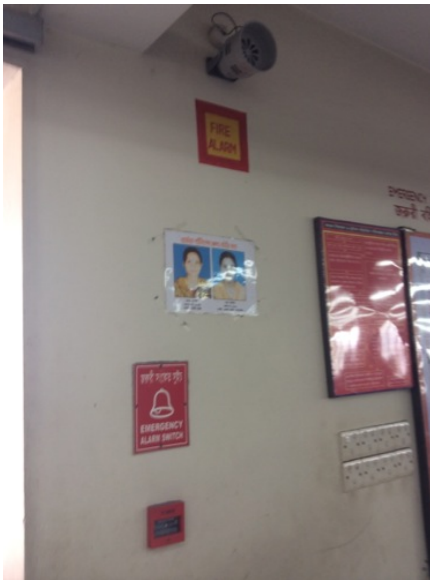
| F-15 | Fire Protection | The fire alarm system is antiquated, not a listed system, and does not provide alarm and notification features consistent with acceptable standards. | Replace the fire alarm system with a new, listed addressable fire alarm system in accordance with NFPA 72. | Design within 4 months, install within 9 months |

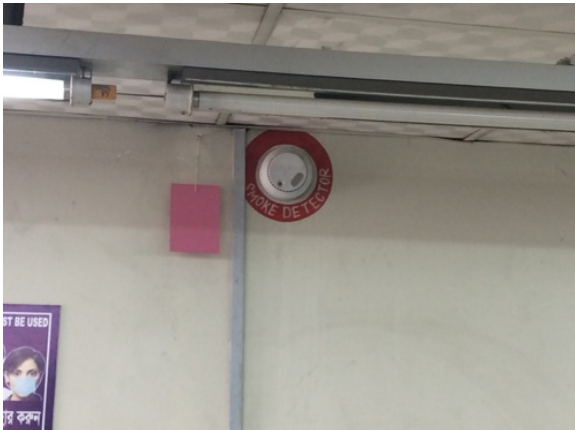
| F-17 | Fire Protection | The building is equipped with single-station smoke alarms. Smoke alarm activation sounds only a local alarm and does not provide automatic fire alarm notification of occupants. | Remove single-station smoke alarms. Provide automatic smoke detection throughout the building, tied into the fire alarm system, in accordance with NFPA 72. | Within 6 months |

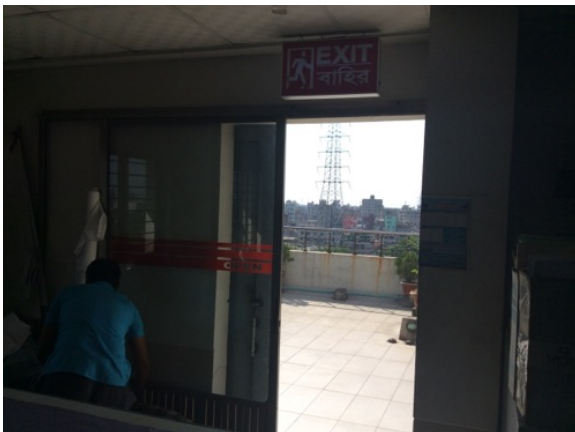
| F-18 | Egress Lighting | Exit sign provided at a door that was not an exit. | Remove exit sign. | Immediate |
| | | Location:<br>Roof | | |
