# **FIRE SAFETY INSPECTION REPORT**

**PANORAMA APPARELS LTD.  
VOGRA (BASAN SARA), P.O-NATIONAL  
UNIVERSITY, SADAR**

**ACCORD**  
on Fire and Building Safety in Bangladesh

September 10, 2014

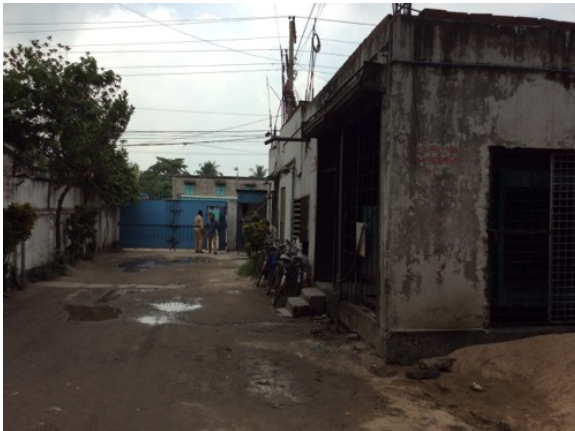
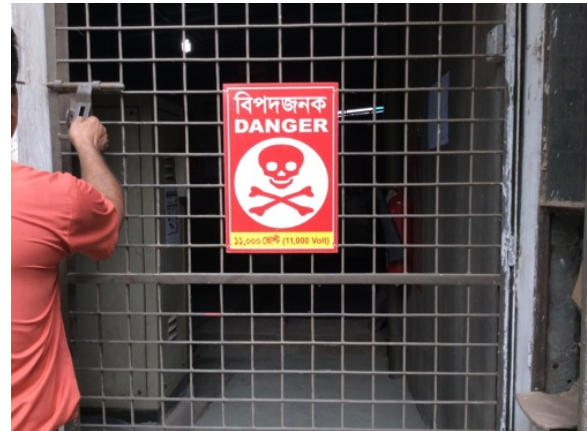
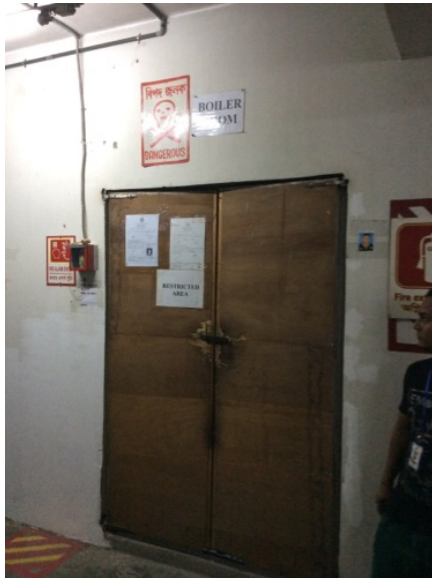
| No. | Category | Finding | Recommendation | Remediation Timeframe |
|---|---|---|---|---|
| F-1 | Fire Rated Construction | The boiler, generator and transformer rooms are not separated by fire-rated construction (openings, non-rated doors and penetrations). | Separate the boiler, generator and transformer rooms by a minimum 2-hr fire-rated construction. Seal and/or protected all openings to maintain the required fire separations. | Within 3 months |

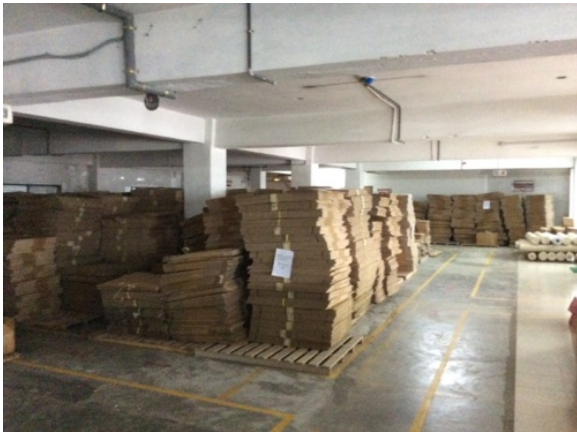
| F-2 | Fire Rated Construction | Area used for combustible storage on the 2nd floor is not separated by fire-rated construction. | <p>Provide dedicated storage rooms separated by minimum 1-hr fire-rated construction.</p> <p>Where separate storage rooms are not feasible, provide defined storage areas and limit the storage arrangement as follows:</p> <ul style="list-style-type: none"> <li>- Maximum height of 2.4m and maximum area of 23m<sup>2</sup></li> <li>- If sprinkler protected: maximum height of 3.66m and maximum area of 93m<sup>2</sup></li> </ul> <p>Separate areas of unenclosed combustible storage by a minimum clear distance of 3m.</p> | Within 3 months |

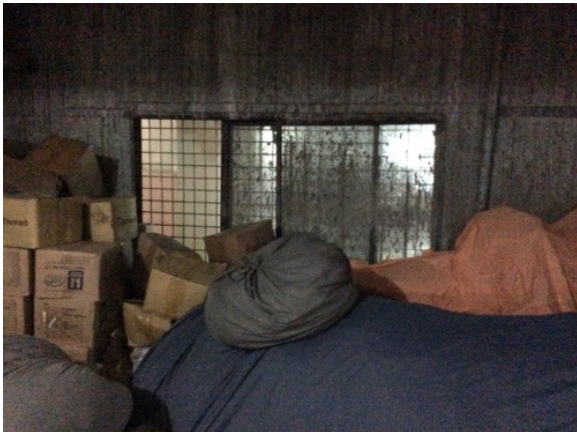
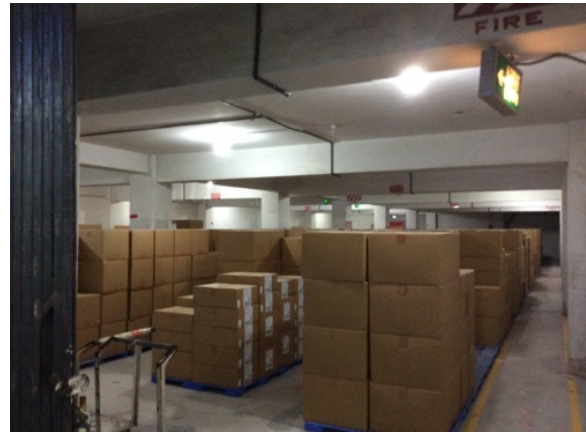
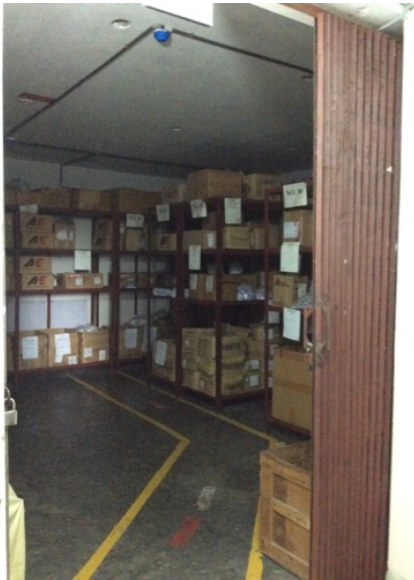
| F-3 | Fire Rated Construction | Rooms used for combustible storage on the ground, 1st and 2nd floors are not separated by fire-rated construction. | Provide dedicated storage rooms separated by minimum 1-hr fire-rated construction. | Within 3 months |

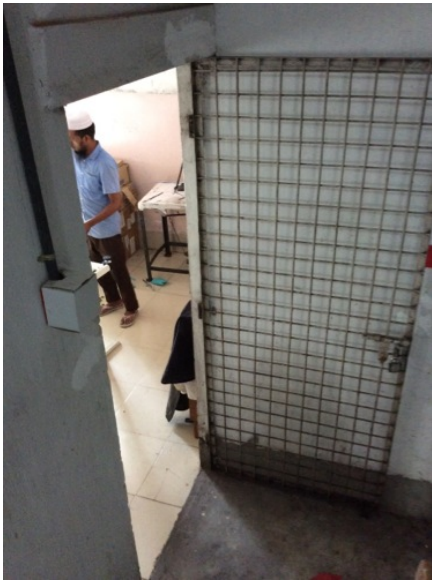
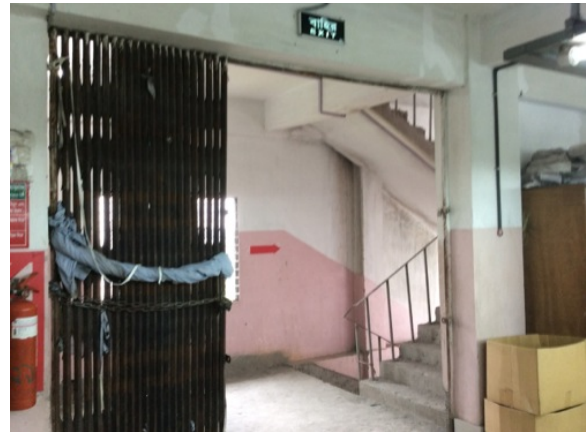
| F-4 | Fire Rated Construction | The exit stairs are not separated from work areas on each floor by fire-rated construction. | <p>Provide minimum 1.5-hr fire rated doors and seal all unprotected openings to separate the exit stairs from work areas on all floor levels. Ensure that the fire doors are self-closing and positive latching and that they are provided with fire exit (panic) hardware where serving production floors.</p> <p>If fire doors are required to be held open for functional reasons, provide automatic-closing devices tied to the fire alarm system.</p> | Within 3 months |

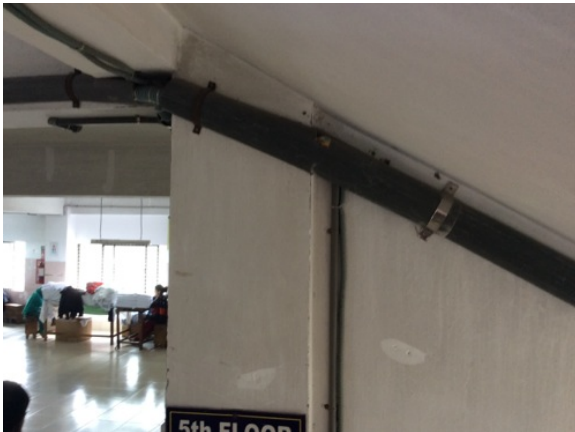
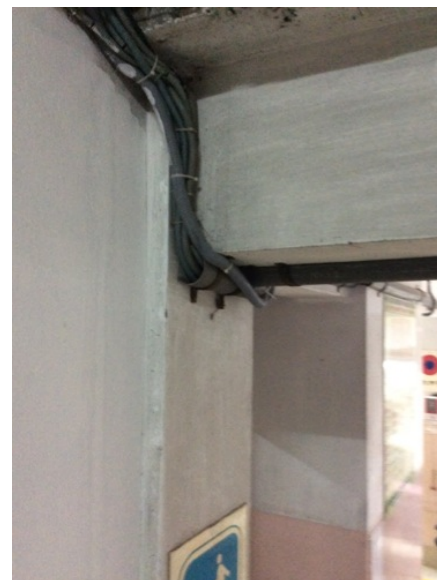
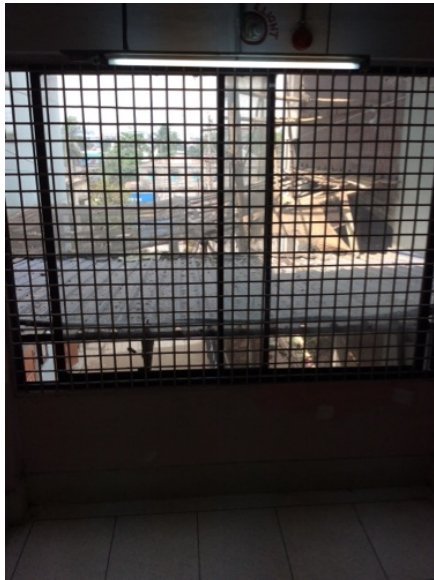
| F-5 | Fire Rated Construction | Unsealed penetrations and openings are located in the central and north exit stair enclosures on each floor. | Seal all penetrations and openings in exit stair enclosure walls to maintain the fire separation. | Within 3 months |

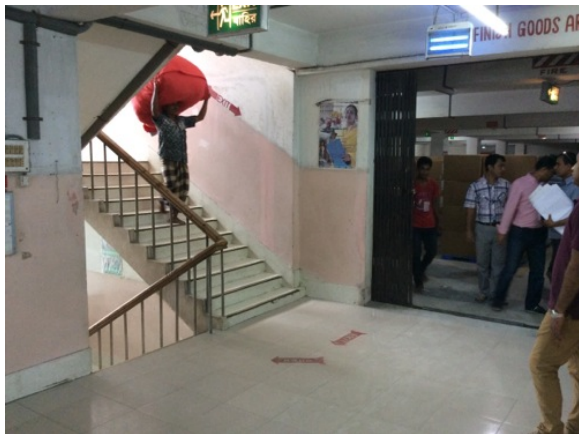
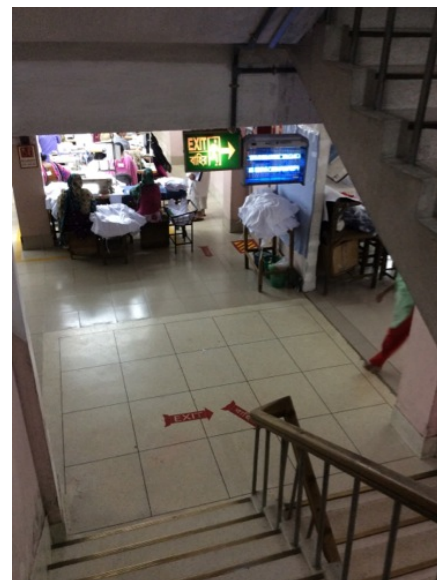
| F-6 | Fire Rated Construction | The north and central exit stairs are not enclosed in fire-rated construction on each floor. | Provide minimum 2-hr fire-rated construction walls and minimum 1.5-hr fire-rated doors for continuous exit stairwell enclosure on each floor. | Within 3 months |

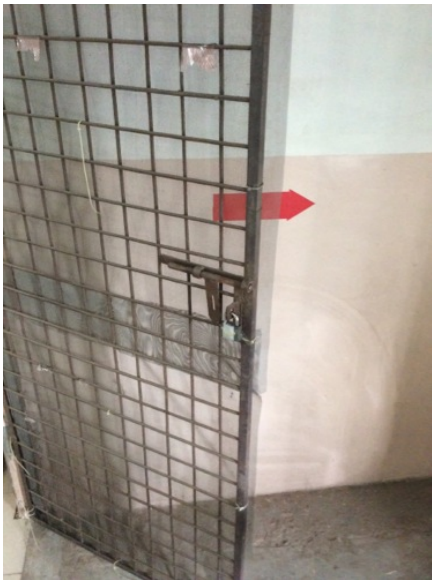
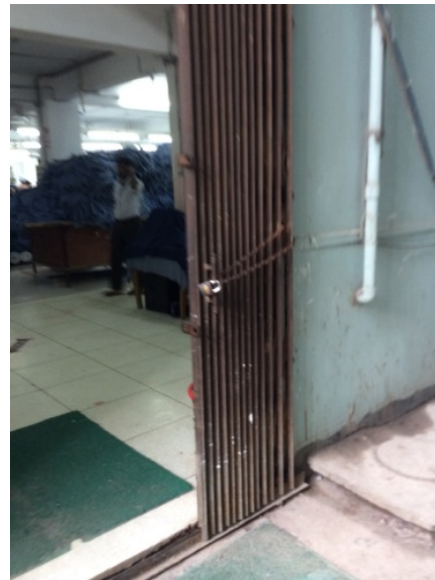
| F-7 | Egress | Egress gates with locking features are provided at building exits, exit stairs and exit discharge. | Remove locking features from all egress doors and gates.<br><br>If locks are required for security reasons, utilize special door locking features complying with NFPA 101. | Immediate |

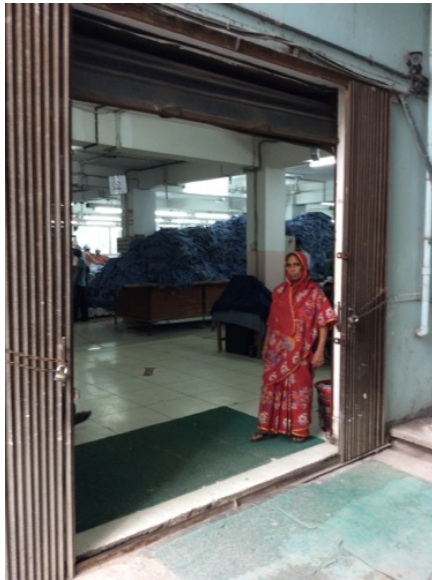
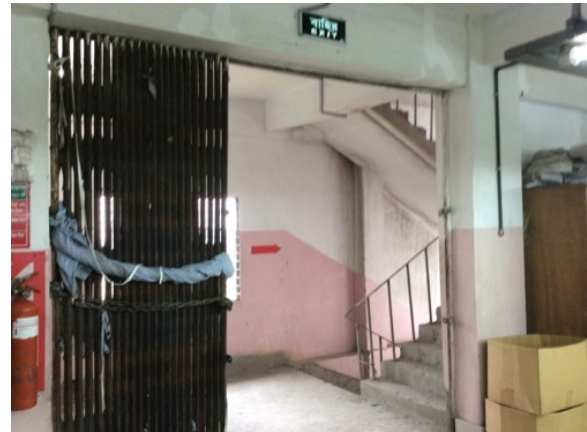
| F-8 | Egress | Collapsible gates and sliding doors are provided at building exits, exit stairs and exit discharge. | Replace all gates and sliding doors along the means of egress with side-hinged, swinging egress doors.<br><br>If locks are required for security reasons, utilize special door locking features complying with NFPA 101. | Within 1 month |

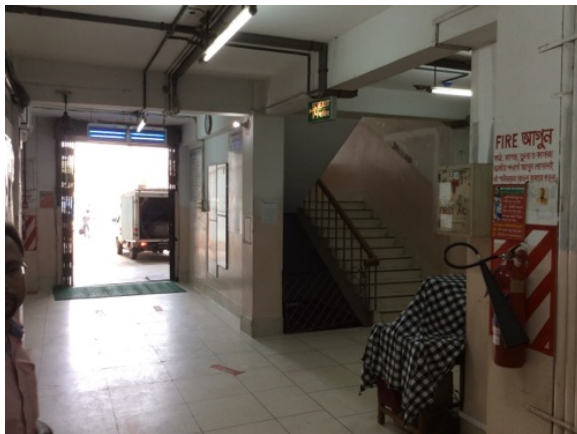
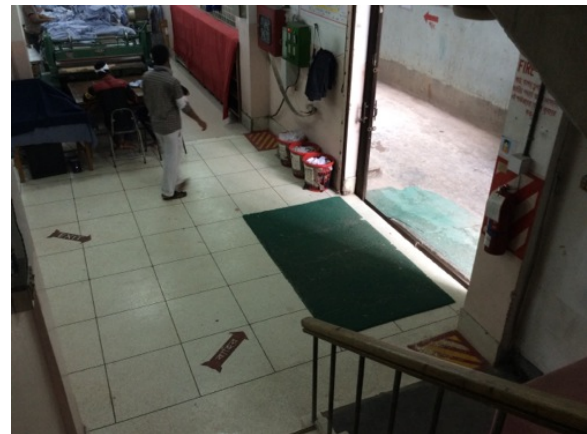
| F-9 | Egress | North and central exit stairs discharge to inside the building. | Provide 2-hr fire-rated exit passageway leading directly outside (vestibules to separate any storage areas). | Within 6 months |

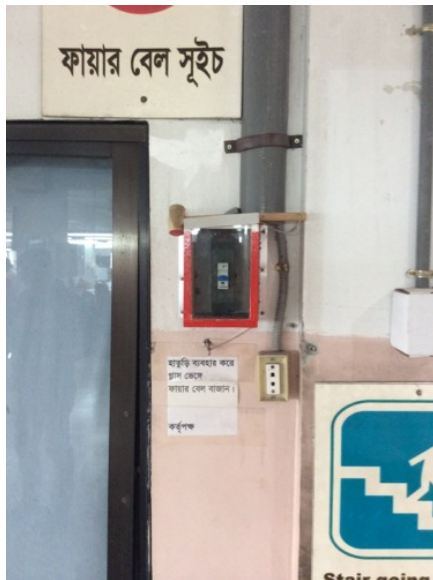
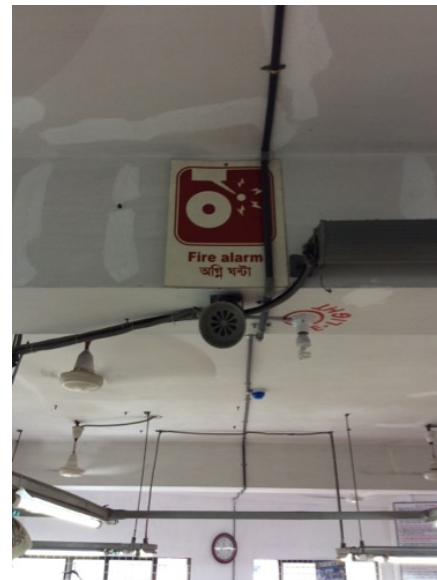
| F-10 | Fire Protection | The fire alarm system is antiquated, not a listed system, and does not provide alarm and notification features consistent with acceptable standards. | Replace the fire alarm system with a new, listed addressable fire alarm system in accordance with NFPA 72. | Design within 4 months, install within 9 months |

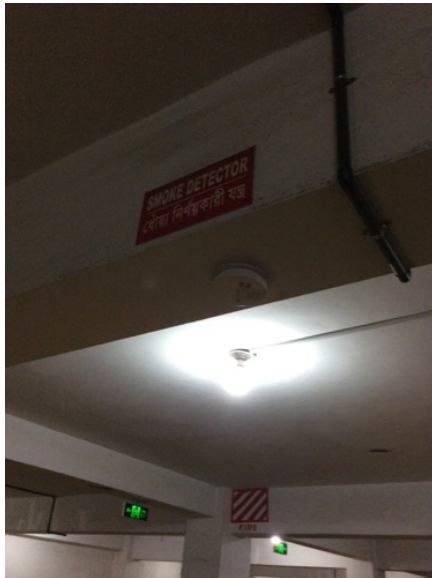
| F-12 | Fire Protection | The building is equipped with single-station smoke alarms. Smoke alarm activation sounds only a local alarm and does not provide automatic fire alarm notification of occupants. | Remove single-station smoke alarms. Provide automatic smoke detection throughout the building, tied into the fire alarm system, in accordance with NFPA 72. | Within 6 months |

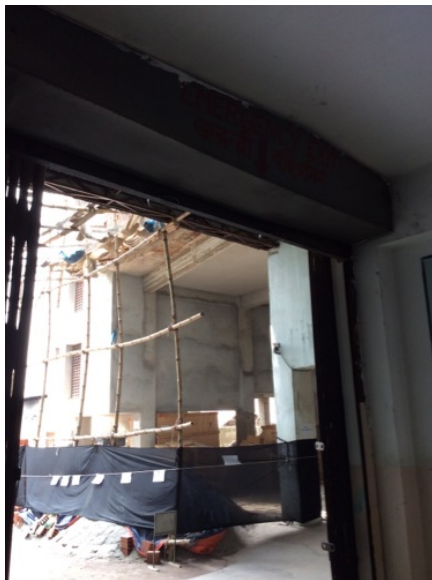
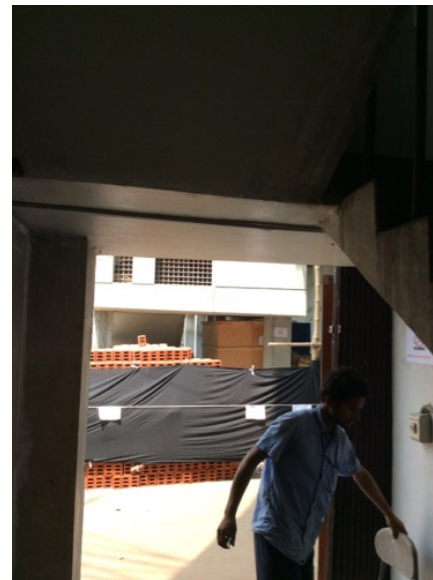
| F-13 | Egress Lighting | Exit signs were not provided at exit stair discharge doors on the ground floor. | Provide exit signs above all exits to the exterior and all doors to the exit stairs. | Within 1 month |
