# **FIRE SAFETY INSPECTION REPORT**

## **AURUM SWEATER LIMITED**

**ADDRESS: 249/1, Teli Para, Gazipur Chowrasta, Gazipur.  
23.996443, 90.382593**

**Inspected By: Shabbir Hossain & Pantha Pallob Das  
Date: 06 July, 2017**

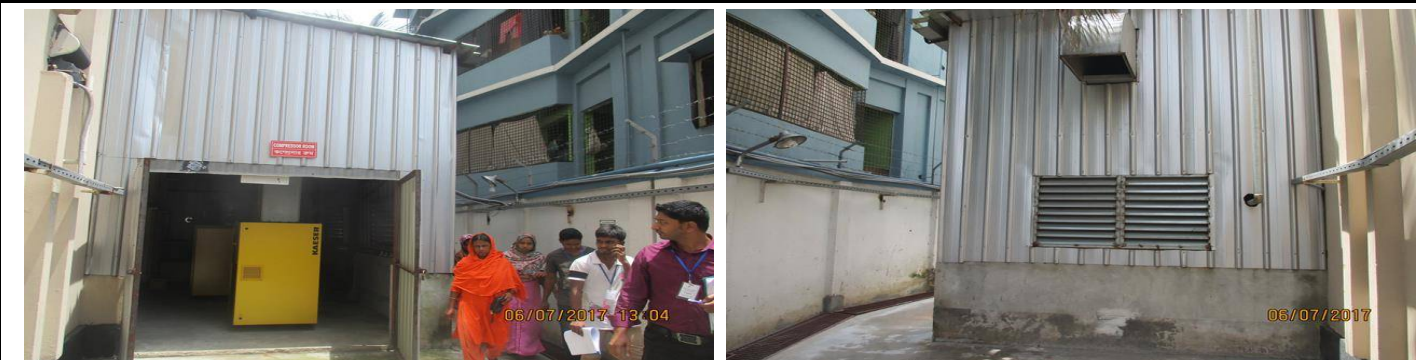
| SI No. | Category | Findings | Required Action | Remediation Time Frame |
|---|---|---|---|---|
| F-1 | Fire Rated Construction | <p>The compressor room is not fire separated with fire rated construction barrier or assemblies.</p> <p><b>Location:</b> Ground Floor (Adjacent to egress court in west side of main building).</p> | <p>Separate the compressor room by a minimum 1-hr fire-rated construction with 0.75-hr fire rated opening protective assemblies like fire rated door.</p> <p>When located to the exterior of a building by at least 3m (10 ft.) distance from surroundings then fire rated construction barrier is not mandatory.</p> | Within 3 months |

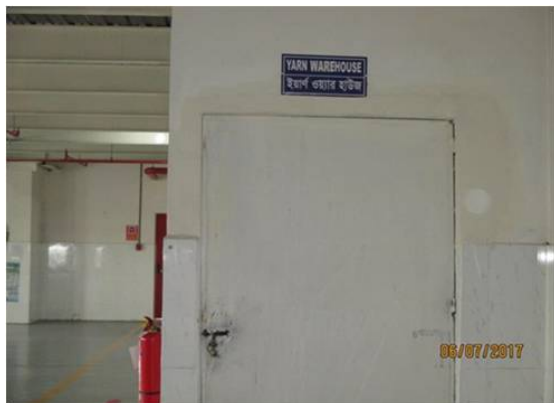
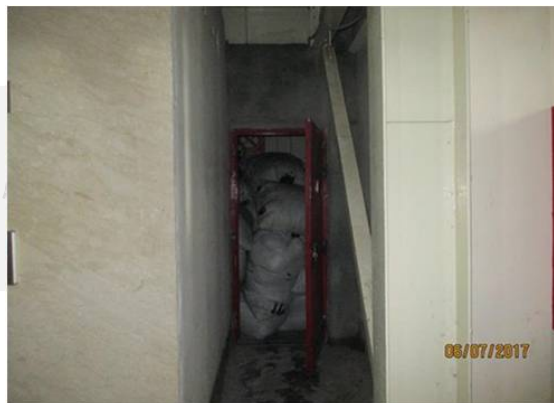
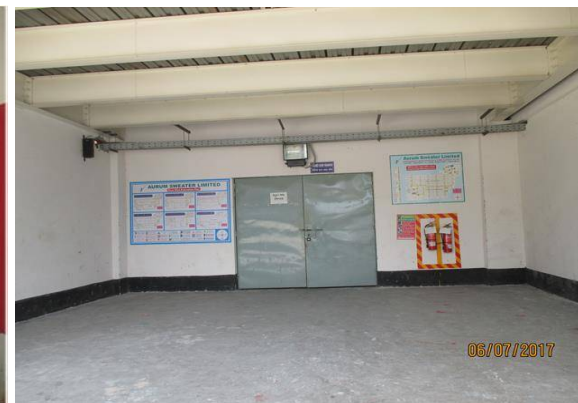
| F-2 | Fire Rated Construction | <p>Rooms used for combustible storage are not separated by fire rated construction.</p> <p><b>Location:</b> Yarn Warehouse on 6th floor, finished goods store and wastage store on ground floor.</p> | <p>Separate the dedicated storage rooms by minimum 1-hr fire-rated construction. Provide 0.75 hr. fire rated door and seal all penetrations and openings by 1 hr. fire rated fire rated barrier construction.</p> | Within 3 months |

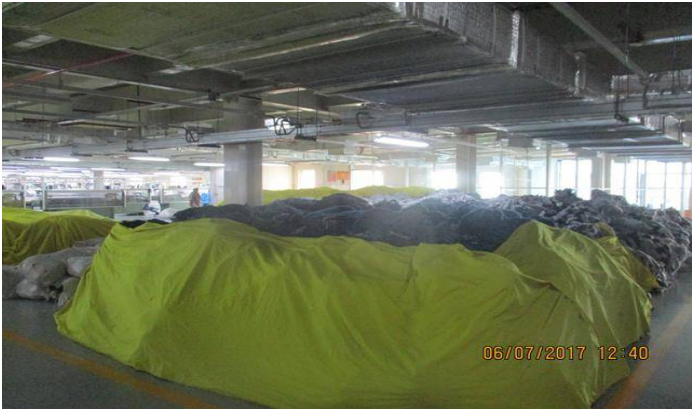
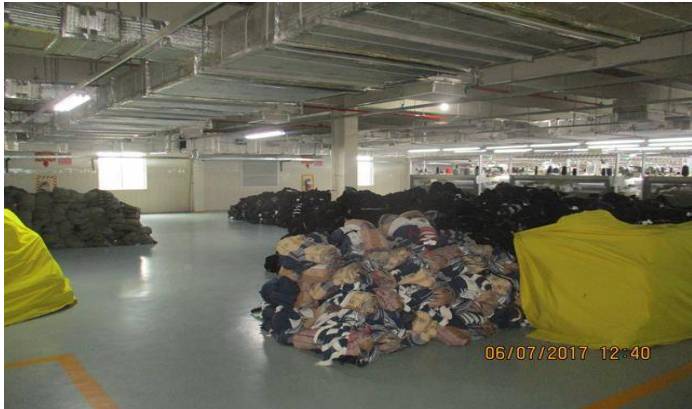
| F-3 | Fire Rated Construction | <p>Areas used for combustible storage open to the factory are not separated by fire rated construction.</p> <p><b>Location:</b> Most of the floors of the building.</p> | <p>Separate the dedicated storage rooms by minimum 1-hr fire-rated construction. Provide 0.75 hr. fire rated door and seal all penetrations and openings by 1 hr. fire rated fire rated barrier construction.</p> <p>Where separate storage rooms are not feasible, provide defined storage areas and limit the storage arrangement as follows: - Maximum height of 2.45m (8ft.) and maximum area of 23m<sup>2</sup> (250 ft<sup>2</sup>)<br/> - If sprinkler protected: maximum height of 3.66m (12ft.) and maximum area of 93m<sup>2</sup> (305ft<sup>2</sup>).<br/> Separate areas of unenclosed combustible storage by a minimum clear distance of 3m (10ft.).</p> | Within 3 months |

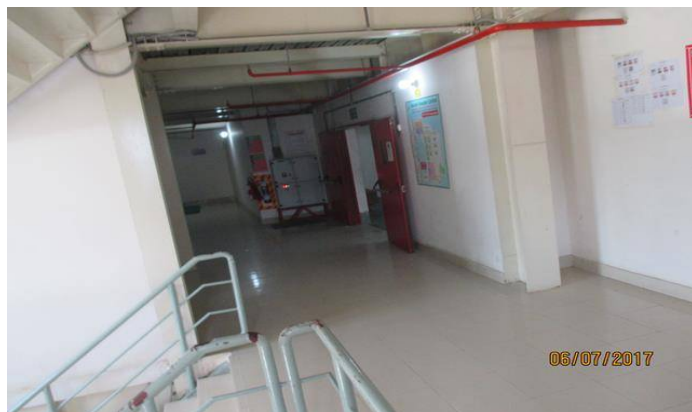
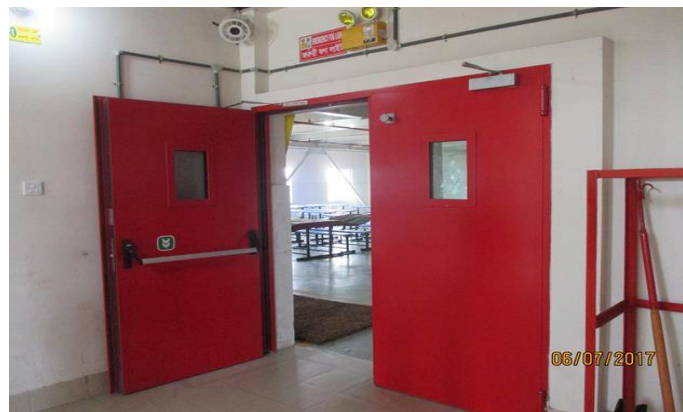
| F-4 | Fire Rated Construction | The exit stairs are not separated from work areas and other spaces on each floor by fire rated construction. | <p>The exit stair enclosure shall be provided with a minimum 1-hr fire resistance rating for buildings with 3 or fewer stories and a minimum of 2- hr. fire resistance rating for buildings 4 or more stories. Provide 0.75 hr. fire rated door and seal all penetrations and openings by 1 hr. fire rated fire rated barrier construction for building with 3 or fewer stories. Provide 1.5 hr. fire rated door and seal all penetrations and openings by 2 hr. fire rated fire rated barrier construction for building with 4 or more stories.</p> <p>Provide a fire-resistive rated assembly between the exterior exit stairs and the building up to 10 ft. beyond the end of the stair to achieve the required separation. The rated assembly shall be approved and/or designed by a qualified fire protection engineer.</p> <p>Ensure that the fire doors are self-closing and positive latching and that they are provided with fire exit (panic) hardware where serving production floors. If fire doors are required to be held open for functional reasons, provide automatic closing devices tied to the fire alarm system.</p> | Within 3 months |

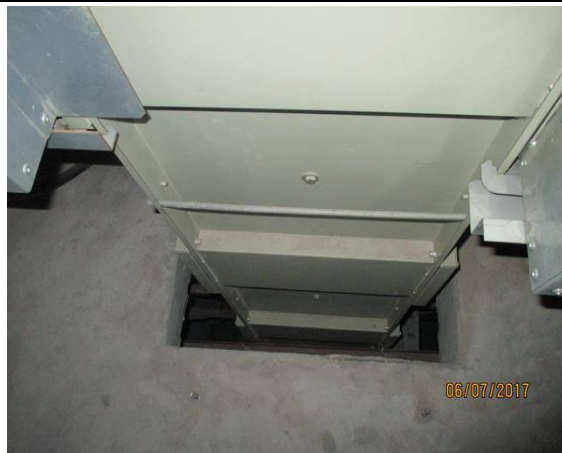
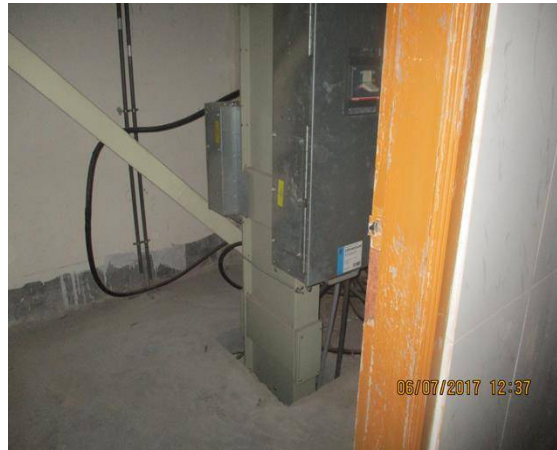
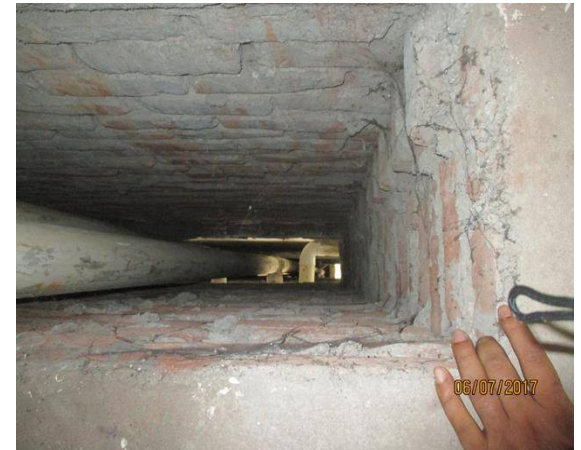
| F-5 | Fire Rated Construction | <p>Unsealed penetrations and openings are located in the fire-rated floor/ceiling assemblies.</p> <p><b>Location:</b> Electrical and Sanitary riser on every floor.</p> | <p>Seal all penetrations and openings in floor/ceiling assemblies to maintain the fire separation.</p> | <p>Within 1 months</p> |

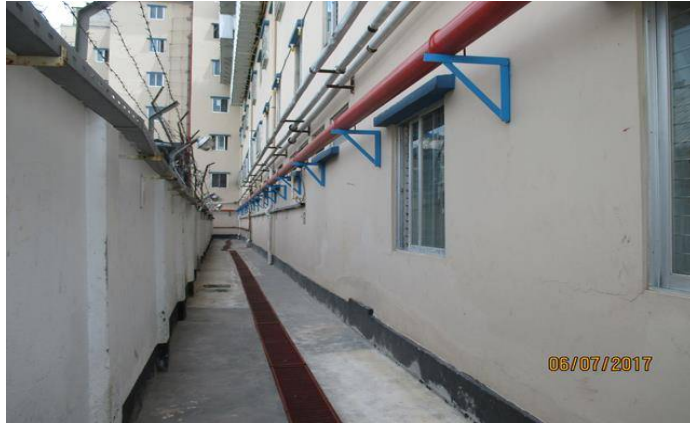
| F-6 | Fire Rated Construction | The exit discharge path/egress court for south-east, south-west and north-east stairs are less than 10 ft. wide but not separated from the building interior. | <p>a. Separate the exit passageway (ceiling, floor, wall etc.) by 2- hr. fire-resistance rated construction and shall terminate at an exit discharge.</p> <p>b. Seal all penetrations and openings to the interior of the building along the discharge path up to a height of 10 ft. to provide a minimum 2-hr fire separation.</p> | Within 3 months |

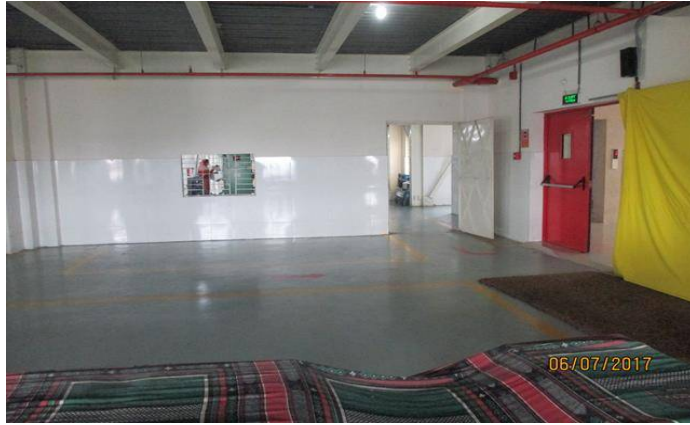
| F-7 | Fire rated construction | <p>Dining found on 5th floor of the building but not fire separated by fire rated construction barrier.</p> <p><b>Location:</b> 6th Floor.</p> | <p>Separate the dining room by minimum 2-hr fire rated construction barrier having direct access to required exit stairs. Sealed and/or protect all opening to maintain the required fire separations.</p> | <p>Within 3 months</p> |

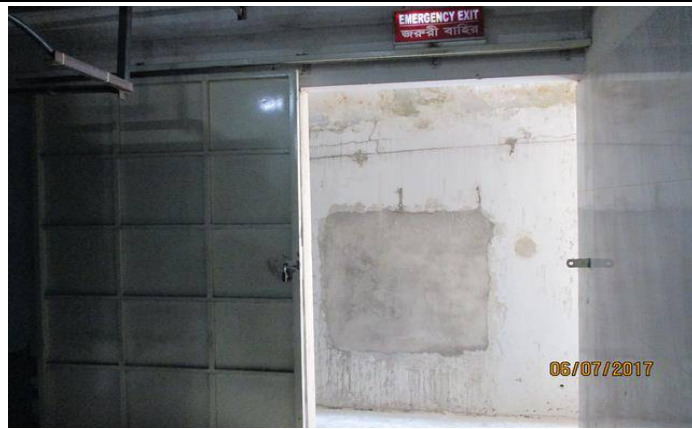
| F-8 | Egress | Non-compliant exit door (sliding) provided in washing section on ground floor . | <p>Replace all collapsible/sliding/shutter type doors &amp; gates by the side-hinged swinging type doors.</p> <p>If locks are required for security reasons, utilize special door locking features complying with NFPA 101.</p> | Immediate |

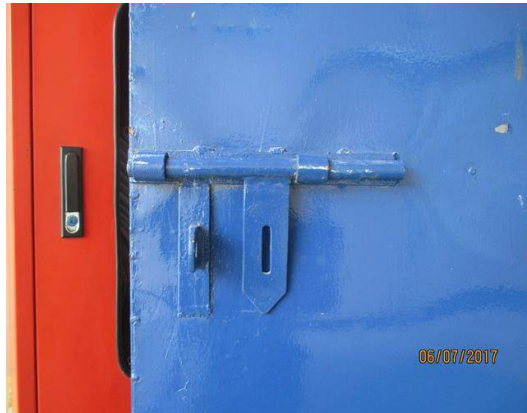
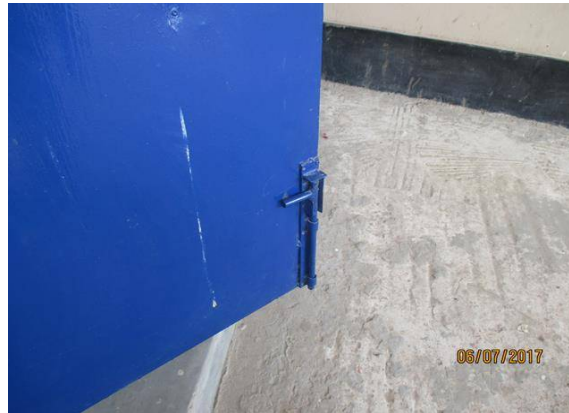
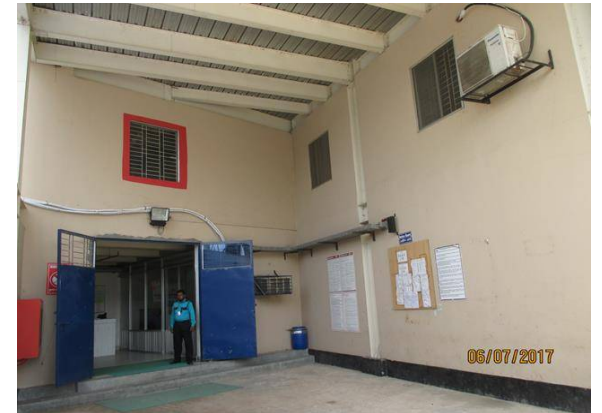
| F-9 | Egress | Non-compliant locking features are provided at building exits on ground floor. All doors and gates were found open and unlocked during inspection. | <ol style="list-style-type: none"> <li>1. Remove all non compliant locking features from egress doors.</li> <li>2. If locks are required for security reasons, utilize special door locking features complying with NFPA 101.</li> <li>3. Doors may be locked where the latch and lock are disengaged with one motion where the occupant load does not exceed 49 persons.</li> <li>4. Doors may be provided with locking hardware from the ingress side provided that a panic bar is installed on any door with an occupant load exceeding 49 persons.</li> </ol> | Immediate |

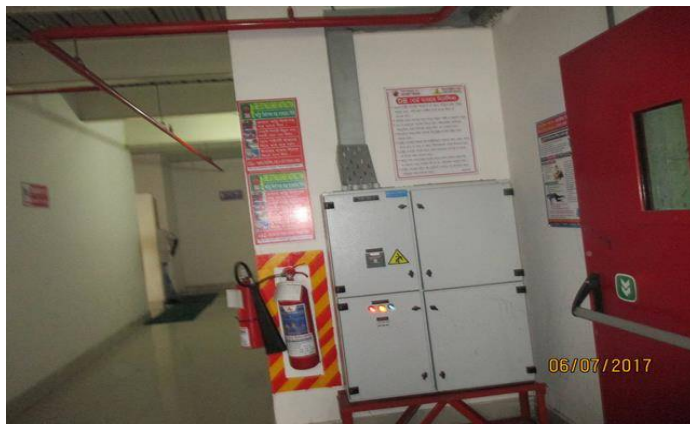
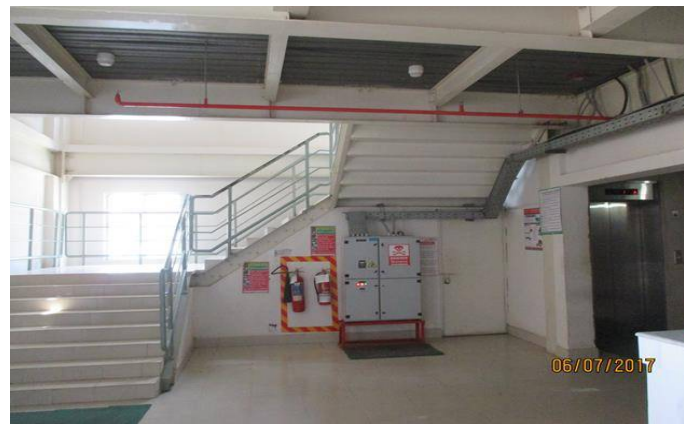
| F-10 | Egress | Electrical Distribution Board were located inside of exit stair on every floors. | Relocate electrical DB from stair enclosure. | Immediate |

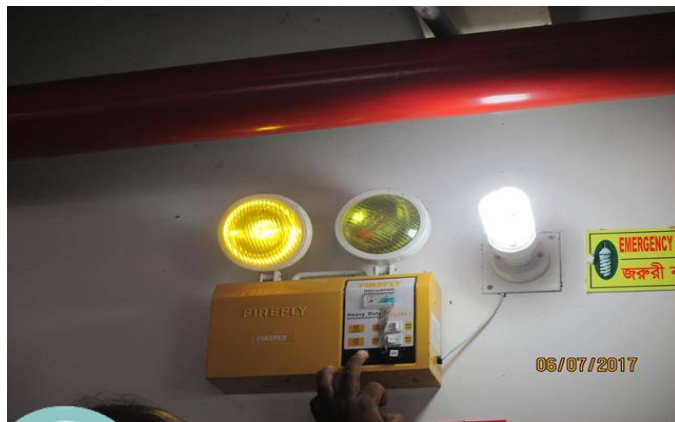
| F-14 | Egress Lighting | Manual on-off switch is provided for emergency lighting / exit signage units. | Remove manual on/off switches from emergency lighting / exit signage units to prevent them from being switched off. | Within 1 month |

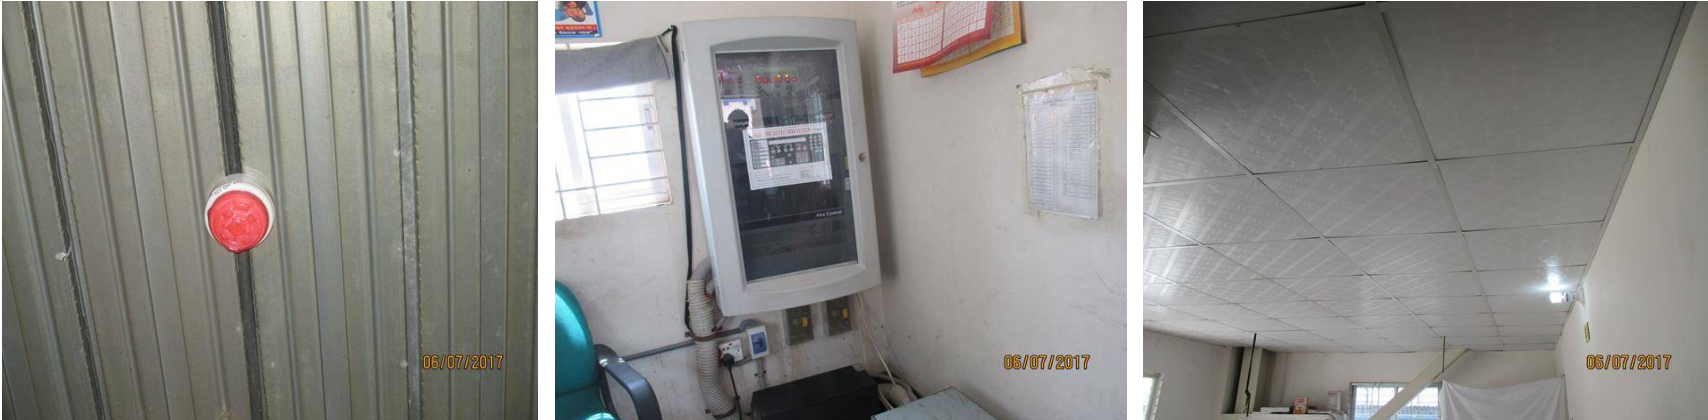
| F-15 | Fire Detection and Alarm System | The fire detection and alarm system installation work is not completed as per NFPA-72. | <p>Install the fire detection and alarm system with a listed addressable fire alarm system in accordance with NFPA 72.</p> <p>Design shall be submitted to ACCORD Chief Safety Inspector for review prior to installation of the system.</p> | Design within 4 months and installation within 9 months. |

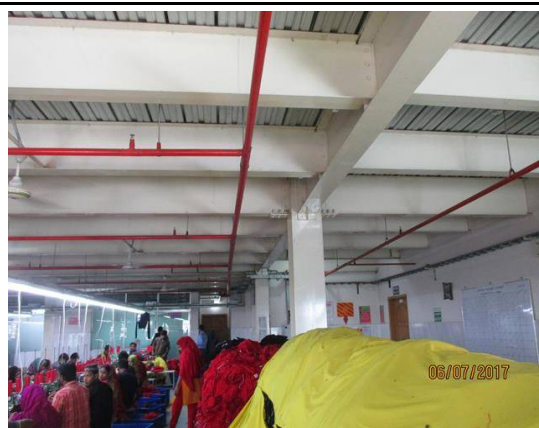
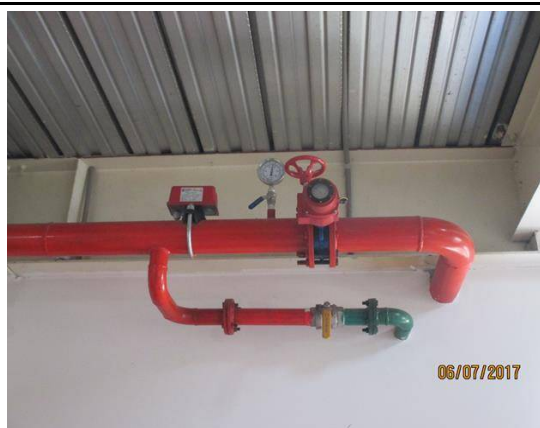
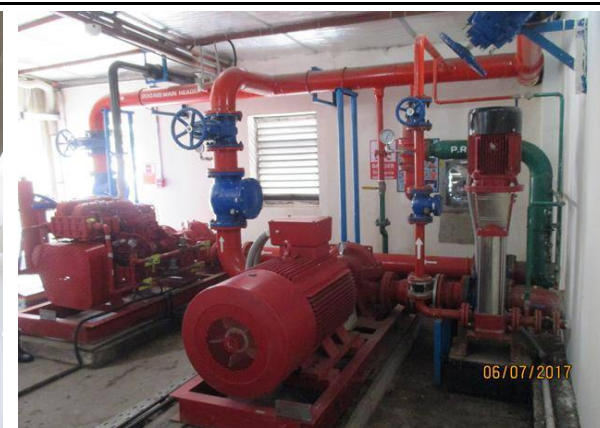
| F-17 | Fire Protection System | <p>The building is 6 storied with non-rated construction where automatic sprinkler system protection is mandatory for entire building.</p> <p><b>Note:</b> Sprinkler system is installed for entire building but there are some installation errors. (Pump, head, zone control valve etc). All the required elements are not listed.</p> | Modify the automatic sprinkler system along with required hose system throughout the building in accordance with NFPA 13,14, 20, 22 and 24. | Design within 4 months and installation within 9 months |
