FIRE SAFETY INSPECTION REPORT

**SIGMA FASHIONS LTD.
RS-61, DHONAI, TAJPUR ROAD, YEARPUR,
ASHULIA, SAVAR, DHAKA**

ACCORD
on Fire and Building Safety in Bangladesh

June 25, 2014

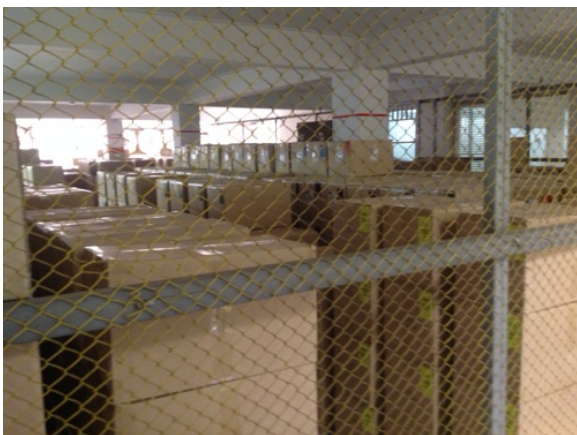
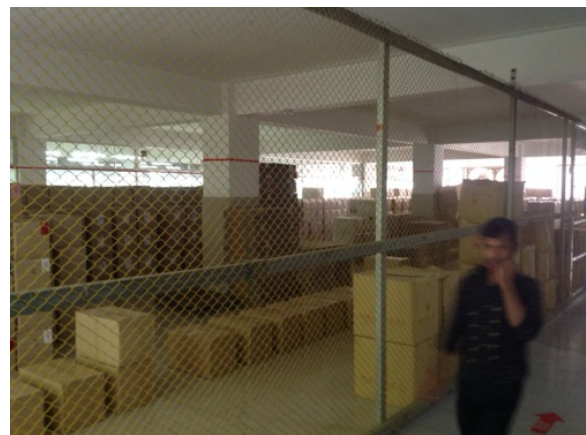
No.	Category	Finding	Recommendation	Remediation Timeframe
F-1	Fire Rated Construction	Areas used for combustible storage are not separated by fire- rated construction on the ground and first (1) floors.	<p>Provide dedicated storage rooms separated by minimum 1-hr fire-rated construction.</p> <p>Where separate storage rooms are not feasible, provide defined storage areas and limit the storage arrangement as follows:</p> <ul style="list-style-type: none"> - Maximum height of 2.4m and maximum area of 23m² - If sprinkler protected: maximum height of 3.66m and maximum area of 93m² <p>Separate areas of unenclosed combustible storage by a minimum clear distance of 3m.</p>	Within 3 months

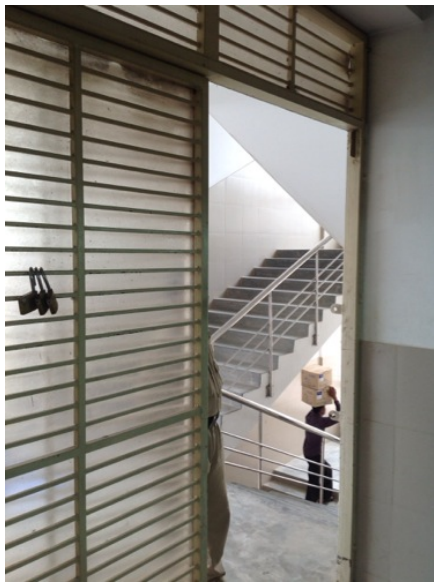
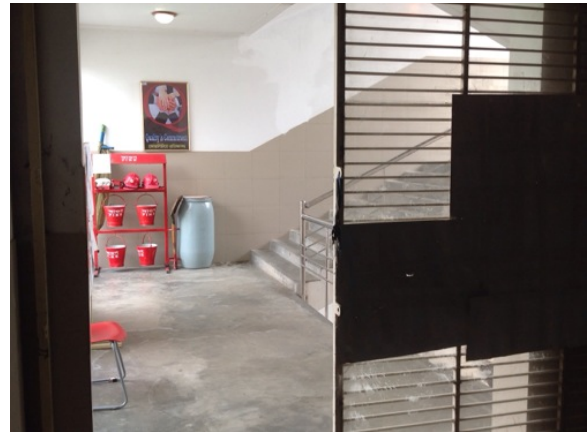
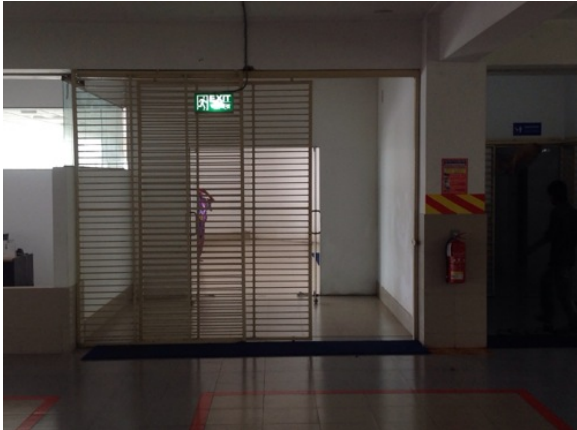
F-2	Fire Rated Construction	The exit stairs are not separated from work areas and other spaces on each floor by fire-rated construction.	Provide minimum 1.5-hr fire rated doors and seal all unprotected openings to separate the exit stairs from work areas and other building spaces on all floor levels. Ensure that the fire doors are self-closing and positive latching and that they are provided with fire exit (panic) hardware where serving production floors.	Within 3 months
-----	-------------------------	--	--	-----------------

If fire doors are required to be held open for functional reasons, provide automatic-closing devices tied to the fire alarm system.

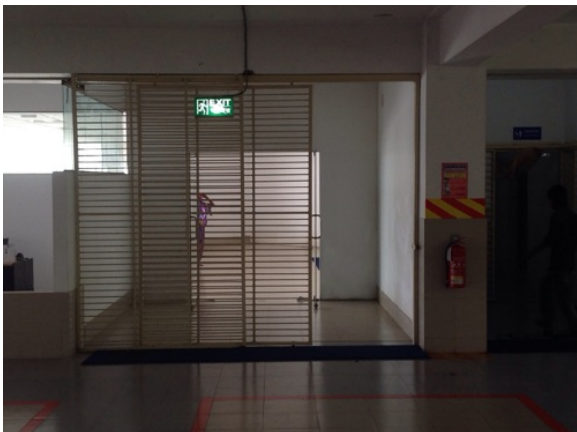
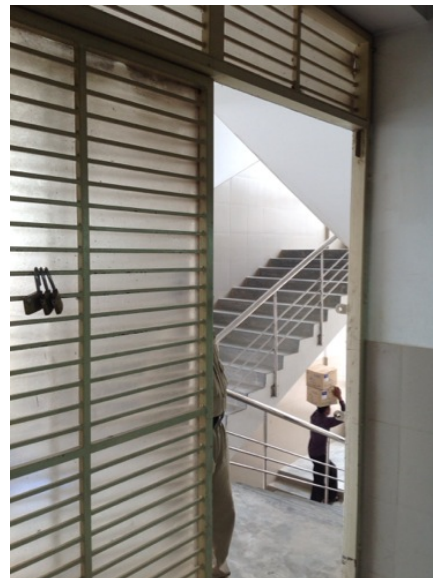
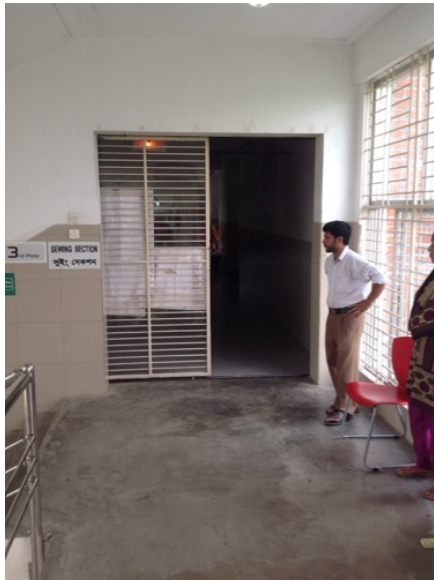
F-3 Egress

Egress doors and gates with locking features are provided at building exits, exit stairs, along egress routes, exit discharge throughout the factory.

Remove locking features from all egress doors / gates.

Immediate

If locks are required for security reasons, utilize special door locking features complying with NFPA 101.

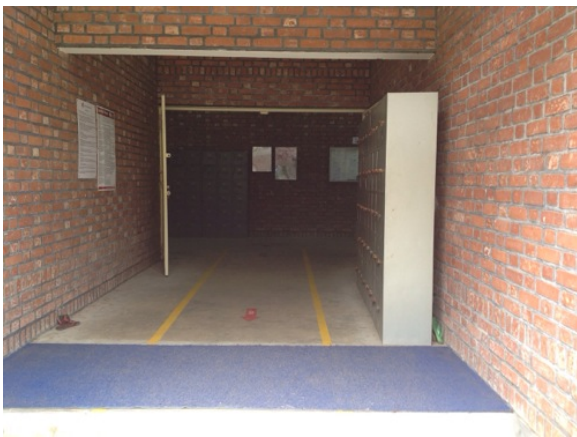
F-4	Egress	Storage was located in the east exit stair discharge.	Remove all storage from exit stairs and egress paths.	Immediate
-----	--------	---	---	-----------

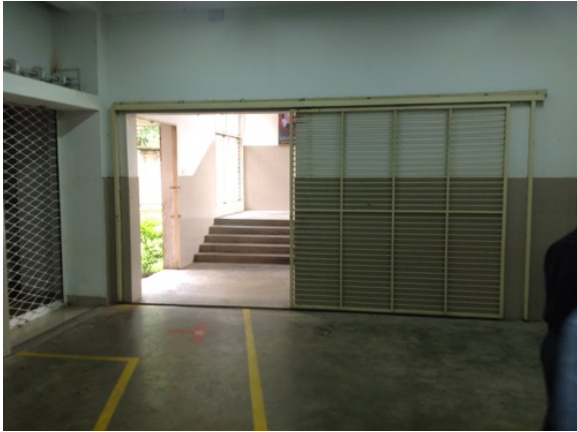
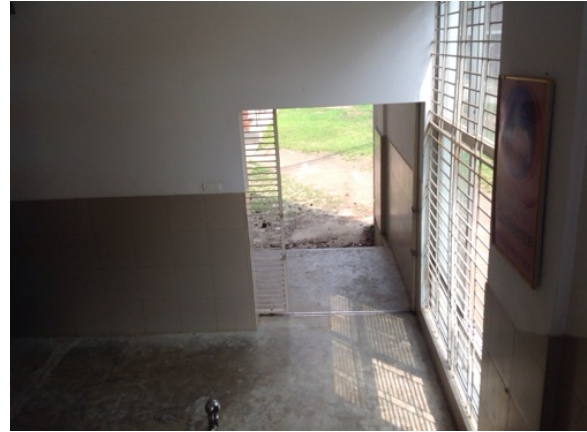
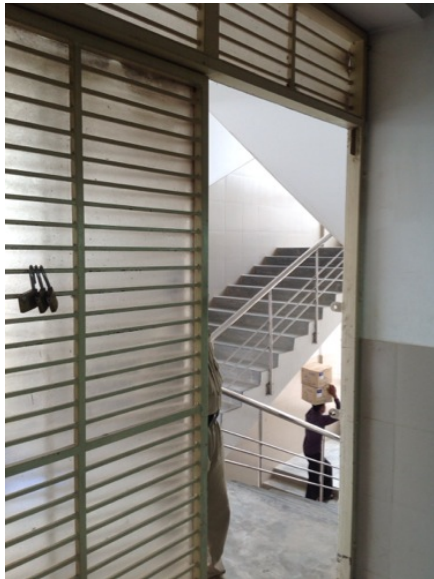
F-5	Egress	Collapsible gates and sliding doors are provided at building exits, exit stairs, along egress routes, exit discharge throughout the factory.	Replace all gates and sliding doors along the means of egress with side-hinged, swinging egress doors. If locks are required for security reasons, utilize special door locking features complying with NFPA 101.	Within 1 month
-----	--------	--	--	----------------

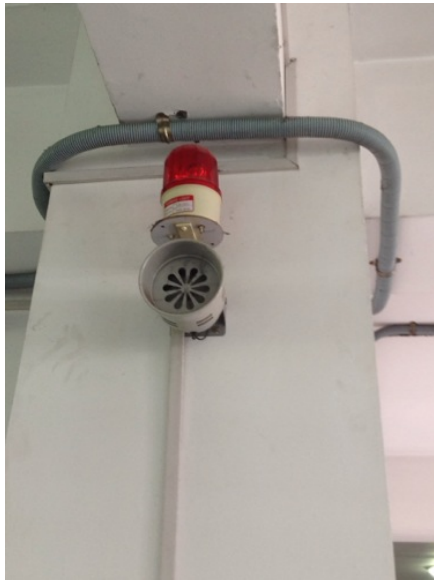
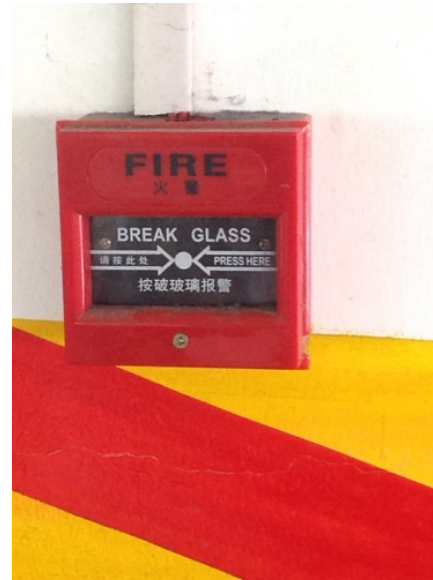
F-6	Fire Protection	The fire alarm system is antiquated, not a listed system, and does not provide alarm and notification features consistent with acceptable standards.	Replace the fire alarm system with a new, listed addressable fire alarm system in accordance with NFPA 72.	Design within 4 months, install within 9 months
-----	-----------------	--	--	---

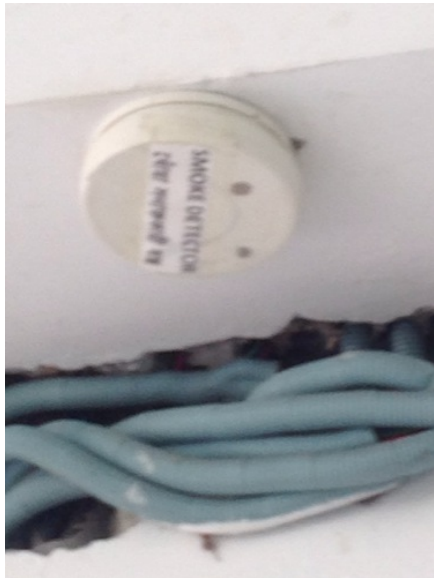
F-7	Fire Protection	Inspection, testing, and maintenance of the fire alarm system is not in accordance with NFPA 72.	Inspect, test and maintain the fire alarm system, and keep written records on-site, in accordance with NFPA 72.	Within 3 months
F-8	Fire Protection	The building is equipped with single-station smoke alarms. Smoke alarm activation sounds only a local alarm and does not provide automatic fire alarm notification of occupants.	Remove single-station smoke alarms. Provide automatic smoke detection throughout the building, tied into the fire alarm system, in accordance with NFPA 72.	Within 6 months

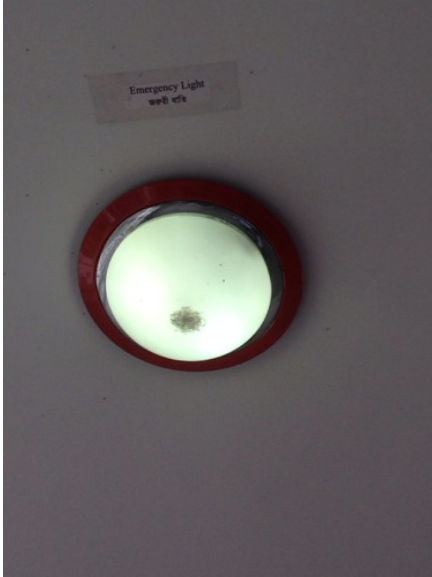
F-9	Egress Lighting	Inspection, testing, and maintenance for the emergency lighting system was not in accordance with The ACCORD standard.	Inspect, test and maintain the emergency lighting system in accordance with The ACCORD standard. Keep written records on-site.	Within 3 months
F-10	Egress Lighting	Based on the number and location of emergency lights observed, adequate illumination levels are not anticipated along egress routes throughout the factory.	Test the emergency lighting system on each floor and provide additional emergency fixtures to provide adequate illumination along the means of egress. Provide a minimum illumination of 10 lux at the floor level within exit stairs and exit discharge paths and minimum 2.5 lux along exit access aisles.	Within 3 months
