# **FIRE SAFETY INSPECTION REPORT**

**Good Rich Sweaters Ltd (new building)**

**ACCORD ID: 12891**

**Date: 29 January, 2018**

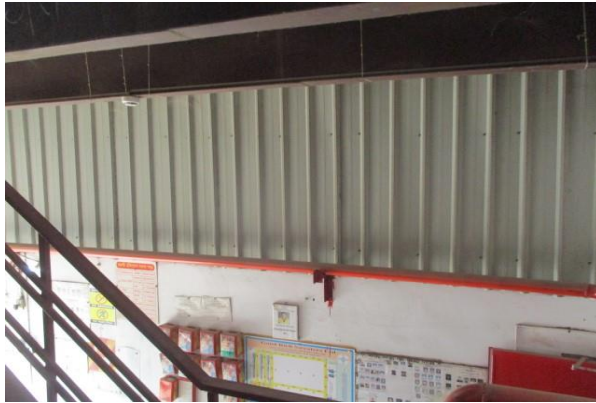
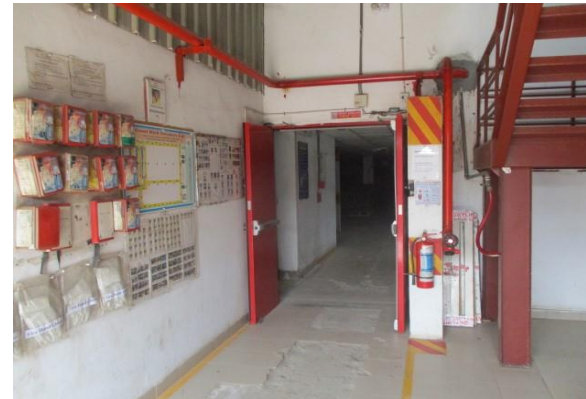
| Sl No. | Category | Findings | Required Action | Remediation Time Frame |
|---|---|---|---|---|
| 1 | Fire Rated Construction | The exit stairs enclosures are not separated from work areas and other spaces on each floor by fire-rated construction(Non rated doors, unsealed penetrations and openings etc.)<br>Building-2. | Provide minimum 1-hr rated doors for buildings with 3 or fewer stories and 1.5-hr fire rated doors for buildings that are 4 or more stories. Seal all unprotected openings to separate the exit stairs from work areas and other building spaces on all floor levels. Ensure that the fire doors are self-closing and positive latching and that they are provided with fire exit (panic) hardware where serving production floors. If fire doors are required to be held open for functional reasons, provide automatic closing devices tied to the fire alarm system. Once fire doors are installed, every door in a stair enclosure serving more than 5 stories shall be provided with re-entry unless it meets. | Within 3 months |

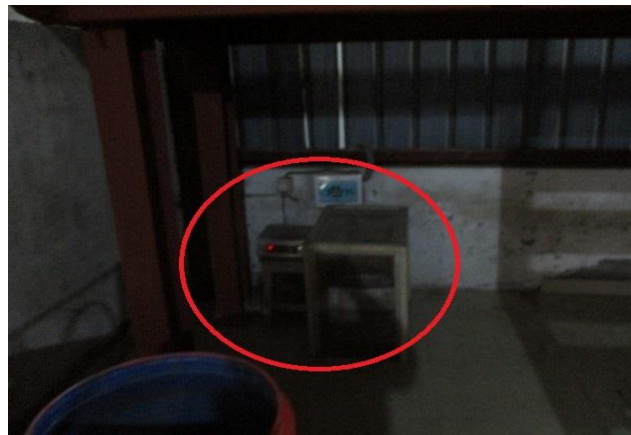
| 3 | Egress | Electrical panel/ IPS was located in all exit stairs.<br>Location: Ground floor. | Remove electrical panel/ IPS from the exit stairs and egress path. | Within 1 month |

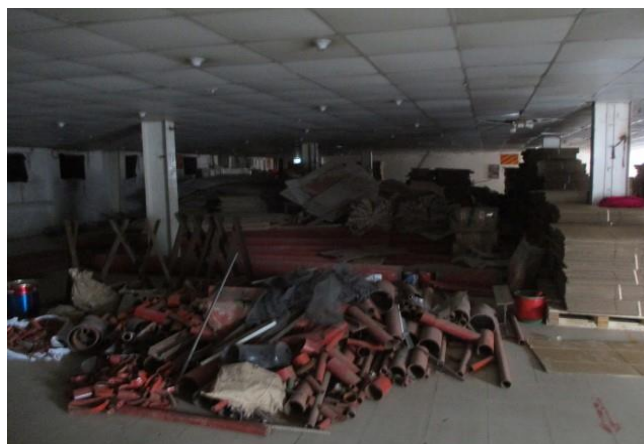
| 4 | Storage Areas | Areas used for combustible storage are not separated by fire-rated construction | <p>Provide dedicated storage rooms separated by minimum 1-hr fire-rated construction.</p> <p>Where separate storage rooms are not feasible, provide defined storage areas and limit the storage arrangement as follows:</p> <ul style="list-style-type: none"> <li>- Maximum height of 2.4m and maximum area of 23m<sup>2</sup></li> <li>- If sprinkler protected: maximum height of 3.66m and maximum area of 93m<sup>2</sup></li> </ul> <p>Separate areas of unenclosed combustible storage by a minimum clear distance of 3m</p> | Within 3 months |

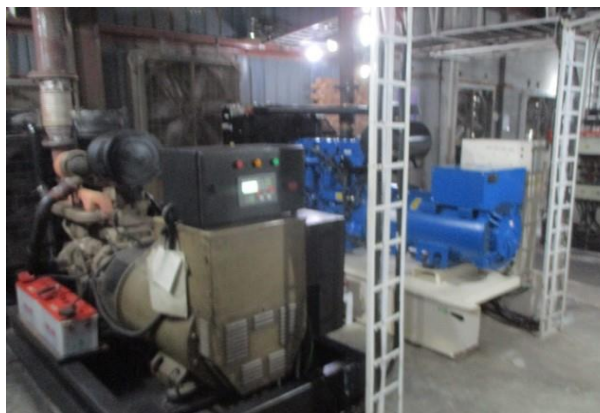
| 5 | Service Room Separation | Generator room is not properly separated by fire rated construction with other Occupancies/Areas | Separate the Generator room by a minimum 2-hr fire rated construction. Seal and/or protected all openings to maintain fire separations. | Within 3 months |

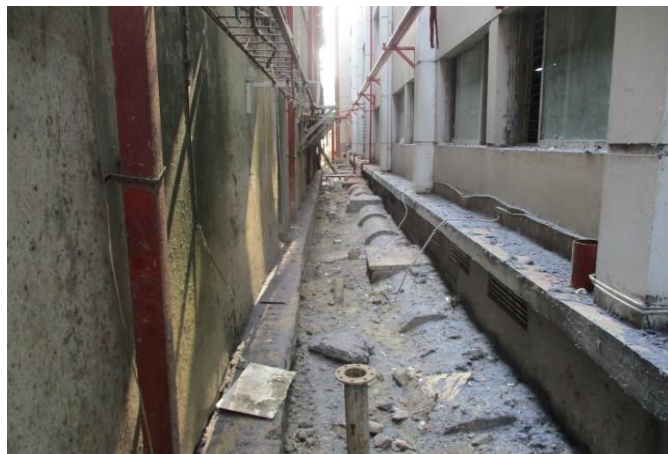
| 6 | Discharge path | The exit discharge paths serving the Northwest exit stairs were less than 10 ft wide and were not separated from the building interior. | Seal all penetrations and openings to the interior of the building along the discharge path, up to a height of 10 ft., to provide a minimum 1-hr fire separation.<br>Alternatively, provide a second remote discharge path to the public way (only include this if feasible) | Within 3 months |

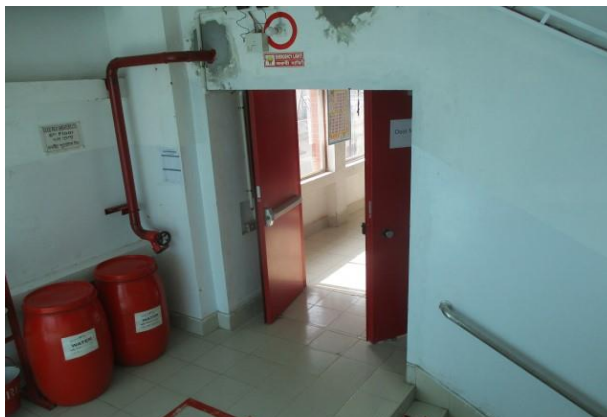
| 11 | Fire Rated Construction | The exit stairs enclosures are not separated from work areas and other spaces on each floor by fire rated construction(Non rated doors, unsealed penetrations and openings etc.) Building-3. | Provide minimum 1-hr rated doors for buildings with 3 or fewer stories and 1.5-hr fire rated doors for buildings that are 4 or more stories. Seal all unprotected openings to separate the exit stairs from work areas and other building spaces on all floor levels. Ensure that the fire doors are self-closing and positive latching and that they are provided with fire exit (panic) hardware where serving production floors. If fire doors are required to be held open for functional reasons, provide automatic closing devices tied to the fire alarm system. Once fire doors are installed, every door in a stair enclosure serving more than 5 stories shall be provided with re-entry unless it meets. | Within 3 months |

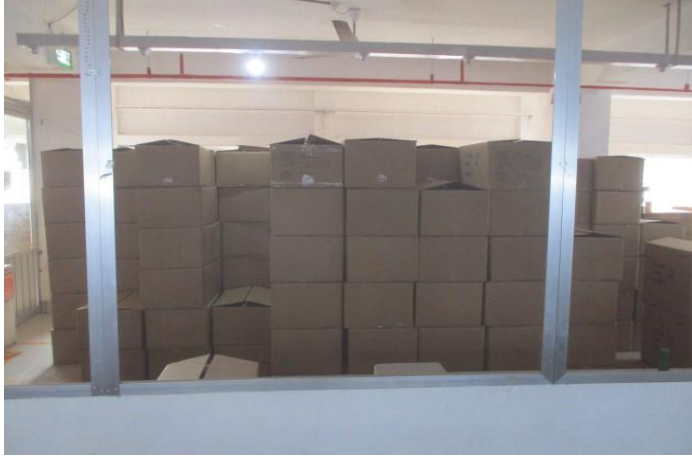
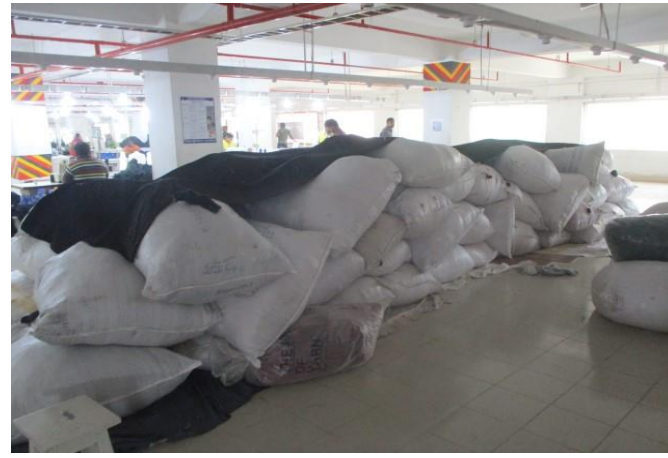
| 12 | Storage Areas | Areas used for combustible storage are not separated by fire-rated construction | <p>Provide dedicated storage rooms separated by minimum 1-hr fire-rated construction.</p> <p>Where separate storage rooms are not feasible, provide defined storage areas and limit the storage arrangement as follows:</p> <ul style="list-style-type: none"> <li>- Maximum height of 2.4m and maximum area of 23m<sup>2</sup></li> <li>- If sprinkler protected: maximum height of 3.66m and maximum area of 93m<sup>2</sup></li> </ul> <p>Separate areas of unenclosed combustible storage by a minimum clear distance of 3m</p> | Within 3 months |

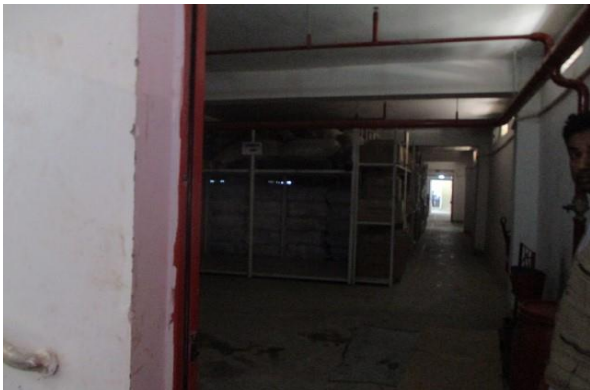
| 13 | Storage Areas | Rooms used for combustible storage on the ground floor are not separated by fire-rated construction. Location: Basement. | Provide dedicated storage rooms separated by minimum 1-hr fire-rated construction. | Within 3 months |

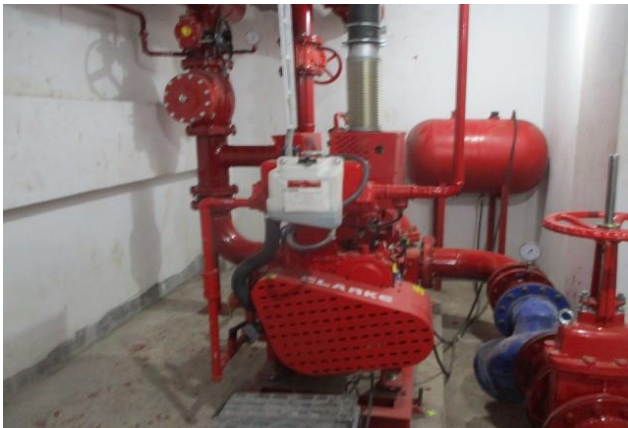
| 16 | Unprotected Fire Pump Room | The fire pump room is not provided with adequate fire separation. Location: Basement. | Provide fire pump room with 2 hr rated fire separation when not sprinklered and 1 hr rated fire separation when provided with automatic sprinklers in accordance with NFPA 20<br>Or,<br>Physically separate the pump room from the protected building by a minimum of 50 ft (15.3 m) in accordance with NFPA 20 | Within 3 months |

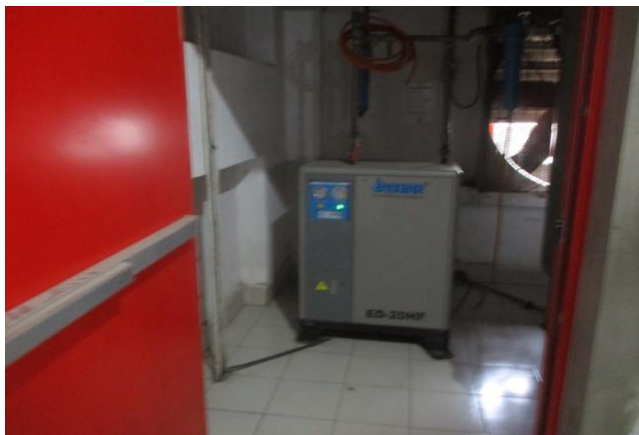
| 17 | Service Room Separation | The air compressor room is not separated by fire rated construction (openings, non-rated doors, penetrations). location: ground floor. | Separate the air compressor room by a minimum 2-hr fire rated construction. Seal and/or protected all openings to maintain fire separations. | Within 3 months |
