# **FIRE SAFETY INSPECTION REPORT**

## **COMFIT COMPOSITE KNIT LTD UNIT 1 GORAI, MIRZAPUR**

**ACCORD**  
on Fire and Building Safety in Bangladesh

April 23, 2014

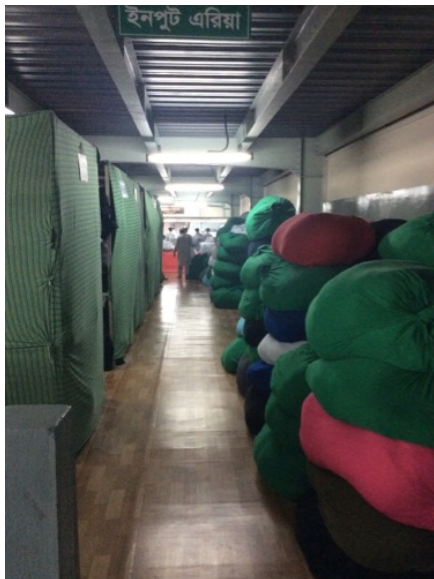
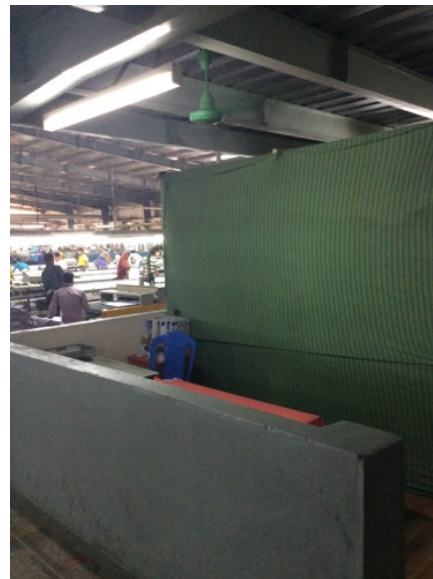
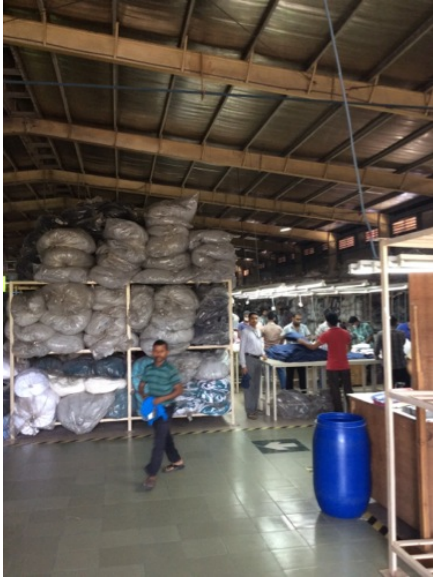
No.	Category	Finding	Recommendation	Remediation Timeframe
F-1	Fire Rated Construction	The storage rooms on the ground and fifth floors, as well as in the printing shed and dying and finishing shed are not separated by fire-rated construction.	Provide dedicated storage rooms separated by minimum 1-hr fire-rated construction.  Where separate storage rooms are not feasible, provide defined storage areas and limit the storage to a maximum height of 2.4m and maximum area of 23m <sup>2</sup> .	Within 3 months

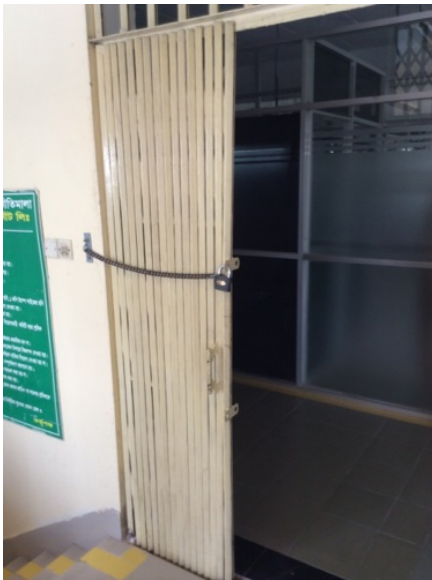
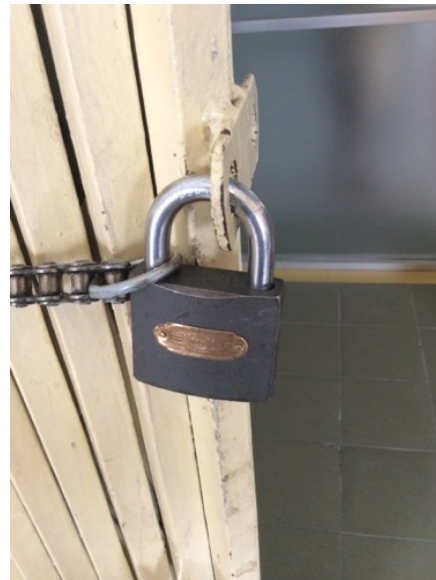
F-2	Fire Rated Construction	The exit stairs are not separated from work areas and other spaces on each floor by fire-rated construction.	<p>Provide minimum 1.5-hr fire rated doors and seal all unprotected openings to separate the exit stairs from work areas and other building spaces on all floor levels. Ensure that the fire doors are self-closing and positive latching and that they are provided with fire exit (panic) hardware where serving production floors.</p> <p>If fire doors are required to be held open for functional reasons, provide automatic-closing devices tied to the fire alarm system.</p>	Within 3 months
-----	-------------------------	--	--	-----------------

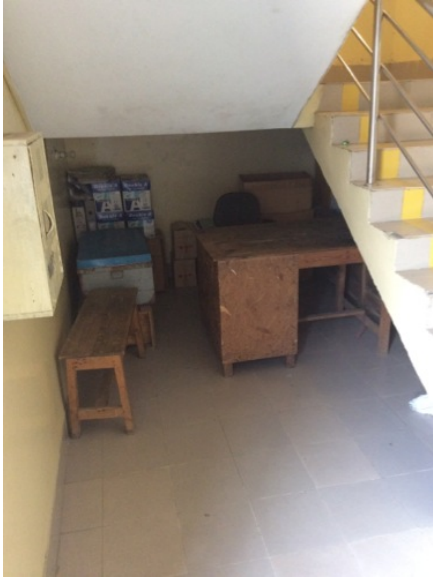
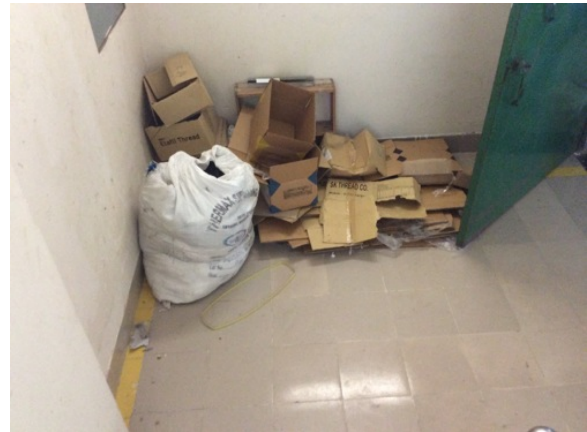
F-4	Egress	Storage was located in each exit stair and along exit discharge locations.	Remove all storage from exit stairs, areas of exit discharge, and egress paths.	Immediate
-----	--------	--	---	-----------

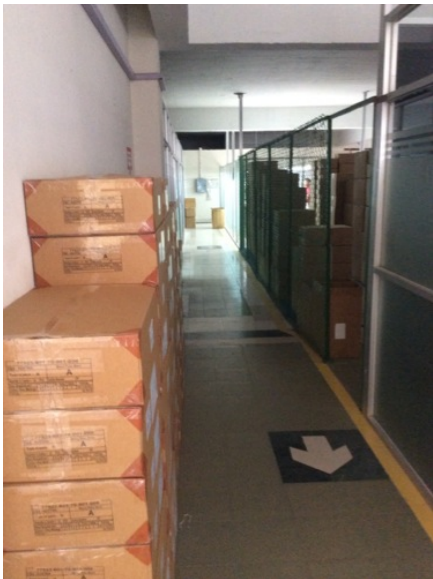
F-5 Egress

Storage was located in the egress path, specifically in the egress aisles of all floors on the west end of the main building.

Keep egress paths and stairs clear of storage.

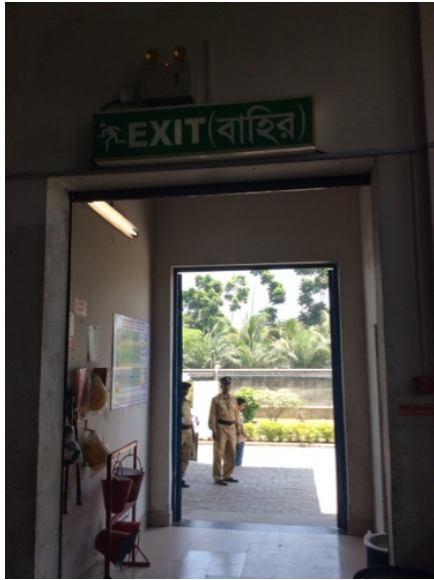
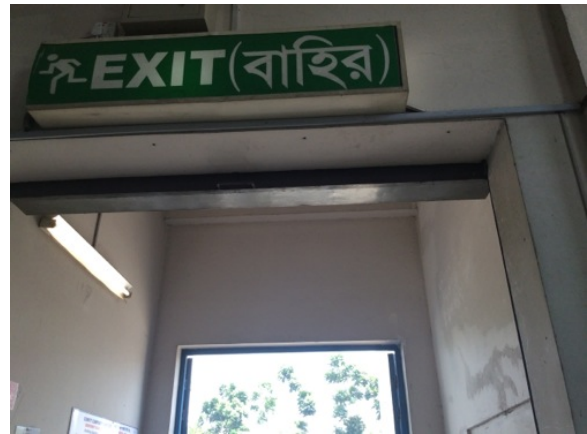
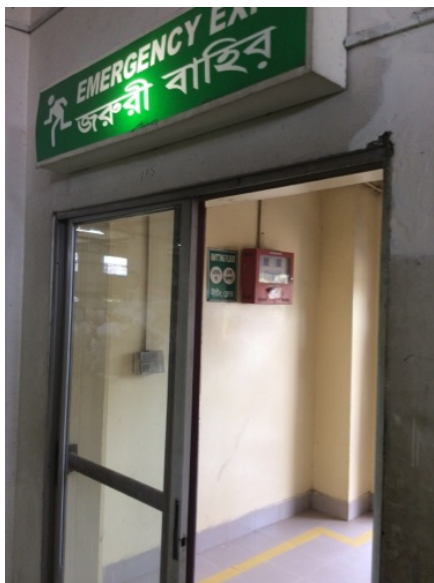
F-6	Egress	Collapsible gates are provided at building exits, exit stairs, along egress routes, and at exit discharge at various locations throughout the building.	Replace all gates / sliding doors along the means of egress with side-hinged, swinging egress doors.	Within 1 month
			If locks are required for security reasons, utilize special door locking features complying with NFPA 101.

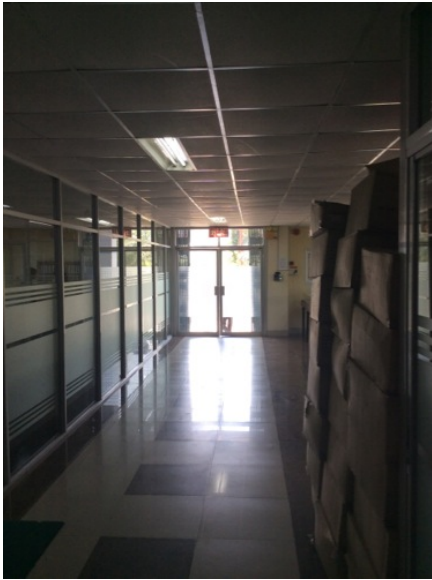
F-7	Egress	Egress door serving >50 in administration area does not swing in the direction of egress travel.	Modify the egress door to swing in the direction of egress travel.	Within 3 months
-----	--------	--	--	-----------------

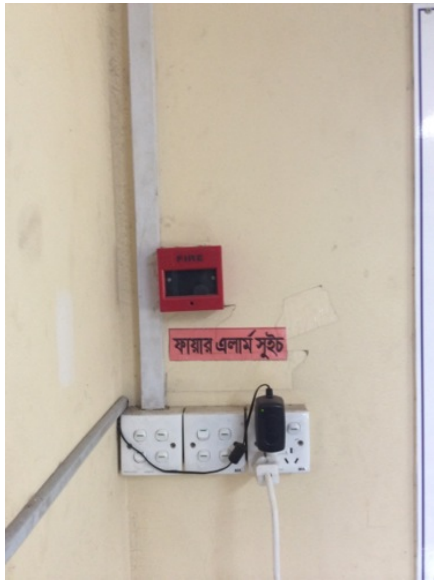
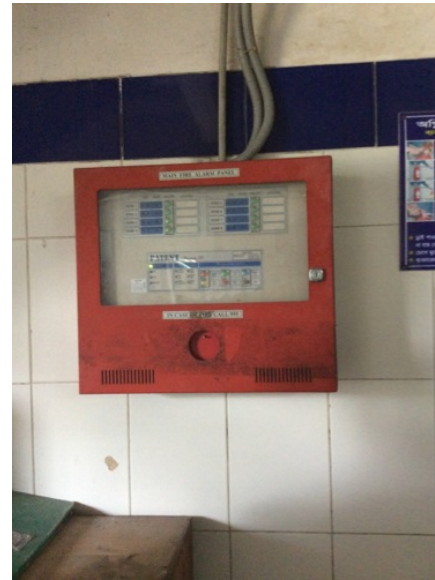
F-8	Fire Protection	The fire alarm system is antiquated, not a listed system, and does not provide alarm and notification features consistent with acceptable standards.	Replace the fire alarm system with a new, listed addressable fire alarm system in accordance with NFPA 72.	Design within 4 months, install within 9 months
-----	-----------------	--	--	---

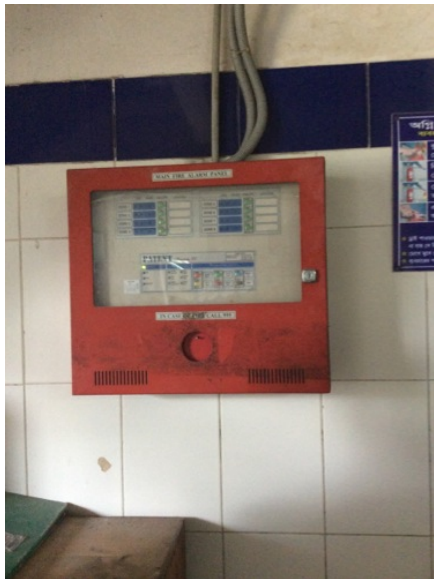
F-9	Fire Protection	Inspection, testing, and maintenance of the fire alarm system is not in accordance with NFPA 72.	Inspect, test and maintain the fire alarm system, and keep written records on-site, in accordance with NFPA 72.	Within 3 months
-----	-----------------	--	---	-----------------

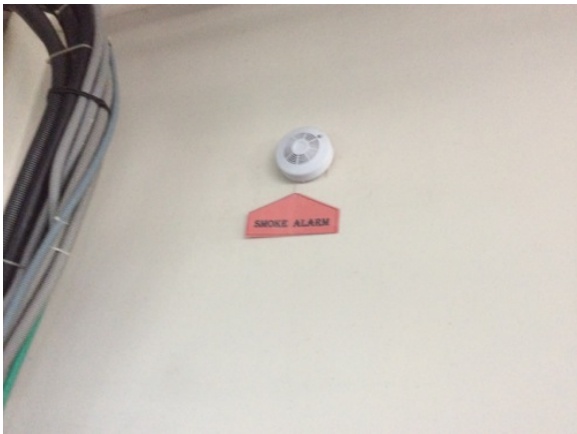
F-10	Fire Protection	The building is equipped with single-station smoke alarms. Smoke alarm activation sounds only a local alarm and does not provide automatic fire alarm notification of occupants.	Remove single-station smoke alarms. Provide automatic smoke detection throughout the building, tied into the fire alarm system, in accordance with NFPA 72.	Within 6 months
------	-----------------	--	---	-----------------

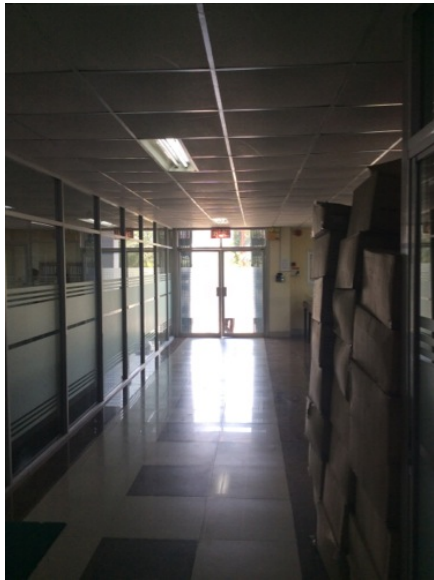
F-11	Egress Lighting	Based on the number and location of emergency lights observed, adequate illumination levels are not anticipated along egress routes in the administration area.	Test the emergency lighting system on each floor and provide additional emergency fixtures to provide adequate illumination along the means of egress. Provide a minimum illumination of 10 lux at the floor level within exit stairs and exit discharge paths and minimum 2.5 lux along exit access aisles.	Within 3 months
------	-----------------	---	--	-----------------

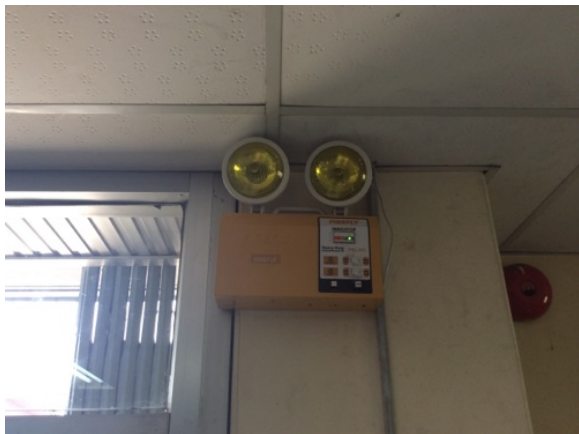
F-12	Egress Lighting	Inspection, testing, and maintenance records for the emergency lighting system were not available.	Inspect, test and maintain the emergency lighting system in accordance with The ACCORD standard. Keep written records on-site.	Within 3 months
------	-----------------	--	--	-----------------
