# **FIRE SAFETY INSPECTION REPORT**

**Euro Arte Apparels Ltd**

**ACCORD ID: 12920**

**Date: 28th, November 2017**

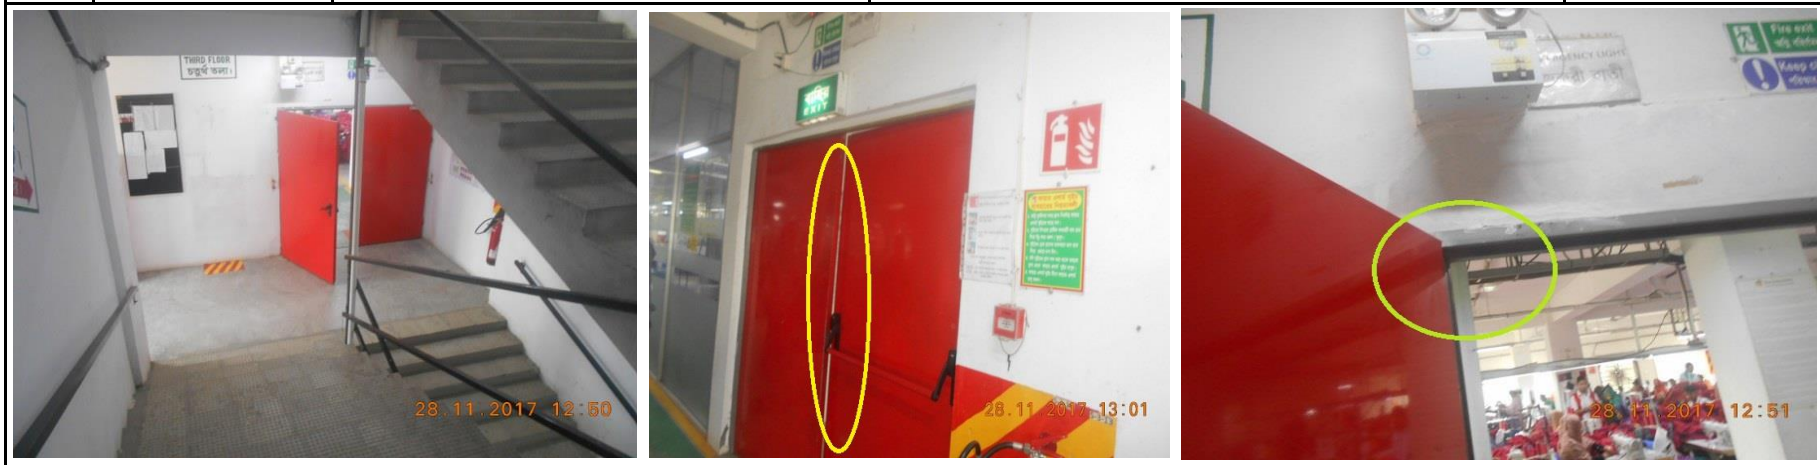
| SI No. | Category | Finding | Recommendation | Remediation TimeFrame |
|---|---|---|---|---|
| F-1 | Fire Rated Construction | The existing fire doors have functional problems including missing door co-ordinators & door closers, proper latching & locking is not anticipated, in some cases fire doors were kept open in unacceptable way. The deficiencies observed compromises the exit stair separation from production floors & other areas. | The fire doors need to be closed, latched and locked automatically. Provide door co-ordinators at double leaf doors & door closers where missing. Provide door holding devices tied to the fire alarm system. Fire doors shall be put through proper maintenance. Proper functioning of fire doors is mandatory to separate the stairs for minimum 2-hr. | Within 3 months |

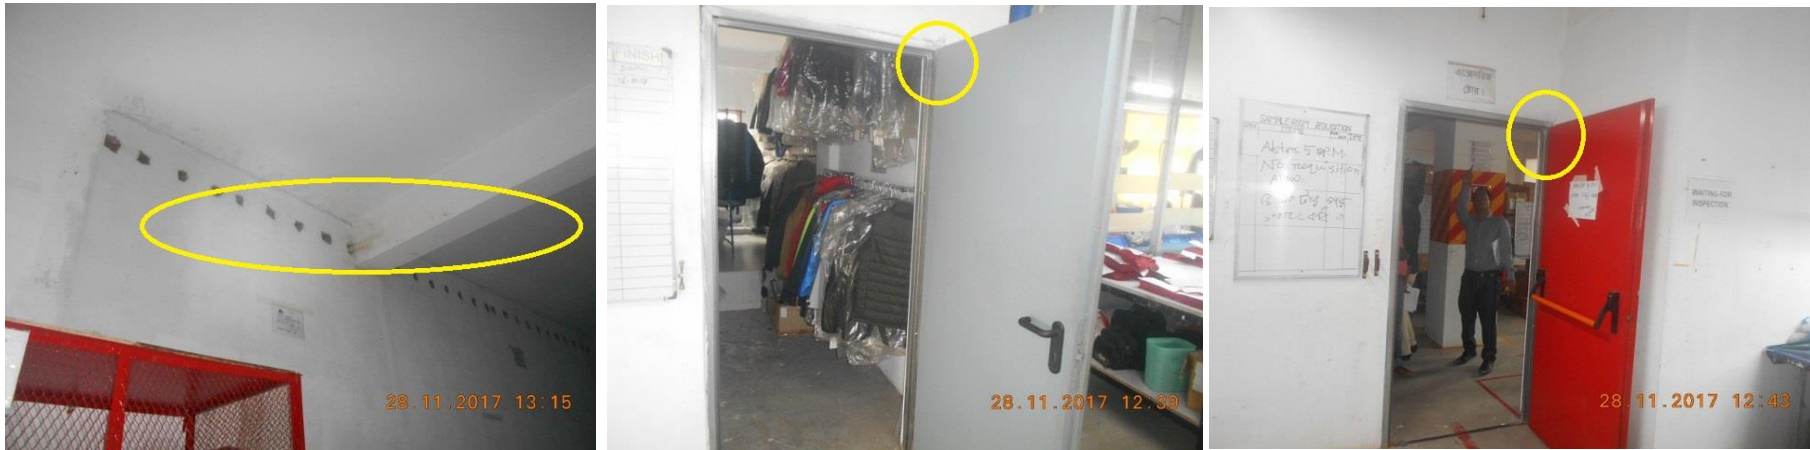
| F-2 | Fire Rated Construction | Unsealed penetrations have been observed at the rated wall of rooms used for combustible storages. Door coordinator is missing at double leaf doors. Door closer is missing in some cases. | Storage rooms shall be separated by minimum 1-hr fire rated construction. Fire doors are required to be ensured to function properly. | Within 3 months |

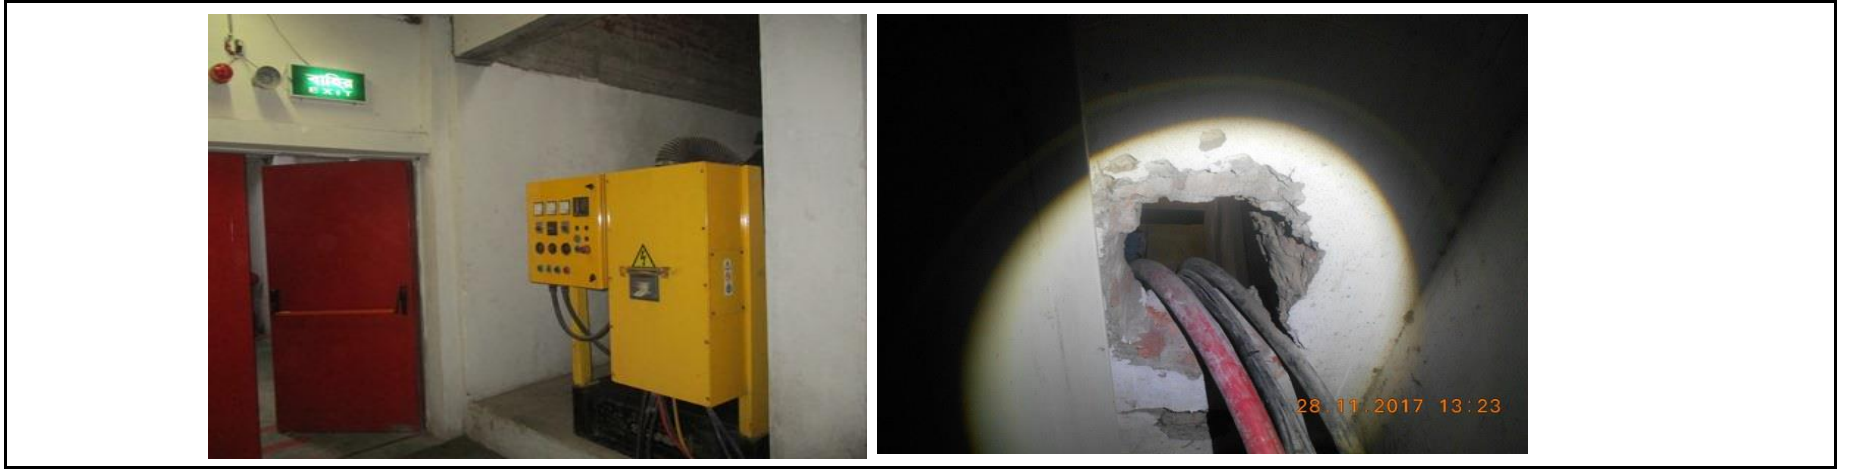
| F-3 | Fire Rated Construction | Unsealed penetration has been observed at the rated wall of generator room. The opening protective is a double leaf door and lacks the door coordinator. | Seal the penetration by a listed fire stop material to maintain fire separation of minimum 2-hr. Door coordinators shall be provided for proper functioning of fire doors.. | Within 3 months |

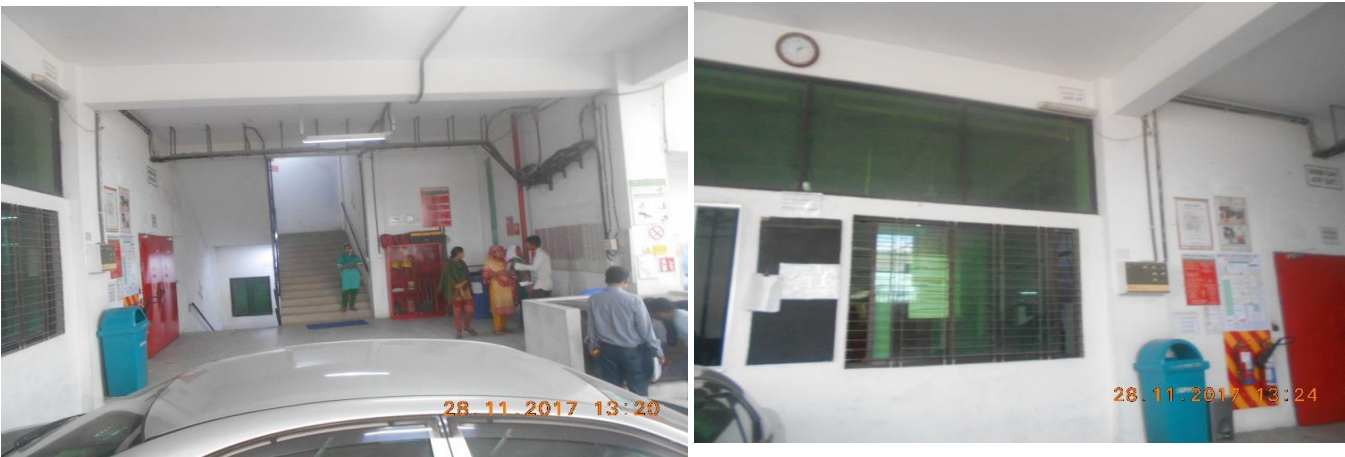
| F-4 | Fire Rated Construction | The North-East exit stair enclosures was not separated from parking areas and and production floor openings at the ground floor by fire-rated construction. r. | The exit stair enclosure shall be separated from any occupancy by a minimum of 2-hr fire resistance rating. Provide 1.5-h rated door where necessary. | Within 3 months |

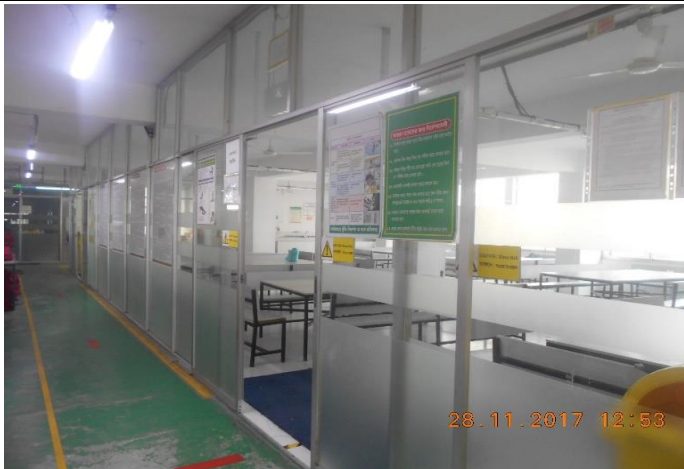
| F-5 | Fire Rated Construction | The dining area is not separated by fire rated construction from production floor. | Separate the dining area by minimum 3-hr fire rated construction. Provide 3-hour fire rated doors at required openings & seal all penetrations. | Within 3 months |

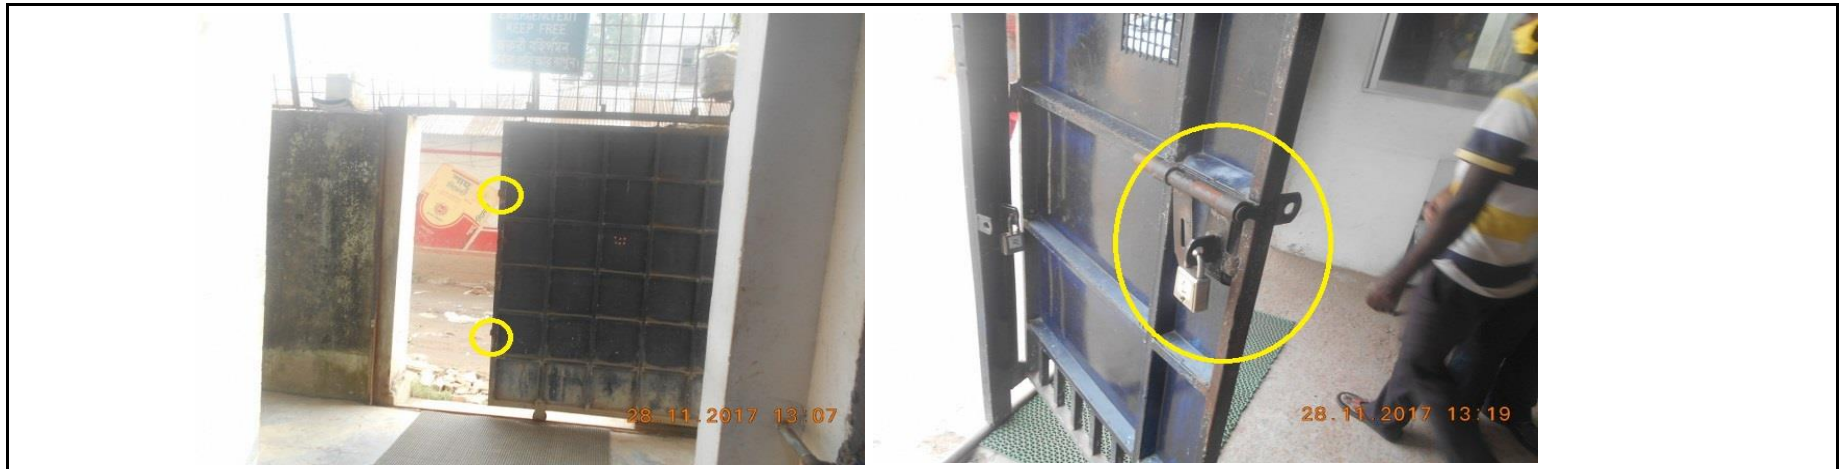
| F-6 | Egress | Egress doors /gates with locking features are provided at building exits. All gates were not open and unlocked during the inspection. | Remove locking features from all egress doors and gates. If locks are required for security reasons, utilize special door locking features complying with NFPA 101 and ACCORD standard 6.8.2. | Immediately |

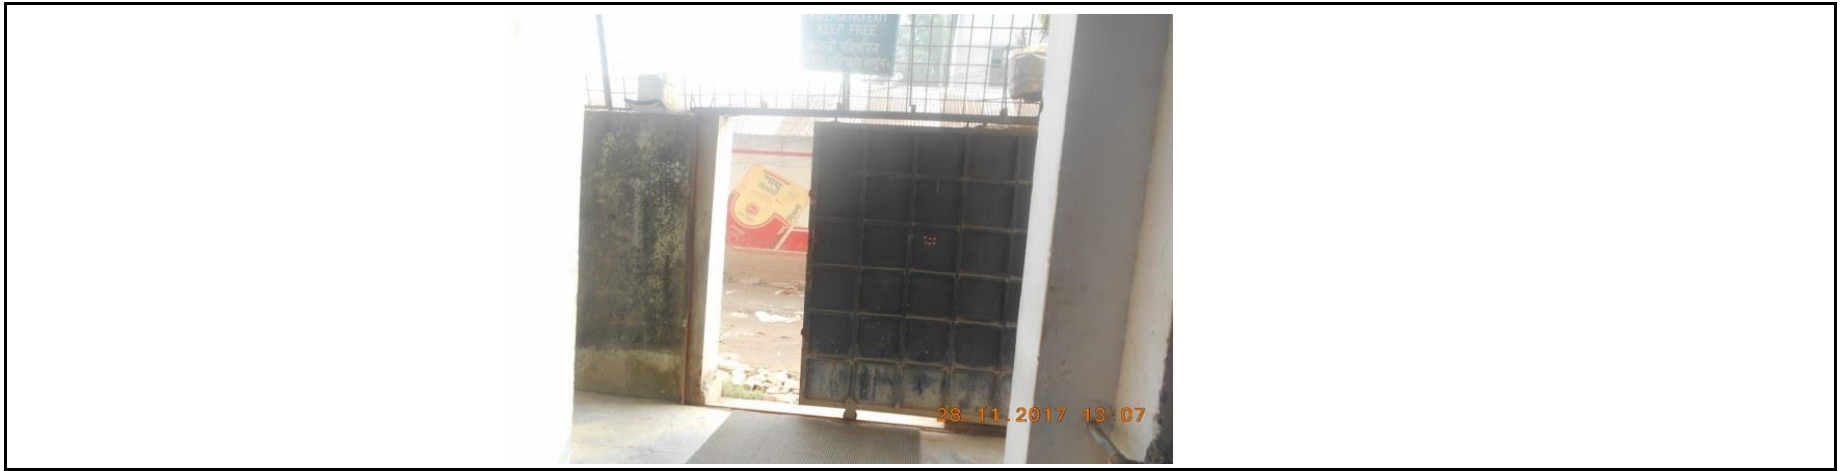
| F-7 | Egress | Sliding doors are provided at building exits and along egress routes. | Replace all non compliant (collapsible and sliding) doors/gates along the means of egress with side-hinged, swinging egress doors. If locks are required for security reasons, utilize special door locking features complying with NFPA 101 in accordance with ACCORD standard 6.8.1. | Within 1 month |

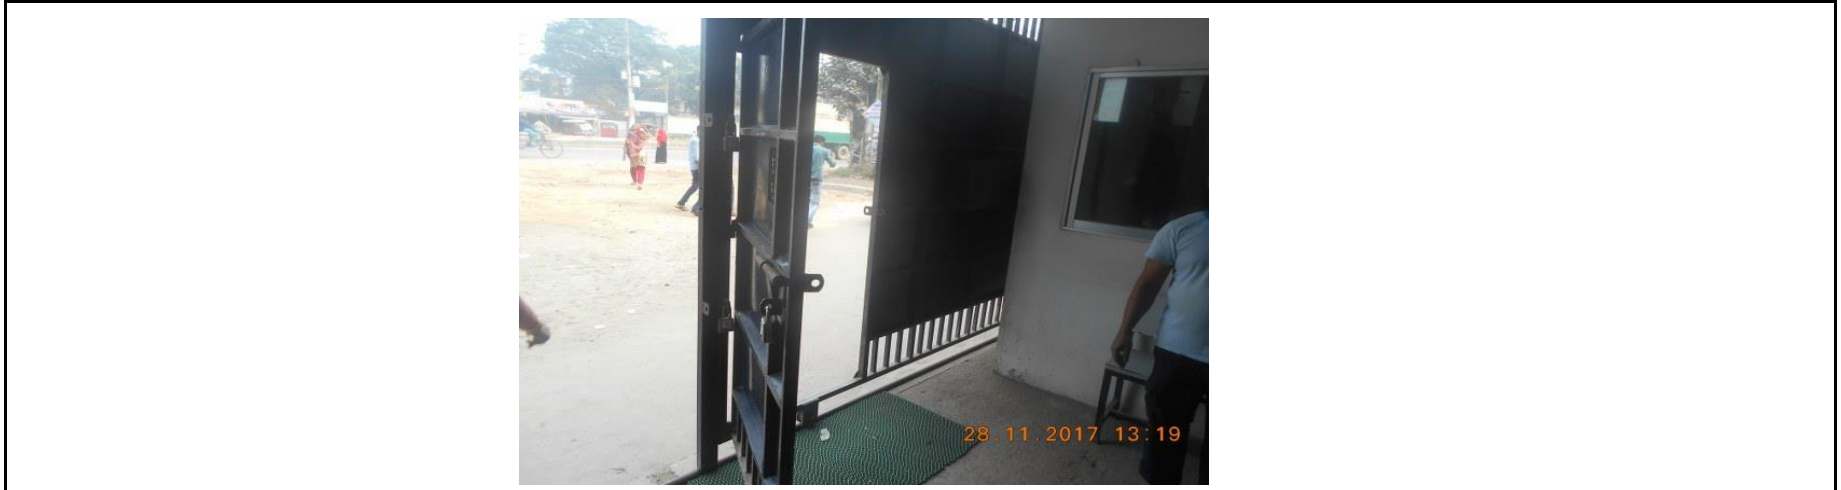
| F-8 | Egress | Egress door on the exit discharge serving 50 or more occupants does not swing in the direction of egress travel at ground floor exit discharge. | Modify the egress door to swing in the direction of egress travel and Provide minimum clear height of 2.03 m. in all means of egress. | Within 1 months |

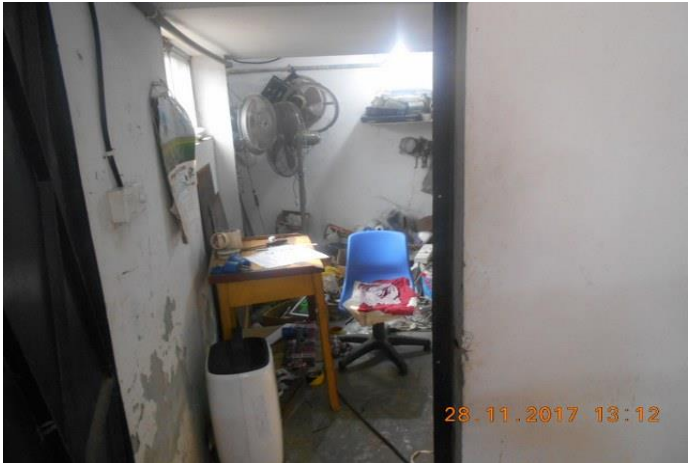
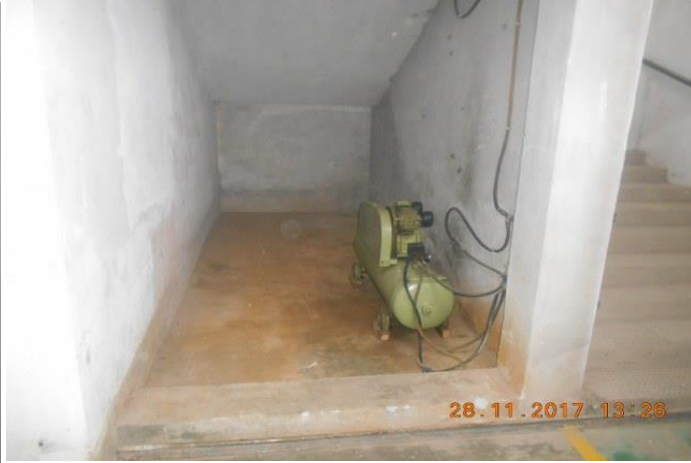
| F-9 | Egress | A maintenance room was located inside the staircase without rated opening. A compressor was located inside the staircase at basement level. | Staircases shall not be used for production or any other occupancy. Staircases shall be free of storages and obstructions. | Within 1 month |

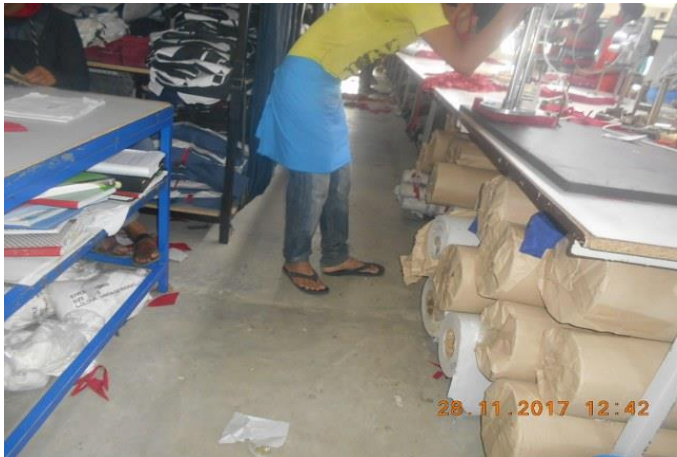
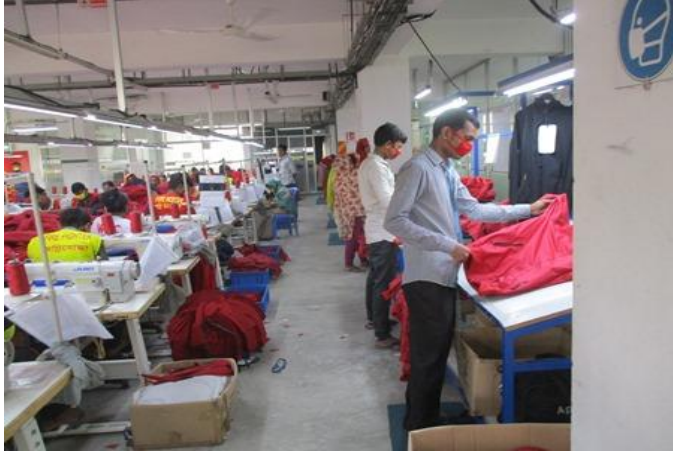
| F-10 | Egress | The width of egress aisles is less than 36-inch at 4th floor. Aisle marking is missing at 3rd floor sewing section. | Provide minimum aisle widths of 36-inch. Aisles shall be properly marked along the egress way. | Within 3 months |

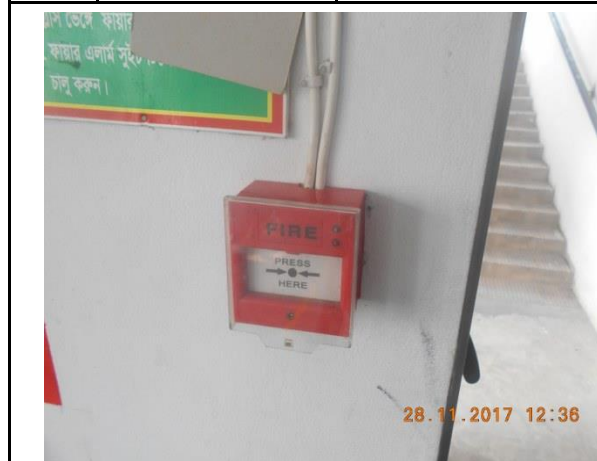
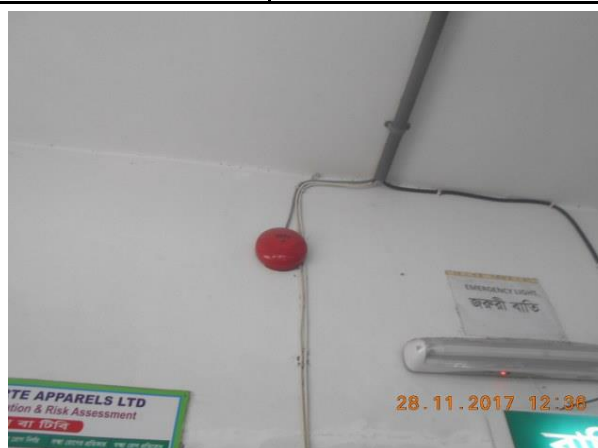
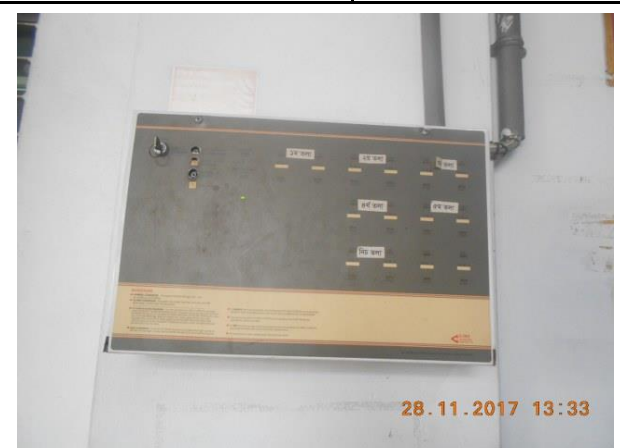
| F-12 | Fire Detection & Alarm | The fire alarm system is antiquated, not a listed system, and does not provide alarm and notification features consistent with acceptable standards. | <p>Design and install an addressable fire detection &amp; alarm (Audio &amp; Visual) system replacing the existing one in compliance with NFPA 72 &amp; Accord standard. Submit the design to Accord for review and approval before installation.</p> <p>Upon approval &amp; installation the owner shall contact the Accord prior to conducting the final acceptance testing of the fire detection &amp; alarm system installation.</p> <p>Also inspect, test and maintain the fire alarm system, and keep written records on-site, in accordance with NFPA 72.</p> | Design within 4 months, install within 9 months |

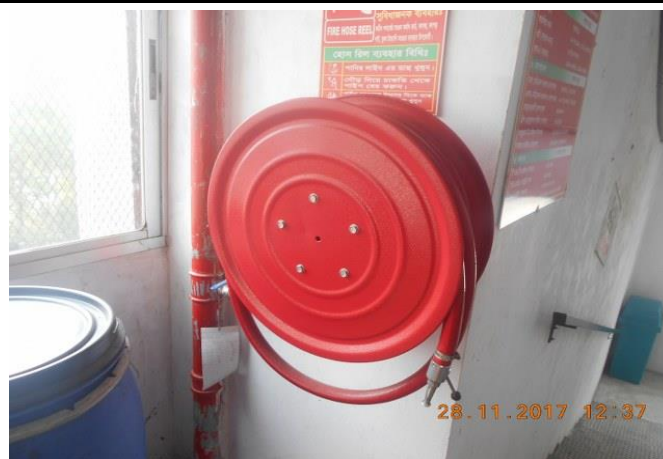
| F-13 | Fire Protection | The existing factory building has an occupied floor greater than 10 meter (33 feet) and is not provided with required standpipe system. | <p>Design &amp; install a new class III standpipe system &amp; fire department (Siamese) connection in accordance with NFPA 14. The standpipe system shall be connected to a dedicated fire pump meeting minimum hydraulic demands of NFPA 14 &amp; Accord standard at the required points. Installation of the fire pump shall be as per NFPA 20. Submit the design to Accord for review and approval before installation.</p> <p>Upon approval &amp; installation the owner shall contact the Accord prior to conducting the final acceptance testing of the standpipe system installation.</p> <p>Also inspect, test and maintain the standpipe system &amp; fire pumps, and keep written records on-site, in accordance with NFPA 14, 20 and ACCORD standards.</p> | Design within 4 months, install within 9 months |

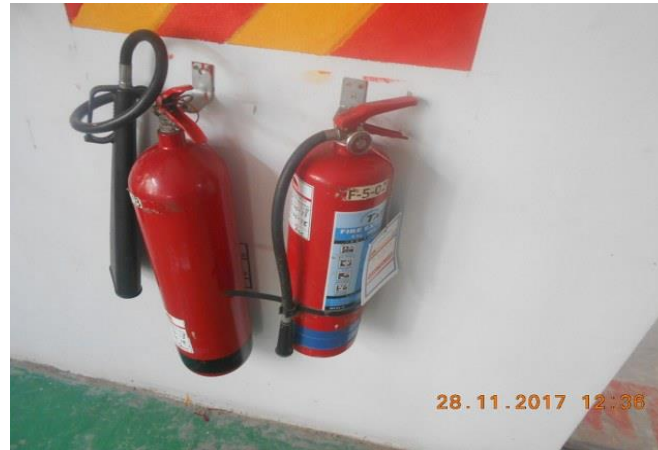
| F-14 | Fire Protection | Inspection, testing and maintenance of portable fire extinguishers is not in accordance with NFPA 10. | Inspect, test and maintain the portable fire extinguishers and keep written records onsite, in accordance with NFPA 10. | Within 3 months |

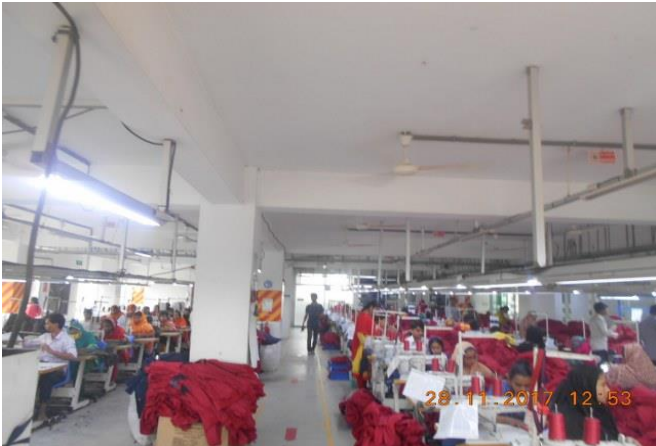
| F-15 | Egress Lighting | Based on the number and location of emergency lights observed, adequate illumination levels are not anticipated along egress routes. | Test the emergency lighting system on each floor and provide additional emergency fixtures to provide adequate illumination along the means of egress. Provide a minimum illumination of 10 lux at the floor level within exit stairs and exit discharge paths and minimum 2.5 lux along exit access aisles. | Within 3 months |

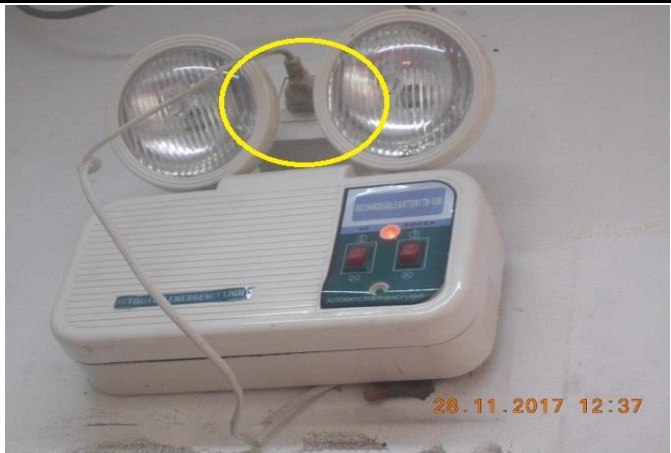
| F-16 | Egress Lighting | Manual on-off switch is provided for emergency lighting / exit sign units on all floors. | Remove manual on/off switches from emergency lighting / exit signage units to prevent them from being switched off. | Within 1 month |

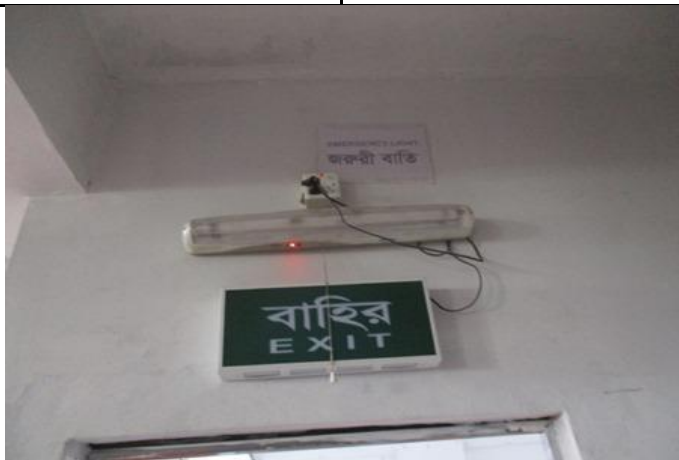
| F-17 | Egress Lighting | Emergency/exit lighting did not function in test mode (burned out, broken, etc.). | Regularly test the emergency lighting system on each floor and replace/repair lights as needed. | Within 1 month |

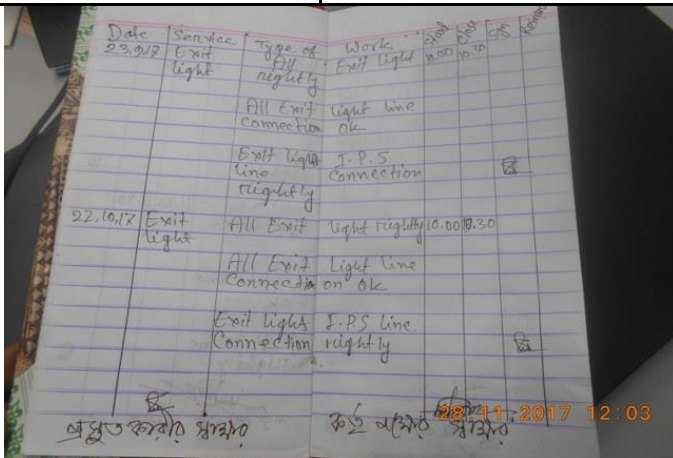
| F-18 | Egress Lighting | Inspection, testing and maintenance for the emergency lighting system was not in accordance with The ACCORD standard. | Inspect, test and maintain the emergency lighting system in the accordance with The ACCORD standard. Keep written records on-site. | Within 3 months |
