FIRE SAFETY INSPECTION REPORT

TROUSER WORLD (PVT) LTD. (NEW BUILDING)

ACCORD ID: 23267

Date: 07 June 2018

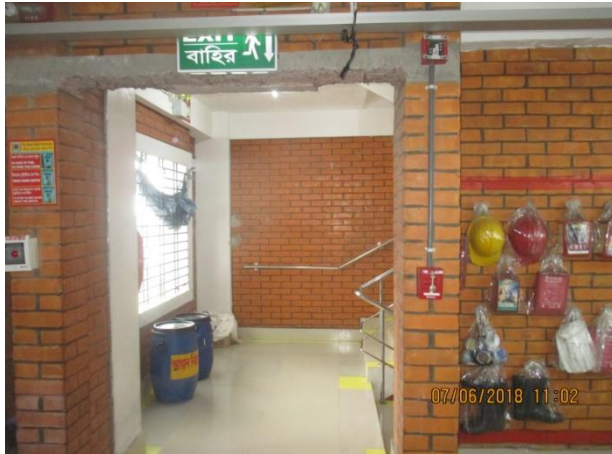
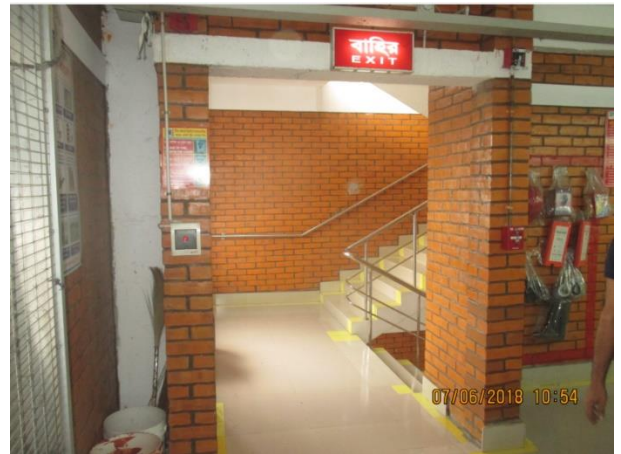
No.	Category	Finding	Recommendation	Remediation Timeframe
F-1	Fire Rated Construction	Exit stairs are not separated from work areas & other spaces on each floor by fire-rated construction due to unprotected openings and penetrations.	<p>Separate the exit stairs from work areas and other building spaces on all floor levels by minimum 2- hr fire-rated construction. Provide minimum 1.5- hr fire rated doors and seal all unprotected openings and penetrations to maintain the fire separation.</p> <p>Ensure that all fire doors are self-closing and positive latching, and are provided with fire exit (panic) hardware where serving production floors or assembly occupancies.</p> <p>If fire doors are required to be held open for functional reasons, provide automatic-closing devices tied to the fire alarm system.</p> <p>Once fire doors are installed, every door in a stair enclosure serving more than 5 stories shall be provided with re-entry unless it meets ACCORD standard 6.8.3.1.</p>	Within 3 months

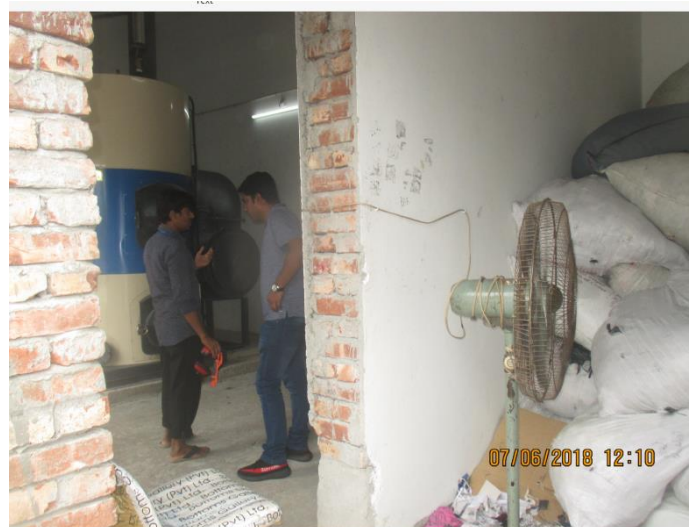
F-2	Fire Rated Construction	The boiler room is not separated by fire-rated construction from jhute store at the ancillary shed.	Separate the boiler room by a minimum 2-hr fire-rated construction. Seal and/or protect all openings to maintain the required fire separations. Provide proper ventilation and consult a qualified engineer (if required).	Within 3 months
-----	-------------------------	---	--	-----------------

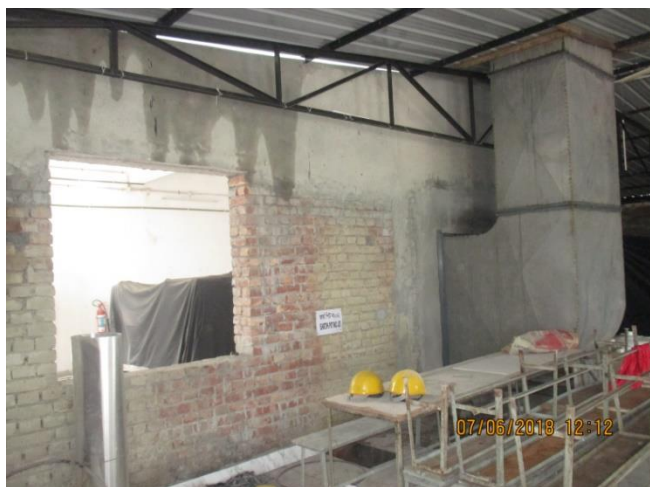
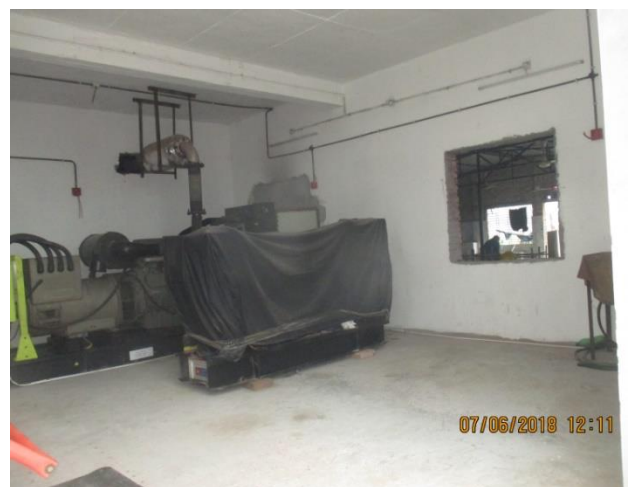
F-3	Fire Rated Construction	The generator room is not separated by fire-rated construction from the adjacent dining area.	Separate the generator room and exhaust duct by a minimum 2-hr fire-rated construction. Seal and/or protect all openings to maintain the required fire separations. Provide proper ventilation and consult a qualified engineer (if required).	Within 3 months
-----	-------------------------	---	--	-----------------

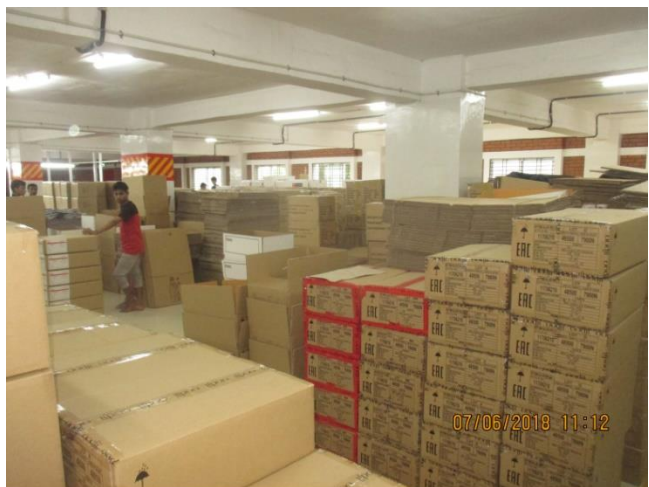
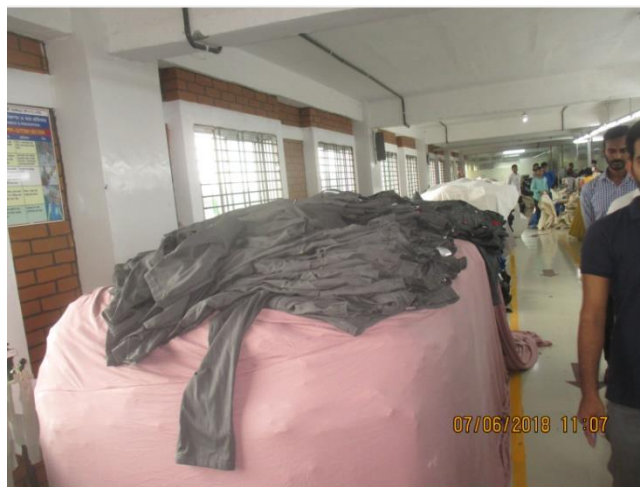
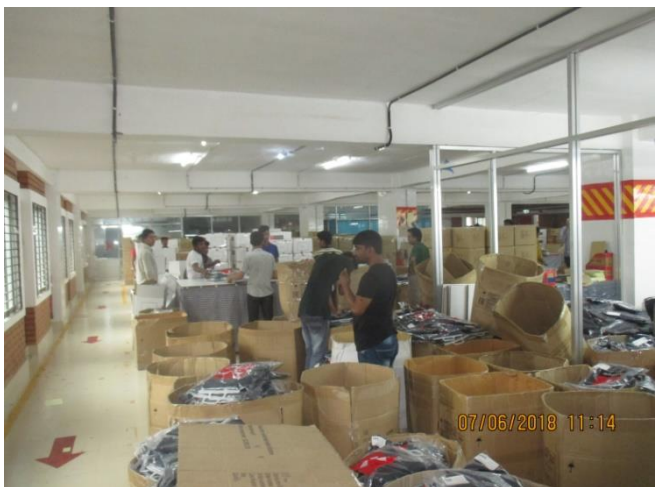
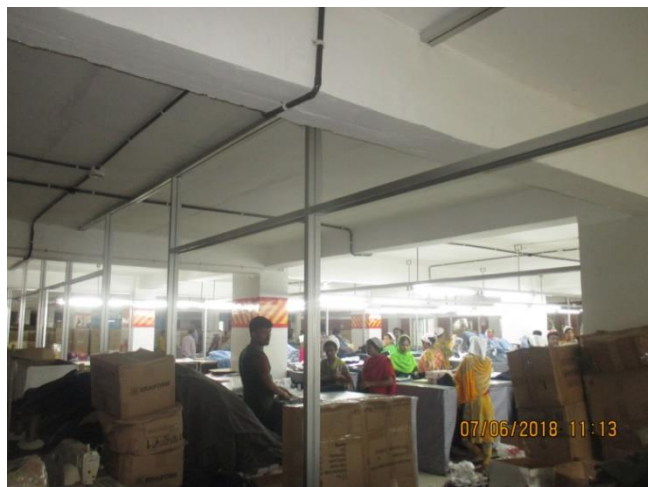
F-4	Fire Rated Construction	Areas on the 1st and 2nd floor used for combustible storage open to the factory are not properly defined and/or not within limits.	Provide defined storage areas and limit the storage arrangement as follows: Maximum height of 2.45m (8 ft) and maximum area of 23 m ² (250 ft ²). If sprinkler protected: maximum height of 3.66m (12 ft) and maximum area of 93m ² (1000 ft ²). Separate the areas of unenclosed combustible storage by a minimum clear distance of 3 m (10 ft).	Within 3 months
-----	-------------------------	--	--	-----------------

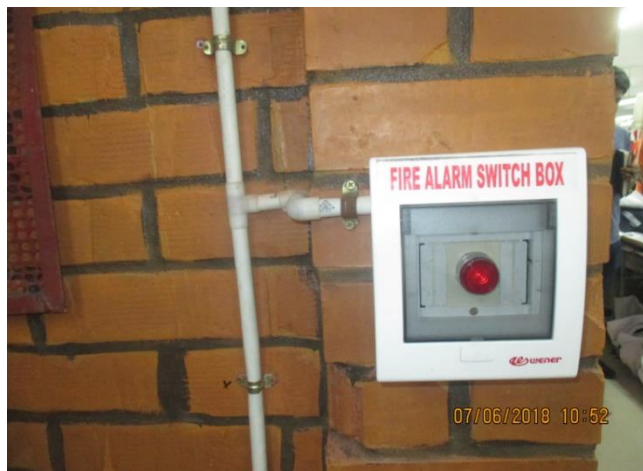
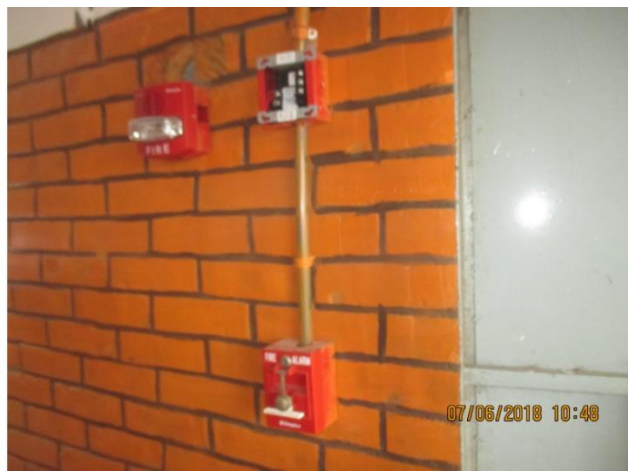
F-5 Fire Protection

The fire detection and alarm system is antiquated, not a listed system and does not provide alarm and notification features consistent with acceptable standards.

Note: Addressable system installation is going on.

Replace the fire detection and alarm system with a new, listed addressable fire detection and alarm system in accordance with NFPA 72 and ACCORD standards.

Design within 2 months
Install within 4 months

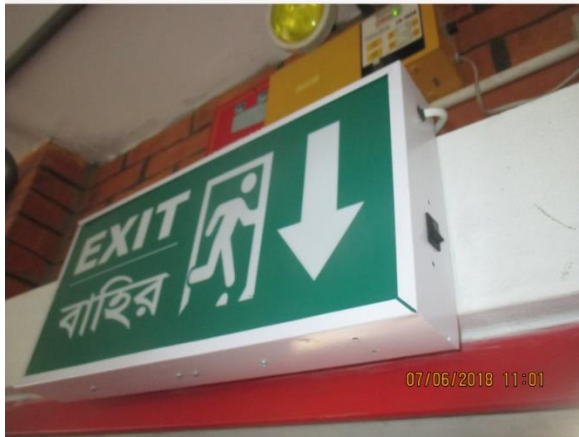
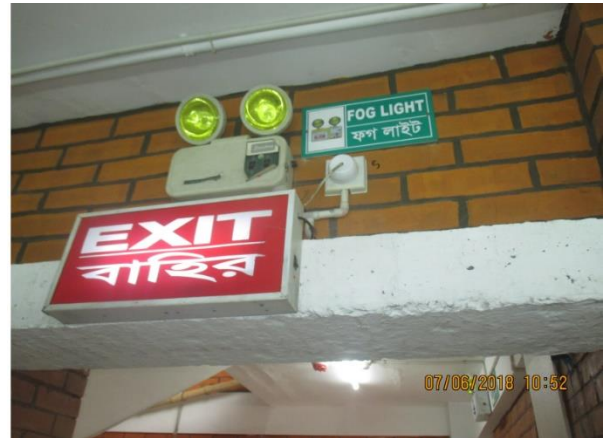
F-7	Egress Lighting	Manual on-off switch is provided for emergency exit signage units.	Remove manual on/off switches from emergency Lighting & exit signage units to prevent them from being switched off.	Within 1 month
-----	-----------------	--	---	----------------
