FIRE SAFETY INSPECTION REPORT

NEXUS KNITWEAR LTD

VOGRA, JOYDEBPUR

ACCORD
on Fire and Building Safety in Bangladesh

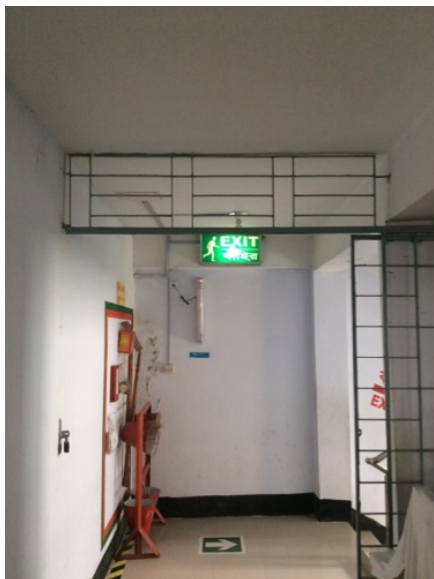
No.	Category	Finding	Recommendation	Remediation Timeframe
F-1	Fire Rated Construction	The exit stairs are not separated from work areas, other spaces on each floor by fire-rated construction.	<p>Provide minimum 1.5-hr fire rated doors and seal all unprotected openings to separate the exit stairs from work areas and other building spaces on all floor levels. Ensure that the fire doors are self-closing and positive latching and that they are provided with fire exit (panic) hardware where serving production floors.</p> <p>If fire doors are required to be held open for functional reasons, provide automatic-closing devices tied to the fire alarm system.</p>	Within 3 months

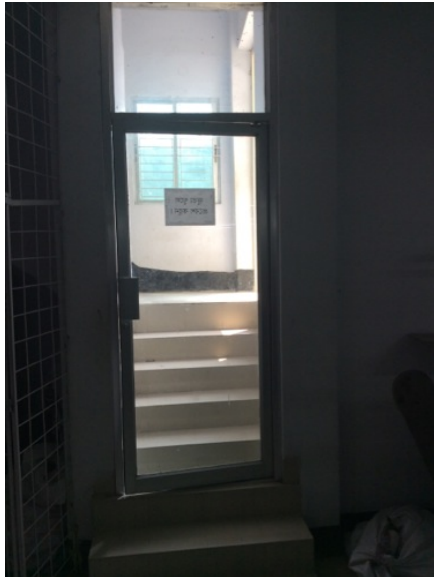
F-2	Fire Rated Construction	Unsealed penetrations and openings are located in exit stair enclosures.	Seal all penetrations and openings in exit stair enclosure walls to maintain the fire separation.	Within 3 months
-----	-------------------------	--------------------------------------------------------------------------	---------------------------------------------------------------------------------------------------	-----------------

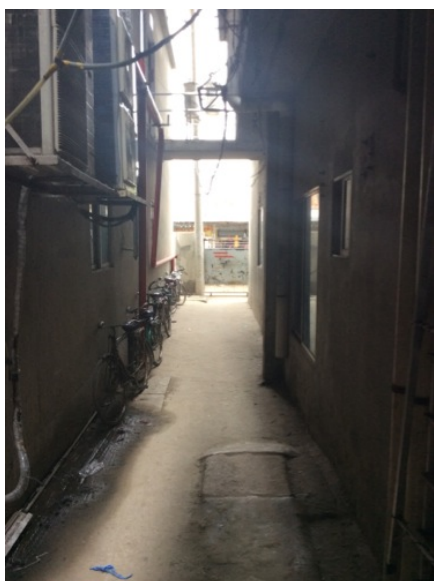
F-3	Fire Rated Construction	Uncovered discharge path to assembly point, with less than 10 ft. building separation, has unprotected openings at a height of less than 10 ft.	Seal all penetrations and openings to the interior of the building, up to a height of 10 ft., to maintain the fire separation. Alternately, provide 1-hr fire-rated separation up to a height of 10 ft.	Within 3 months
-----	-------------------------	-------------------------------------------------------------------------------------------------------------------------------------------------	---------------------------------------------------------------------------------------------------------------------------------------------------------------------------------------------------------	-----------------

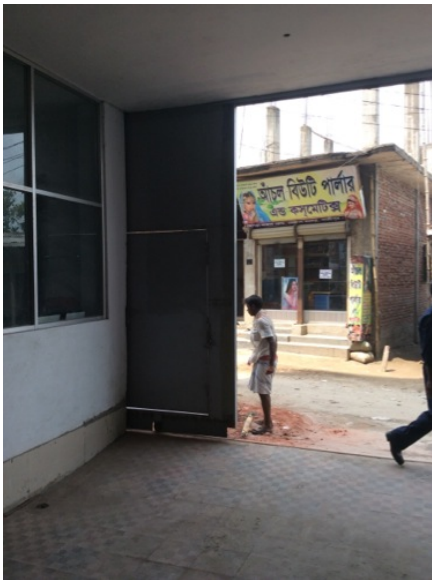
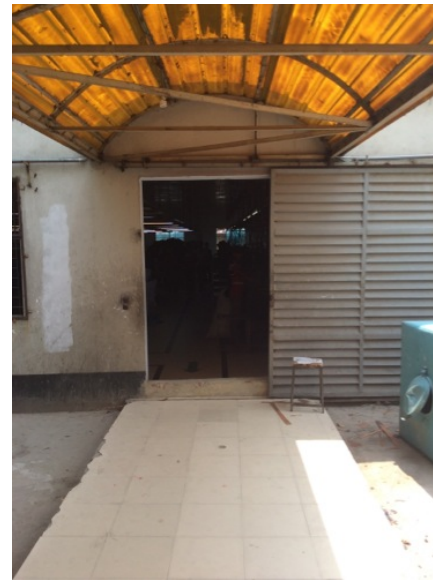
F-4	Egress	Egress doors & gates with locking features are provided at building exits, exit stairs, along egress routes, exit discharge. throughout all floors of the factory. All gates & doors were open and unlocked during the inspection.	Remove locking features from all egress doors / gates. If locks are required for security reasons, utilize special door locking features complying with NFPA 101.	Immediate
-----	--------	------------------------------------------------------------------------------------------------------------------------------------------------------------------------------------------------------------------------------------	--------------------------------------------------------------------------------------------------------------------------------------------------------------------------	-----------

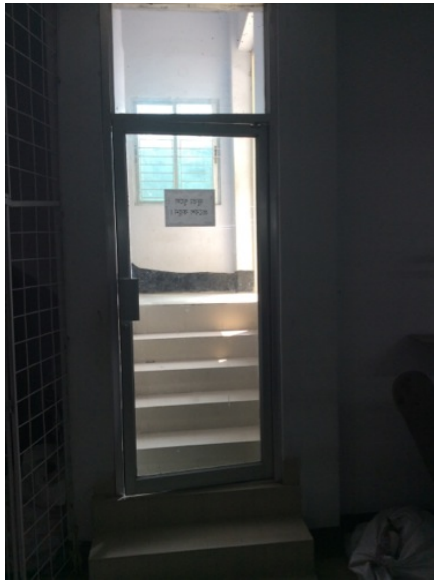
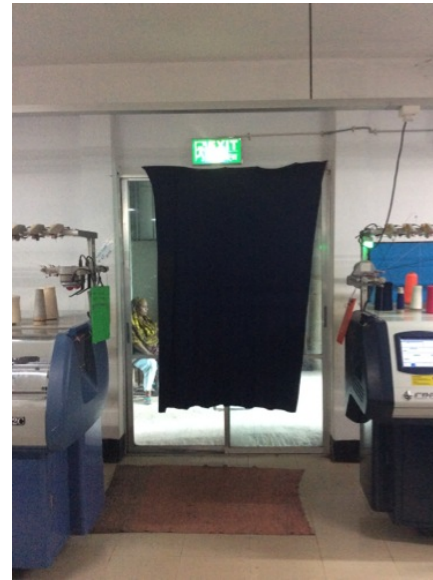
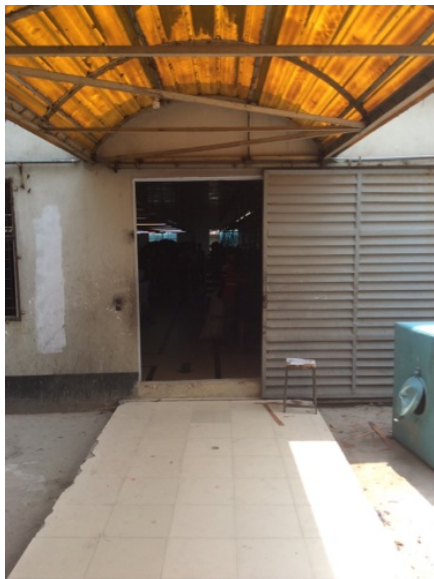
F-5	Egress	Collapsible gates & sliding doors are provided at main building exits, along egress routes.	Replace all gates / sliding doors along the means of egress with side-hinged, swinging egress doors. If locks are required for security reasons, utilize special door locking features complying with NFPA 101.	Within 1 month
-----	--------	---------------------------------------------------------------------------------------------	------------------------------------------------------------------------------------------------------------------------------------------------------------------------------------------------------------------------	----------------

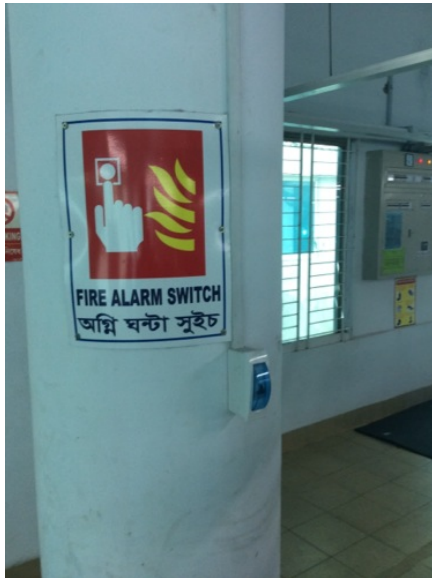
F-6	Fire Protection	The fire alarm system is antiquated, not a listed system, and does not provide alarm and notification features consistent with acceptable standards.	Replace the fire alarm system with a new, listed addressable fire alarm system in accordance with NFPA 72.	Design within 4 months, install within 9 months
-----	-----------------	------------------------------------------------------------------------------------------------------------------------------------------------------	------------------------------------------------------------------------------------------------------------	-------------------------------------------------

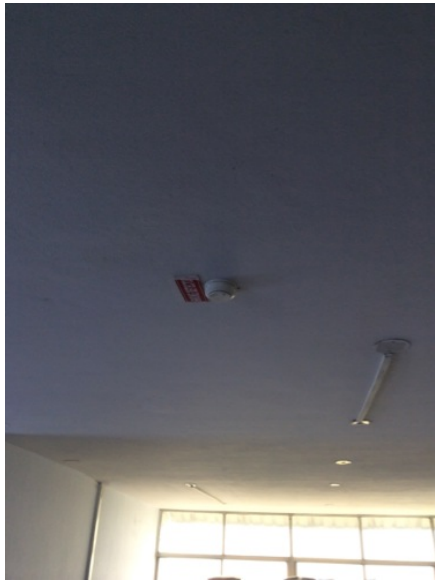
F-7	Fire Protection	Inspection, testing, and maintenance for the fire alarm system were not in accordance with NFPA 72 requirements.	Inspect, test and maintain the fire alarm system, and keep written records on-site, in accordance with NFPA 72.	Within 3 months
F-8	Fire Protection	The building is equipped with single-station smoke alarms. Smoke alarm activation sounds only a local alarm and does not provide automatic fire alarm notification of occupants.	Remove single-station smoke alarms. Provide automatic smoke detection throughout the building in accordance with NFPA 72.	Within 6 months

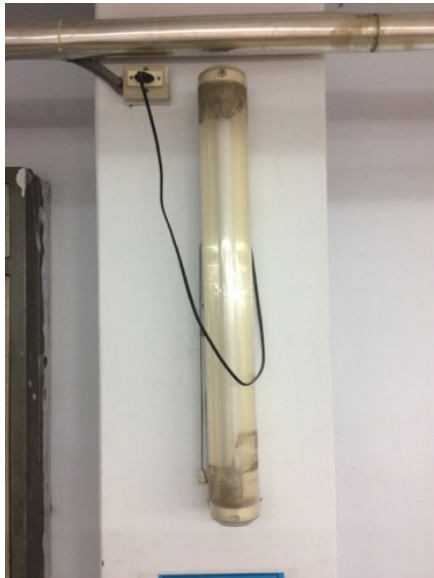
F-9	Fire Protection	Based on visual inspection of placement of horns, and observed noise level in the factory, the fire alarm system does not appear to provide adequate notification coverage.	Provide additional notification appliances such that the fire alarm system is audible throughout the building in accordance with NFPA 72. Provide visual notification appliances in areas with high noise levels in accordance with NFPA 72.	Within 6 months
F-10	Egress Lighting	Manual on-off switch is provided for emergency lighting / exit signage units on all floors of the factory.	Remove manual on/off switches from emergency lighting / exit signage units to prevent them from being switched off.	Within 1 month
