FIRE SAFETY INSPECTION REPORT

MAHADI FASHION PVT LTD.

ACCORD ID: 11996

ACCORD
on Fire and Building Safety in Bangladesh

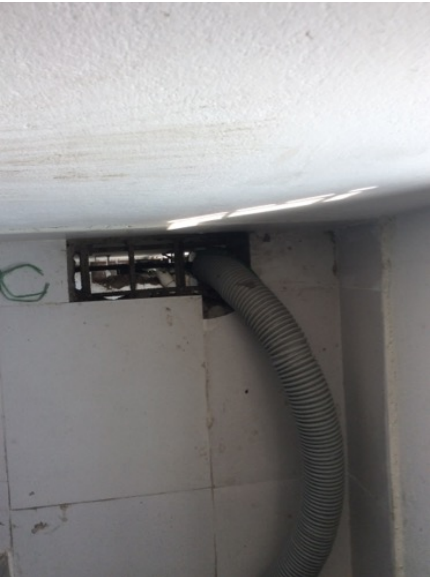
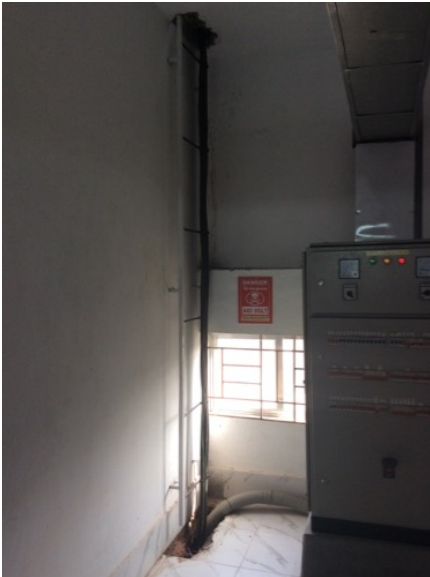
No.	Category	Finding	Recommendation	Remediation Timeframe	
F-1	Fire Rated Construction	Unsealed electrical shafts are located in the fire-rated floor/ceiling assemblies at northeast corner.	Provide a minimum 2-hr fire-rated shaft to separate the utility risers from each floor level and seal all penetrations in floor/ceiling assemblies to maintain the fire separation.	Within 3 months

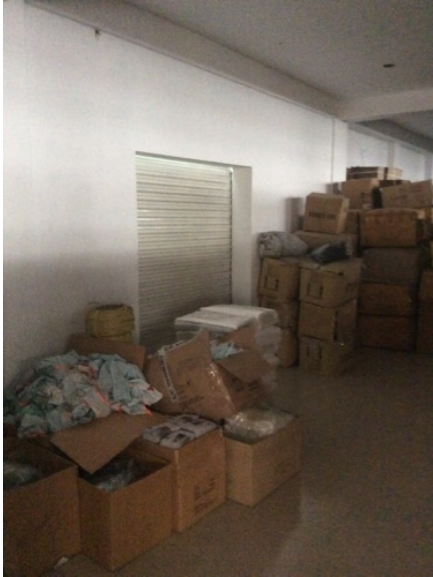
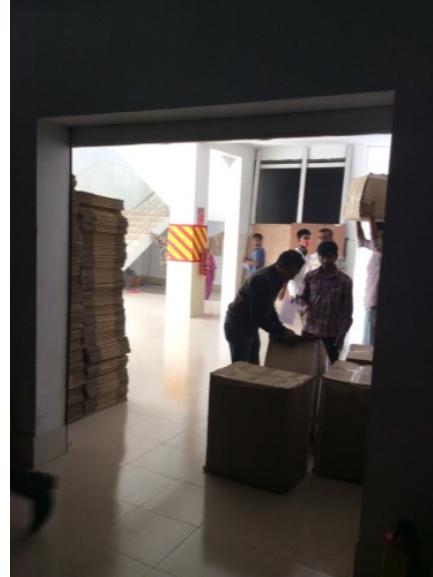
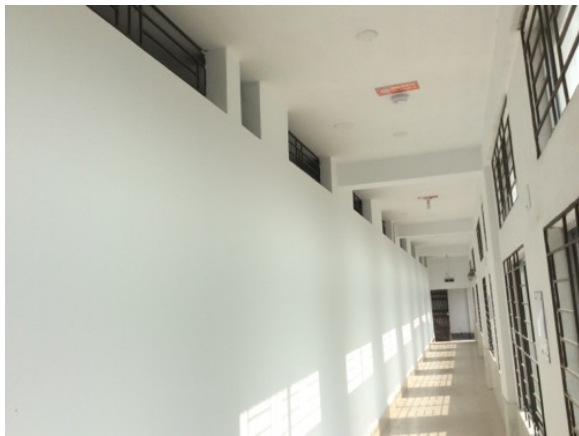
F-2	Fire Rated Construction	Rooms used for combustible storage are not separated by fire-rated construction on the ground floor.	Provide dedicated storage rooms separated by minimum 1-hr fire-rated construction.	Within 3 months
-----	-------------------------	--	--	-----------------

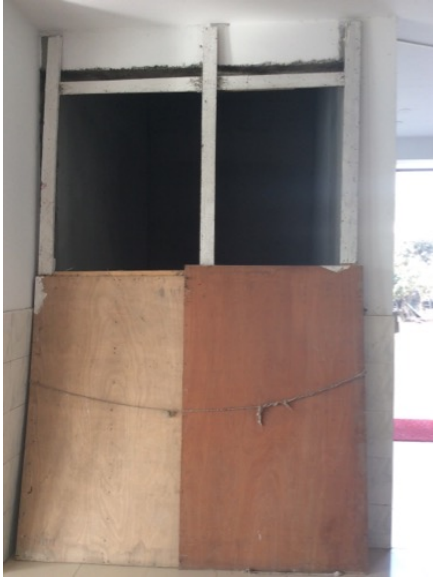
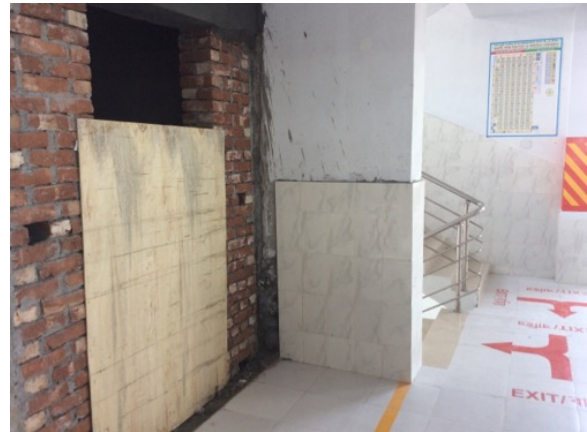
F-3	Fire Rated Construction	The empty elevator shafts does not have the proper fire rated construction on each floor.	Provide the proper 2 hr. fire rating for the shaft and 1.5 hr. fire rating for the elevator door.	Within 3 months
-----	-------------------------	---	---	-----------------

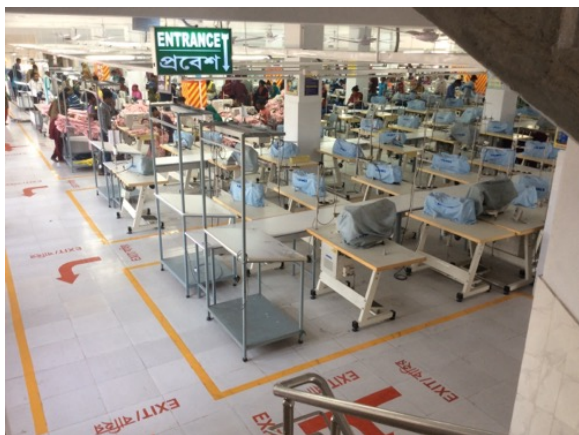
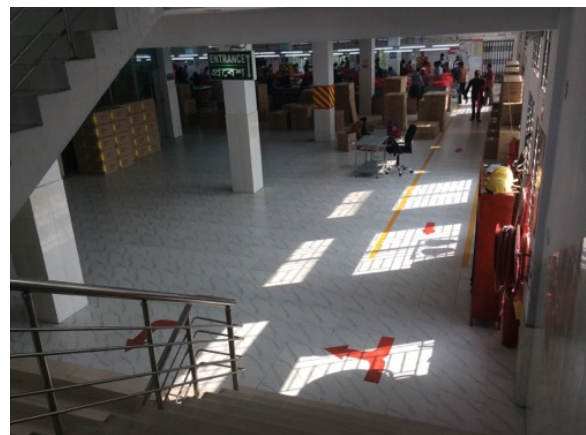
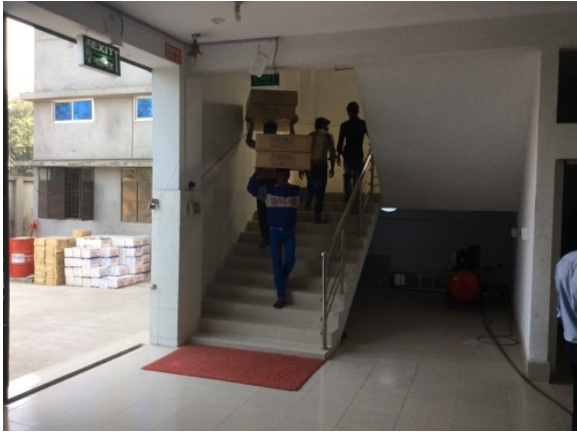
F-4	Fire Rated Construction	The exit stair enclosures are not separated from work areas on each floor by fire-rated construction.	The exit stair enclosure shall be provided with a minimum 1-hr fire resistance rating for buildings with 3 or fewer stories and a minimum of 2-hr fire resistance rating for buildings 4 or more stories. Provide minimum 1.5-hr fire rated doors for buildings that are 4 or more stories. Ensure that the fire doors are self-closing and positive latching and they are provided with fire exit (panic) hardware where serving production floors. If fire doors are required to be held open for functional reasons, provide automatic-closing devices tied to the fire alarm system.	Within 3 months
-----	-------------------------	---	--	-----------------

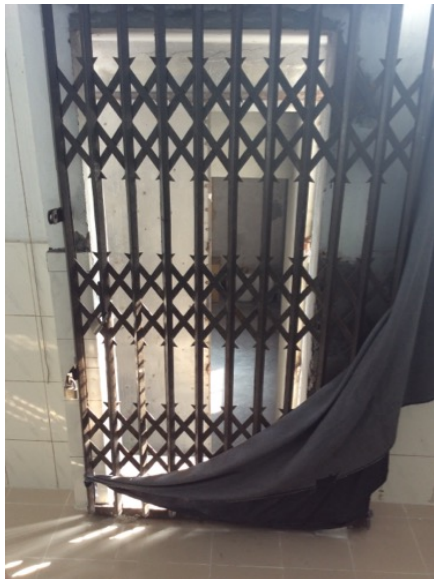
F-5	Fire Rated Construction	The northeast exit stair is not separated from maintenance room on the 2nd floor by fire-rated construction.	Provide minimum 2-hr fire-rated construction wall. Seal all unprotected openings to separate the exit stairs from other building spaces on all floor levels.	Within 3 months
-----	-------------------------	--	--	-----------------

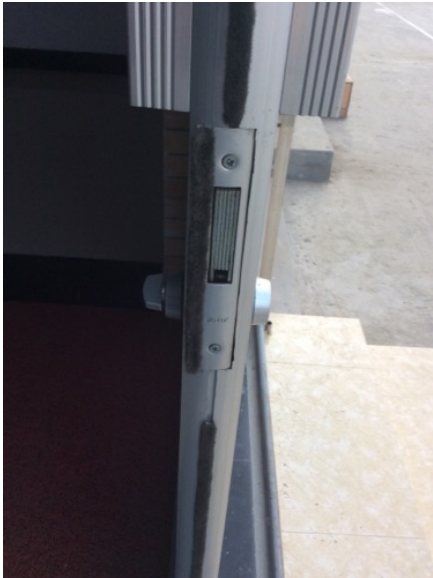
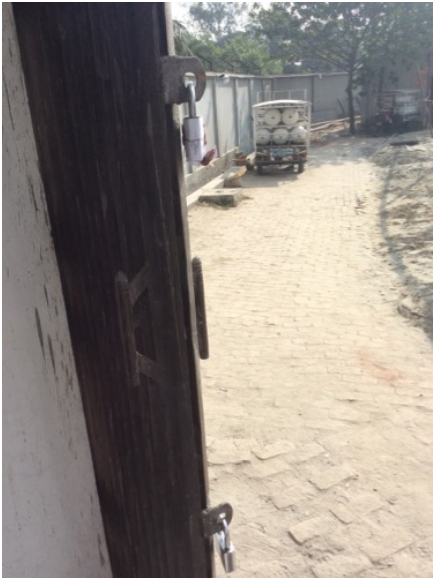
F-6	Egress	Egress doors and gates with locking features are provided at building exits, along egress routes and exit discharge.	Remove locking features from all egress doors and gates. If locks are required for security reasons, utilize special door locking features complying with NFPA 101 and ACCORD standard 6.8.2.	Immediately

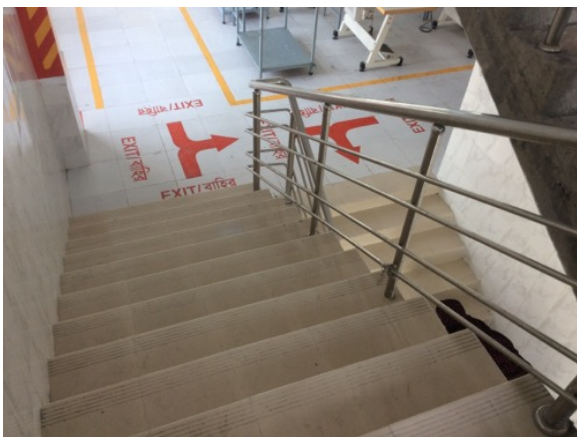
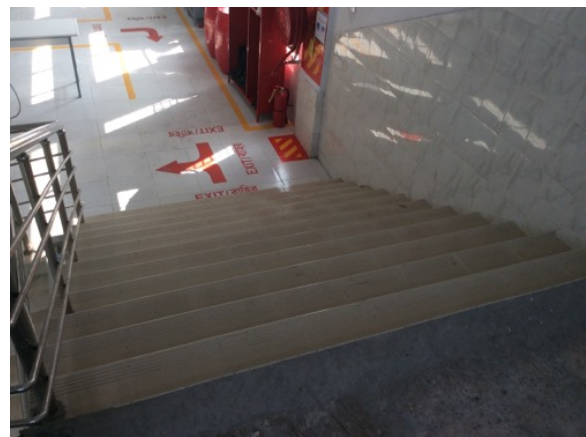
F-10 Egress

Handrails are not provided on both sides of the exit stair.

Provide handrails on both sides of the exit stair. New handrails shall have a minimum height of 865 mm (34 in.) and a maximum height of 965 mm (38 in.) as measured from the leading edge of the tread. Intermediate handrails shall be provided when the stair width exceeds 2.2 m (87 in.)

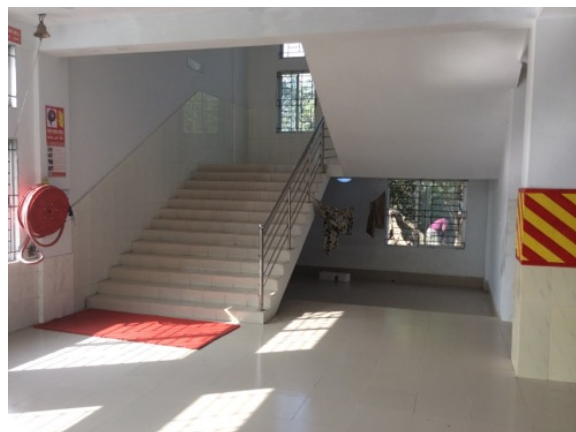
F-11	Egress	Southwest and northwest exit stairs discharge inside the building on the ground floor.	Modify stair to discharge directly outside or Provide 2-hr fire-rated exit passageway leading directly outside (vestibules to separate any storage areas).	Within 6 months
------	--------	--	--	-----------------

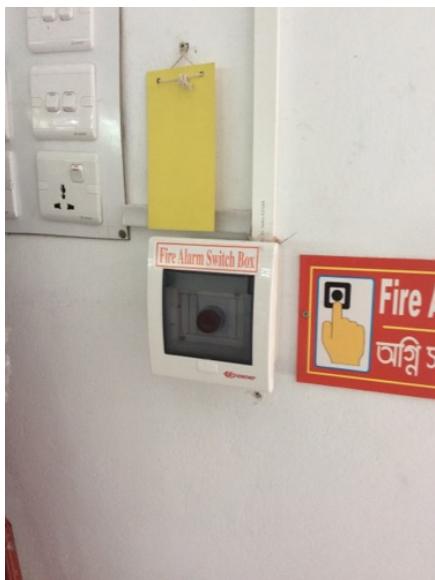
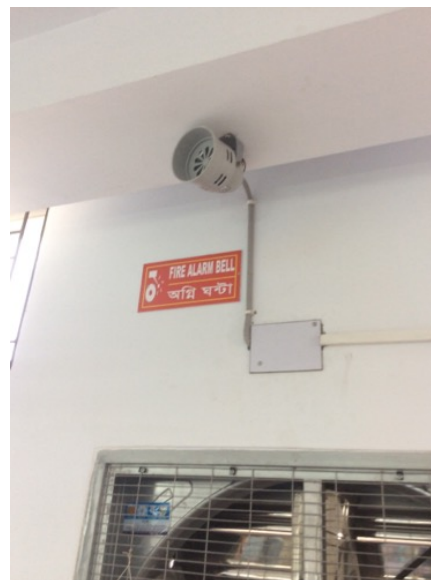
F-12	Fire Protection	The fire alarm system is antiquated, not a listed system and does not provide alarm and notification features consistent with acceptable standards.	Replace the fire alarm system with a new, listed addressable fire alarm system in accordance with NFPA 72.	Design within 4 months, install within 9 months
------	-----------------	---	--	---

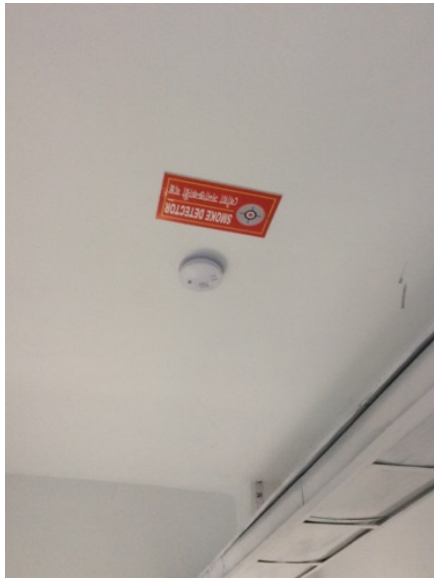
F-21	Fire Protection	The building is equipped with single-station smoke alarms. Smoke alarm activation sounds only a local alarm and does not provide automatic fire alarm notification of occupants.	Remove single-station smoke alarms. Provide automatic smoke detection throughout the building, tied into the fire alarm system, in accordance with NFPA 72.	Within 6 months

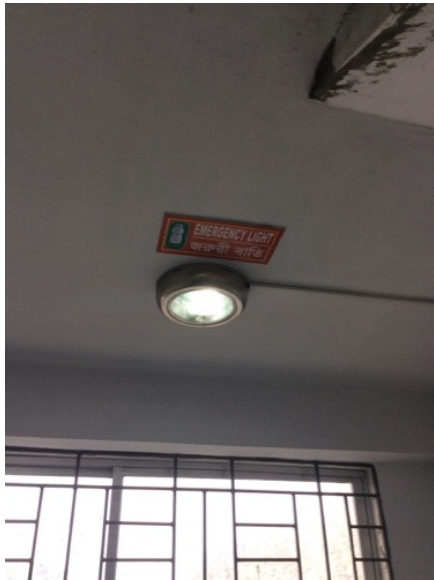
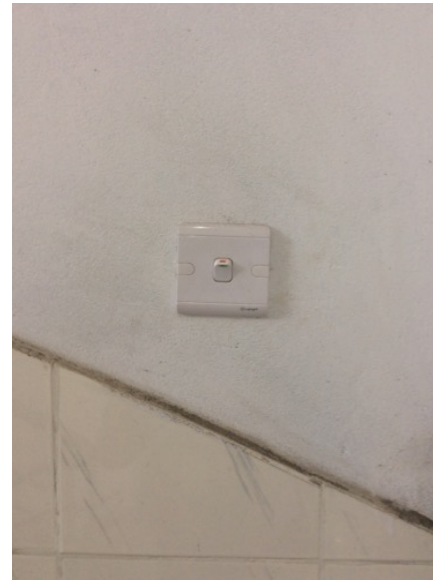
F-22	Fire Protection	The required standpipe system is not provided for the building in accordance with the ACCORD standard.	Install a new standpipe system in accordance with ACCORD standard 5.4 and NFPA 14.	Within 6 months
			<p>A class III system shall be installed in buildings with the highest occupiable floor 10 m (33 ft.) above grade or more.</p> <p>A class I system shall be permitted in buildings protected throughout by an approved automatic sprinkler system.</p>	
F-23	Egress Lighting	Manual on-off switch is provided for emergency lighting units on each floor and each stair.	Remove manual on/off switches from emergency lighting units to prevent them from being switched off.	Within 1 month
