# **FIRE SAFETY INSPECTION REPORT**

**REEDISHA TEXSTRIPE LTD.**

**ACCORD ID: 11882**

February 7, 2015

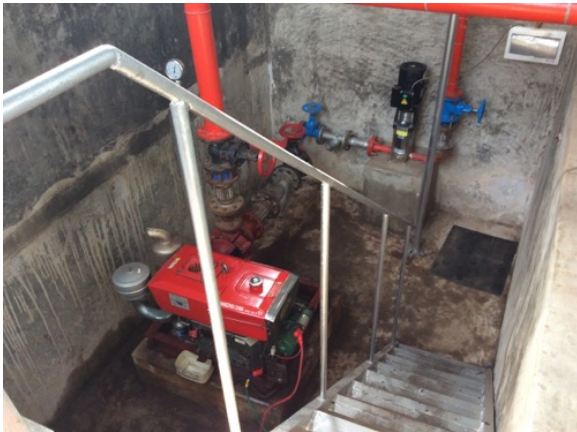
F-2	Fire Rated Construction	The fire pump room is not provided with adequate fire rated separation.	Provide fire pump room with 2 hr. rated fire separation when not sprinklered and 1 hr. rated fire separation when provided with automatic sprinklers, in accordance with NFPA 20.	Within 3 months
-----	-------------------------	---	---	-----------------

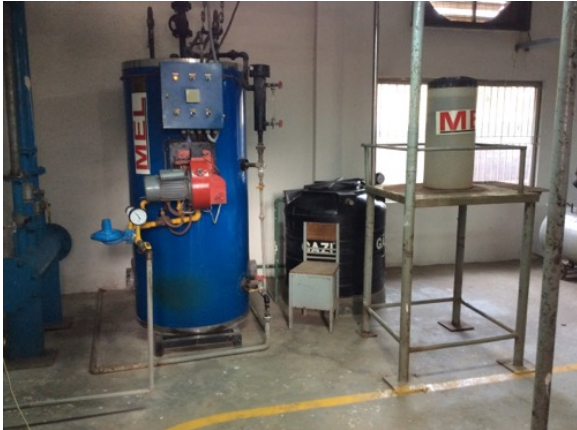
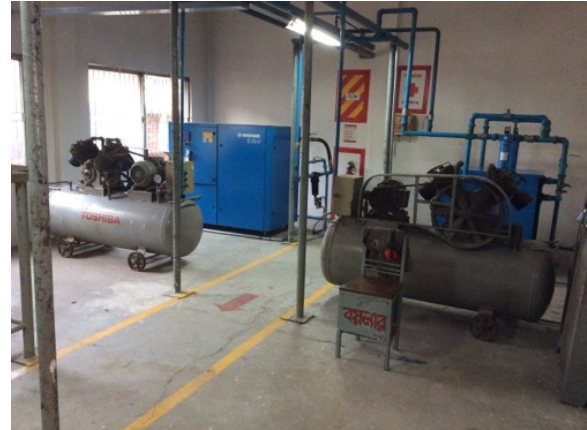
F-3	Fire Rated Construction	The boiler and compressor room is not separated by fire-rated construction due to non-rated doors and penetrations	Separate the boiler and compressor room by a minimum 1-hr fire-rated construction for non-high rise, and 2-hr fire rated construction for high rise. Seal and/or protect all openings to maintain the required fire separations. When located to the exterior of a building, 3m (10 ft.) separation is required. Provide proper ventilation and consult a qualified engineer.	Within 3 months
-----	-------------------------	--	---	-----------------

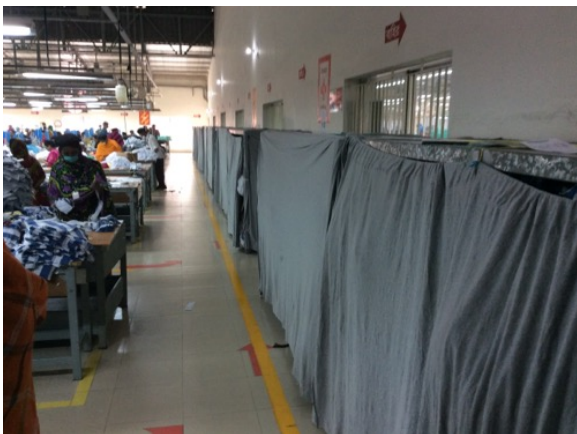
F-4	Fire Rated Construction	Areas used for combustible storage on ground floor open to the factory are not separated by fire-rated construction.	Maximum height of 2.45m (8ft.) and maximum area of 23m <sup>2</sup> (250 ft <sup>2</sup> ) or If sprinkler protected: maximum height of 3.66m (12ft.) and maximum area of 93m <sup>2</sup> (305ft <sup>2</sup> ).	Within 3 months
			Separate areas of unenclosed combustible storage by a minimum clear distance of 3m (10ft.).

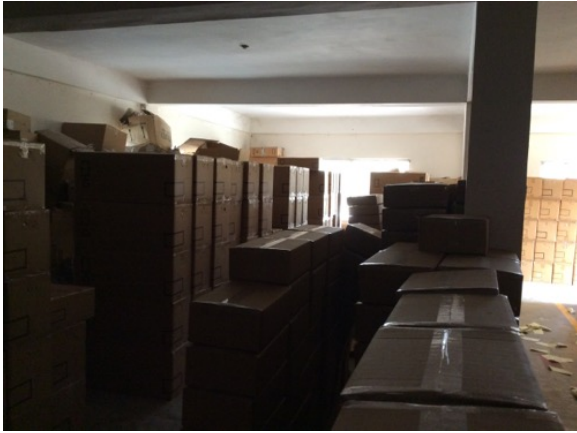
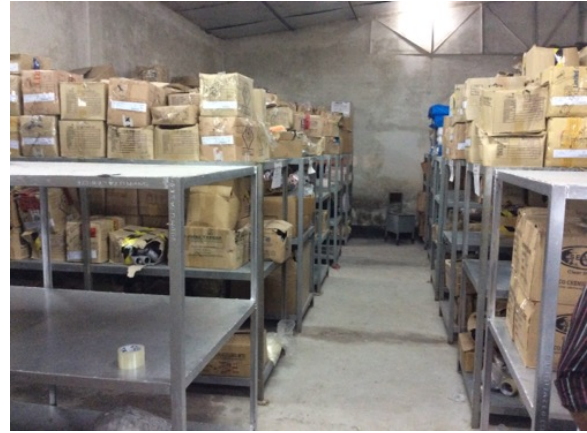
F-5	Fire Rated Construction	Rooms used for combustible storage on ground and 1st floors are not separated by fire-rated construction.	Provide dedicated storage rooms separated by minimum 1-hr fire-rated construction.	Within 3 months
-----	-------------------------	---	--	-----------------

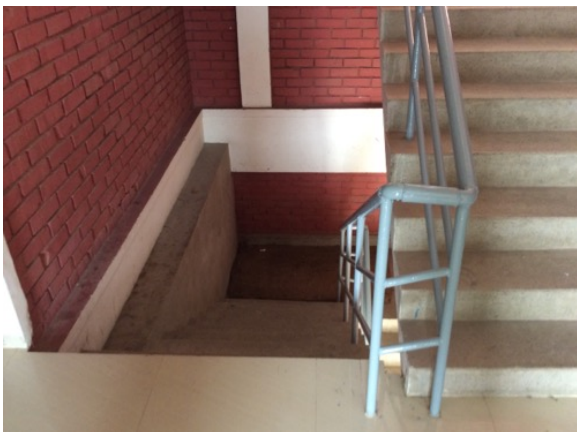
F-6	Fire Rated Construction	The exit stair is not separated from other spaces on 1st floor by fire-rated construction.	<p>Provide minimum 1-hr rated doors for buildings with 3 or fewer stories and 1.5-hr fire rated doors for buildings that are 4 or more stories. Seal all unprotected openings to separate the exit stairs from work areas and other building spaces on all floor levels. Ensure that the fire doors are self-closing and positive latching and that they are provided with fire exit (panic) hardware where serving production floors.</p> <p>If fire doors are required to be held open for functional reasons, provide automatic-closing devices tied to the fire alarm system.</p> <p>Once fire doors are installed, every door in a stair enclosure serving more than 5 stories shall be provided with re-entry unless it meets ACCORD standard 6.8.3.1.</p>	Within 3 months
-----	-------------------------	--	--	-----------------

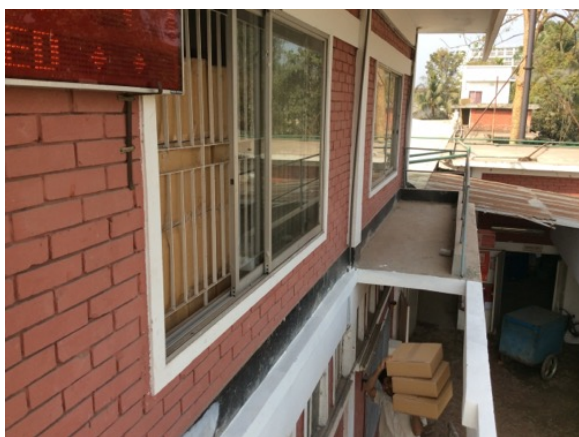
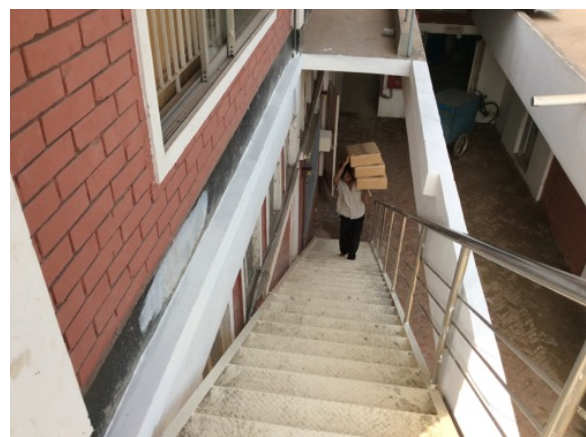
F-7	Fire Rated Construction	The exterior exit stair is not properly separated from the building.	Exterior exit stairs shall be separated from the building with a rating requirement of 1 hr. fire rating for 3 or fewer stories or 2 hr. fire rating for 4 or more stories. The rating of the exterior wall shall extend 3.05 m (10ft) beyond the ends of the stair structure.	Within 6 months
-----	-------------------------	--	--	-----------------

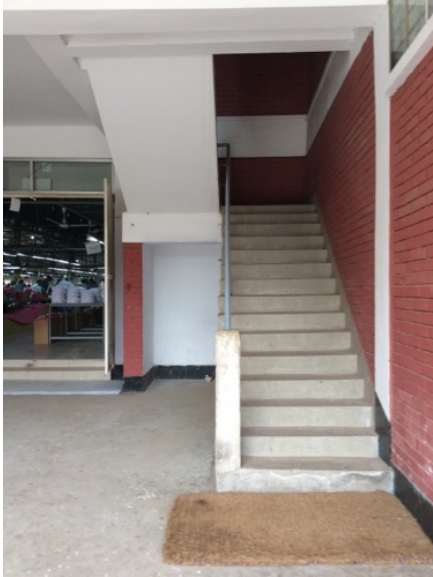
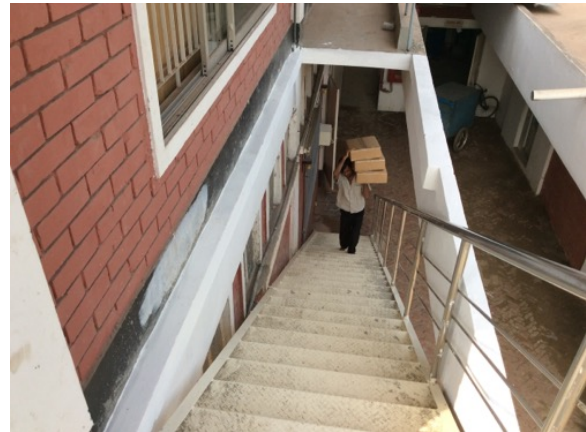
F-9	Egress	Handrails are not provided on both sides of the exit stairs.	Provide handrails on both sides of the exit stair. New handrails shall have a minimum height of 865 mm (34 in.) and a maximum height of 965 mm (38 in.) as measured from the leading edge of the tread. Intermediate handrails shall be provided when the stair width exceeds 2.2 m (87 in.)	Within 3 months
-----	--------	--	--	-----------------

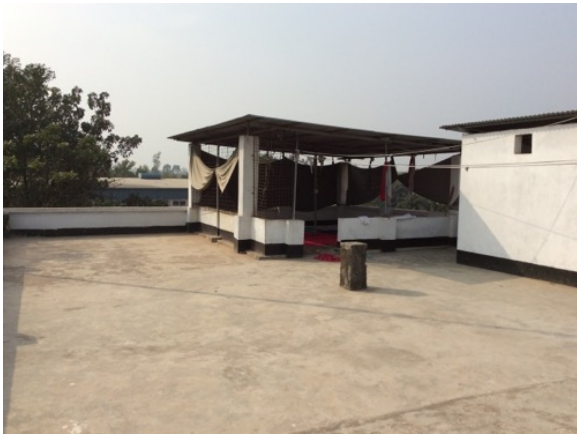
F-10 Egress

The occupiable roof was not provided with an adequate parapet.

All occupiable roofs shall be provided with parapets or guards with a minimum height of 1067 mm (42 in.)

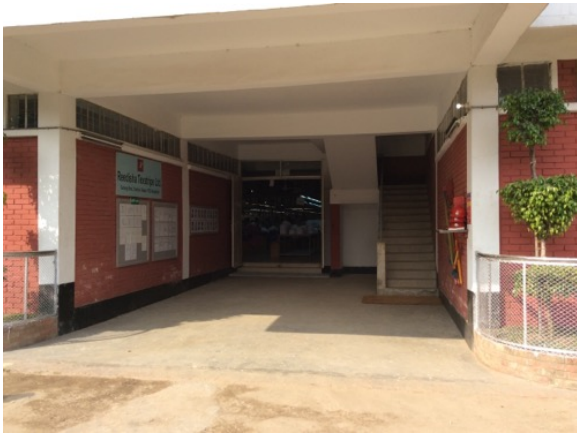
F-12	Fire Protection	The required no smoking signs are not present in the factory.	Smoking is prohibited in any garment factory building or separate storage building. Signs shall be posted in Bengali and English at all building entrances. If the factory creates a designated smoking area outside the building, information of these areas will be posted on the signs.	Within 1 months
------	-----------------	---	--	-----------------

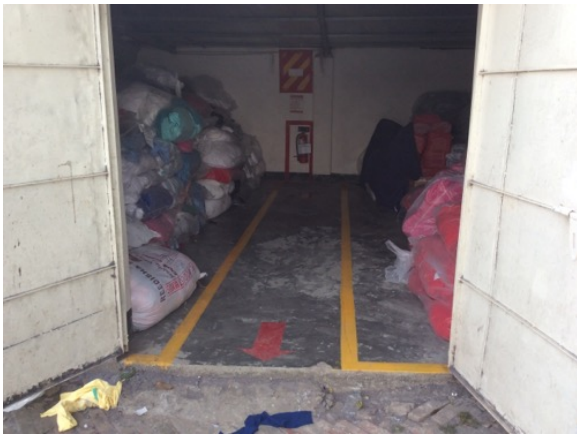
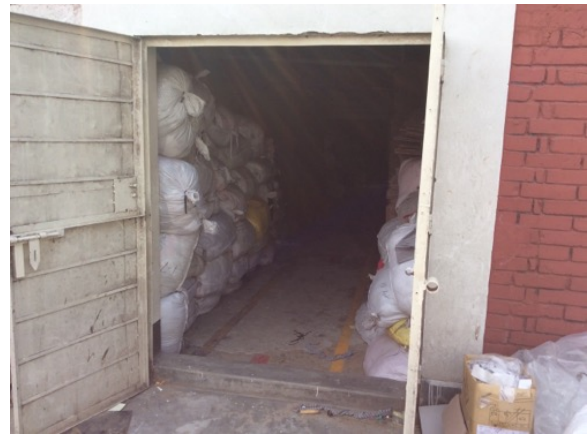
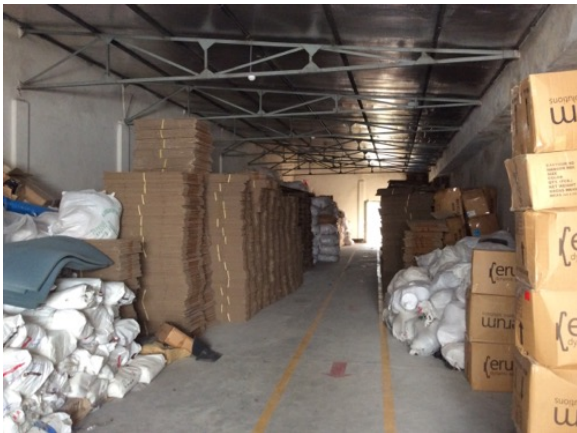
No.	Category	Finding	Recommendation	Remediation Timeframe
F-1	Fire Rated Construction	Rooms used for combustible storage are not separated by fire- rated construction.	Provide dedicated storage rooms separated by minimum 1-hr fire-rated construction.	Within 3 months

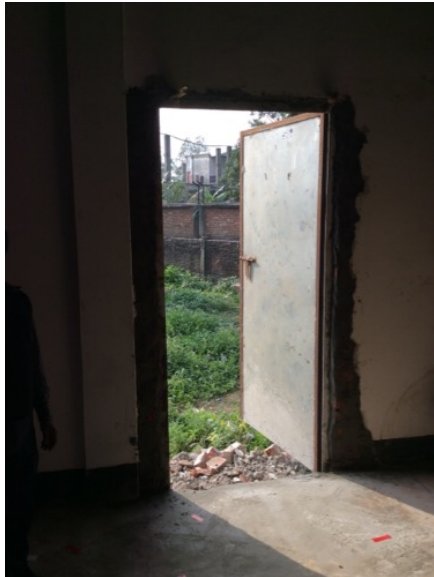
F-8	Egress Lighting	Exit signage was not provided at a building exit.	Provide exit signs above all building exits to the exterior, all doors to the exit stairs and along all paths of travel where a change of direction is not obvious.	Within 1 month
-----	-----------------	---	---	----------------
