# **FIRE SAFETY INSPECTION REPORT**

**APPOLLO KNIT WEAR BD. LTD.**

**ACCORD**  
on Fire and Building Safety in Bangladesh

April 12, 2014

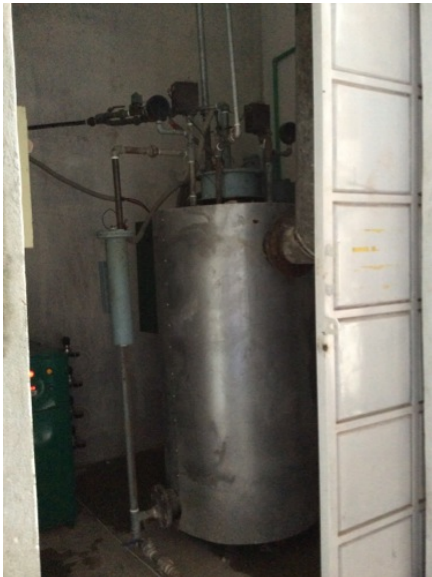
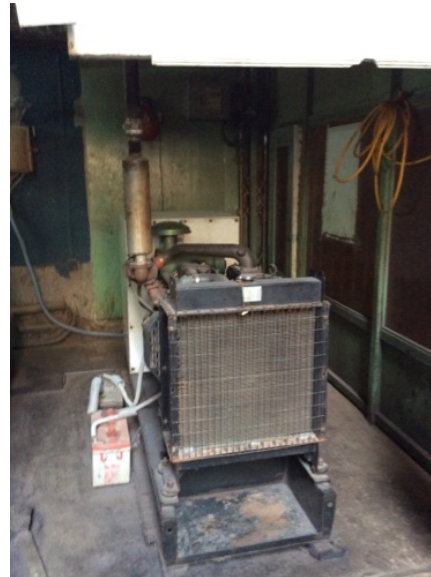
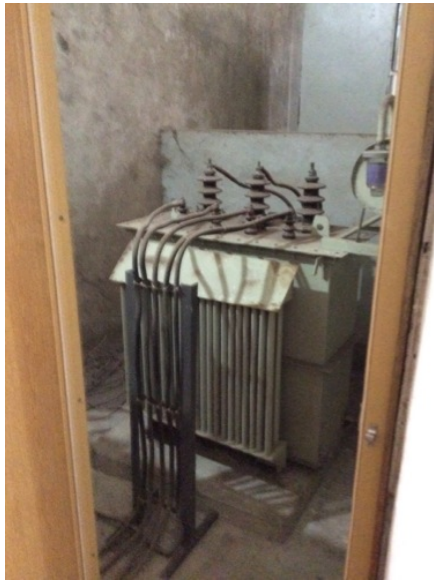
No.	Category	Finding	Recommendation	Remediation Timeframe
F-1	Fire Rated Construction	The boiler, generator, and transformer rooms are not provided with fire-rated construction that is openings, non-rated doors, and penetrations at ground floor adjacent structures.	Separate the boiler, generator, and transformer rooms by a minimum 2-hr fire-rated construction. Seal and/or protected all openings to maintain the required fire separations	Within 3 months

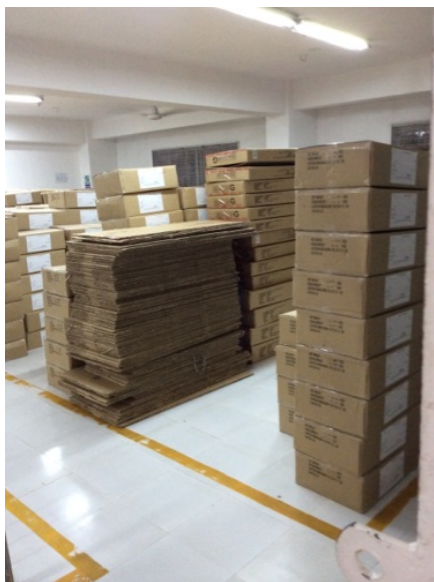
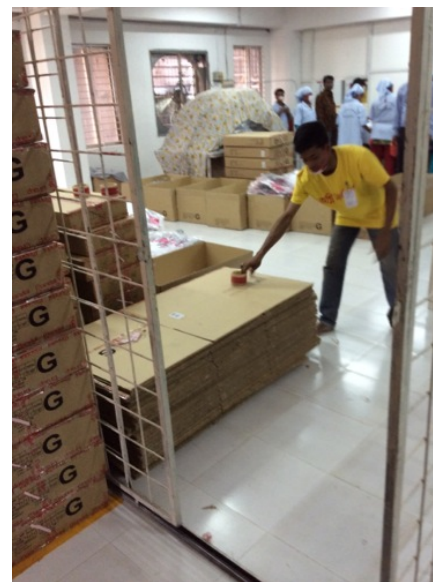
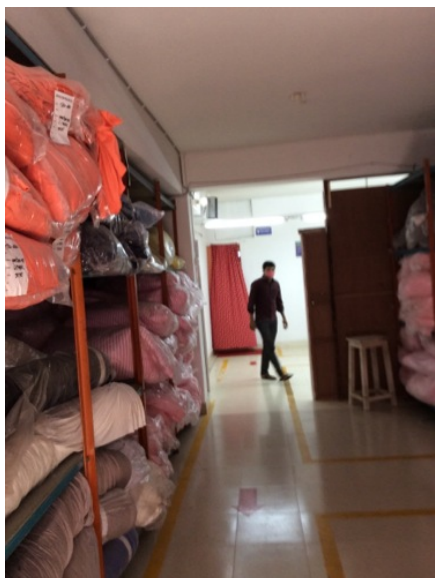
F-2	Fire Rated Construction	Areas used for combustible storage are not separated by fire-rated construction. At levels ground, 1,2,3, and 4 production floors	Provide dedicated storage rooms separated by minimum 1-hr fire-rated construction.	Within 3 months
-----	-------------------------	---	--	-----------------

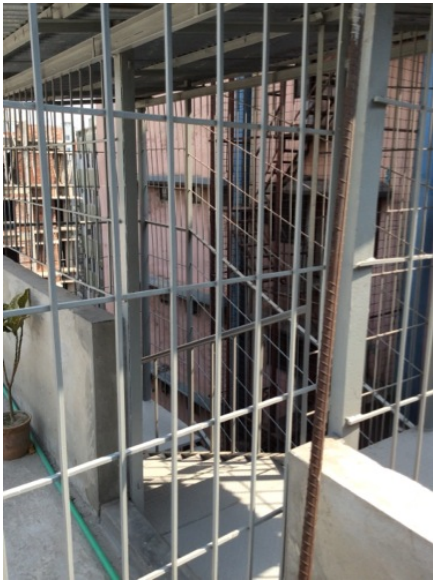
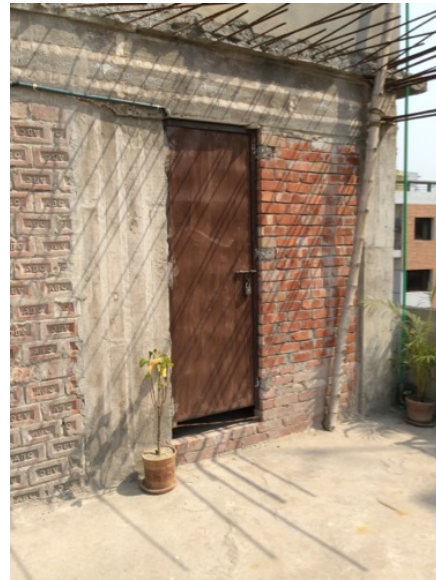
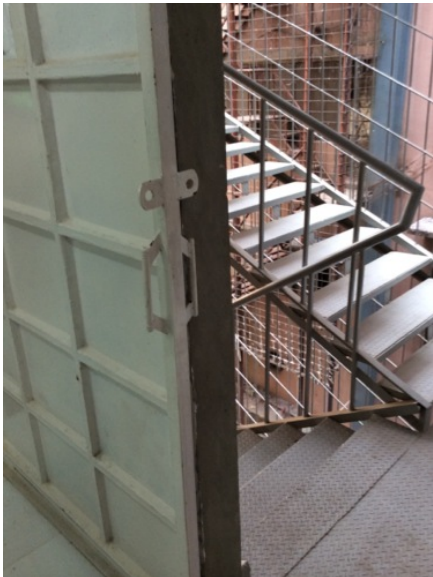
F-3	Fire Rated Construction	The exit stairs are not separated from work areas on each floor by fire-rated construction.	Provide minimum 1.5-hr fire rated doors and seal all unprotected openings to separate the exit stairs from work areas and other building spaces on all floor levels. Ensure that the fire doors are self-closing and positive latching and that they are provided with fire exit (panic) hardware where serving production floors.	Within 3 months
			If fire doors are required to be held open for functional reasons, provide automatic-closing devices tied to the fire alarm system.

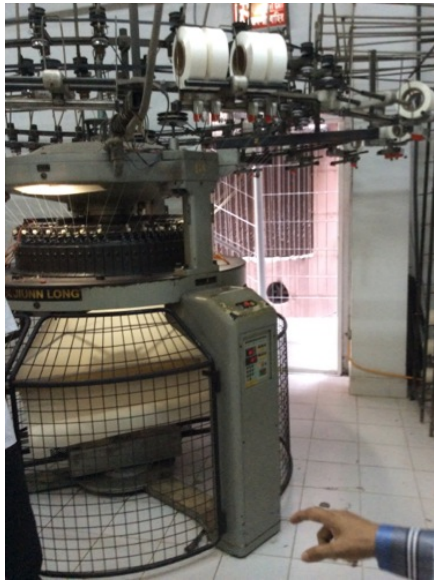
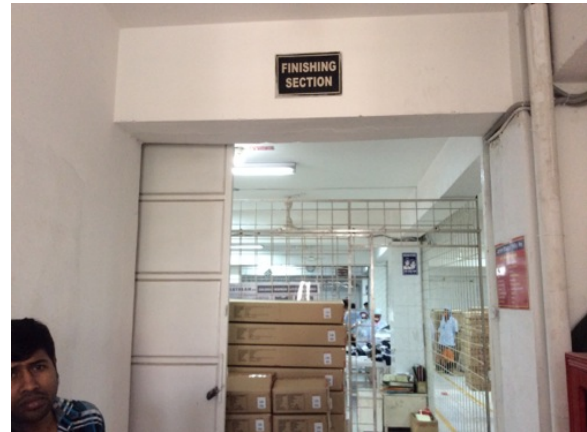
F-4	Egress	Storage was located in the egress path at floors 1,2,3,4,5, and 6.A knitting machine is obstructing egress to exit stair at floors 4.	Keep egress paths and stairs clear of storage.	Immediate
-----	--------	---	--	-----------

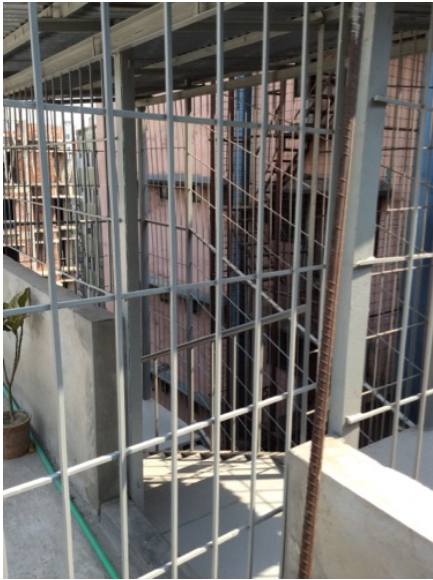
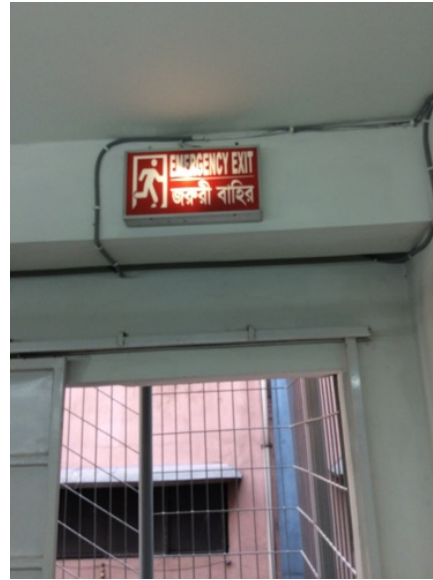
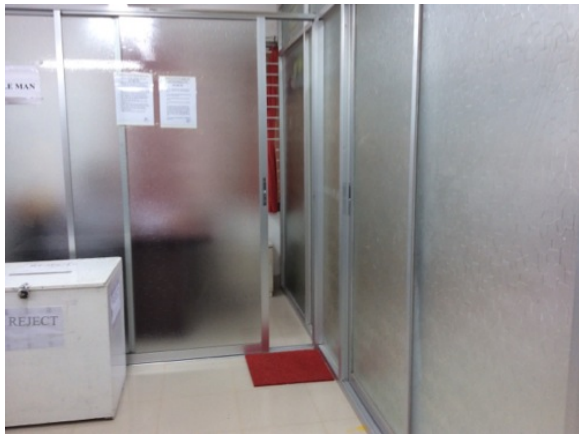
F-6	Egress	Collapsible gates / sliding doors are provided at building exits, exit stairs, along egress routes, exit discharge. In all levels and at main building exit discharge.	Replace all gates / sliding doors along the means of egress with side-hinged, swinging egress doors.  If locks are required for security reasons, utilize special door locking features complying with NFPA 101.	Within 1 month
-----	--------	--	--	----------------

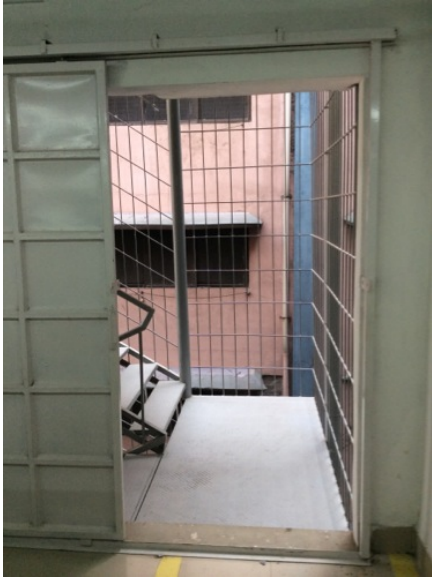
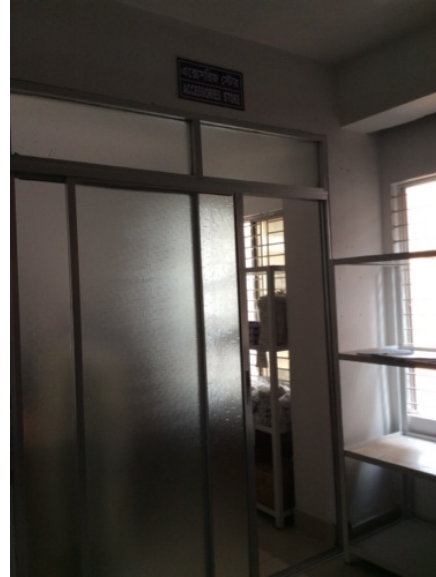
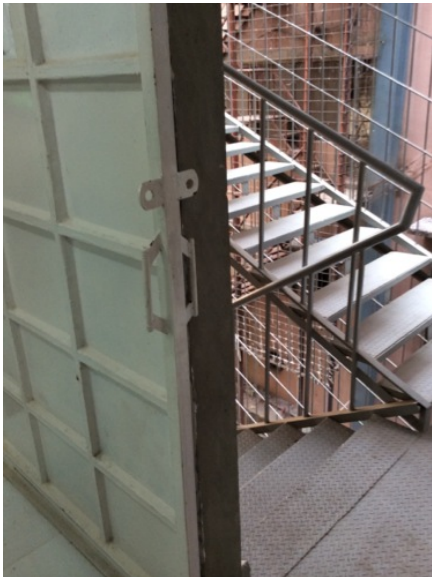
F-8	Egress	Egress doors / gates with locking features are provided at building exits, exit stairs, along egress routes, exit discharge in all through out the building.All gates were open at the time of inspection.	Remove locking features from all egress doors / gates.  If locks are required for security reasons, utilize special door locking features complying with NFPA 101.	Within 3 months
-----	--------	--	--	-----------------

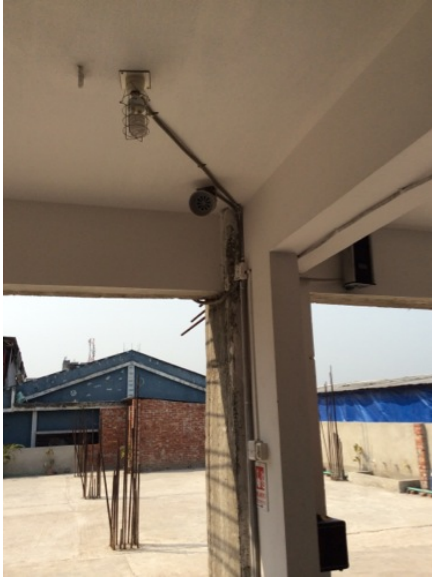
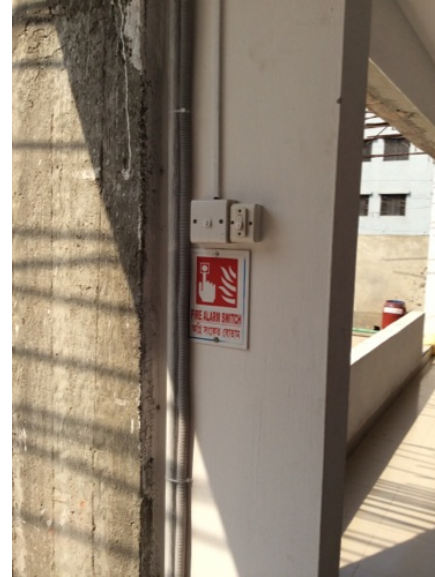
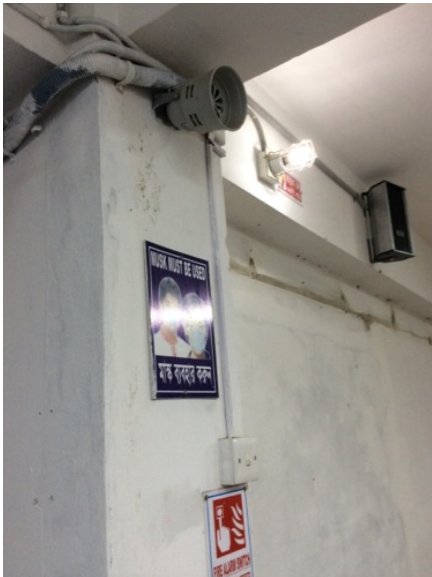
F-9	Fire Protection	The fire alarm system is antiquated, not a listed system, and does not provide alarm and notification features consistent with acceptable standards.	Replace the fire alarm system with a new, listed addressable fire alarm system in accordance with NFPA 72.	Design within 4 months, install within 9 months
-----	-----------------	--	--	---

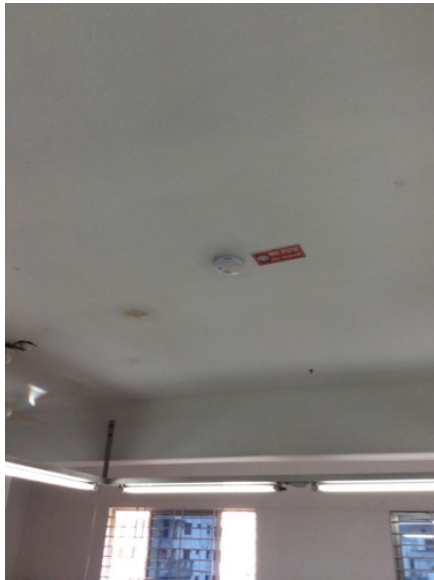
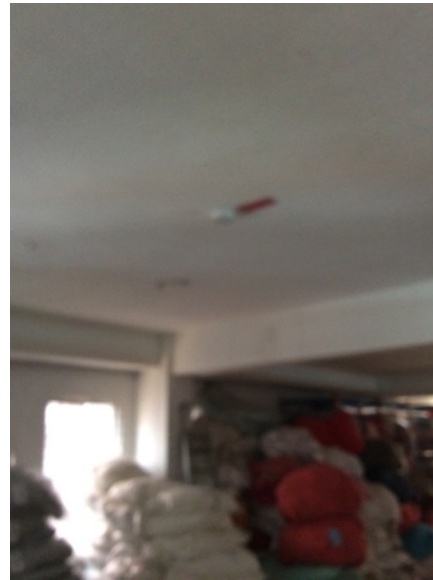
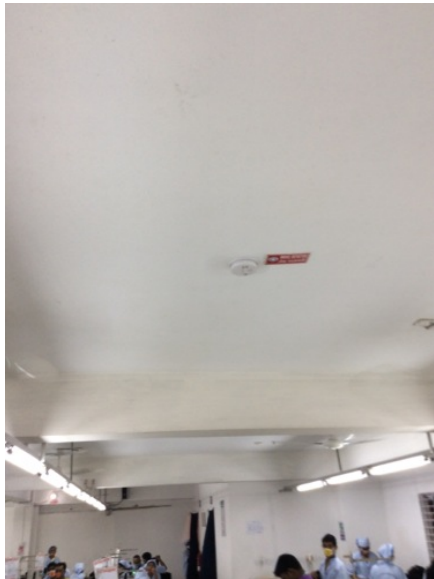
F-10	Fire Protection	Inspection, testing, and maintenance of the fire alarm system was not in accordance with NFPA -72	Inspect, test and maintain the fire alarm system, and keep written records on-site, in accordance with NFPA 72.	Within 3 months
F-11	Fire Protection	Remove single-station smoke alarms. Provide automatic smoke detection throughout the building in accordance with NFPA 72.	Replace the single-station smoke alarms with automatic smoke detectors tied into the fire alarm system.	Within 6 months
