FIRE SAFETY INSPECTION REPORT

Entrust Fashions Limited

ACCORD ID: 23537

Fire Safety Inspection Report

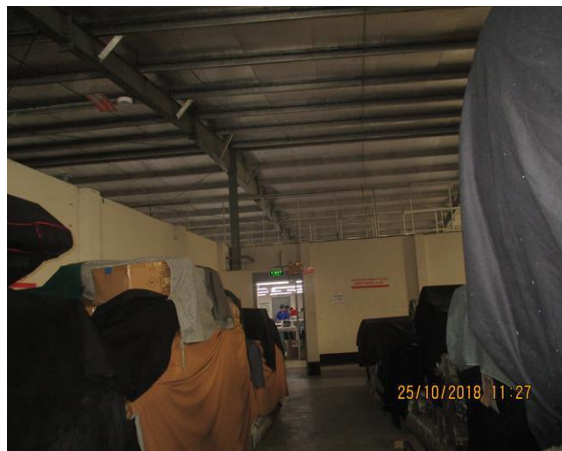
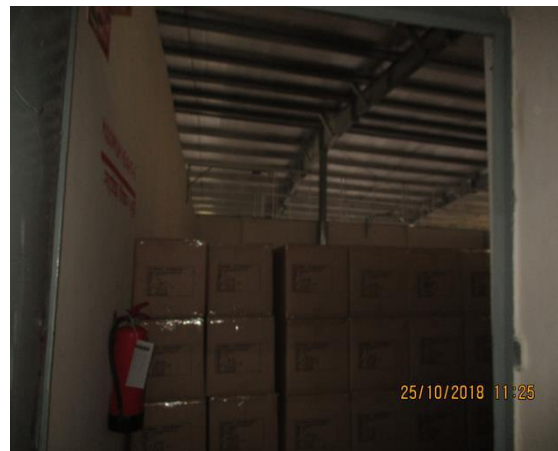
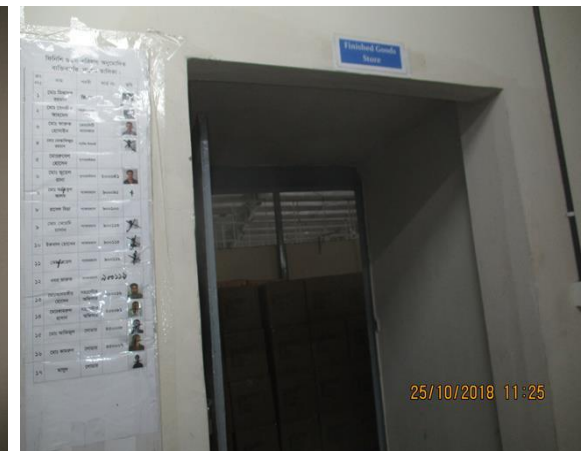
SI No.	Category	Findings	Required Action	Remediation Time Frame
F-01	Fire Rated Construction	Rooms used for combustible storage are not separated by fire rated construction. Location: Shed-2.	Separate the dedicated storage rooms by minimum 1-hr fire-rated construction. Provide 0.75 hr. fire rated door and seal all penetrations and openings by 1 hr. fire rated fire rated barrier construction.	Within 3 months

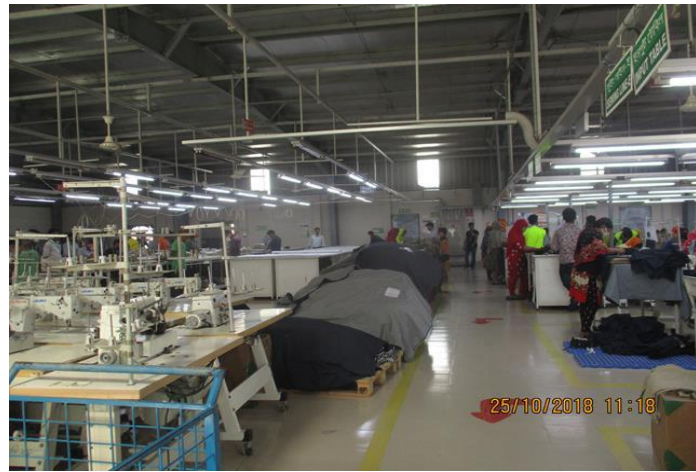
F-02	Fire Rated Construction	<p>Areas used for combustible storage open to the factory are not separated by fire rated construction.</p> <p>Location: Shed-01.</p>	<p>Separate the dedicated storage rooms by minimum 1-hr fire-rated construction. Provide 0.75 hr. fire rated door and seal all penetrations and openings by 1 hr. fire rated fire rated barrier construction.</p> <p>Where separate storage rooms are not feasible, provide defined storage areas and limit the storage arrangement as follows: - Maximum height of 2.45m (8ft.) and maximum area of 23m² (250 ft²) - If sprinkler protected: maximum height of 3.66m (12ft.) and maximum area of 93m² (305ft²). Separate areas of unenclosed combustible storage by a minimum clear distance of 3m (10ft.).</p>	Within 3 months
------	-------------------------	--	--	-----------------

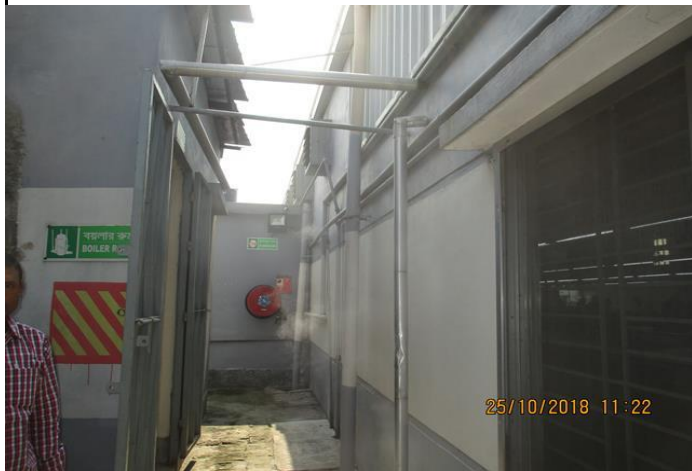
F-03	Fire Rated Construction	Boiler room was not fire separated with shed-2 as there were unprotected openings (Windows) in shed within 10 ft distance.	Separate the boiler and compressor rooms by a minimum 1-hr fire-rated construction for non-high rise, and 2-hr fire rated construction for high rise. Seal and/or protect all openings to maintain the required fire separations. When located to the exterior of a building, 3m (10 ft.) separation is required. Provide proper ventilation and consult a qualified engineer.	Within 3 months.
------	-------------------------	--	--	------------------

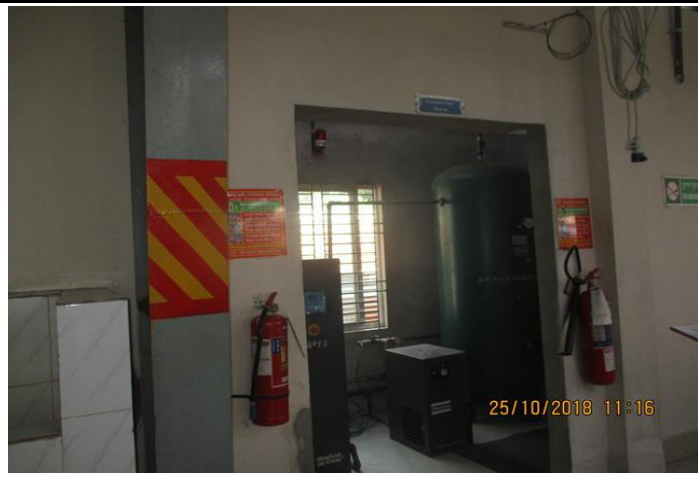
F-04	Fire Rated Construction	Compressor room was not fire separated with adjacent production area in shed-1 as the installed door was not fire rated.	Separate the compressor rooms by a minimum 1-hr fire-rated construction with minimum 45 minutes rated fire door. When located to the exterior of a building, 3m (10 ft.) separation is required. Provide proper ventilation and consult a qualified engineer.	Within 3 months.

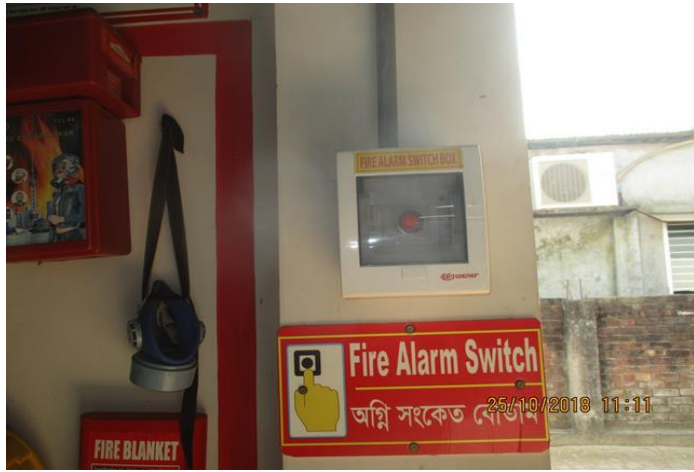
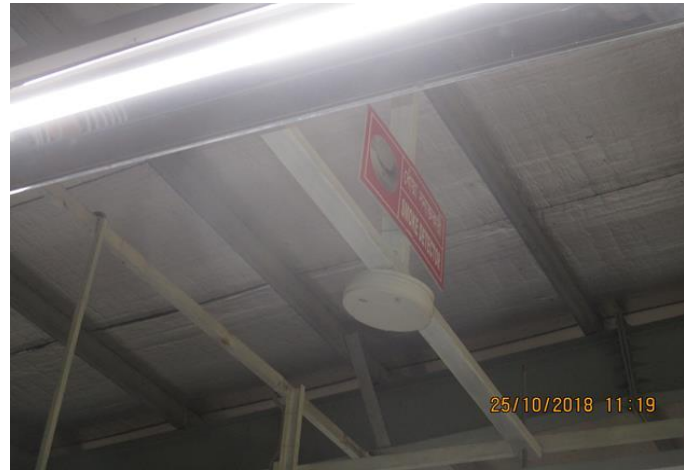
F-06	Egress Lighting	Manual on-off switch is provided for emergency lighting / exit signage units.	Remove manual on/off switches from emergency lighting / exit signage units to prevent them from being switched off.	Within 1 month
F-07	Egress Lighting	Inspection, testing and maintenance for the emergency lighting system was not in accordance with The ACCORD standard.	Inspect, test and maintain the emergency lighting system in the accordance with The ACCORD standard. Keep written records on-site.	Within 1 month
F-08	Fire Detection and Alarm System	The fire alarm system is antiquated, not a listed system and does not provide alarm and notification features consistent with acceptable standards.	Replace the fire alarm system with a new, listed addressable fire alarm system in accordance with NFPA 72.	Design submission within 2 months and installation within 6 months.
