# **FIRE SAFETY INSPECTION REPORT**

## **SQ Celcius Limited (Unit 2)**

**ACCORD ID: 23352**

**Date: 11 November, 2018**

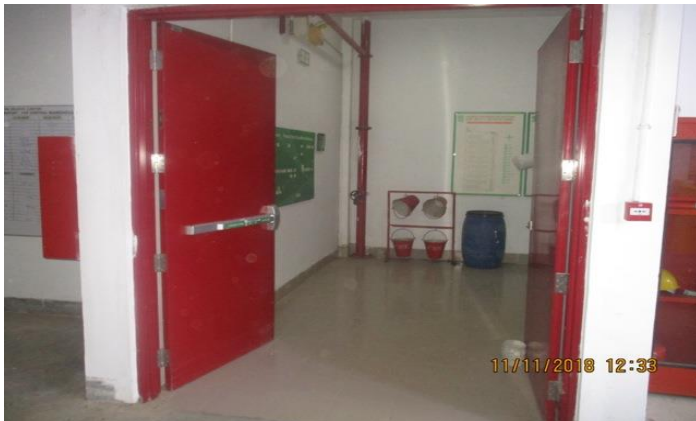
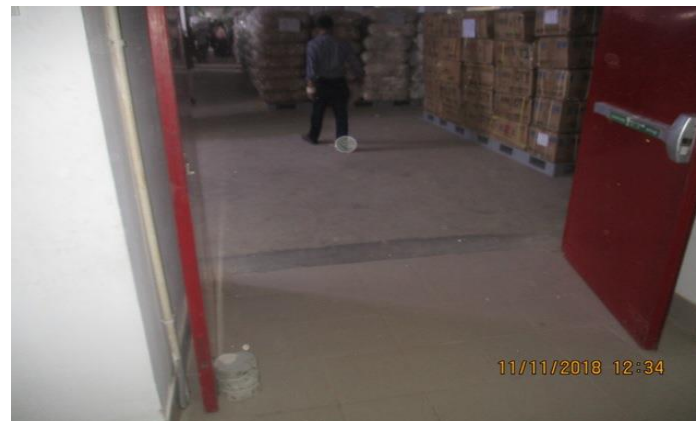
| SI No. | Category | Findings | Required Action | Remediation Time Frame |
|---|---|---|---|---|
| F-1 | Fire Rated Construction | <p>Existing 2 nos. of Exit stairs upto 2nd floor is not separated from the store rooms (Bonded Warehouse, Fabrics Warehouse)</p> <p>Note: Fire doors installation are going on. From 3rd Floor, vertical upgradation is going on.</p> | separate the exit stairs from the work areas and other building spaces with 2 hr. fire rated construction materials. | Within 3 months |

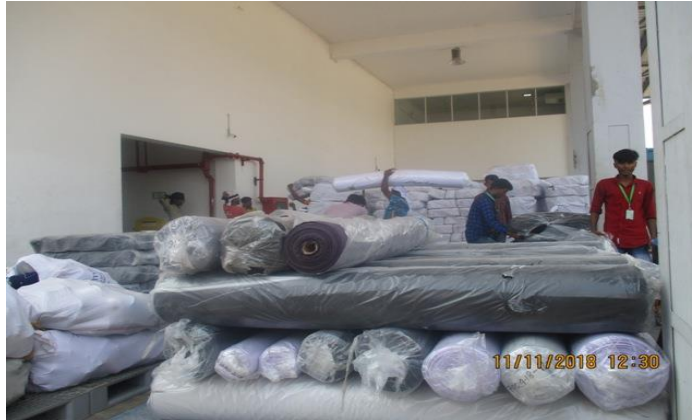
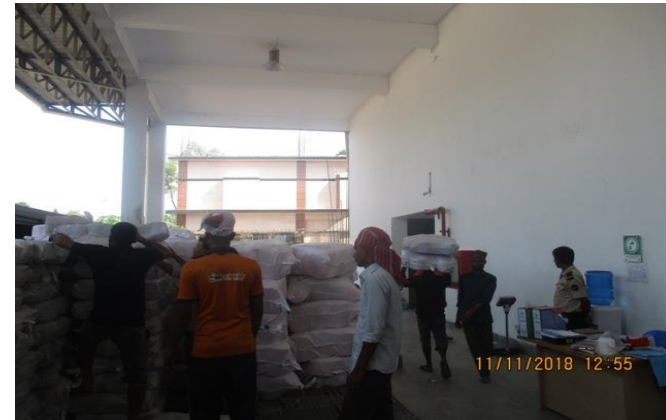
| F-2 | Fire Rated Construction | Stair-01 discharges inside the building & exit discharge point is not separated from the combustible store arrangement. | <p>Either modify the discharge point to discharge directly outside the building</p> <p>or, provided 2 hr. fire rated exit passageway to discharge directly outside the building.</p> <p>Seal all the penetration with 2 hr. fire rated materials.</p> | Within 3 months |

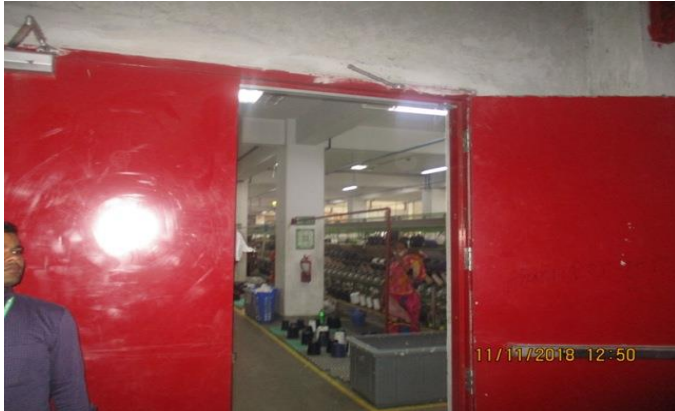
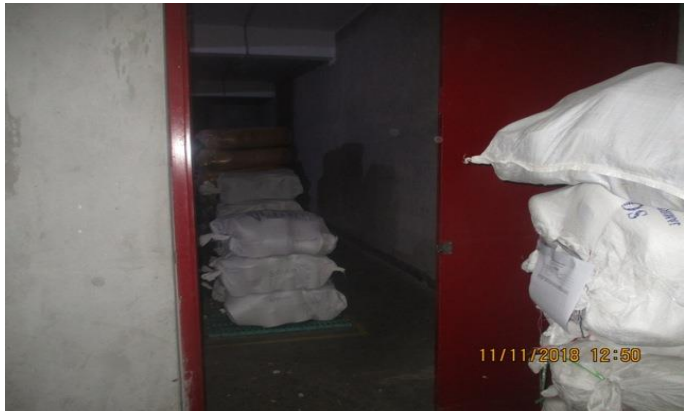
| F-3 | Fire Rated Construction | On ground floor, Winding Section & Store room is not properly fire separated as installed fire door is not functional appropriately | Provide the 1 hr. fire rated separation between the winding section & the store room | Within 1 month |

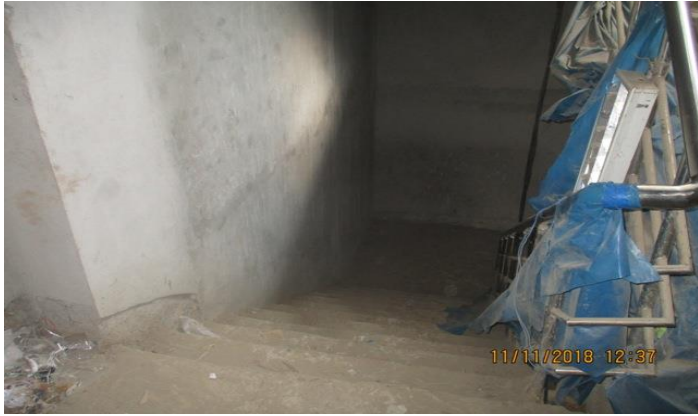
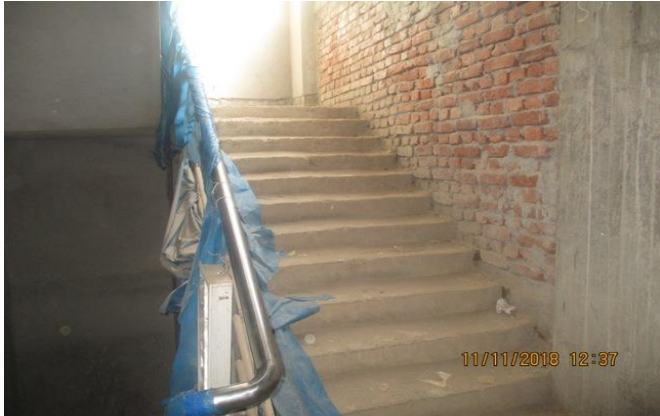
| F-4 | Means of Egress | Both Side hand rails is not provided at the Exit Stair -02 | Provide hand rails on both side of the exit stair- 02 | Within 1 month |

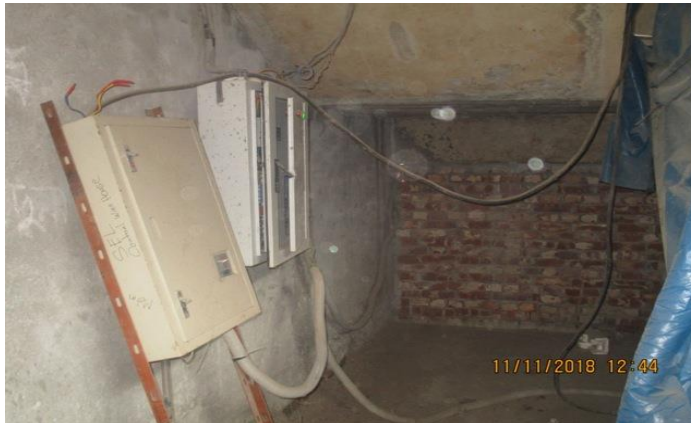
| F-5 | Means of Egress | Electrical Panel was located at stair-02 on Ground floor | Exit stair shall be free from any sort of storage | Immediate |

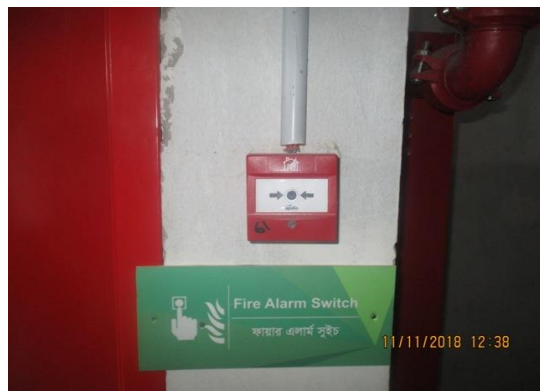
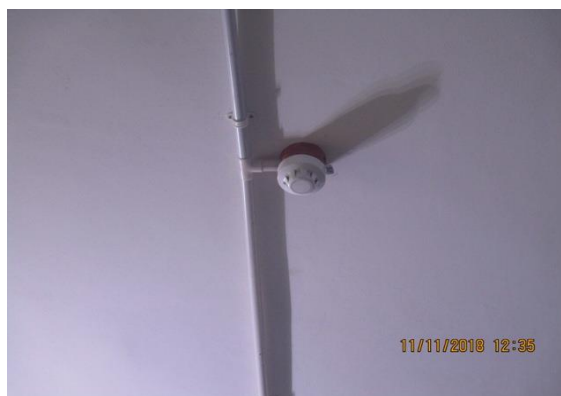
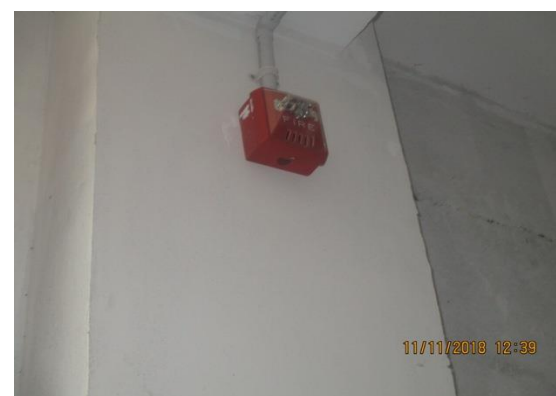
| F-6 | Fire Alarm & Detection System | Fire alarm system installation requires detailed review to confirm compliance with NFPA 72 and ACCORD standards. | <p>Submit as-built drawings, testing records, equipment certification and other relevant documentation to the ACCORD for review and approval.</p> <p>If installed system requires modification or alteration then all the applicable works shall have to be accomplished as per NFPA-72</p> | Within 3 months |

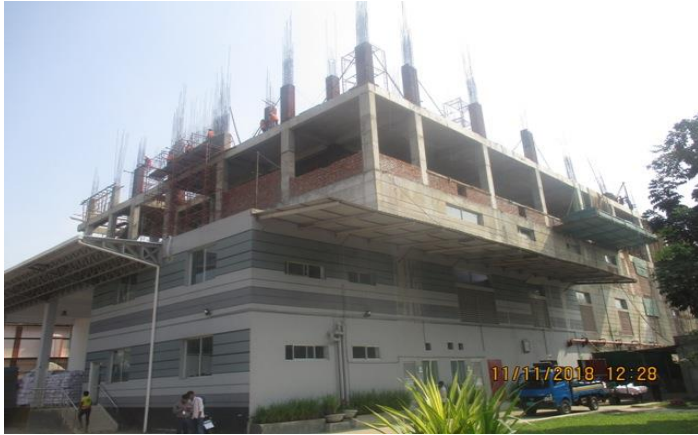
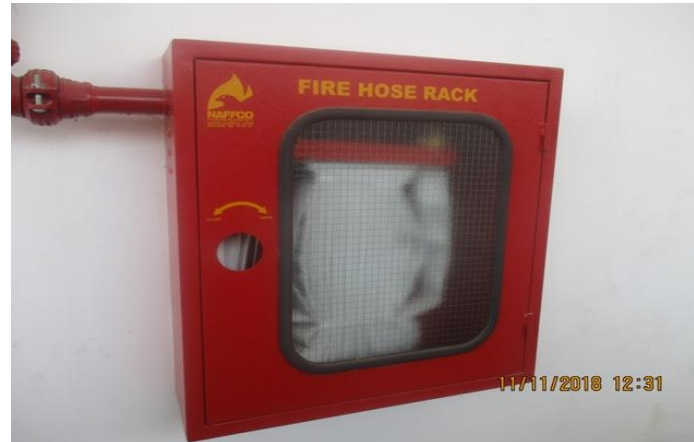
| F-8 | Fire Protection System | Currently building is under construction. Once completed, H.O.F. height will be more than 10m or 33 ft. Based on that, approved standpipe system is required to install | Provide a standpipe system throughout the building in accordance with NFPA 14. | Within 3 months |
