# **FIRE SAFETY INSPECTION REPORT**

**SURMA GARMENTS LTD.**

**AICHA NOADDA, RAJASHON ROAD SAVAR, DHAKA**

May 12, 2014

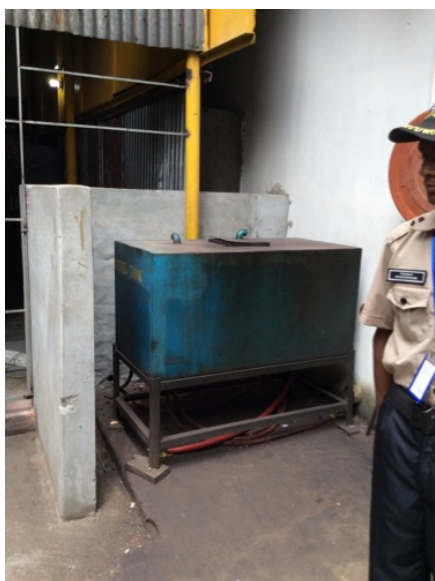
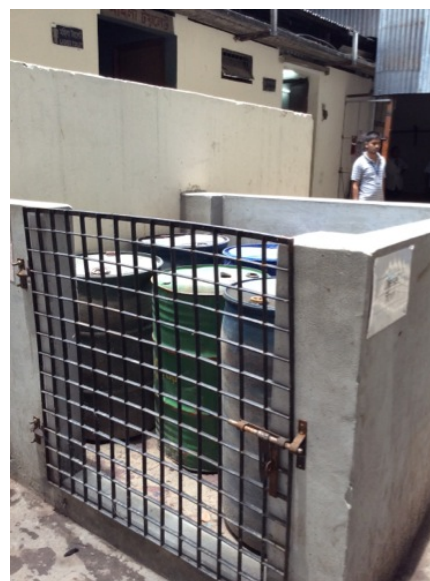
| F-1 | Fire Rated Construction | Flammable liquid storage( fuel storage for generator )area is not separated by fire-rated construction (openings, non-rated doors, penetrations) on ground floor south east shed. | Separate the flammable liquid storage room by a minimum 2-hr fire-rated construction. Seal and/or protected all openings to maintain the required fire separations. | Within 3 months |

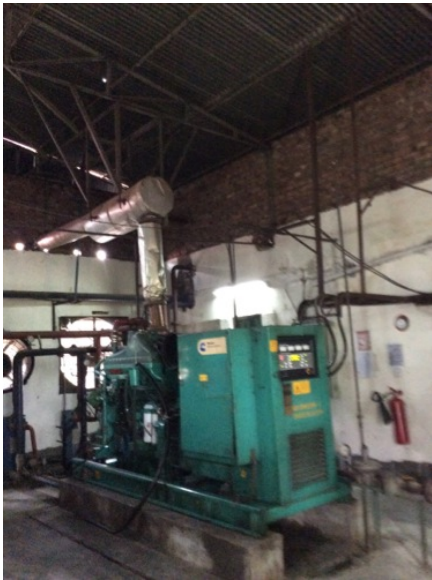
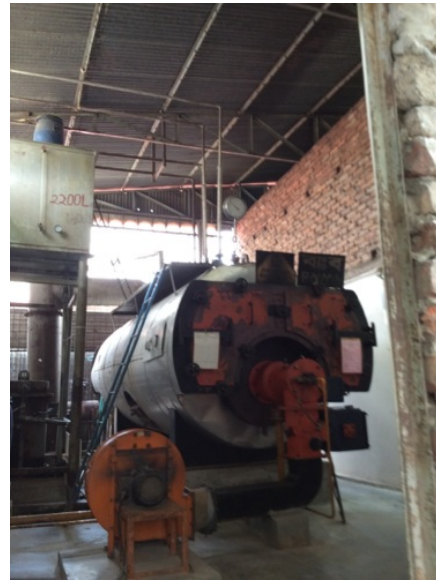
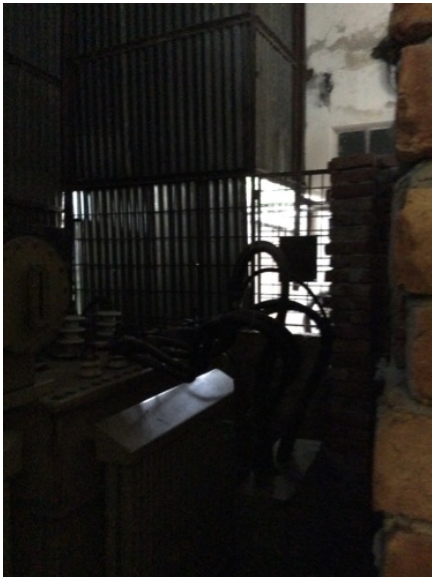
| F-2 | Fire Rated Construction | The boiler, generator, transformer room is not separated by fire-rated construction (openings, non-rated doors, penetrations) ground floor at the southeast shed. | Separate the boiler, generator, transformer room by a minimum 2-hr fire-rated construction. Seal and/or protected all openings to maintain the required fire separations | Within 3 months |

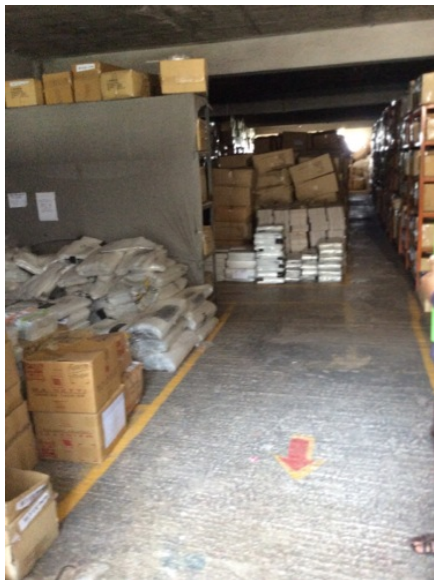
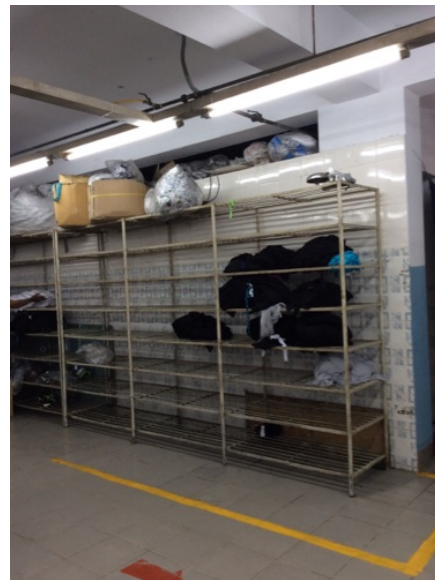
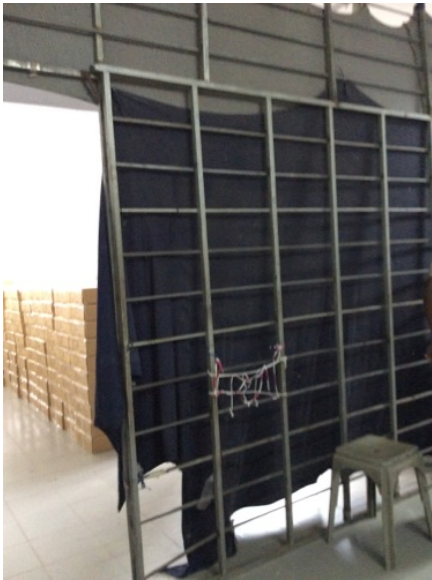
| F-3 | Fire Rated Construction | Areas used for combustible storage are not separated by fire-rated construction on floors 1, 2, 3, 4, and 5. | <p>Provide dedicated storage rooms separated by minimum 1-hr fire-rated construction.</p> <p>Where separate storage rooms are not feasible, provide defined storage areas and limit the storage arrangement as follows:</p> <ul style="list-style-type: none"><li>- Maximum height of 2.4m and maximum area of 23m<sup>2</sup></li><li>- If sprinkler protected: maximum height of 3.66m and maximum area of 93m<sup>2</sup></li></ul> <p>Separate areas of unenclosed combustible storage by a minimum clear distance of 3m.</p> | Within 3 months |

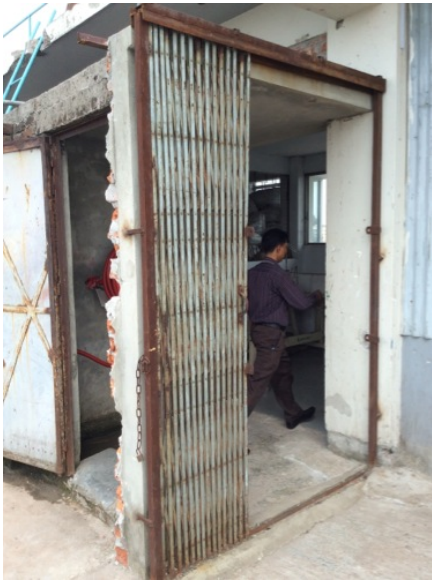
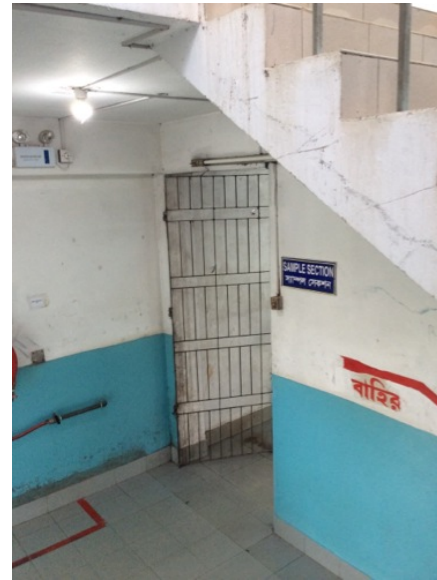
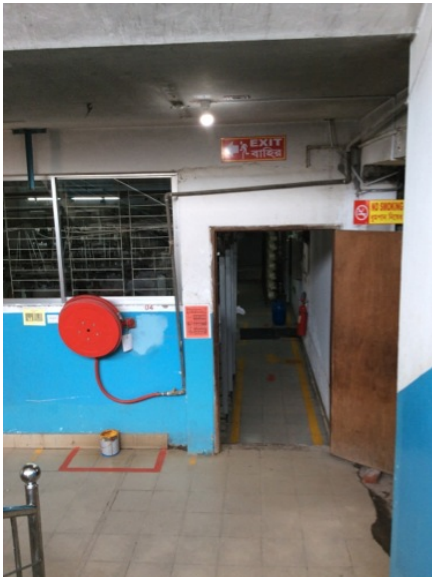
| F-4 | Fire Rated Construction | The exit stairs are not separated from work areas, other spaces on each floor by fire-rated construction. | <p>Provide minimum 1.5-hr fire rated doors and seal all unprotected openings to separate the exit stairs from work areas and other building spaces on all floor levels. Ensure that the fire doors are self-closing and positive latching and that they are provided with fire exit (panic) hardware where serving production floors.</p> <p>If fire doors are required to be held open for functional reasons, provide automatic-closing devices tied to the fire alarm system.</p> | Within 3 months |

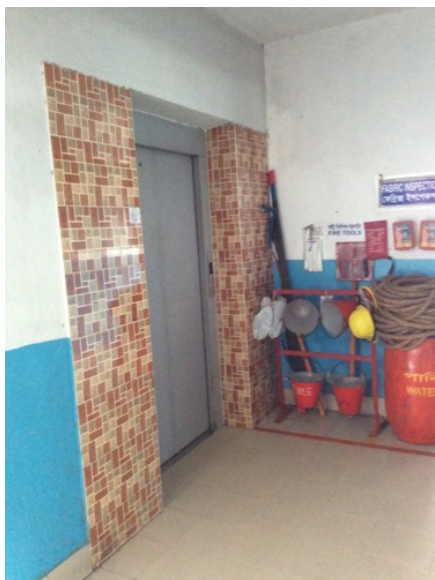
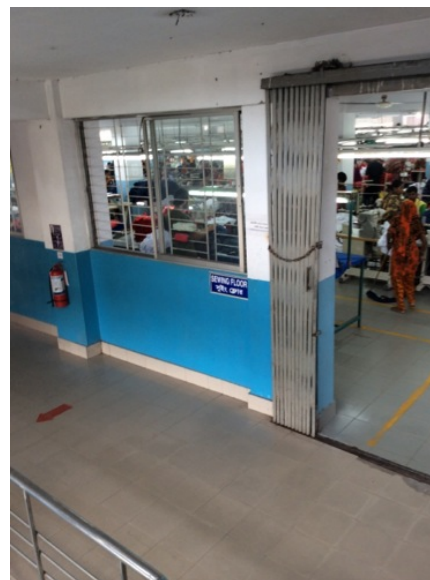
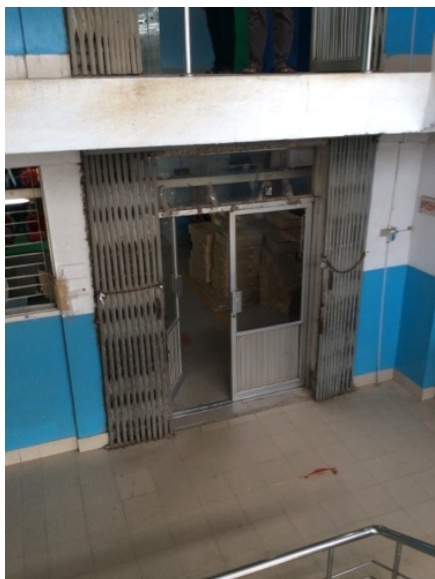
| F-5 | Fire Rated Construction | Unsealed penetrations and openings are located in exit stair enclosures. | Seal all penetrations and openings in exit stair enclosure walls to maintain the fire separation. | Within 3 months |

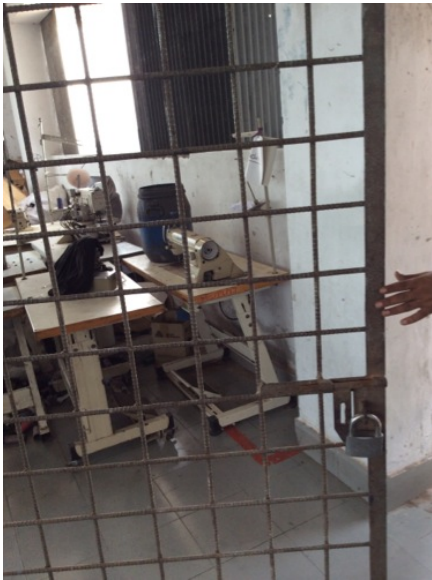
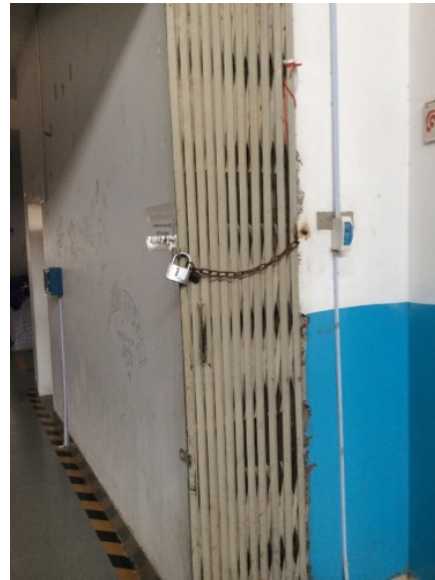
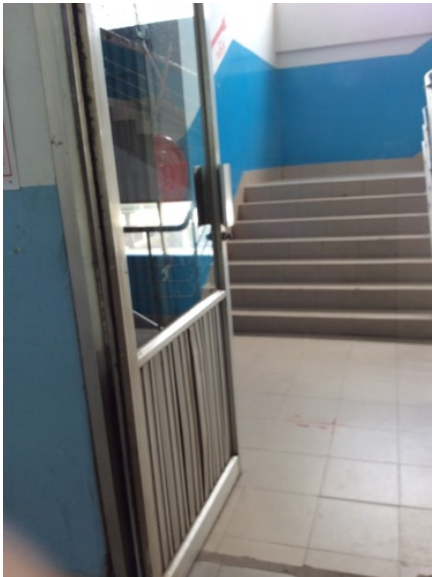
| F-6 | Egress | Egress doors / gates with locking features are provided at building exits, exit stairs, along egress routes, exit discharge on all floors. All doors/gates were open and unlocked during the inspection. | Remove locking features from all egress doors / gates.<br><br>If locks are required for security reasons, utilize special door locking features complying with NFPA 101. | Immediate |

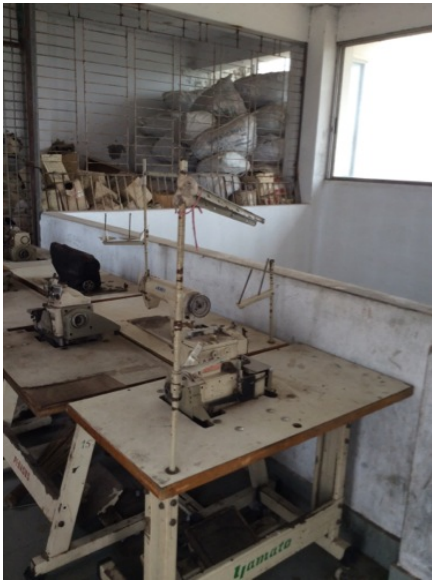
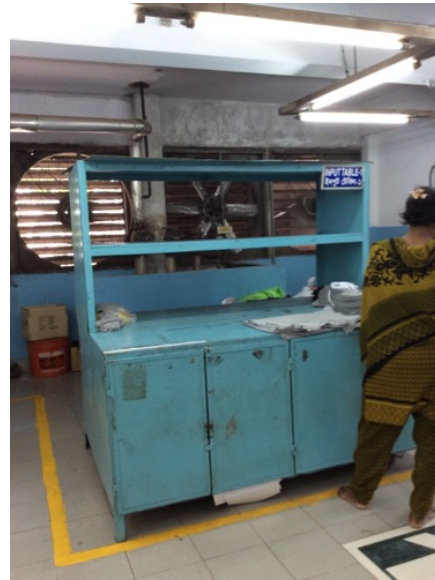
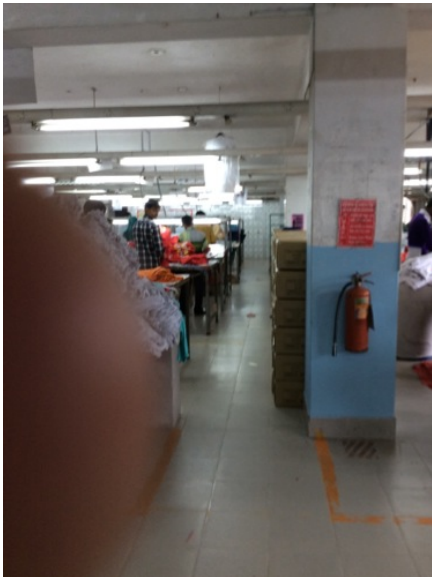
| F-7 | Egress | Storage was located in the egress path on floors 1, 2, 3, 4, and 5. | Keep egress paths and stairs clear of storage. | Immediate |

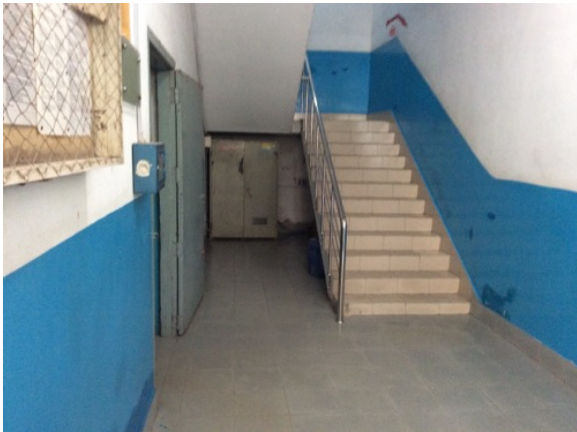
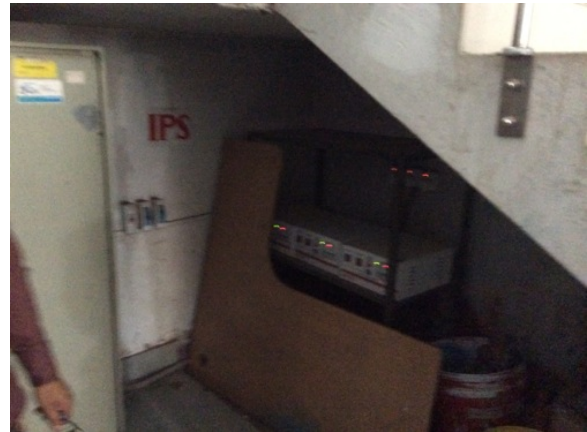
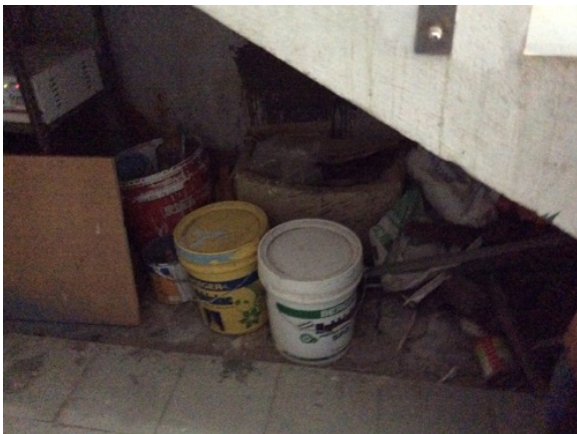
| F-8 | Egress | Storage was located in the exit stair on ground floor northwest exit stair. | Remove all storage from exit stairs and egress paths. | Immediate |

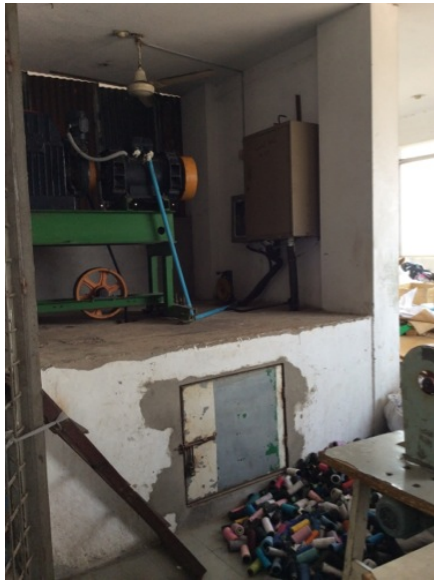
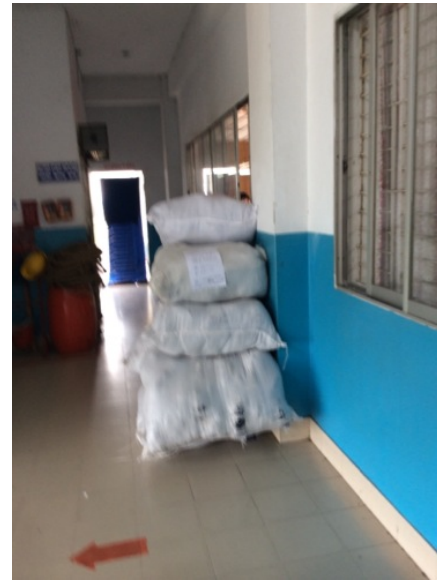
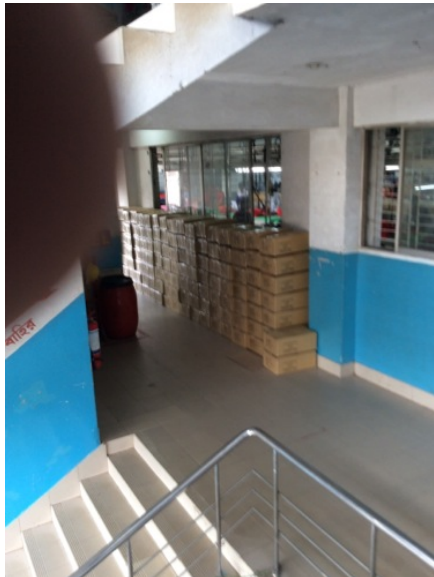
| F-9 | Egress | Storage was located in the exit stair on floors 1, 2, 3, 4, 5, and 6. | Remove all storage from exit stairs and egress paths. | Immediate |

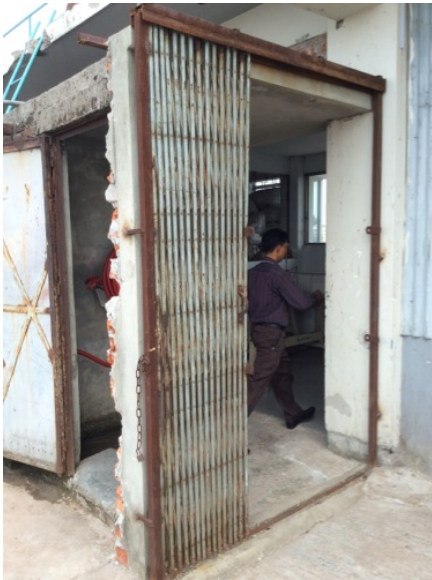
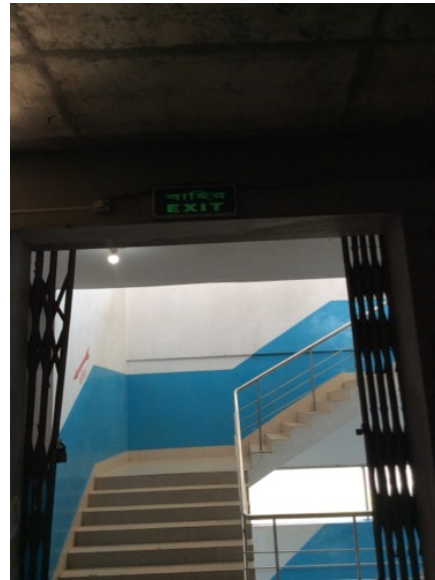
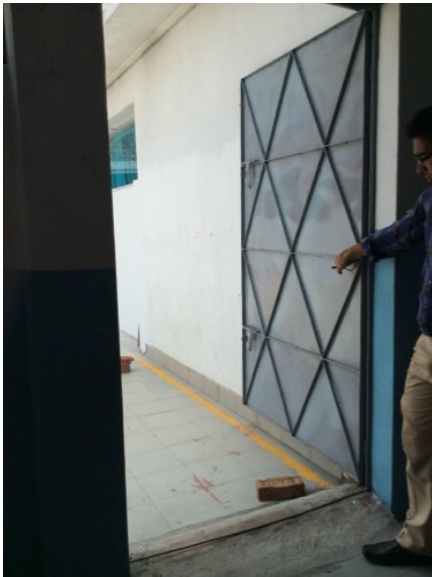
| F-10 | Egress | Collapsible gates / sliding doors are provided at building exits, exit stairs, along egress routes, exit discharge on all floors of the building. | <p>Replace all gates / sliding doors along the means of egress with side-hinged, swinging egress doors.</p> <p>If locks are required for security reasons, utilize special door locking features complying with NFPA 101.</p> | Within 1 month |

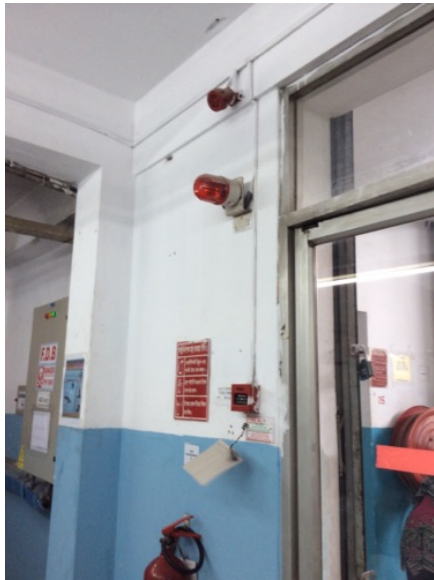
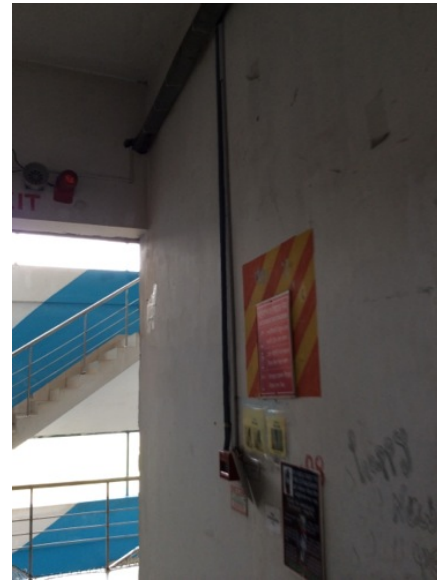
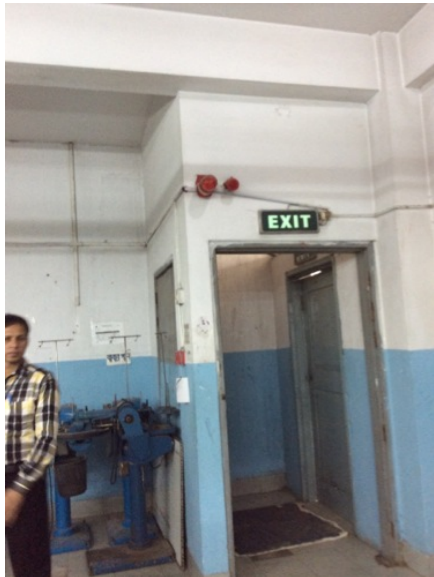
| F-11 | Fire Protection | The fire alarm system is antiquated, not a listed system, and does not provide alarm and notification features consistent with acceptable standards. | Replace the fire alarm system with a new, listed addressable fire alarm system in accordance with NFPA 72. | Design within 4 months, install within 9 months |

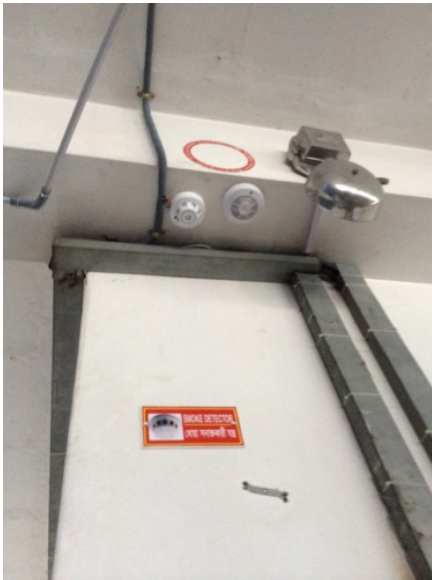
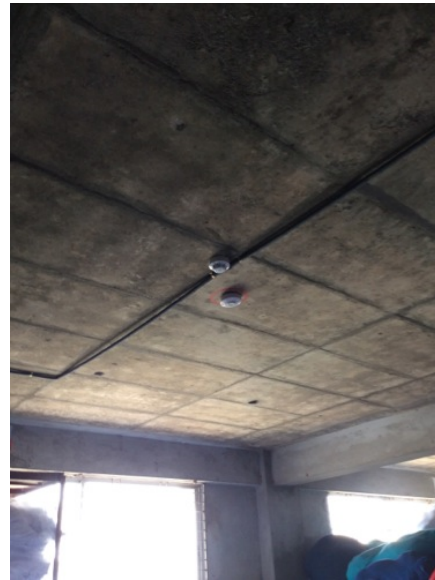
| F-13 | Fire Protection | Remove single-station smoke alarms. Provide automatic smoke detection throughout the building in accordance with NFPA 72. | Replace the single-station smoke alarms with automatic smoke detectors tied into the fire alarm system. | Within 6 months |

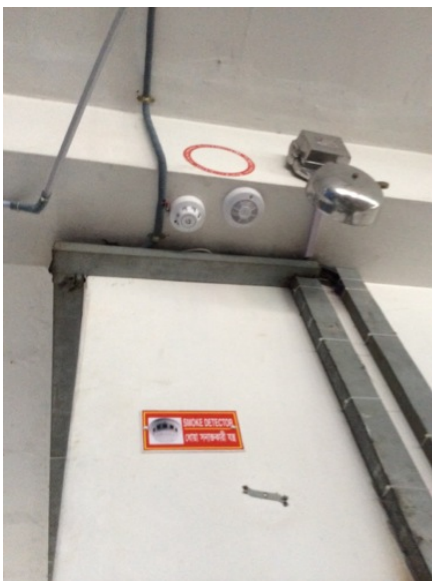
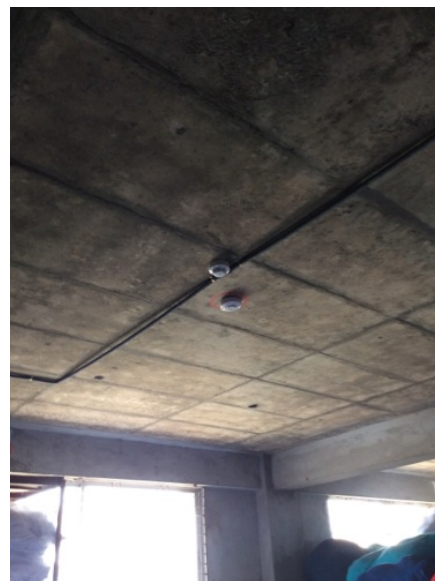
| F-14 | Fire Protection | It was observed during inspection that the factory is in progress of installing a smoke alarm system tied to the fire alarm system, however, the work is in progress and is not yet operational. | To complete the on going works on smoke alarm system to be tied to the fire alarm system | Within 6 months |
