# **FIRE SAFETY INSPECTION REPORT**

**Geebee (Bangladesh) Limited - Extended Unit**

**ACCORD ID: 23257**

**Date: 8th November, 2018**

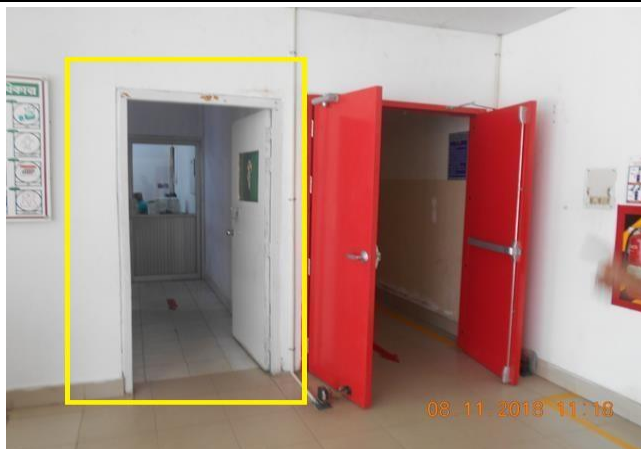
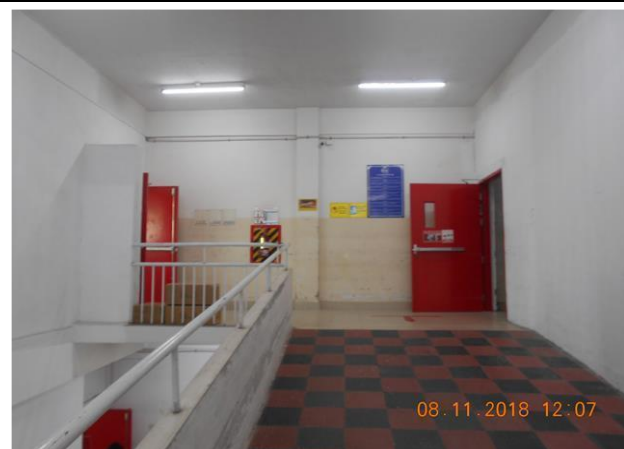
| Sl No. | Category | Findings | Required Action | Remediation Time Frame |
|---|---|---|---|---|
| 1 | Fire Rated Construction | The exit stairs are not separated from work areas and other spaces on each floor by fire rated construction. | Provide minimum 1.5-hr fire rated doors and seal all unprotected openings to separate the exit stairs from work areas and other building spaces on all floor levels.<br>If fire rated doors are required to be held open for functional reasons, provide automatic closing devices tied to the fire alarm system. | Within 3 months |

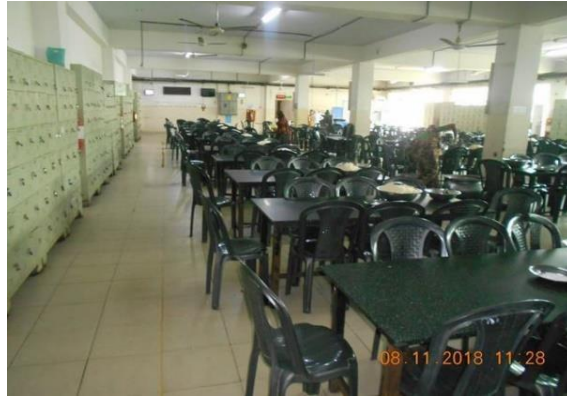
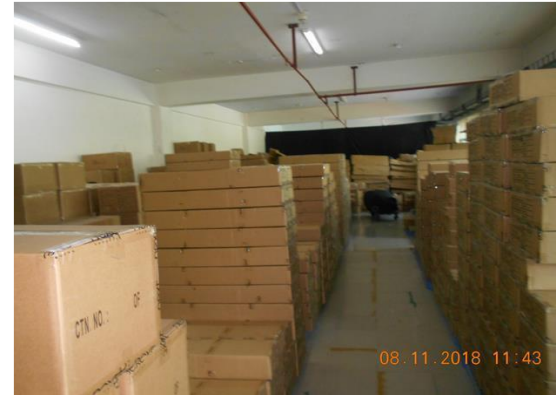
| 2 | Fire Rated Construction | Finished goods and dining areas is not separated by fire-rated construction (openings, non-rated doors, penetrations).<br>Location: On 1st floor. | Separate the storage and dining areas by a minimum 2-hr fire-rated construction. Separate dining room shall have at least two direct access to exit stair/out side of the building. Seal and/or protect all openings to maintain the required fire separations | Within 3 months |

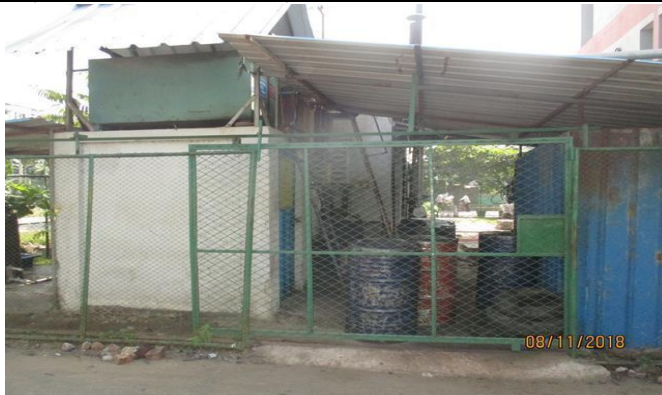
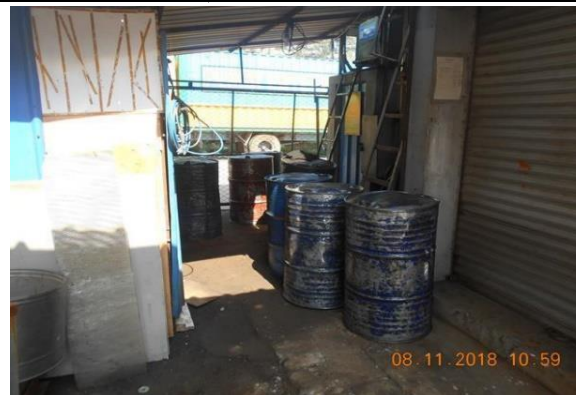
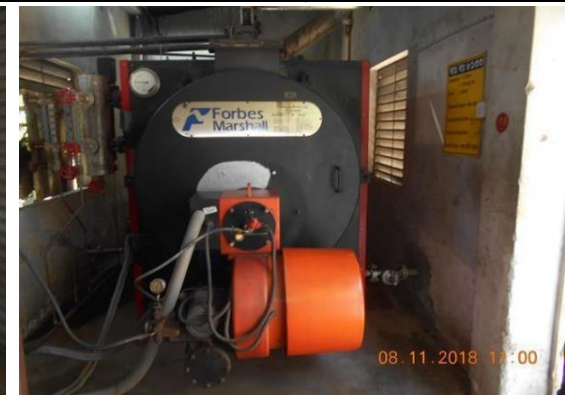
| 3 | Fire Rated Construction | Diesel fuel storage is located beside the boiler shed on the ground floor. | <p>Remove all diesel fuel storage from the boiler/generator room areas and relocate to the exterior such that the diesel fuel storage is at least 10 ft from required egress paths.</p> <p>If located along egress paths or in a utility building, separate the diesel fuel storage with 2- hr fire rated construction. There shall be no diesel fuel storage in a factory production building.</p> | Within 3 months |

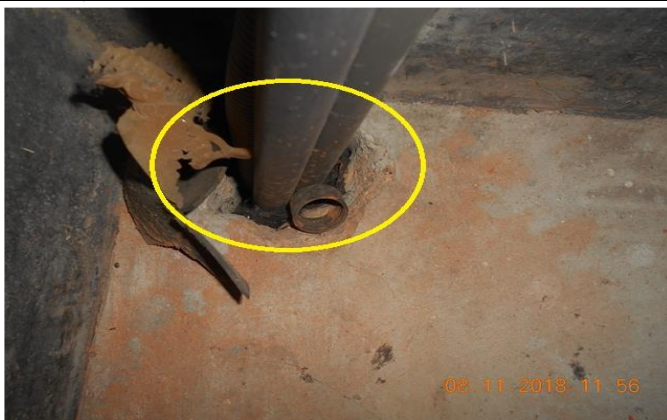
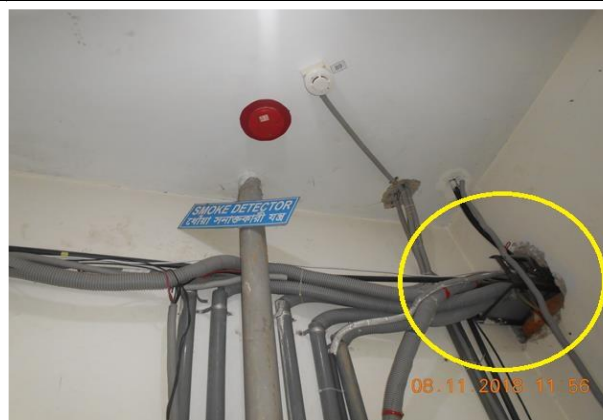
| 4 | Fire Rated Construction | Unsealed penetrations and openings are located in the fire rated floor/ceiling assemblies.<br>Location: Electrical riser penetration on all floors. | Provide a minimum 2-hr fire rated shaft to separate the utility risers from each floor level and seal all penetrations in floor/ceiling assemblies to maintain the fire separation. | Within 3 months |

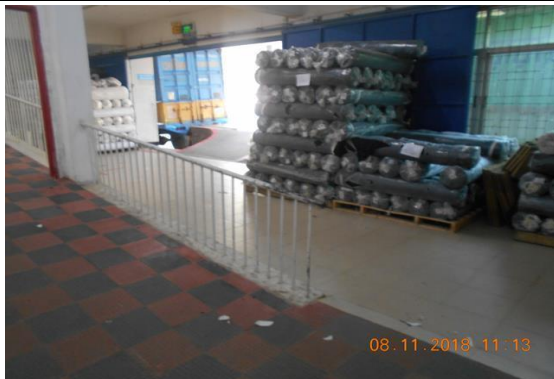
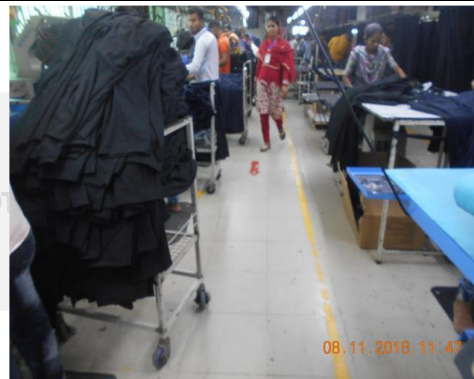
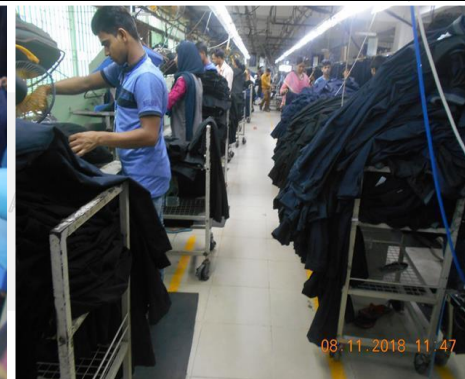
| 6 | Egress | Storage was located in the egress path. Location: Discharge path of ramp and finishing section on 1st floor. | Remove all storage materials from the exit stairs and egress path. Means of egress shall be maintained continuously free and clear of all obstructions/storage. | Immediate |

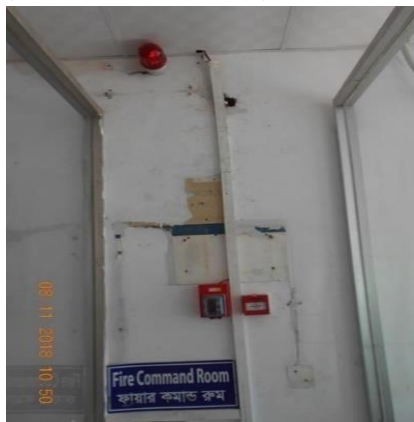
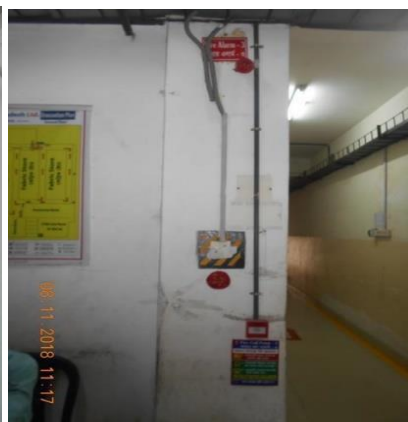
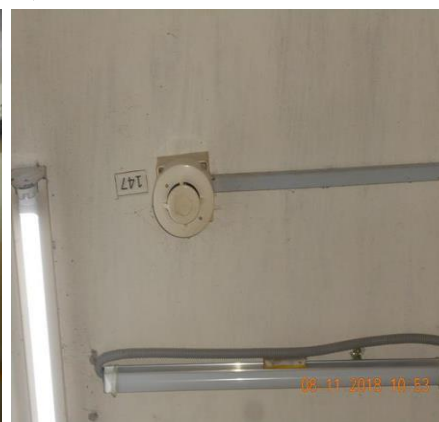
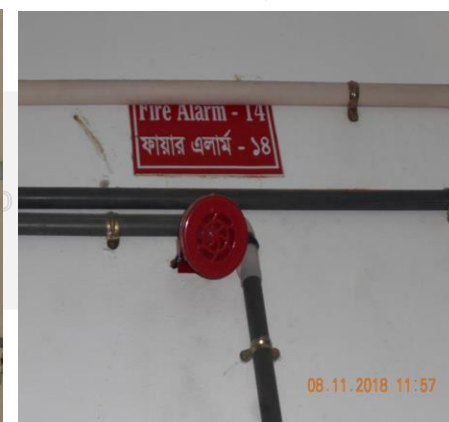
| 8 | Fire Detection and Alarm System | The fire alarm and detection system is antiquated, not a listed system, and does not provide alarm and notification features consistent with acceptable standards. | Replace the fire alarm and detection system with a new, listed addressable fire alarm and detection system in accordance with NFPA 72. | Design within 4 months, Install within 9 months |

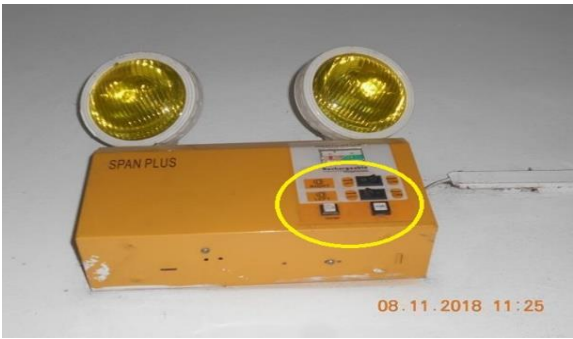
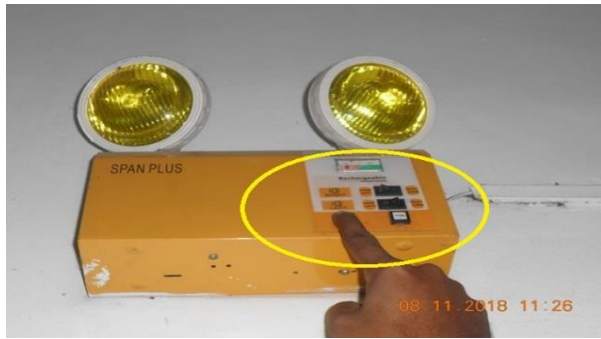
| 12 | Emergency Lighting | Manual on-off switch is provided for emergency lighting/exit signage units. | Remove manual on/off switches from emergency lighting /exit signage units to prevent them from being switched off. | Within 1 month |

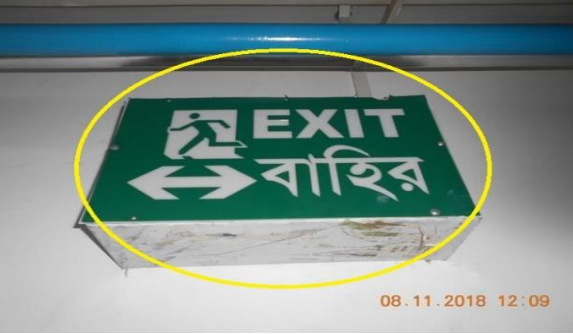
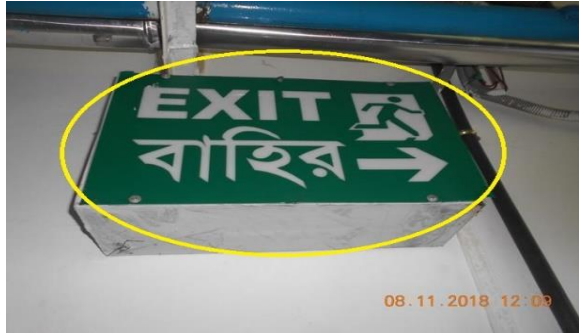
| 13 | Emergency Lighting | Emergency power is not provided/connected with some directional exit signs on the production floor. | Provide emergency power connection with the directional exit signs. | Within 1 month |
