# FIRE SAFETY INSPECTION REPORT

## Kaizer Knitwears Ltd.

ACCORD ID: 12389

Date: 21 May 2018

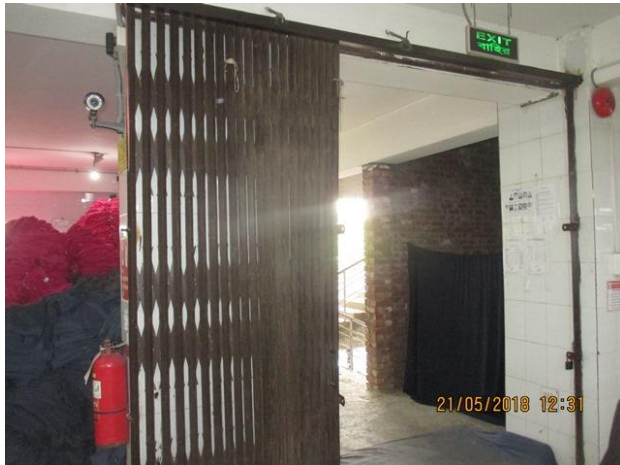
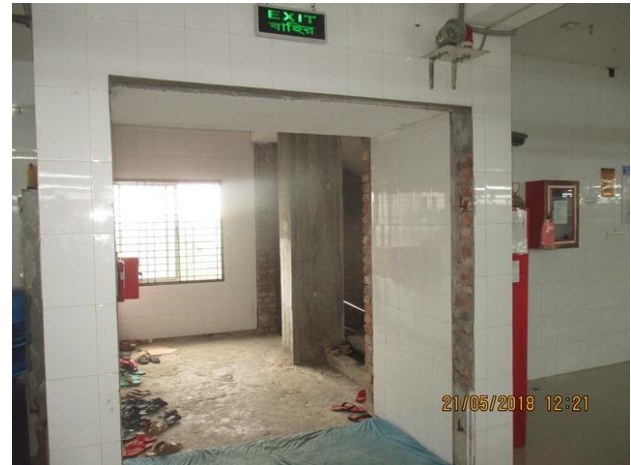
| No. | Category | Finding | Recommendation | Remediation<br>Timeframe |
|---|---|---|---|---|
| F-1 | Fire Rated<br>Construction | Exit stairs are not separated from work areas & other spaces on each floor by fire-rated construction due to unprotected openings and penetrations. | <p>Separate the exit stairs from work areas and other building spaces on all floor levels by minimum 2- hr fire-rated construction. Provide minimum 1.5- hr fire rated doors and seal all unprotected openings and penetrations to maintain the fire separation.</p> <p>Ensure that all fire doors are self-closing and positive latching, and are provided with fire exit (panic) hardware where serving production floors or assembly occupancies.</p> <p>If fire doors are required to be held open for functional reasons, provide automatic-closing devices tied to the fire alarm system.</p> <p>Once fire doors are installed, every door in a stair enclosure serving more than 5 stories shall be provided with re-entry unless it meets ACCORD standard 6.8.3.1.</p> | Within 3 months |

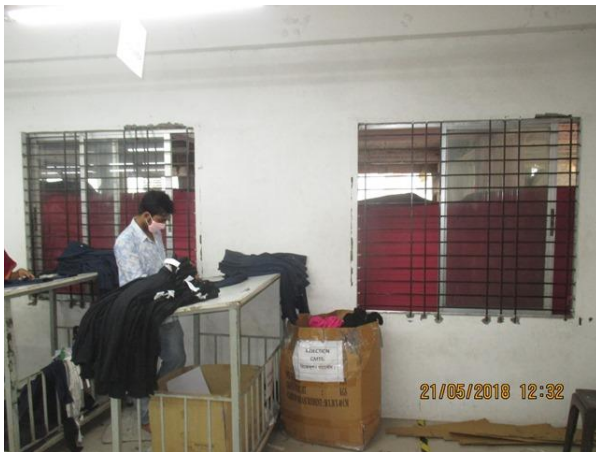
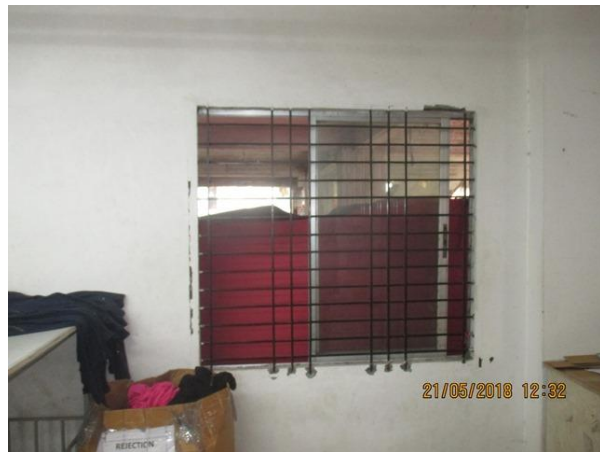
| F-3 | Fire Rated Construction | Temporary storage area on Part-B is not properly separated from Part-A by a minimum 1-hr fire-rated construction. | Provide dedicated storage rooms separated by minimum 1-hr fire-rated construction. Seal all openings to maintain the required fire separation. | Within 3 months |

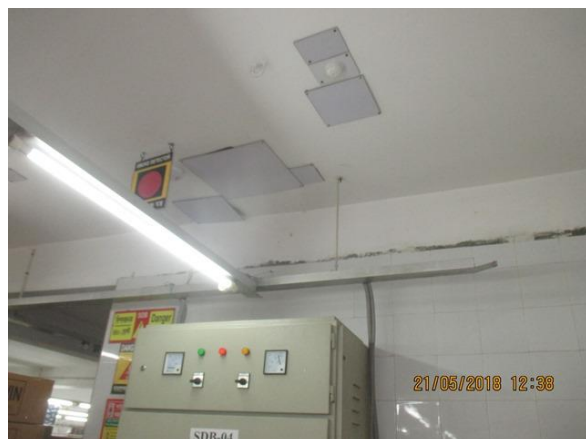
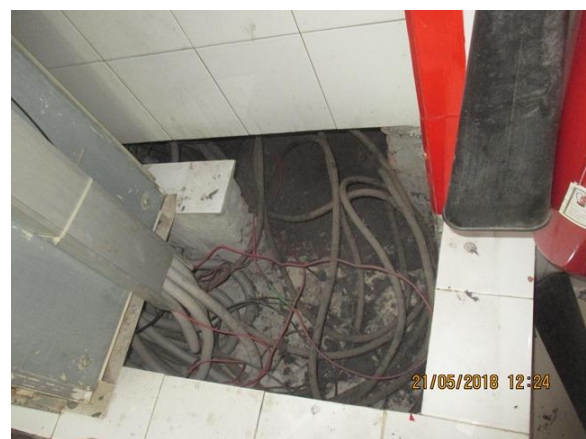
| F-4 | Fire Rated Construction | Unsealed electrical shaft is located in the fire-rated floor/ceiling assemblies. | Provide a minimum 2-hr fire-rated shaft to separate the utility risers from each floor level and seal all penetrations in floor/ceiling assemblies to maintain the fire separation. | Within 3 months |

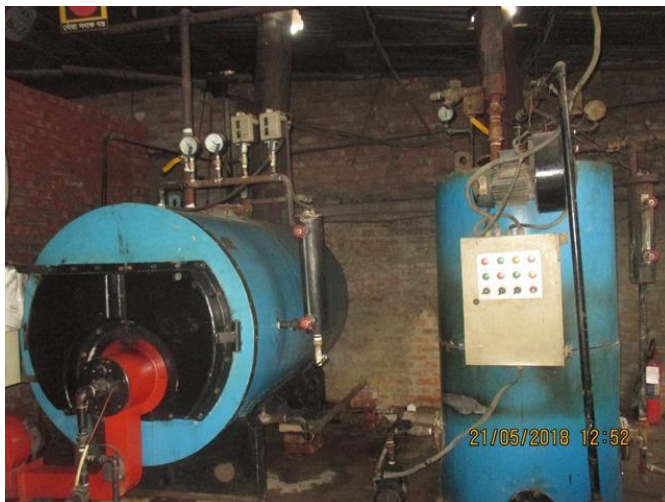
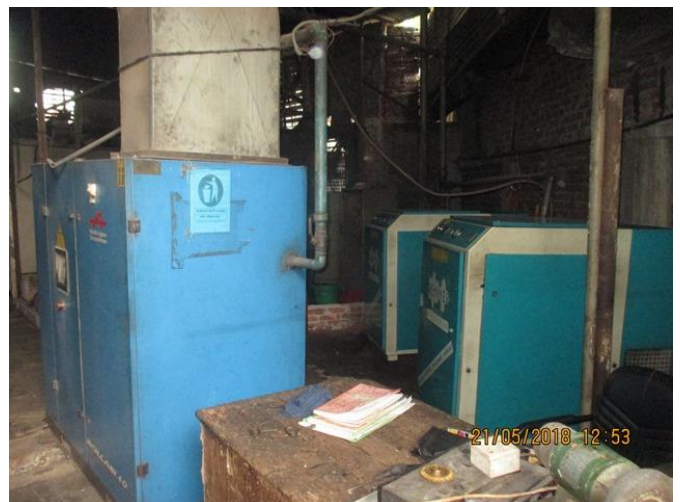
| F-5 | Fire Rated Construction | The boiler, generator and compressor is not separated by fire-rated construction from each other and from wastage storage at the ancillary shed. | Separate the boiler, generator and compressor room by a minimum 2-hr fire-rated construction for high rise, Seal and/or protect all openings to maintain the required fire separations. Provide proper ventilation and consult a qualified engineer. | Within 3 months |

| If applicable: When located to the exterior of a building, separate those rooms by a minimum distance of 3m (10 ft). | | | | |

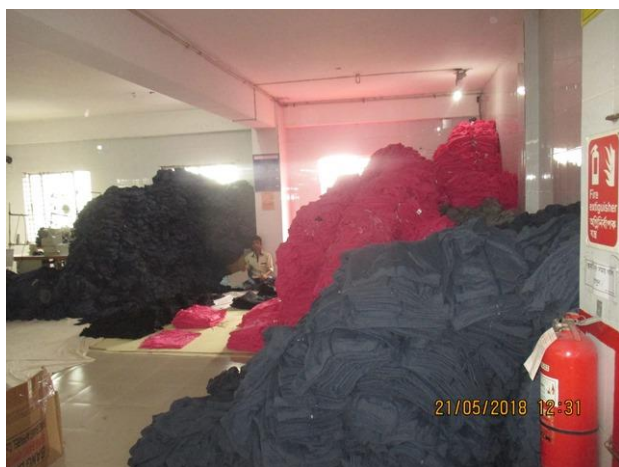
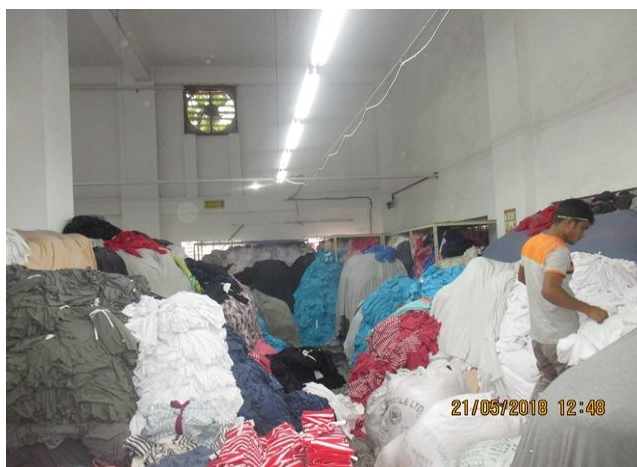
| F-6 | Fire Rated Construction | Areas on the ground and 1 <sup>st</sup> floor used for combustible storage open to the factory are not properly defined and/or not within limits. | <p>Provide defined storage areas and limit the storage arrangement as follows:</p> <p>Maximum height of 2.45m (8 ft) and maximum area of 23 m<sup>2</sup> (250 ft<sup>2</sup>).</p> <p>If sprinkler protected: maximum height of 3.66m (12 ft) and maximum area of 93m<sup>2</sup> (1000 ft<sup>2</sup>).</p> <p>Separate the areas of unenclosed combustible storage by a minimum clear distance of 3 m (10 ft).</p> | Within 3 months |

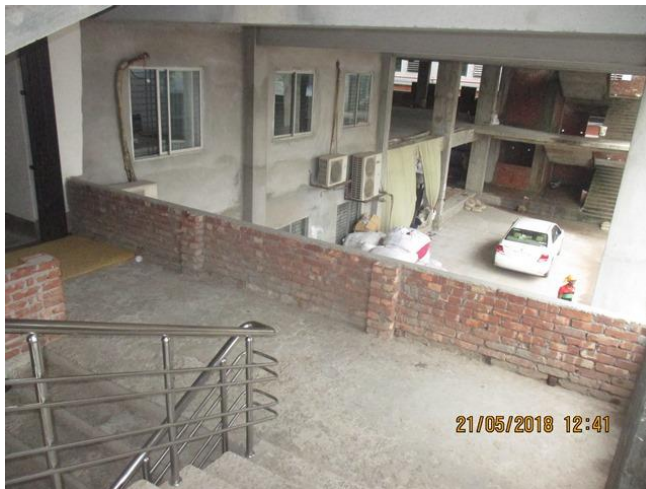
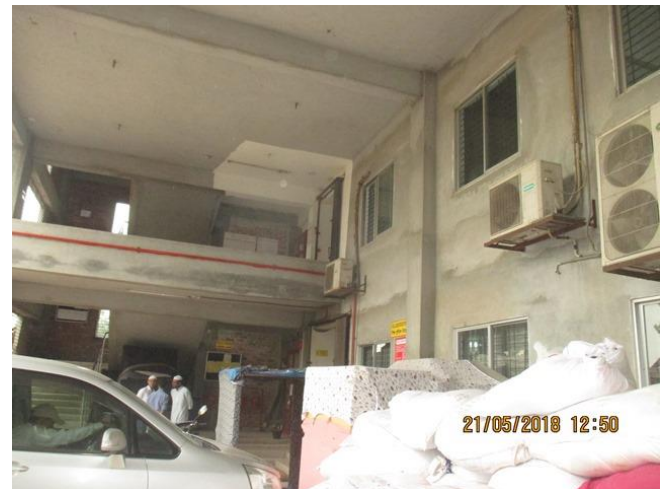
| F-7 | Fire Rated Construction | South-west exit stair discharge lobby is not protected from ground and mezzanine floor. | Seal all penetrations and openings in exit stair discharge lobby to maintain the required fire separation of the means of egress and stair discharge path. | Within 3 months |

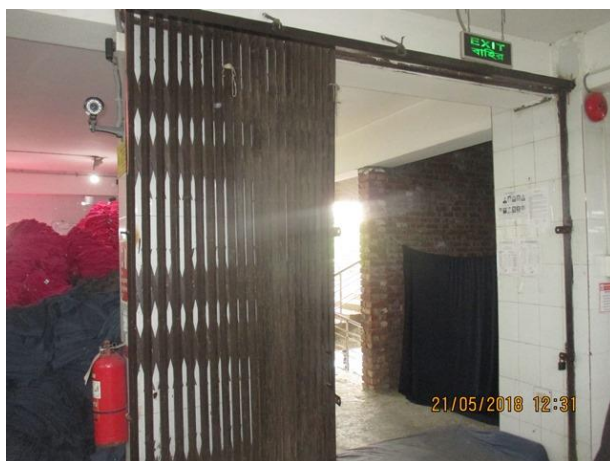
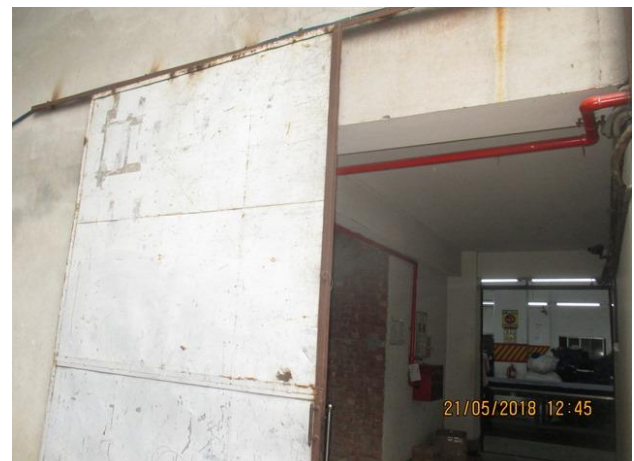
| F-8 | Egress | Collapsible gates, sliding doors and roll down shutter type doors are provided at the building exits, exit stairs, along egress routes and exit discharge. | Replace all gates, sliding Doors and rolling shutters along the means of egress with side-hinged, swinging egress doors.<br><br>If locks are required for security reasons, utilize special door locking features complying with NFPA 101. | Within 1 month |

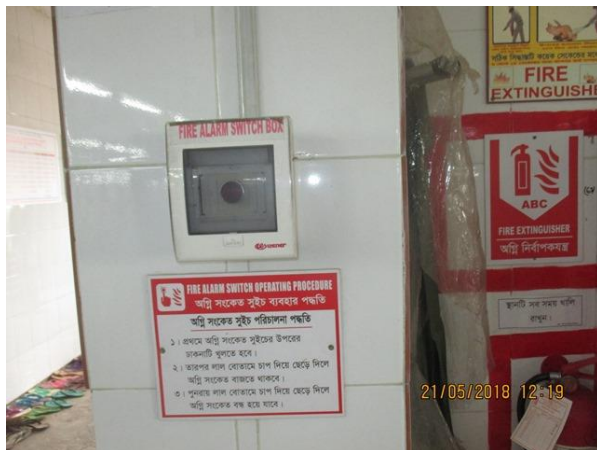
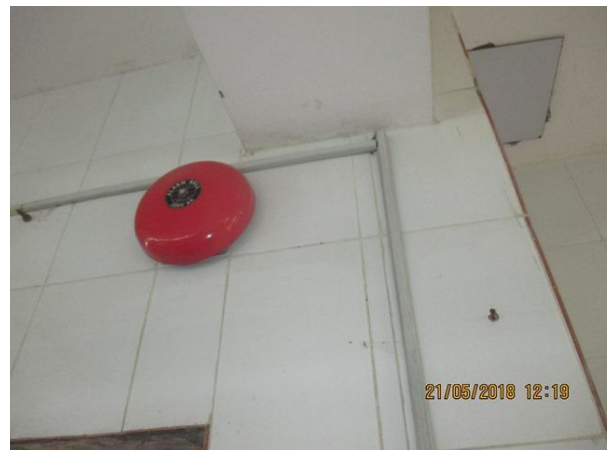
| F-9 | Fire Protection | The fire detection and alarm system is antiquated, not a listed system and does not provide alarm and notification features consistent with acceptable standards. | Replace the fire detection and alarm system with a new, listed addressable fire detection and alarm system in accordance with NFPA 72 and ACCORD standards. | Design within 3 months<br>Install within 9 months |

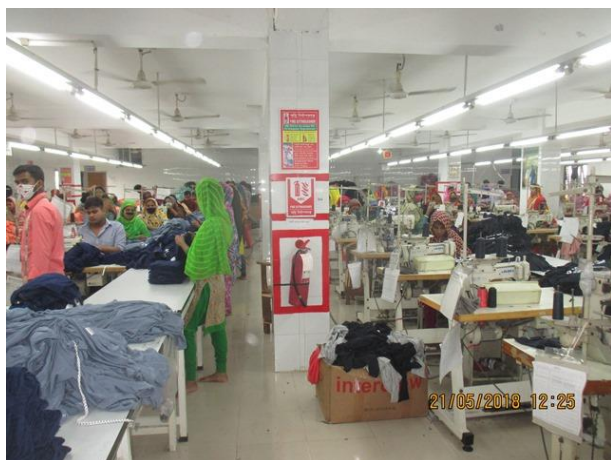
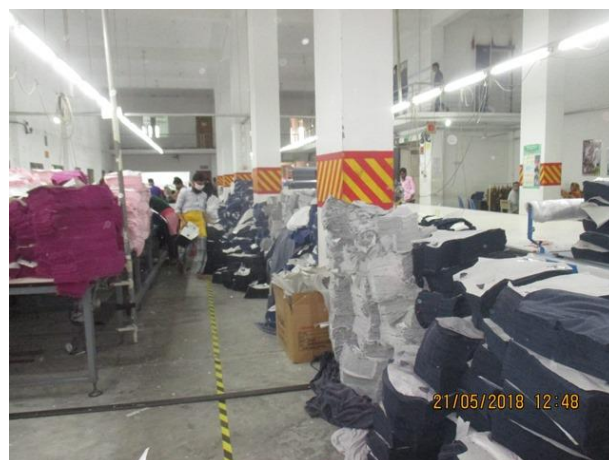
| F-14 | Egress | The width of egress aisles is less than 36-in.<br><br>At all floors. | Provided egress aisles with a minimum unobstructed clear-width of 0.9 m (36 in.). | Within 3 months |

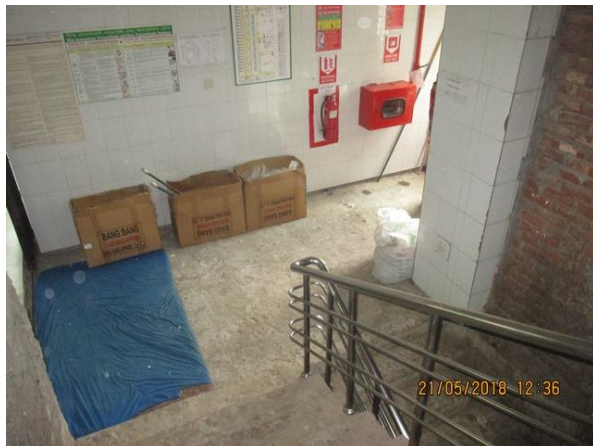
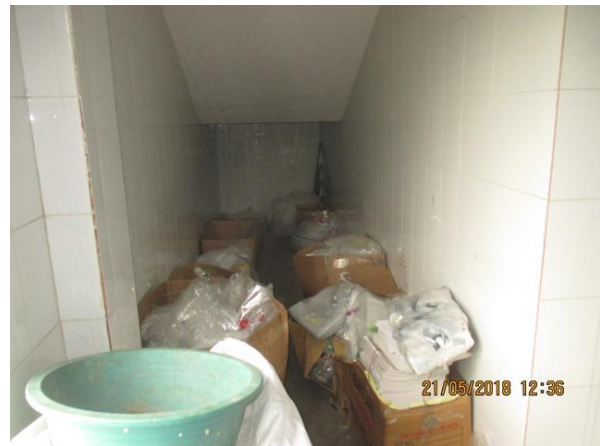
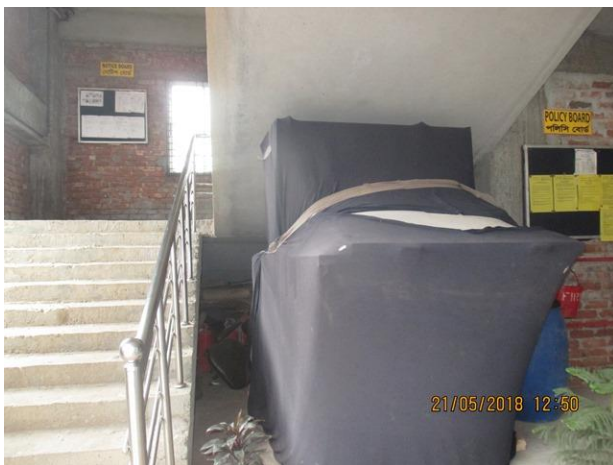
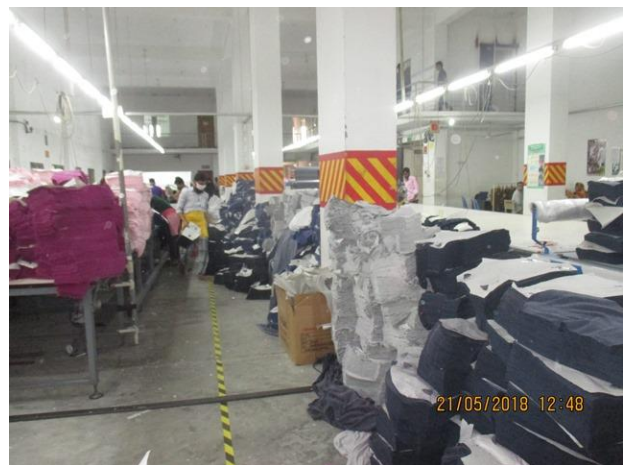
| F-21 | Egress | Storage was located in the exit stairs, aisles and means of egress at different floors. | Remove all storage from exit stairs, aisles and all means of egress. | Immediately |

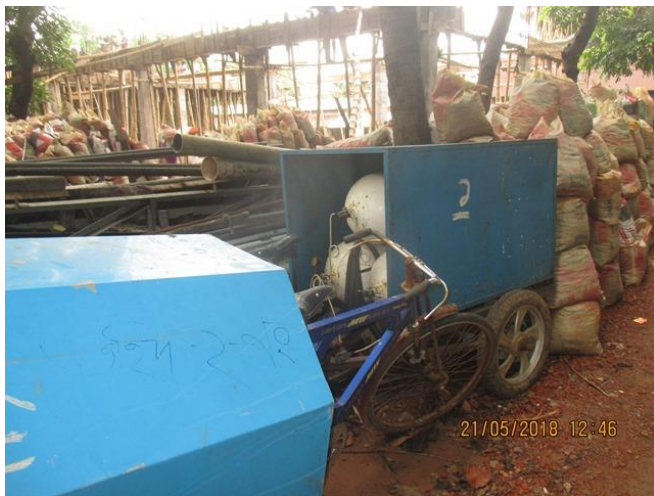
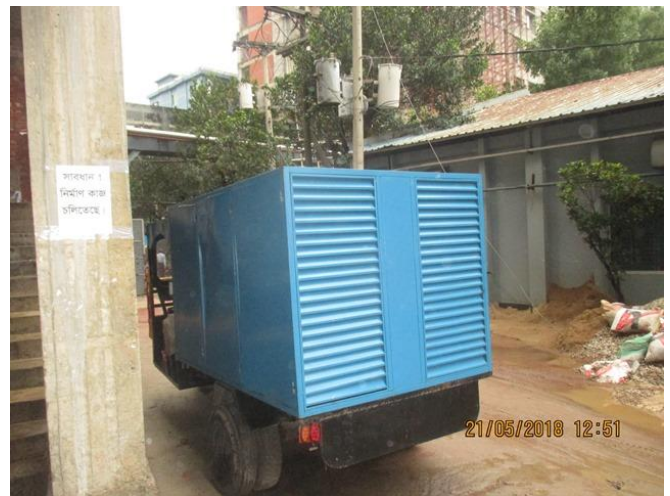
| F-23 | Fire Rated Construction | Liquefied or compressed gas cylinders are located within the factory. | The storage or use of liquefied or compressed flammable gas cylinders shall be prohibited within the factory building. | Immediately |

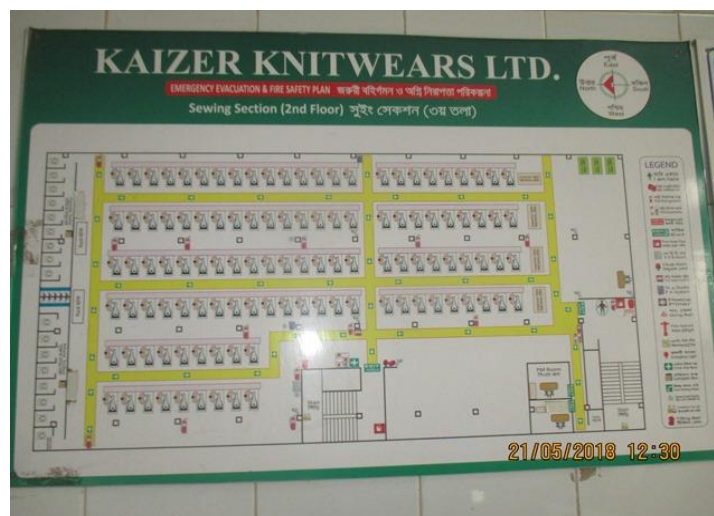
F-24 Egress

Exits are not remotely located from each other such that a single fire event could compromise both exits.

Modify exit arrangement to meet ACCORD standard section 6.6.6.

Provide additional exit(s) to meet ACCORD standard section 6.6.6.

Provide sprinkler protection in accordance with NFPA 13 to meet ACCORD standard section 6.6.6.
