# **FIRE SAFETY INSPECTION REPORT**

**SHARMIN FASHIONS LIMITED**  
**EAST NARASHINGHAPUR, ZIRABO, ASHULIA, SAVAR**

**ACCORD**  
on Fire and Building Safety in Bangladesh

April 23, 2014

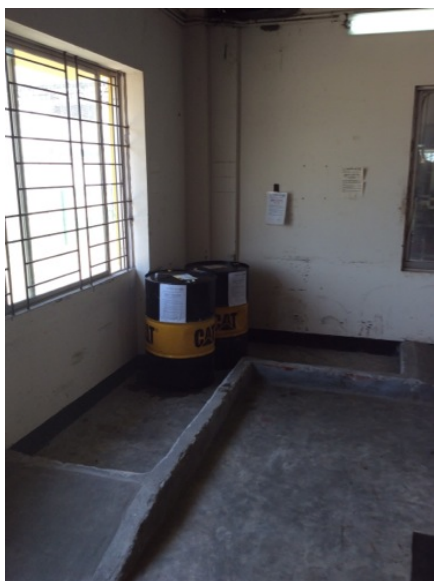
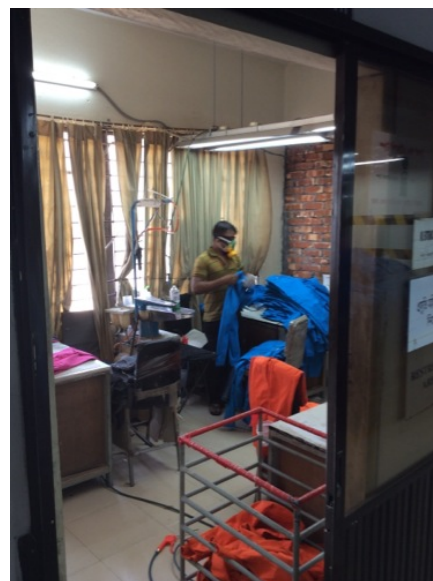
No.	Category	Finding	Recommendation	Remediation Timeframe
F-1	Fire Rated Construction	Hazardous materials / flammable liquid storage areas are not separated by fire-rated construction (openings, non-rated doors, penetrations).  Locations: -55 gallon drums of diesel fuel located adjacent to generators. -Possible hazardous area on First floor where masked personnel was spraying unknown substance in an unsealed, non-ventilated area.	Separate the hazardous materials / flammable liquid storage room by a minimum 2-hr fire-rated construction. Seal and/or protected all openings to maintain the required fire separations.	Within 3 months

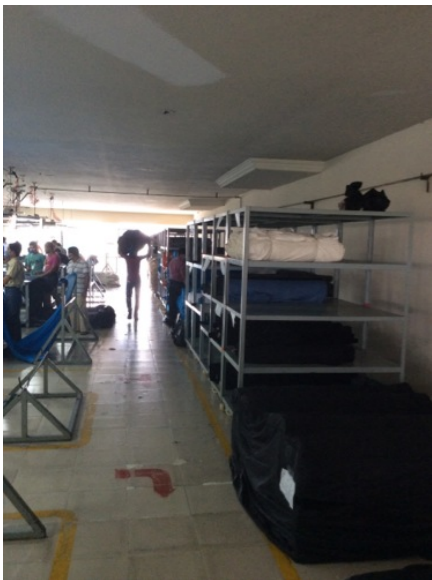
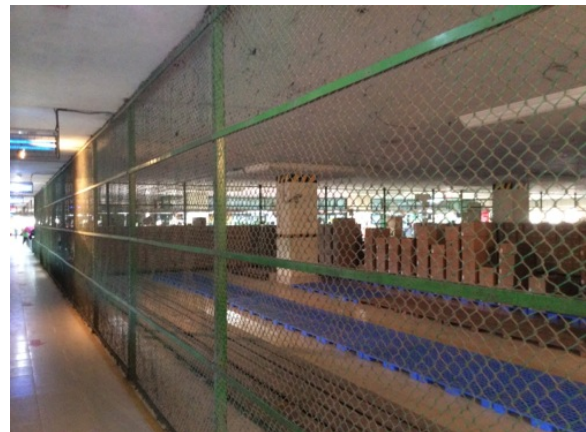
F-2	Fire Rated Construction	<p>Areas used for combustible storage are not separated by fire-rated construction.</p> <p>Locations:</p> <ul style="list-style-type: none"><li>-Storage areas on the First floor had gated doors and security mesh for separation which does not create a fire barrier.</li><li>-General storage on multiple floors was open to production areas.</li></ul>	<p>Provide dedicated storage rooms separated by minimum 1-hr fire-rated construction.</p> <p>Where separate storage rooms are not feasible, provide defined storage areas and limit the storage arrangement as follows:</p> <ul style="list-style-type: none"><li>- Maximum height of 2.4m and maximum area of 23m<sup>2</sup></li><li>- If sprinkler protected: maximum height of 3.66m and maximum area of 93m<sup>2</sup></li></ul> <p>Separate areas of unenclosed combustible storage by a minimum clear distance of 3m.</p>	Within 3 months

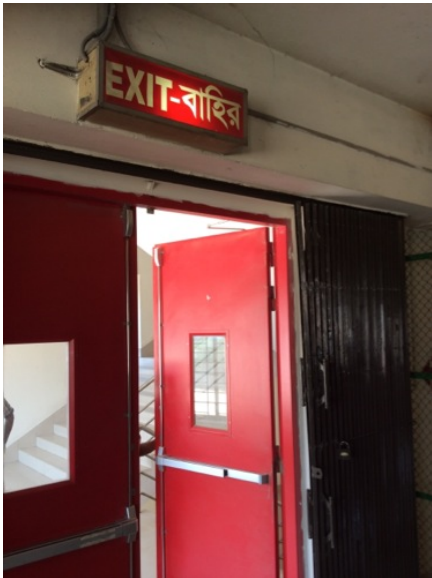
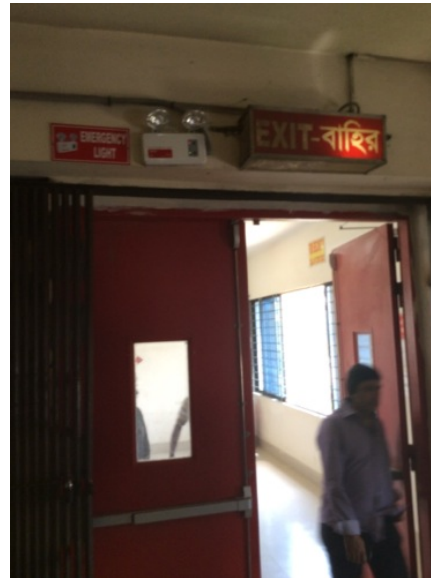
F-3	Fire Rated Construction	<p>The exit stairs are not separated from work areas and other spaces on each floor by fire-rated construction.</p> <p>At the time of the inspection, it appeared that the doors to the exit stairs were possible fire-rated doors; however, it was unclear whether or not these doors were listed assemblies. A test report was provided by factory personnel; however, it is not evident that the tests were conducted by an approved listing agency.</p>	<p>Provide minimum 1.5-hr fire rated doors and seal all unprotected openings to separate the exit stairs from work areas and other building spaces on all floor levels.</p> <p>Ensure that the fire doors are self-closing and positive latching and that they are provided with fire exit (panic) hardware where serving production floors.</p> <p>If fire doors are required to be held open for functional reasons, provide automatic-closing devices tied to the fire alarm system.</p>	Within 3 months

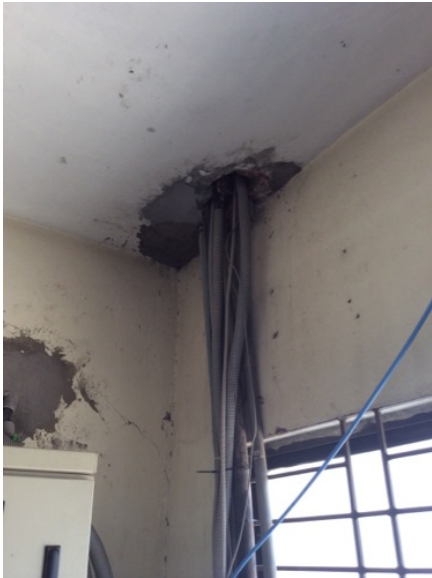
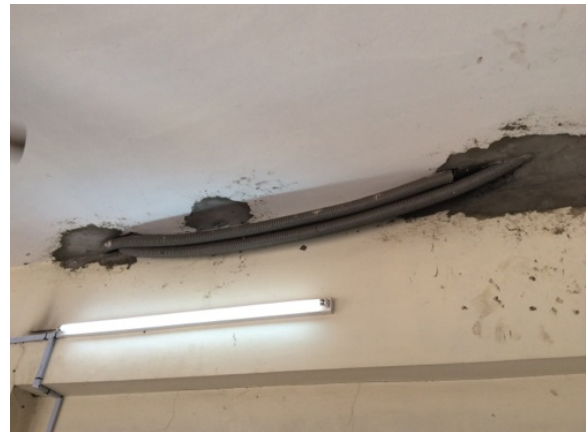
F-4	Fire Rated Construction	Unsealed penetrations and openings are located in the fire-rated wall and ceiling assemblies.	Provide a minimum 2-hr fire-rated shaft to separate the utility risers from each floor level.  Seal all penetrations and openings in wall and ceiling assemblies to maintain the fire separation.	Within 3 months
-----	-------------------------	---	---	-----------------

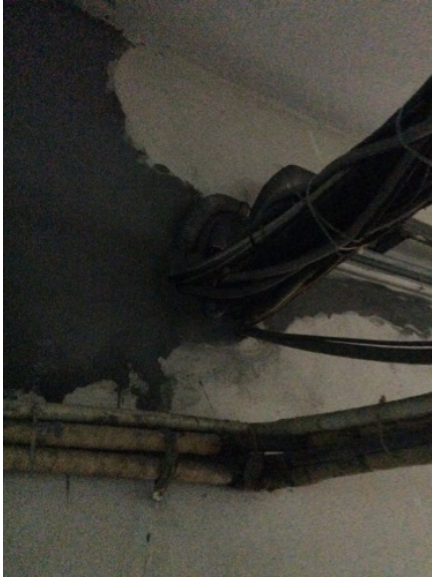
F-5	Fire Rated Construction	Unsealed penetrations and openings are located in exit stair enclosures.	Seal all penetrations and openings in exit stair enclosure walls to maintain the fire separation.	Within 3 months
-----	-------------------------	--	---	-----------------

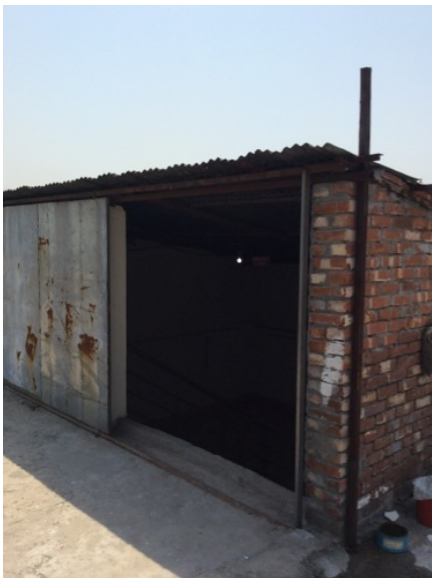
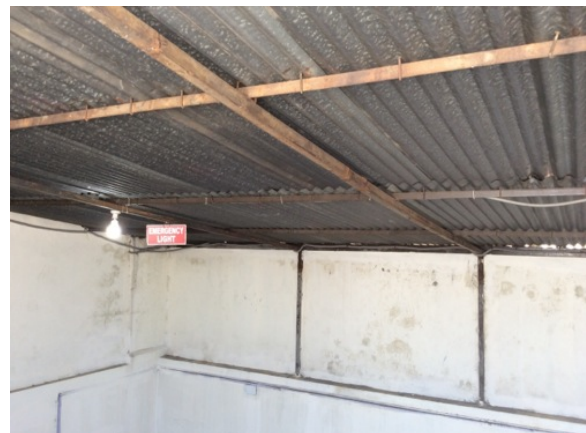
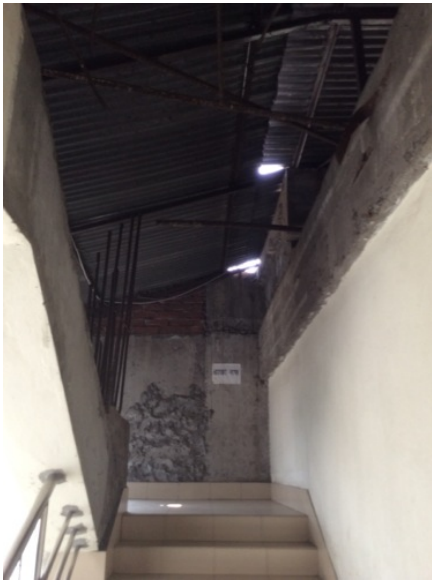
F-6	Fire Rated Construction	Corrugated metal roofing is used to cover the exit stairs at the Roof level, which does not constitute the classification of fire-rated construction for the stairs.	Enclose the stairs with a minimum 2-hr fire-rated construction.	Within 3 months
-----	-------------------------	--	---	-----------------

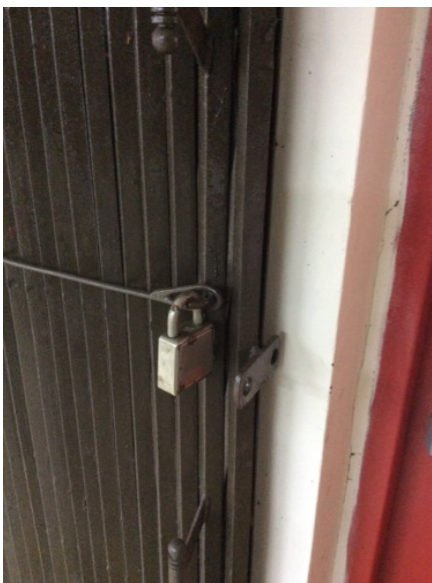
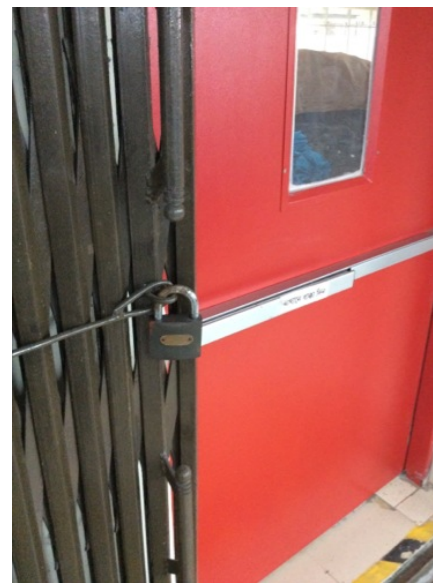
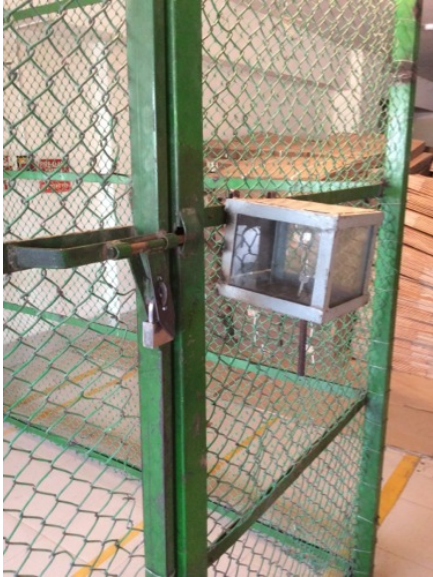
F-7	Egress	Egress doors / gates with locking features are provided at building exits, exit stairs, along egress routes, and exit discharge.  Locations: All floors.	Remove locking features from all egress doors / gates.  If locks are required for security reasons, utilize special door locking features complying with NFPA 101.	Immediate
-----	--------	---	--	-----------

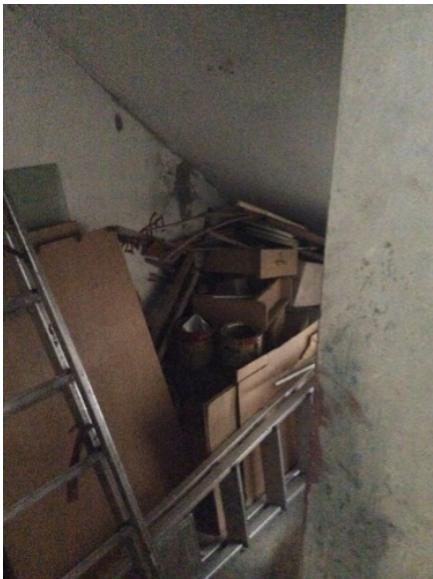
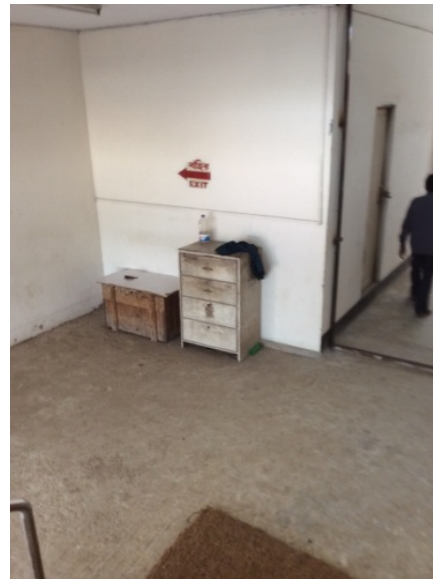
F-8 Egress

Storage was located in the exit stair.

Locations:  
Various exit stair landings.

Remove all storage from exit stairs and egress paths.

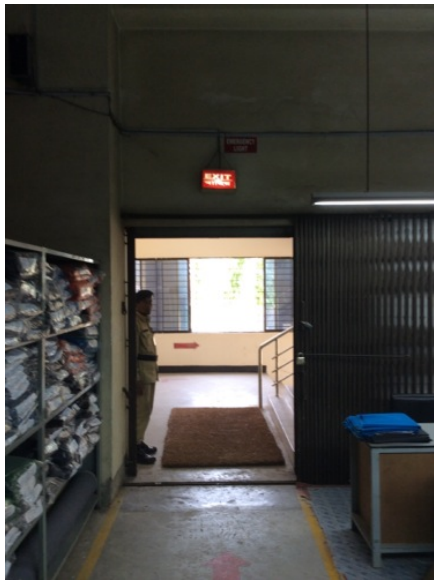
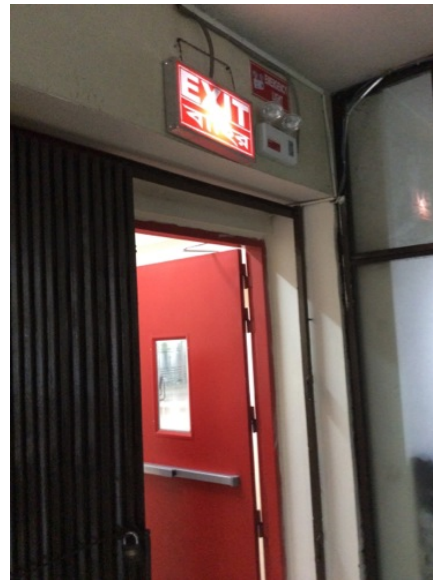
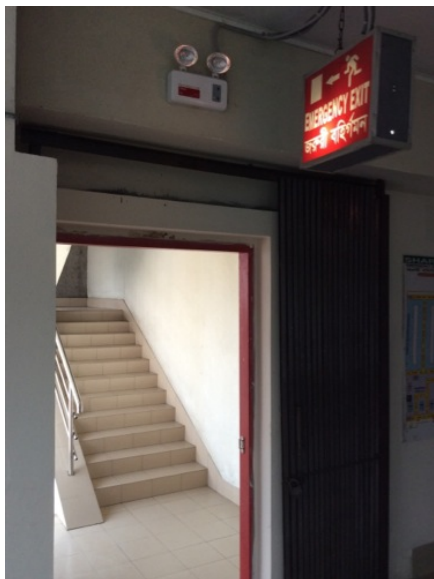
F-9	Egress	<p>Collapsible gates and sliding doors are provided at building exits, exit stairs, along egress routes, and exit discharge.</p> <p>Locations: Collapsible gates and sliding doors on all floors.</p>	<p>Replace all gates / sliding doors along the means of egress with side-hinged, swinging egress doors.</p> <p>If locks are required for security reasons, utilize special door locking features complying with NFPA 101.</p>	Within 1 month
-----	--------	---	---	----------------

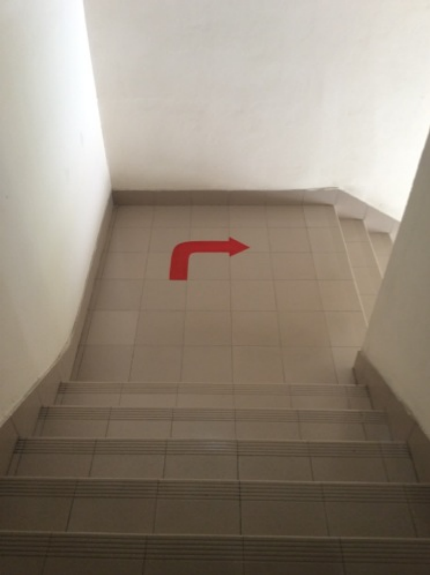
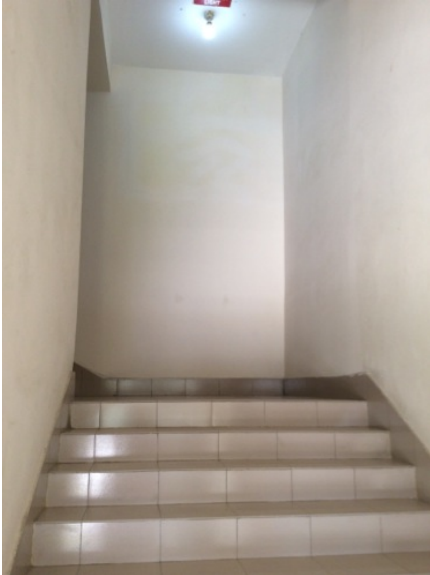
F-10	Egress	Current travel distances are excessive on the Ground floor since what appears to be a horizontal exit does not have adequate separation.	Provide adequate separation and opening protectives for horizontal exits in compliance with the requirements of BNBC Part 4, Section 3.12. In addition, upgrade the fire alarm, detection, and firefighting systems per the applicable findings elsewhere in this report.	Within 3 months	
F-11	Egress	Handrails are not provided in the exit stair.  Location: East exit stair (Stair 07).	Provide handrails on both sides of exit stair.	Within 3 months

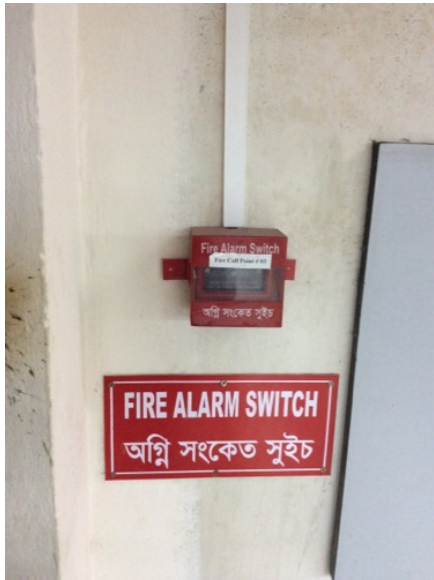
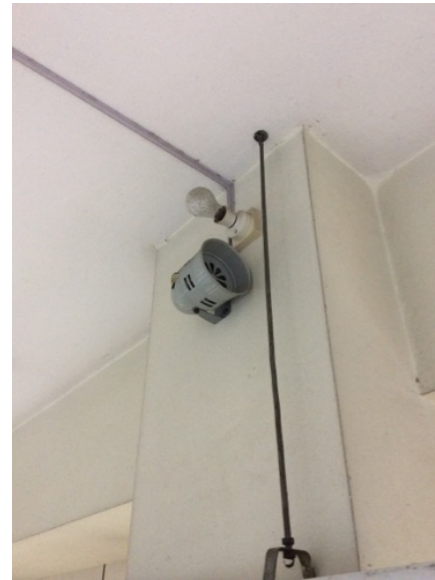
F-12	Fire Protection	The fire alarm system is antiquated, not a listed system, and does not provide alarm and notification features consistent with acceptable standards.	Replace the fire alarm system with a new, listed addressable fire alarm system in accordance with NFPA 72.	Design within 4 months, install within 9 months

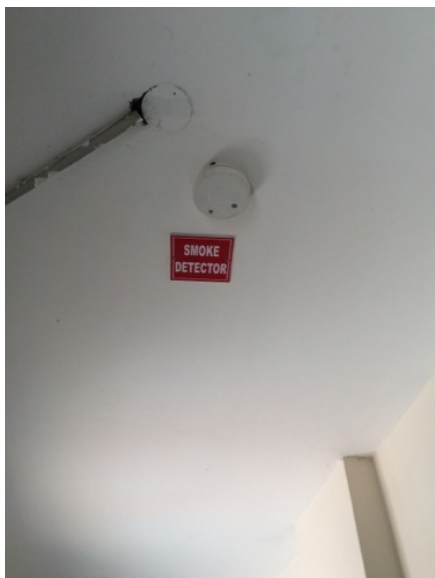
F-13	Fire Protection	Inspection, testing, and maintenance for the fire alarm system was not in accordance with NFPA 72.	Inspect, test and maintain the fire alarm system, and keep written records on-site, in accordance with NFPA 72.	Within 3 months
F-14	Fire Protection	The building is equipped with single-station smoke alarms. Smoke alarm activation sounds only a local alarm and does not provide automatic fire alarm notification of occupants.	Replace the single-station smoke alarms with automatic smoke detectors tied into the fire alarm system. Configure the fire alarm system to initiate occupant notification upon activation of any two smoke detectors in addition to the manual fire alarm stations.	Within 6 months

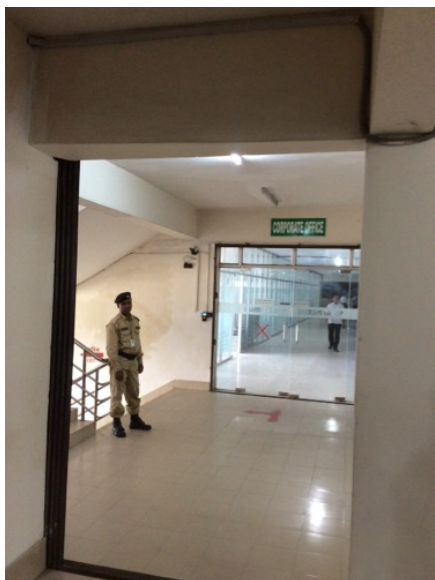
F-15	Egress Lighting	Exit sign not provided at exit.  Location: Southeast exit stair (Stair 01) on Fourth floor.	Provide exit signs above all exits to the exterior and all doors to the exit stairs.	Within 1 month
------	-----------------	--	--	----------------

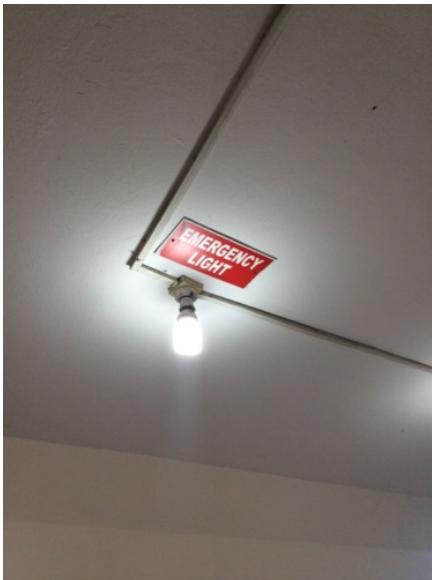
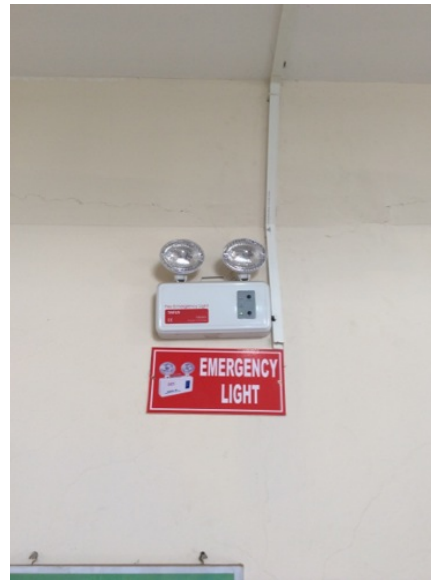
F-16	Egress Lighting	Based on the number and location of emergency lights observed, adequate illumination levels are not anticipated along egress routes.	Test the emergency lighting system on each floor and provide additional emergency fixtures to provide adequate illumination along the means of egress. Provide a minimum illumination of 10 lux at the floor level within exit stairs and exit discharge paths and minimum 2.5 lux along exit access aisles.	Within 3 months
		Locations: All areas.

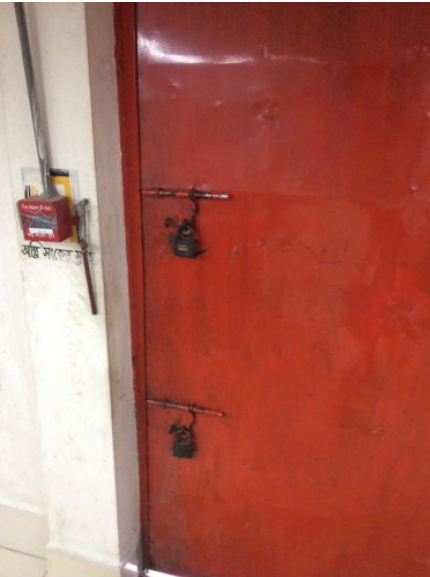
No.	Category	Finding	Recommendation	Remediation Timeframe					
F-1	Egress	Egress doors with locking features are provided at building exits and exit discharge.	Remove locking features from all egress doors.  If locks are required for security reasons, utilize special door locking features complying with NFPA 101.	Immediate

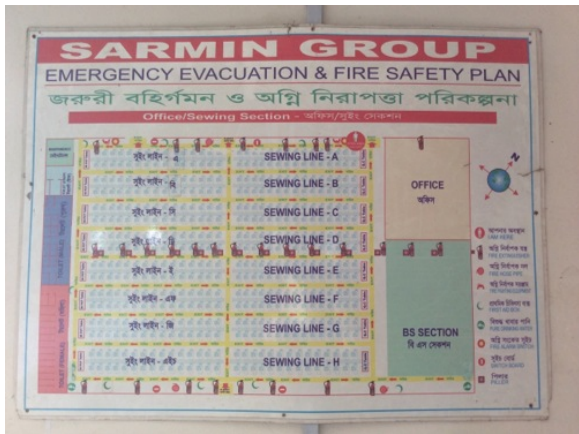
F-2	Egress	Evacuation plan does not indicate use of two adequate exits with exit signs.	Update evacuation plans to indicate relevant exits and to provide adequate exit knowledge.	Within 1 month
F-2	Egress	Evacuation plan does not indicate use of two adequate exits with exit signs.	Update evacuation plans to indicate relevant exits and to provide adequate exit knowledge.	Within 1 month

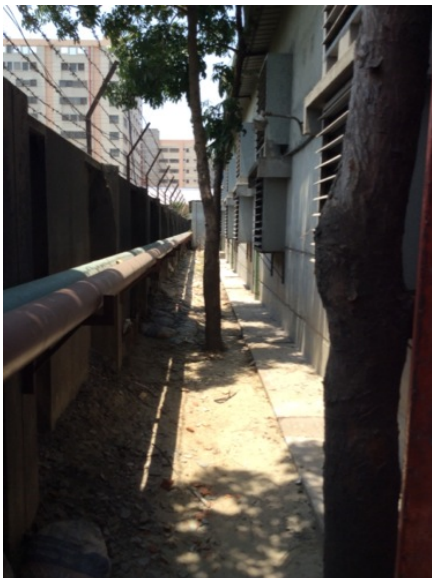
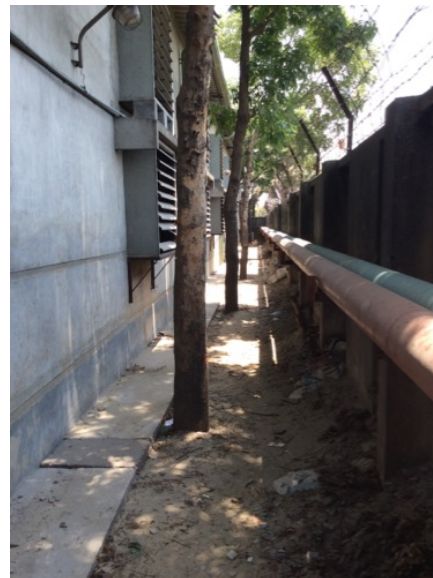
F-3 Egress

Exit discharge path from south exit is an uncovered egress court less than 10 feet wide.

Provide minimum 1-hr fire-rated factory exterior wall up to 10ft above grade.

Seal and/or protect all openings to maintain the required fire separations.

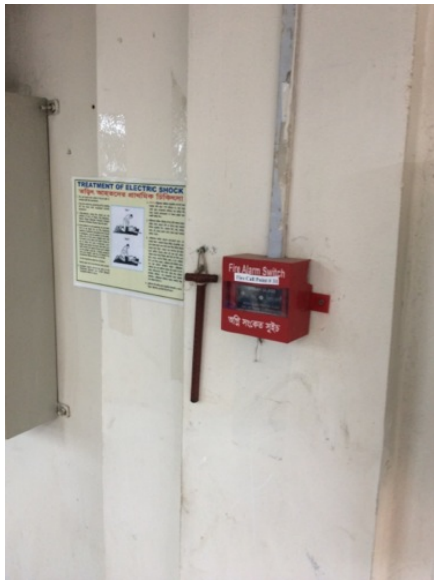
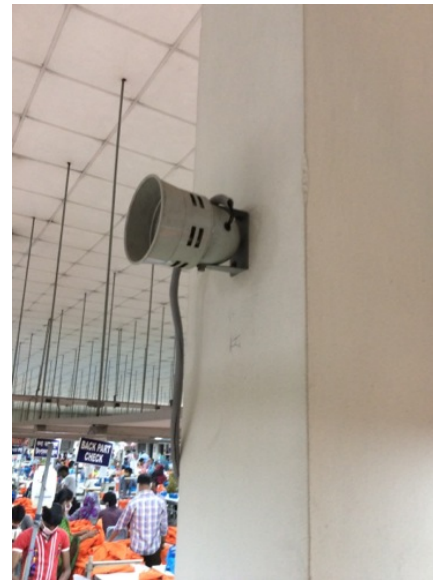
F-4	Fire Protection	The fire alarm system is antiquated, not a listed system, and does not provide alarm and notification features consistent with acceptable standards.	Replace the fire alarm system with a new, listed addressable fire alarm system in accordance with NFPA 72.	Design within 4 months, install within 9 months
-----	-----------------	--	--	---

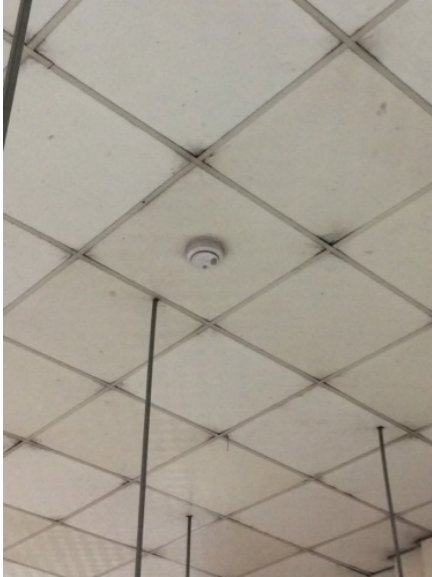
F-6	Fire Protection	The building is equipped with single-station smoke alarms. Smoke alarm activation sounds only a local alarm and does not provide automatic fire alarm notification of occupants.	Replace the single-station smoke alarms with automatic smoke detectors tied into the fire alarm system. Configure the fire alarm system to initiate occupant notification upon activation of any two smoke detectors in addition to the manual fire alarm stations.	Within 6 months
-----	-----------------	--	---	-----------------

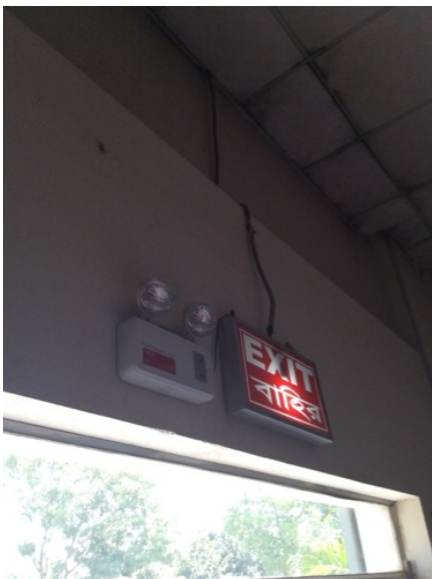
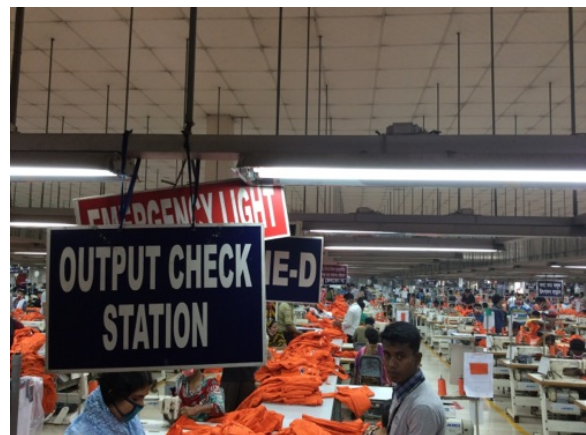
F-7 Egress Lighting

Based on the number and location of emergency lights observed, adequate illumination levels are not anticipated along egress routes.

Locations:  
All areas.

Test the emergency lighting system on each floor and provide additional emergency fixtures to provide adequate illumination along the means of egress. Provide a minimum illumination of 10 lux at the floor level within exit stairs and exit discharge paths and minimum 2.5 lux along exit access aisles.
