# **FIRE SAFETY INSPECTION REPORT**

**Blue Planet Fashion Wear Ltd.**

**ACCORD ID: 23415**

**Date: 13 January 2019**

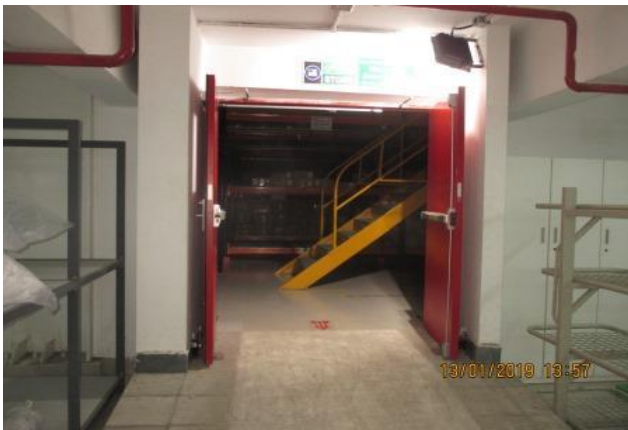
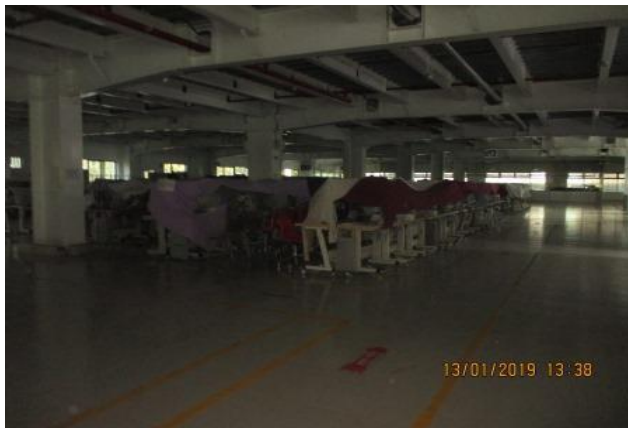
| SI No. | Category | Finding | Recommendation | Remediation Time Frame |
|---|---|---|---|---|
| F-1 | Fire Rated Construction | Process goods and store room used for combustible storage are not separated by fire rated construction from production area on several floors. | Provide dedicated storage rooms separated by minimum 1-hr fire-rated construction. Where separate storage rooms are not feasible, provide defined storage areas and limit the storage arrangement as follows: - Maximum height of 2.45m (8ft.) and maximum area of 23m <sup>2</sup> (250 ft <sup>2</sup> ) - If sprinkler protected: maximum height of 3.66m (12ft.) and maximum area of 93m <sup>2</sup> (1000 ft <sup>2</sup> ) Separate areas of unenclosed combustible storage by a minimum clear distance of 3m (10ft.). | Within 3 months |

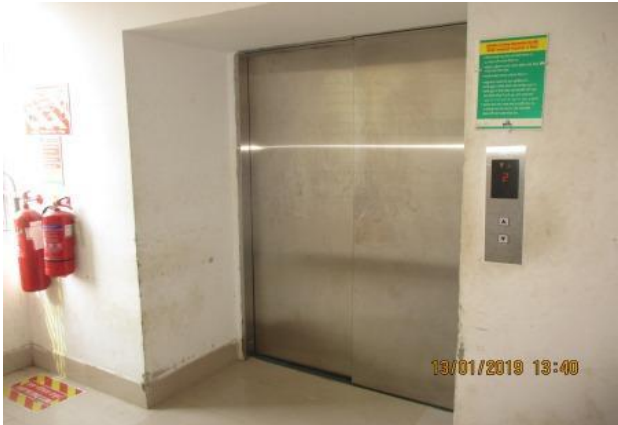
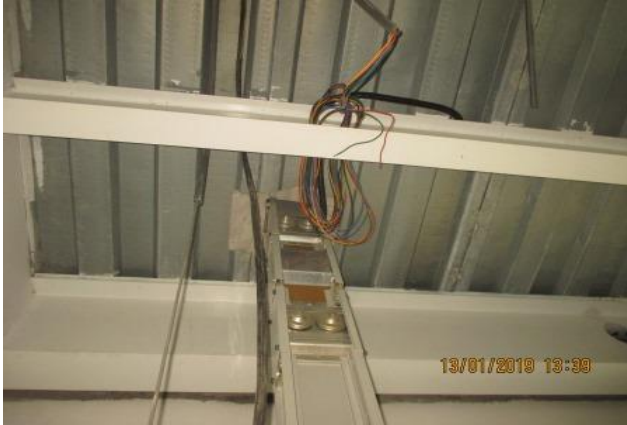
| F-2 | Fire Rated Construction | Unsealed electrical and lift shafts are located in the fire-rated floor/ceiling assemblies. | Provide a minimum 2-hr fire rated shaft to separate the utility risers from each floor level and seal all penetrations in floor/ceiling assemblies to maintain the fire separation. | Within 3 months |

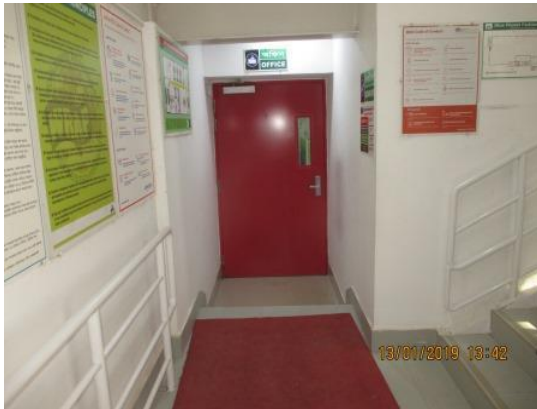
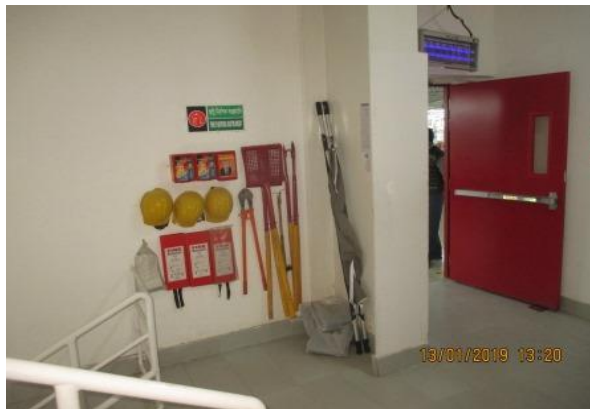
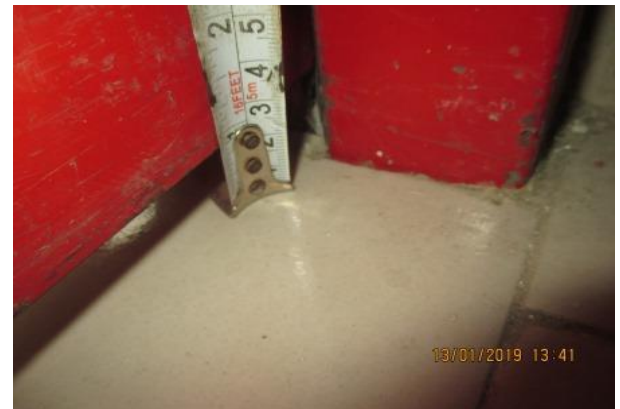
| F-3 | Fire Rated Construction | The exit stairs are not separated from work areas and other spaces on each floor by fire rated construction. | <p>Separate the exit stairs from work areas and other building spaces on all floor levels by minimum 2- hr. fire-rated construction. Provide minimum 1.5-hr fire rated doors for buildings that are 4 or more stories. Seal all unprotected openings to separate the exit stairs from work areas and other building spaces on all floor levels.</p> <p>Ensure that the fire doors are self-closing and positive latching and that they are provided with fire exit (panic) hardware where serving production floors.</p> <p>If fire doors are required to be held open for functional reasons, provide automatic closing devices tied to the fire alarm system. Once fire doors are installed, every door in a stair enclosure serving more than 5 stories shall be provided with re-entry unless it meets ACCORD standard 6.8.3.1.</p> | Within 3 months |

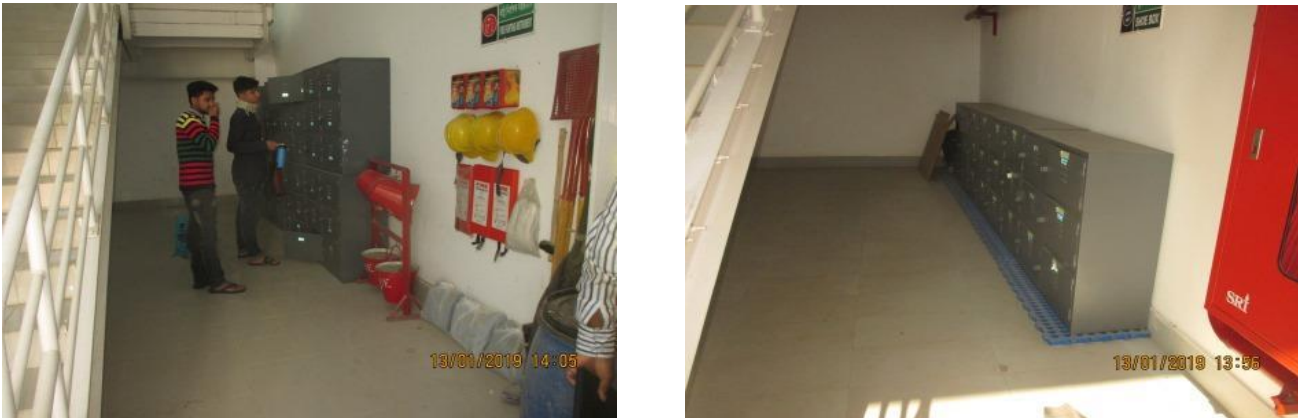
| F-4 | Egress | Storage (Locker) was located in exit stair enclosure on ground floor. | Remove all storage (obstructions) from exit stairs and egress paths. | Immediately |

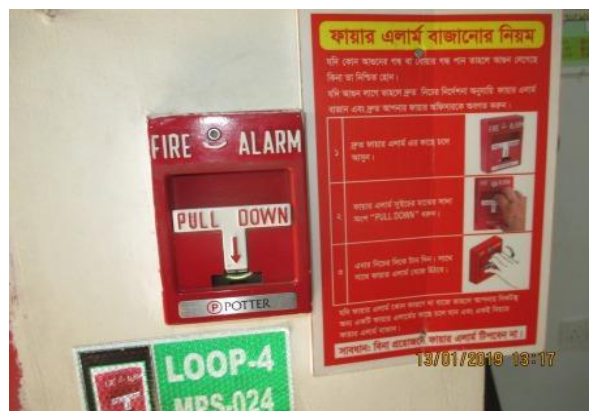
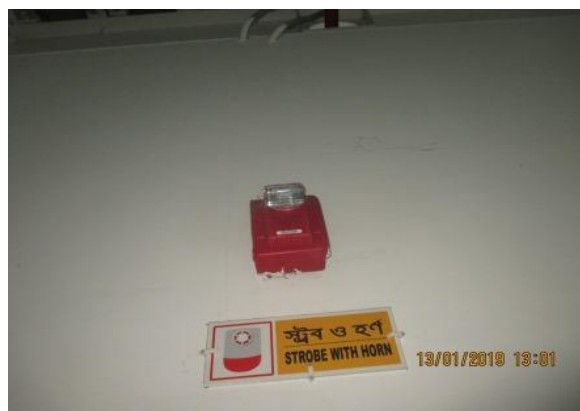
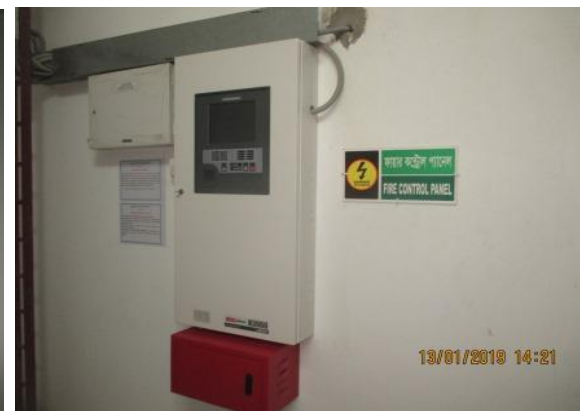
| F-5 | Fire Detection | Fire detection system installation requires detailed review to confirm compliance with NFPA 72 and ACCORD standards. | Submit installed addressable fire alarm system as-built drawing, testing records, equipment certification and other relevant documentation to the ACCORD for review. | Design submission within 2 months, install within 4 months (if modification required) |

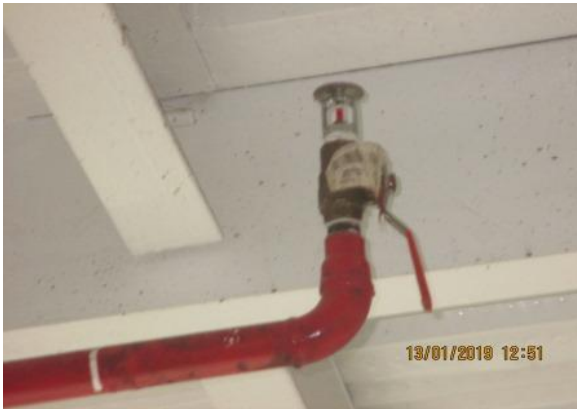
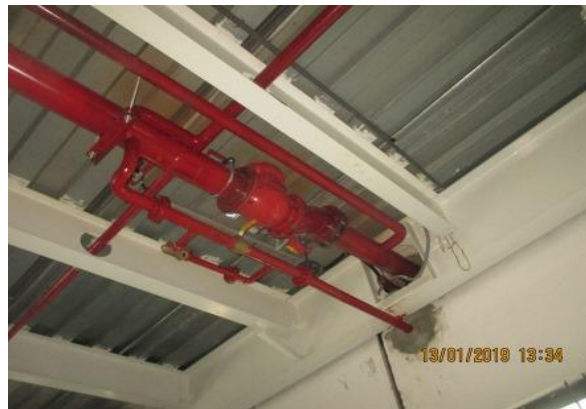
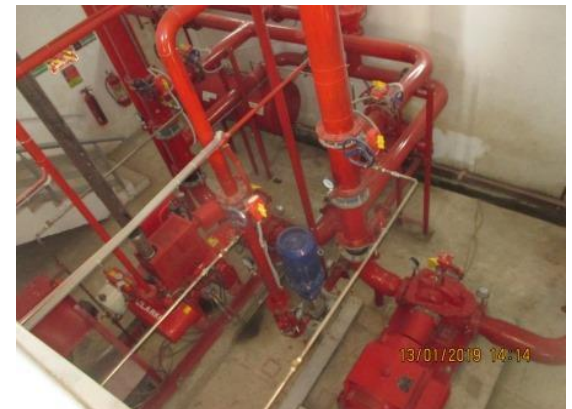
| F-7 | Fire Protection | Automatic Sprinkler system installation requires detailed review to confirm compliance accordance with NFPA 13, 14 & 20 and ACCORD standards. | Submit sprinkler system as-built drawings, testing records, equipment certification and other relevant documentation to the ACCORD for review. | Design submission within 2 months, install within 6 months (if modification required) |

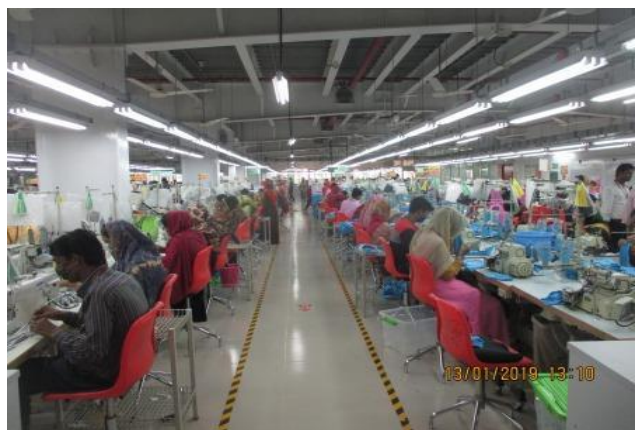
| F-9 | Egress Lighting | Based on the number and location of emergency lights observed, adequate illumination levels are not anticipated along egress routes. | Test the emergency lighting system on each floor and provide additional emergency fixtures to provide adequate illumination along the means of egress. Provide a minimum illumination of 10 lux at the floor level within exit stairs and exit discharge paths and minimum 2.5 lux along exit access aisles. | Within 3 months |

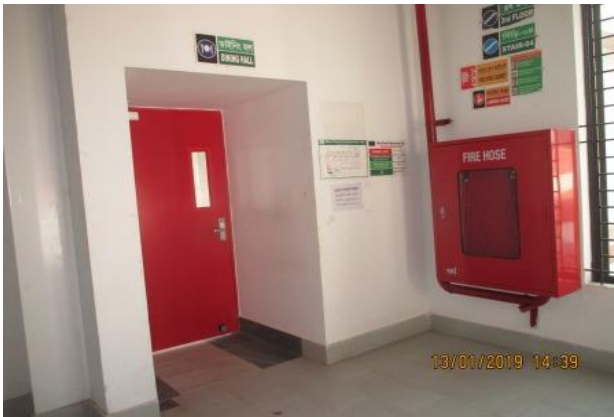
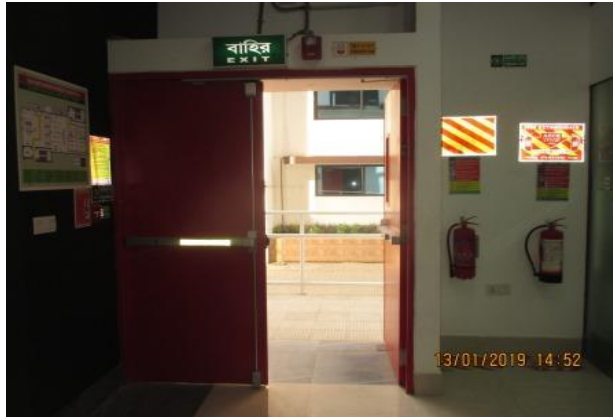
| SI No. | Category | Finding | Recommendation | Remediation Time Frame |
|---|---|---|---|---|
| F-1 | Fire Rated Construction | The exit stairs are not separated from work areas and other spaces on each floor by fire rated construction. | <p>Separate the exit stairs from work areas and other building spaces on all floor levels by minimum 2- hr. fire-rated construction. Provide minimum 1.5-hr fire rated doors for buildings that are 4 or more stories. Seal all unprotected openings to separate the exit stairs from work areas and other building spaces on all floor levels.</p> <p>Ensure that the fire doors are self-closing and positive latching and that they are provided with fire exit (panic) hardware where serving production floors.</p> <p>If fire doors are required to be held open for functional reasons, provide automatic closing devices tied to the fire alarm system. Once fire doors are installed, every door in a stair enclosure serving more than 5 stories shall be provided with re-entry unless it meets ACCORD standard 6.8.3.1.</p> | Within 3 months |

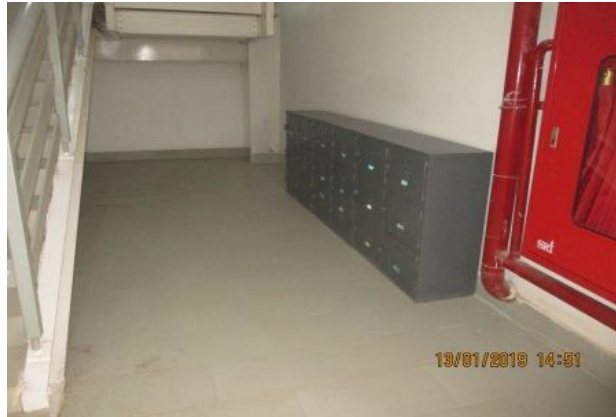
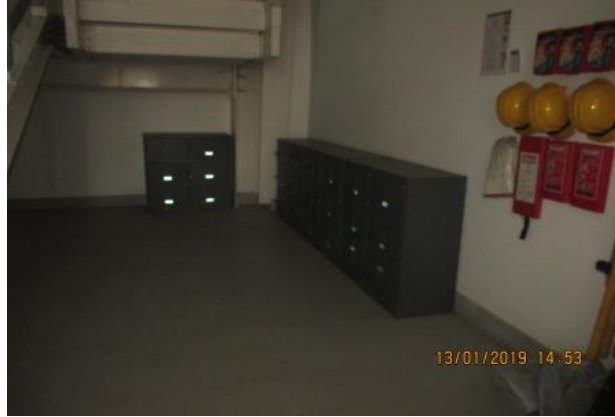
| F-2 | Egress | Storage (Locker) was located in exit stair enclosure on ground floor. | Remove all storage (obstructions) from exit stairs and egress paths. | Immediately |

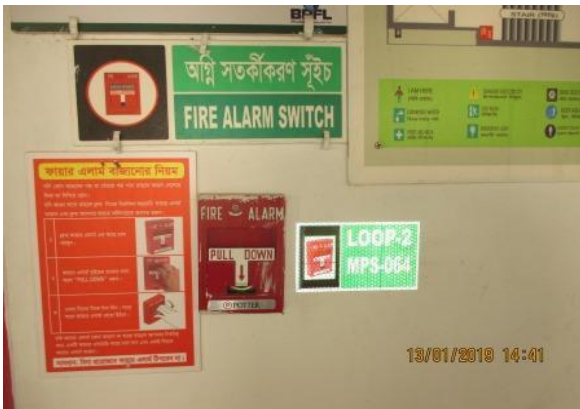
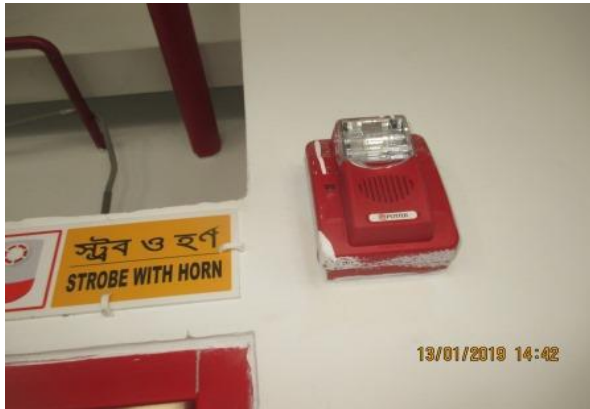
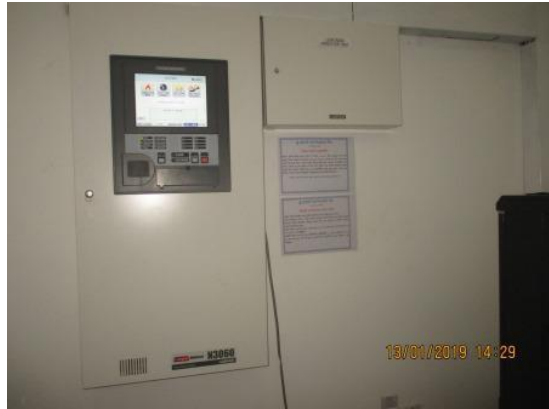
| F-3 | Fire Detection | Fire detection system installation requires detailed review to confirm compliance with NFPA 72 and ACCORD standards. | Submit installed addressable fire alarm system as-built drawing, testing records, equipment certification and other relevant documentation to the ACCORD for review. | Design submission within 2 months, install within 4 months (if modification required) |

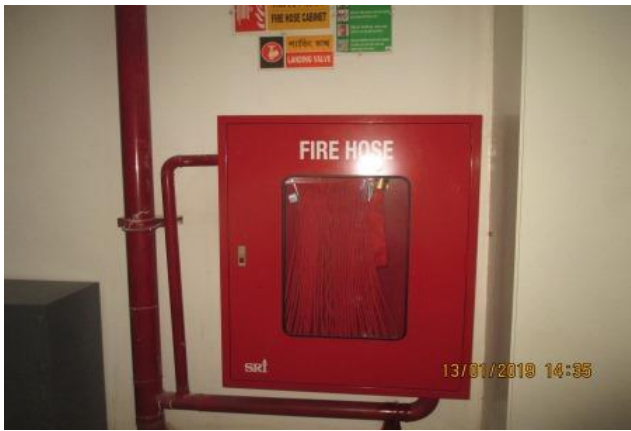
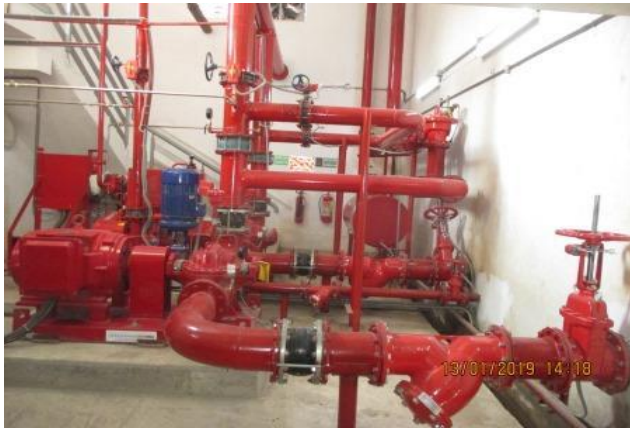
| F-5 | Fire Protection | Standpipe system installation requires detailed review to confirm compliance accordance with NFPA 14 & 20 and ACCORD standards. | Submit standpipe system as-built drawings, testing records, equipment certification and other relevant documentation to the ACCORD for review. | Design submission within 2 months, install within 4 months (if modification required) |
