# **FIRE SAFETY INSPECTION REPORT**

**HASAN TANVIR FASHION WEARS LTD.  
PLOT # 397, CHANDONA CHOWRASTA JOYDEBPUR  
ROAD, GAZIPUR-1702**

April 23, 2014

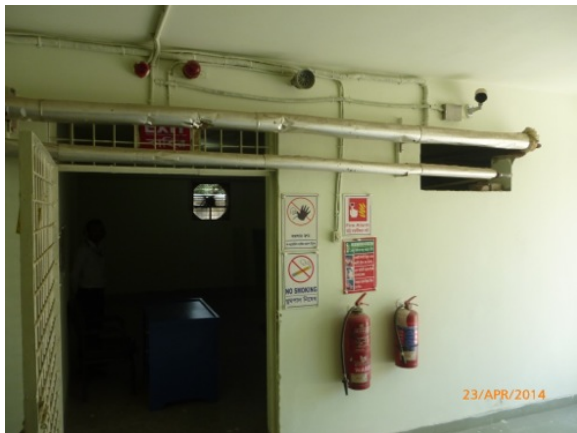
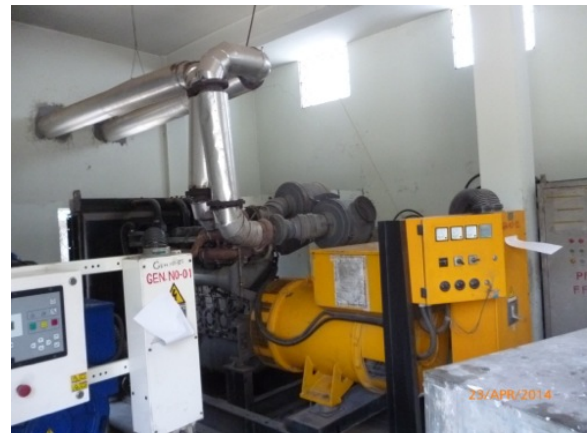
| No. | Category | Finding | Recommendation | Remediation Timeframe |
|---|---|---|---|---|
| F-1 | Fire Rated Construction | The boiler, generator, transformer rooms are not separated by fire-rated construction. All located in ground floor. (openings, non-rated doors, penetrations). | Separate the boiler, generator, transformer rooms by a minimum 2-hr fire-rated construction. Seal and/or protected all openings to maintain the required fire separations | Within 3 months |

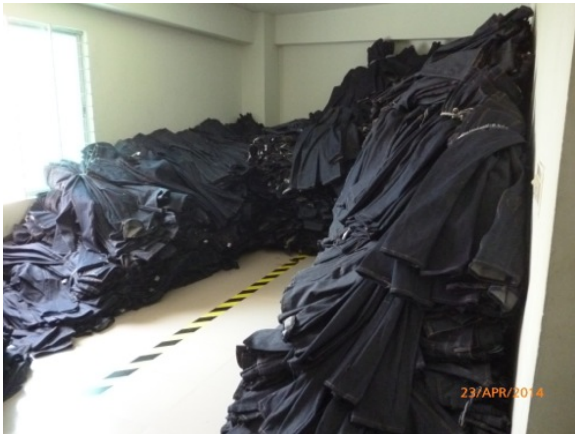
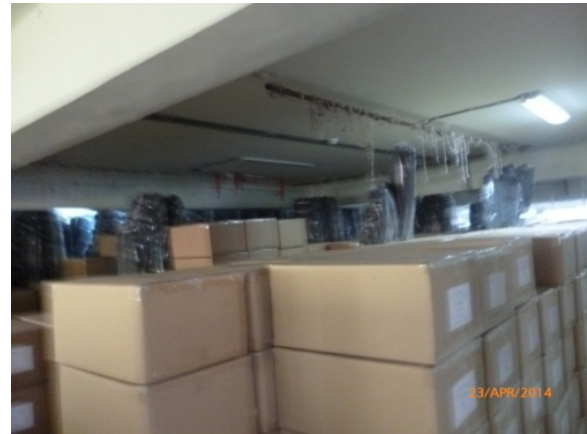
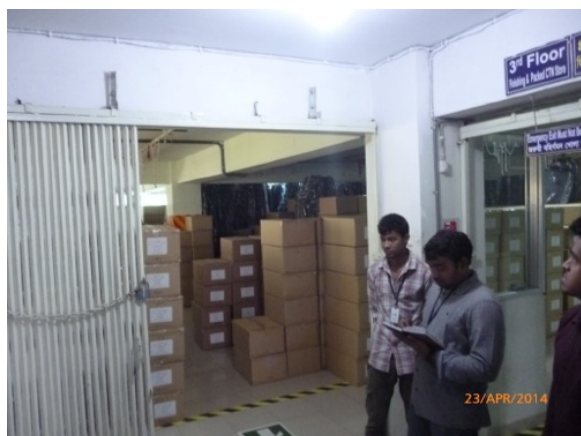
| F-2 | Fire Rated Construction | <p>Areas used for combustible storage are not separated by fire-rated construction.</p> <p>Locations: Ground floor, 3rd floor.</p> | <p>Provide dedicated storage rooms separated by minimum 1-hr fire-rated construction.</p> <p>Where separate storage rooms are not feasible, provide defined storage areas and limit the storage arrangement as follows:</p> <ul style="list-style-type: none"><li>- Maximum height of 2.4m and maximum area of 23m<sup>2</sup></li><li>- If sprinkler protected: maximum height of 3.66m and maximum area of 93m<sup>2</sup></li></ul> <p>Separate areas of unenclosed combustible storage by a minimum clear distance of 3m.</p> | Within 3 months |

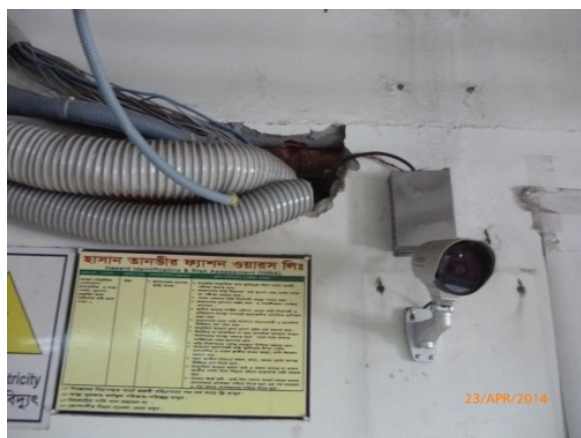
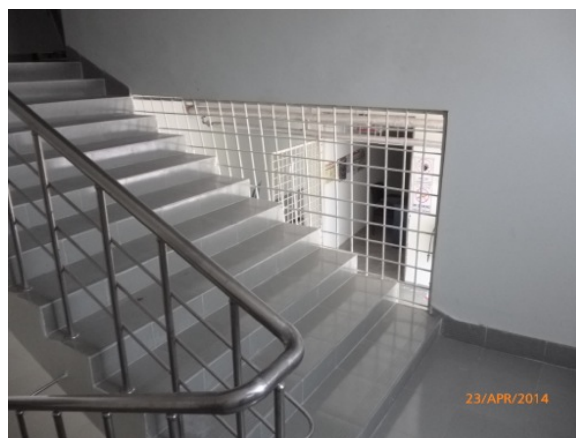
| F-3 | Fire Rated Construction | Unsealed penetrations and openings are located in exit stair enclosures. | Seal all penetrations and openings in exit stair enclosure walls to maintain the fire separation. | Within 3 months |

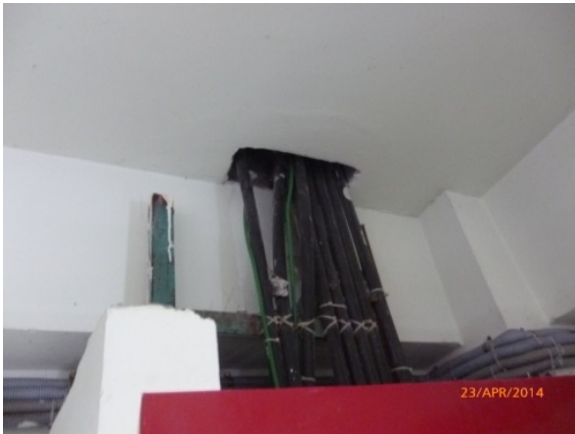
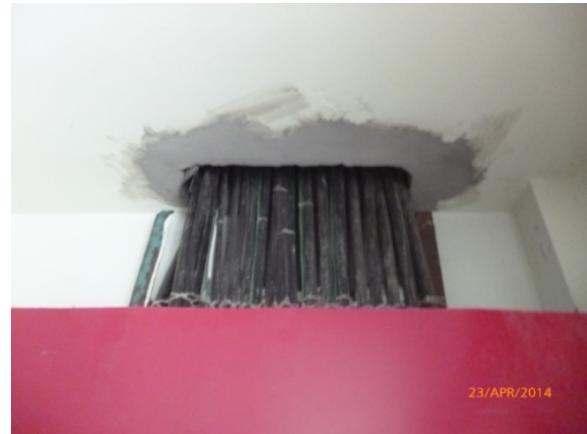
| F-4 | Fire Rated Construction | Unsealed penetrations and openings are located in the fire-rated floor/ceiling assemblies. | Provide a minimum 2-hr fire-rated shaft to separate the utility risers from each floor level. | Within 3 months |

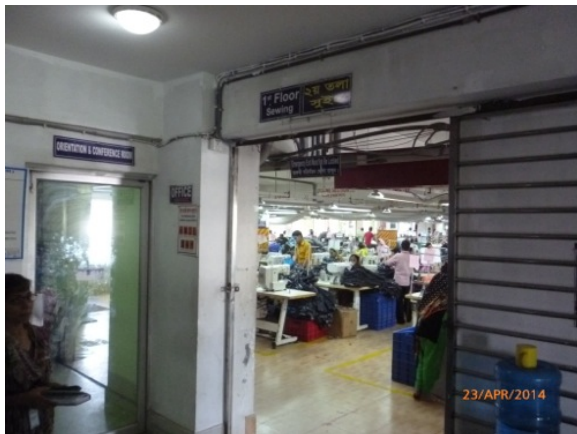
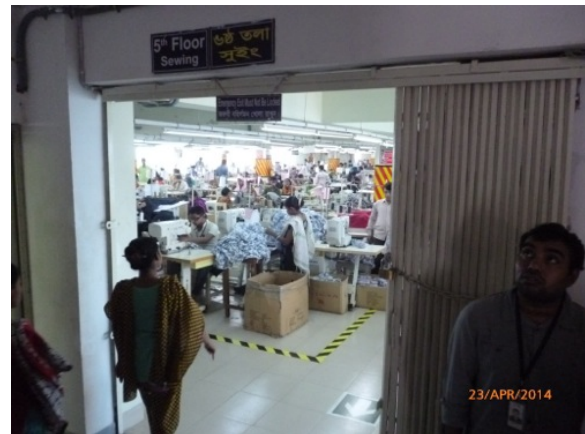
| F-5 | Fire Rated Construction | The exit stairs are not separated from work areas, other spaces on each floor by fire-rated construction. | <p>Provide minimum 1.5-hr fire rated doors and seal all unprotected openings to separate the exit stairs from work areas and other building spaces on all floor levels. Ensure that the fire doors are self-closing and positive latching and that they are provided with fire exit (panic) hardware where serving production floors.</p> <p>If fire doors are required to be held open for functional reasons, provide automatic-closing devices tied to the fire alarm system.</p> | Within 3 months |

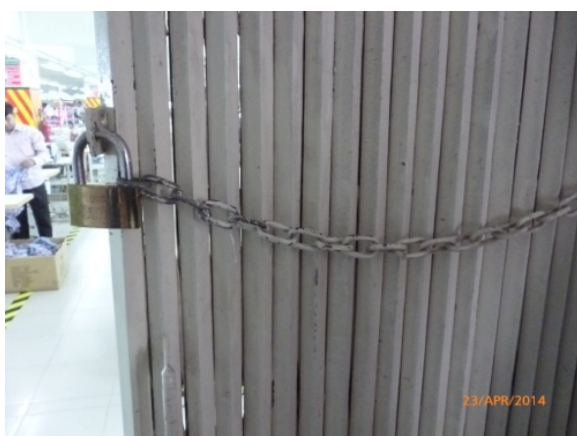
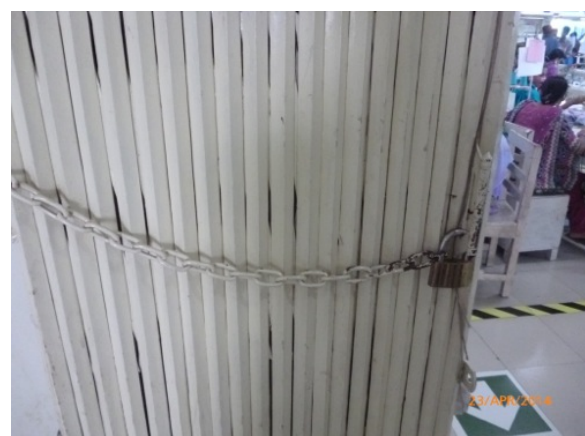
| F-6 | Egress | <p>Egress doors and gates with locking features are provided at building exits, exit stairs and exit discharge.</p> <p>All gates/doors were open and unlocked during the inspection.</p> | <p>Remove locking features from all egress doors / gates.</p> <p>If locks are required for security reasons, utilize special door locking features complying with NFPA 101.</p> | Immediate |

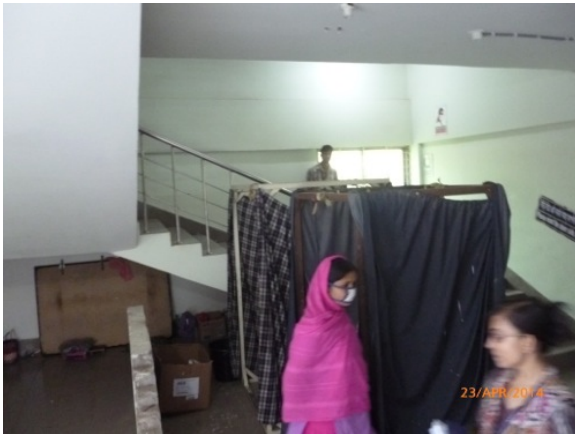
| F-7 | Egress | <p>Storage was located below the SE exit stair.</p> | <p>Remove all storage from exit stairs and egress paths.</p> | Immediate |

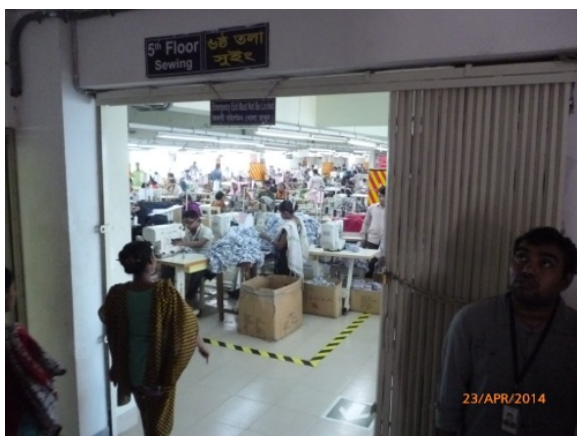
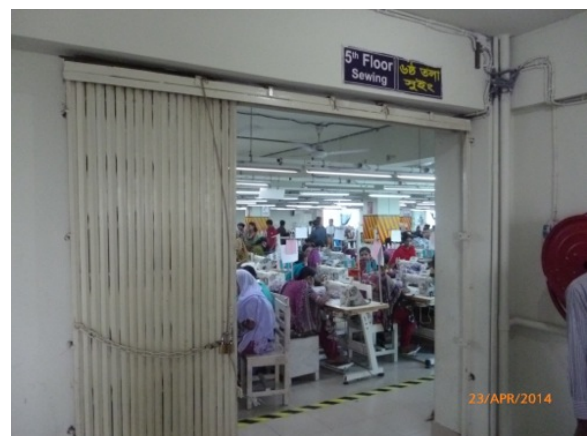
| F-8 | Egress | Sliding gates and doors are provided at building exits, exit stairs and exit discharge. | Replace all sliding gates and doors along the means of egress with side-hinged, swinging egress doors. | Within 1 month |

| | | | If locks are required for security reasons, utilize special door locking features complying with NFPA 101. | |

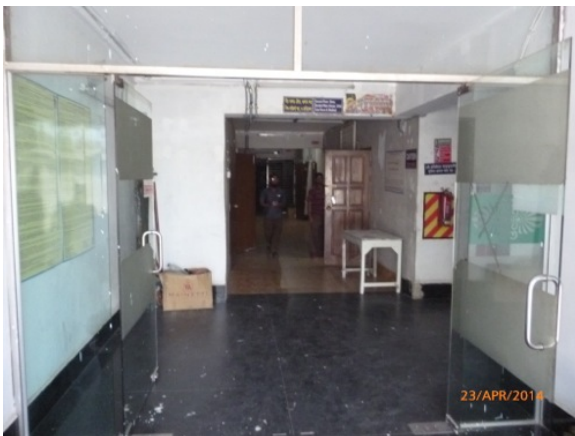
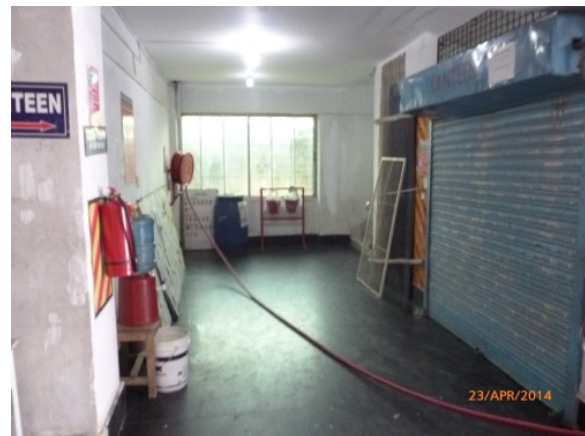
| F-9 | Egress | NW exit stairs discharge inside the building storage loading way. | <p>Modify stair to discharge directly outside.</p> <p>or</p> <p>Provide 2-hr fire-rated exit passageway leading directly outside (vestibules to separate any storage areas).</p> <p>or</p> <p>Provide sprinkler protection for discharge floor in accordance with NFPA 13.</p> | Within 6 months |

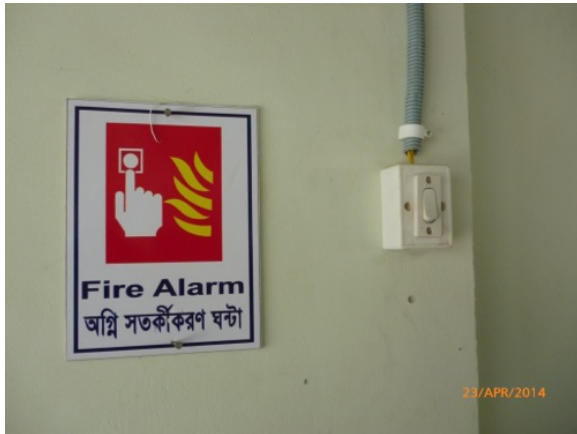
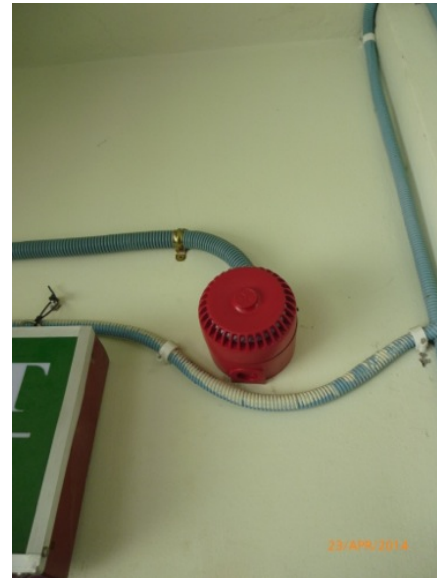
| F-10 | Fire Protection | The fire alarm system is antiquated, not a listed system, and does not provide alarm and notification features consistent with acceptable standards. | Replace the fire alarm system with a new, listed addressable fire alarm system in accordance with NFPA 72. | Design within 4 months, install within 9 months |
