# **FIRE SAFETY INSPECTION REPORT**

**POLE STAR FASHION DESIGN LTD.  
SHORIFPUR, NATIONAL UNIVERSITY, GAZIPUR**

**ACCORD**  
on Fire and Building Safety in Bangladesh

April 20, 2014

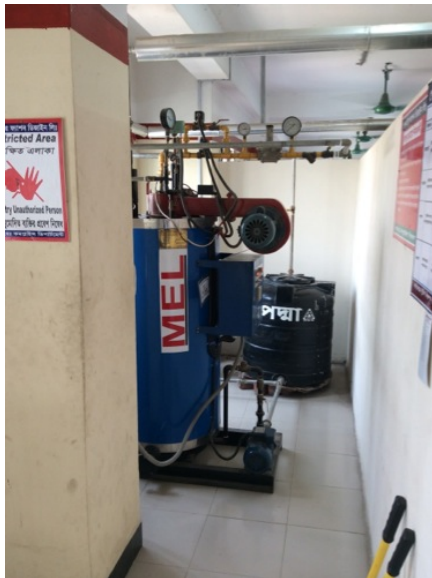
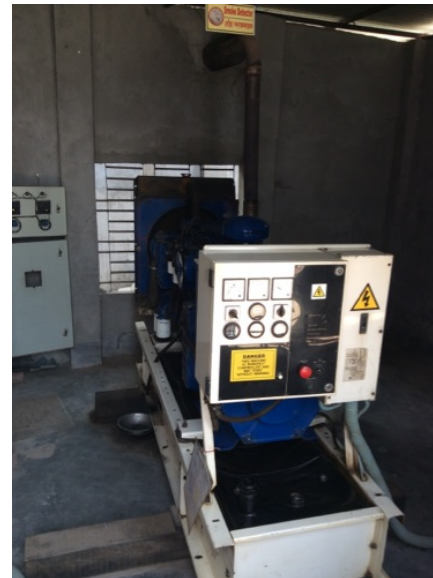
| No. | Category | Finding | Recommendation | Remediation Timeframe |
|---|---|---|---|---|
| F-1 | Fire Rated Construction | The boiler and generator rooms are not separated by fire-rated construction (openings, non-rated doors, penetrations). | Separate the boiler and generator rooms by a minimum 2-hr fire-rated construction. Seal and or protected all openings to maintain the required fire separations | Within 3 months |

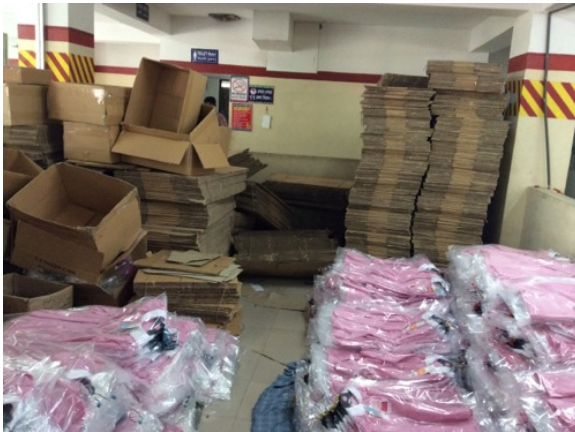
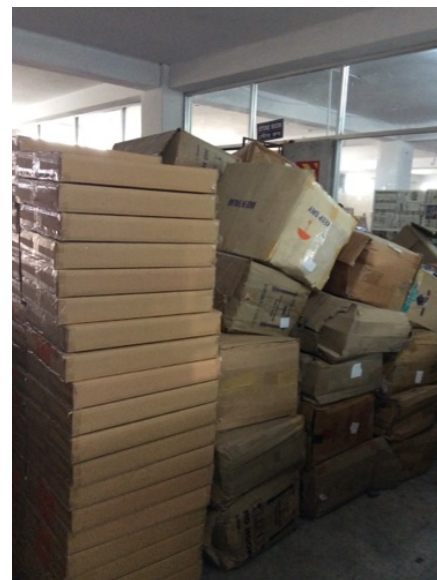
| F-2 | Fire Rated Construction | Areas used for combustible storage in the ground and 1st floors are not separated by fire-rated construction. | <p>Provide dedicated storage rooms separated by minimum 1-hr fire-rated construction.</p> <p>Where separate storage rooms are not feasible, provide defined storage areas and limit the storage arrangement as follows:</p> <ul style="list-style-type: none"><li>- Maximum height of 2.4m and maximum area of 23m<sup>2</sup></li><li>- If sprinkler protected: maximum height of 3.66m and maximum area of 93m<sup>2</sup></li></ul> <p>Separate areas of unenclosed combustible storage by a minimum clear distance of 3m.</p> | Within 3 months |

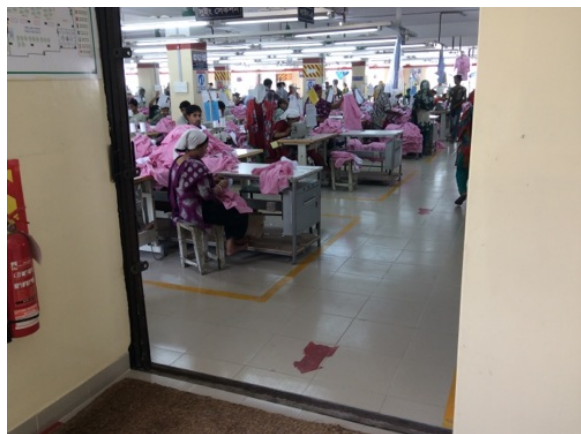
| F-3 | Fire Rated Construction | The exit stairs are not separated from work areas or other spaces on each floor by fire-rated construction. | Provide minimum 1.5-hr fire rated doors and seal all unprotected openings to separate the exit stairs from work areas and other building spaces on all floor levels. Ensure that the fire doors are self-closing and positive latching and that they are provided with fire exit (panic) hardware where serving production floors.<br><br>If fire doors are required to be held open for functional reasons, provide automatic-closing devices tied to the fire alarm system. | Within 3 months |

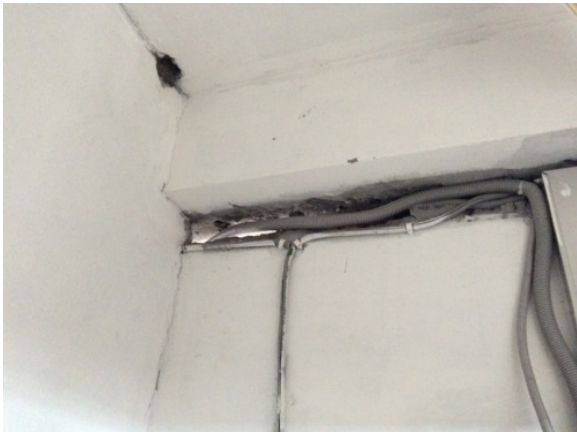
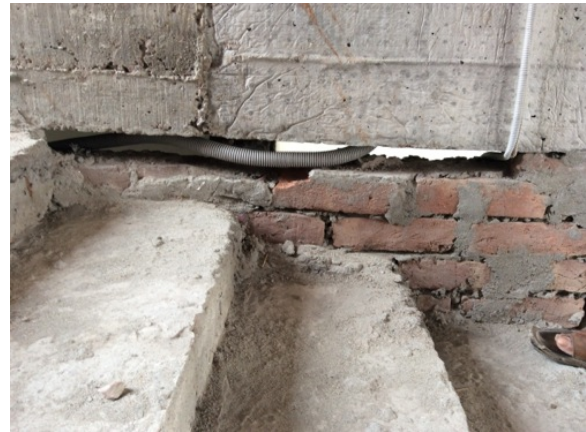
| F-4 | Fire Rated Construction | Unsealed penetrations and openings are located in the NW exit stair enclosures. | Seal all penetrations and openings in exit stair enclosure walls to maintain the fire separation. | Within 3 months |

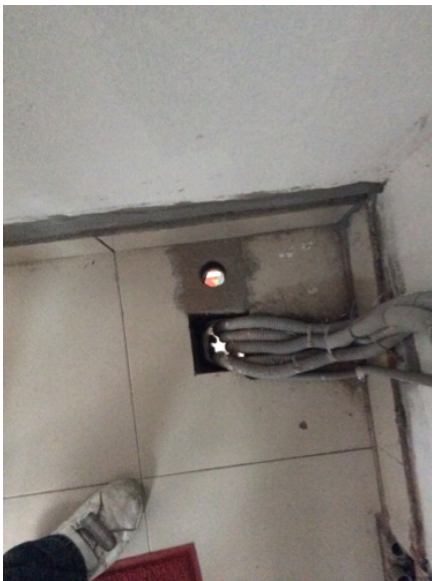
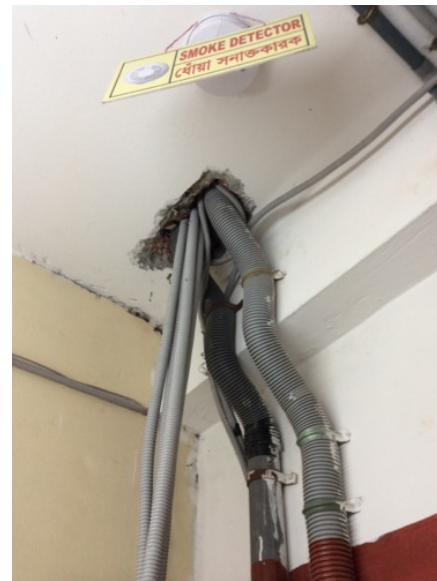
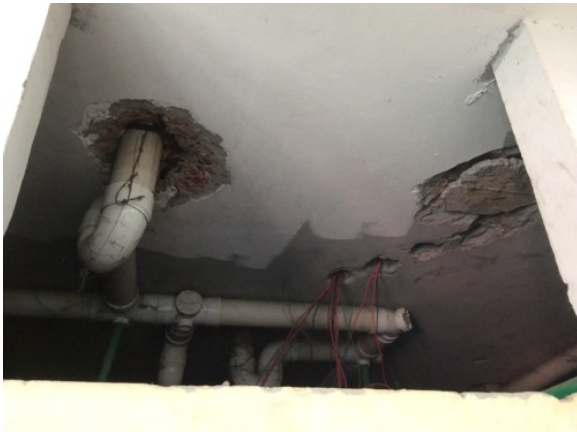
| F-5 | Fire Rated Construction | Unsealed penetrations and openings in the several floors are located in the fire-rated floor/ceiling assemblies. | Provide a minimum 2-hr fire-rated shaft to separate the utility risers from each floor level.<br><br>Seal all penetrations and openings in floor/ceiling assemblies to maintain the fire separation. | Within 3 months |

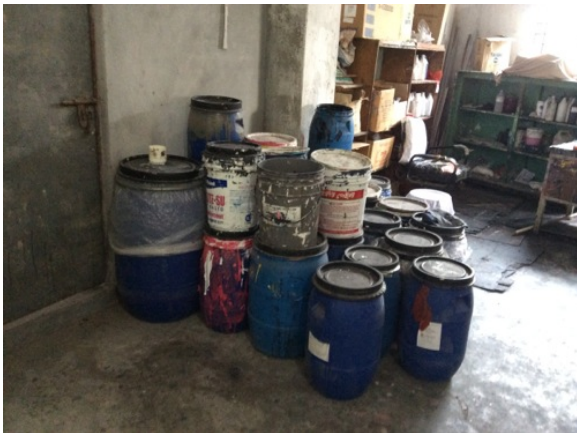
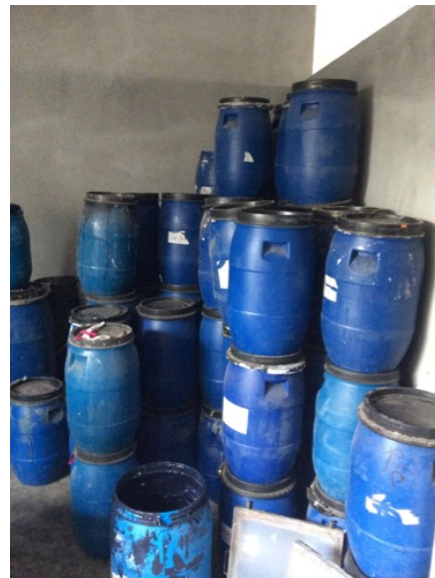
| F-6 | Fire Rated Construction | Hazardous materials / flammable liquid storage area in the ground floor is not separated by fire-rated construction (openings, non-rated doors, penetrations). | Separate the hazardous materials / flammable liquid storage room by a minimum 2-hr fire-rated construction. Seal and/or protected all openings to maintain the required fire separations. | Within 3 months |

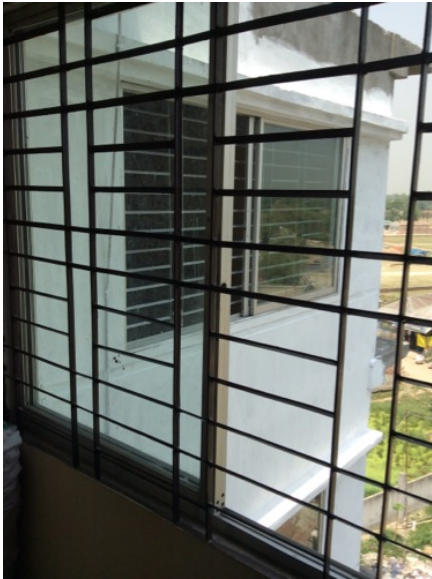
| F-7 | Fire Rated Construction | Unsealed penetrations and openings are located in exterior of the NW exit stair enclosures. | Seal all penetrations and openings in exit stair enclosure walls to maintain the fire separation. | Within 3 months |

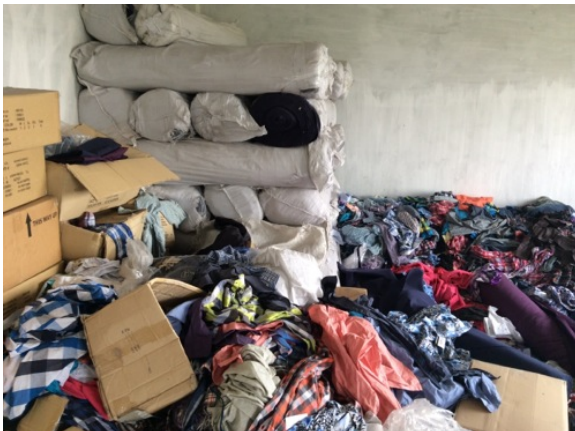
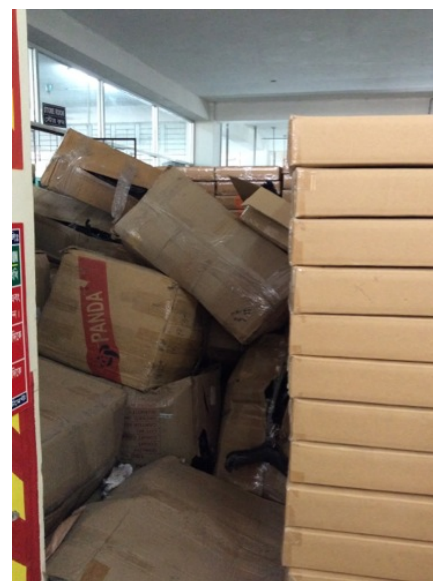
| F-8 | Fire Rated Construction | Areas used for combustible storage room in the ground and 4th floors are not separated by fire-rated construction. | Provide dedicated storage rooms separated by minimum 1-hr fire-rated construction. | Within 3 months |

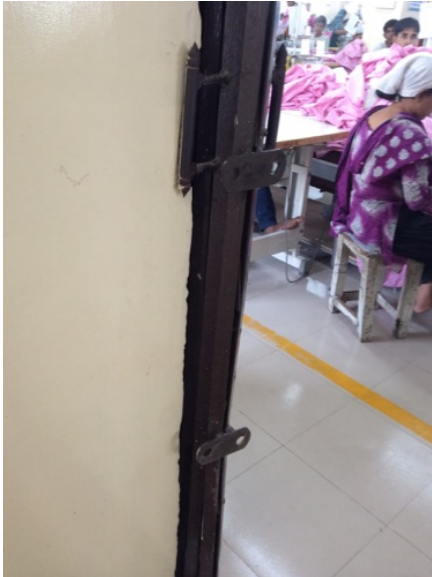
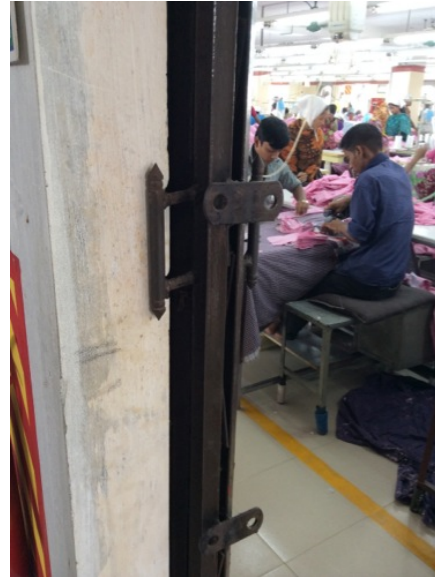
| F-9 | Egress | Egress doors / gates with locking features are provided at building exits and exit stairs.<br><br>All gates/doors were open and unlocked during the inspection. | Remove locking features from all egress doors / gates.<br><br>If locks are required for security reasons, utilize special door locking features complying with NFPA 101. | Immediate |

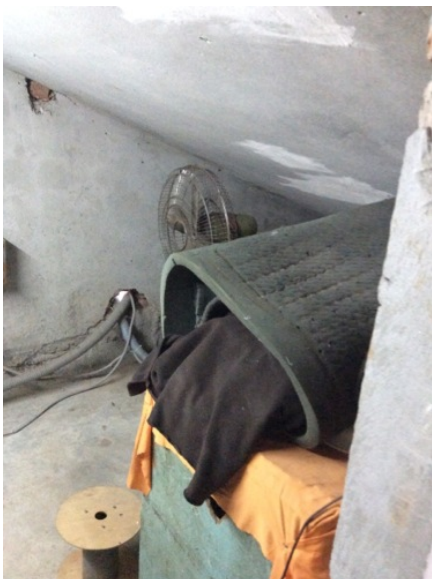
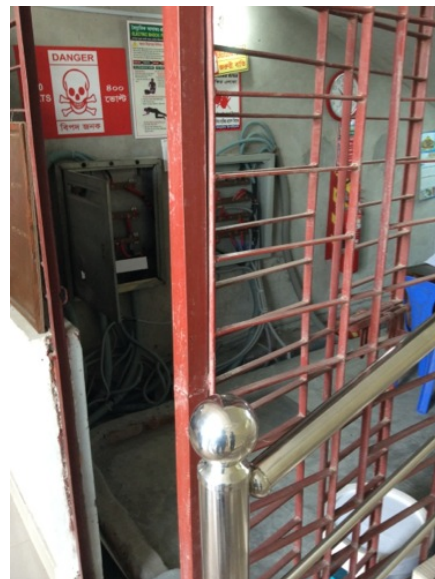
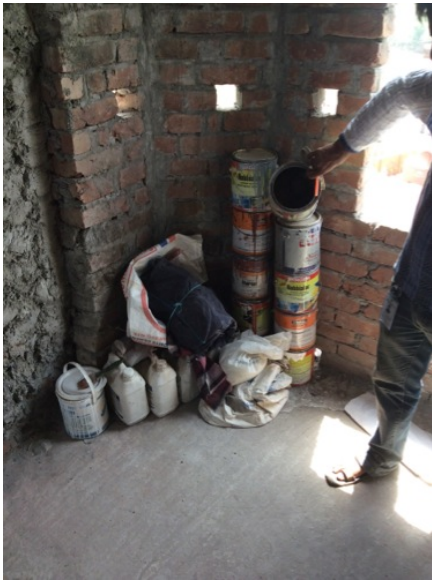
| F-10 | Egress | Storage was located in the exit stair. | Remove all storage from exit stairs and egress paths. | Immediate |

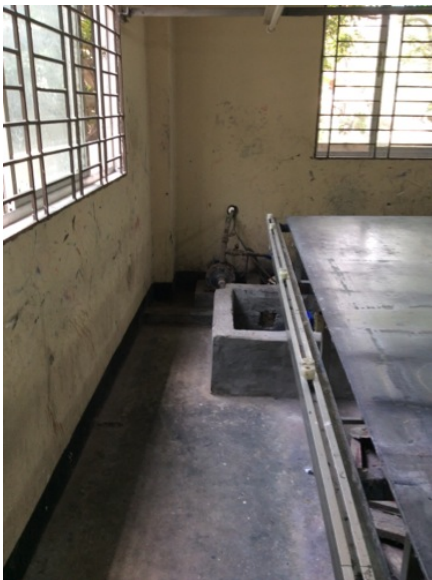
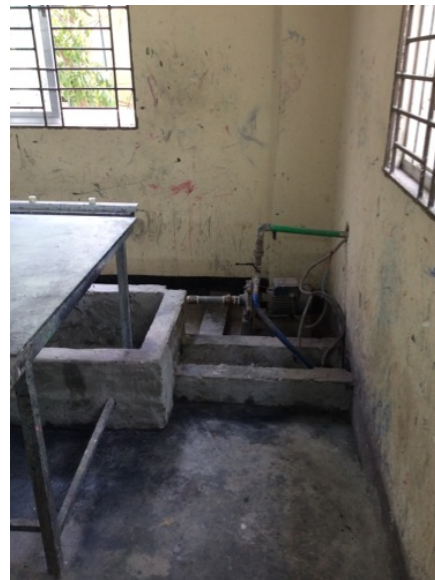
| F-11 | Egress | The water pump on ground floor was located in the egress path. | Keep egress paths and stairs clear of storage. | Immediate |

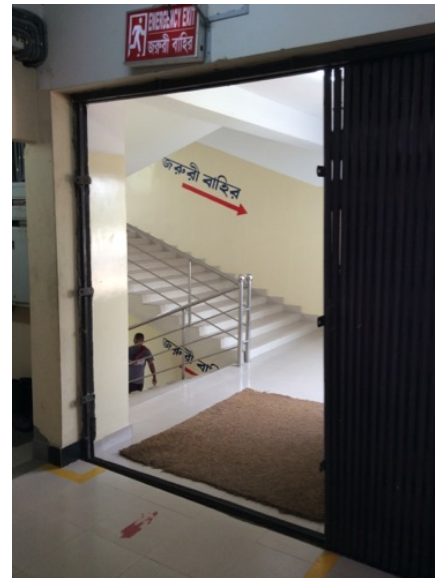
| F-12 | Egress | Collapsible gates / sliding doors are provided at building exits and exit stairs. | Replace all gates / sliding doors along the means of egress with side-hinged, swinging egress doors. | Within 1 month |

If locks are required for security reasons, utilize special door locking features complying with NFPA 101.

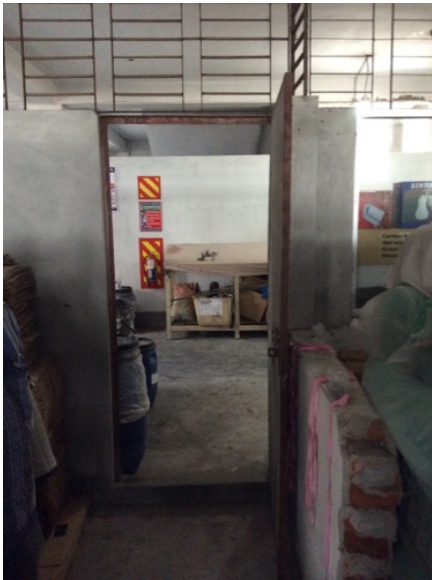
| F-13 | Egress | Egress door in the storage room of ground floor does not swing in the direction of egress travel. | Modify the egress door to swing in the direction of egress travel. | Within 3 months |

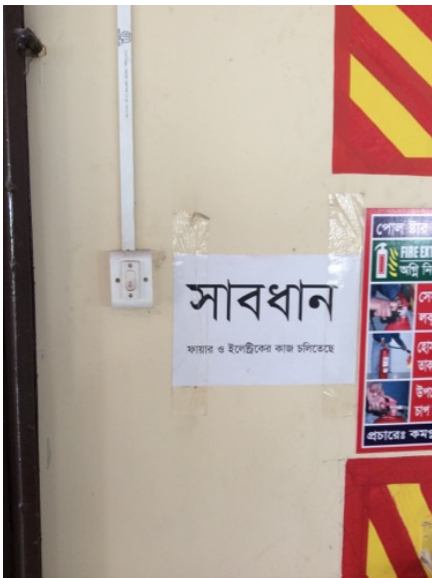
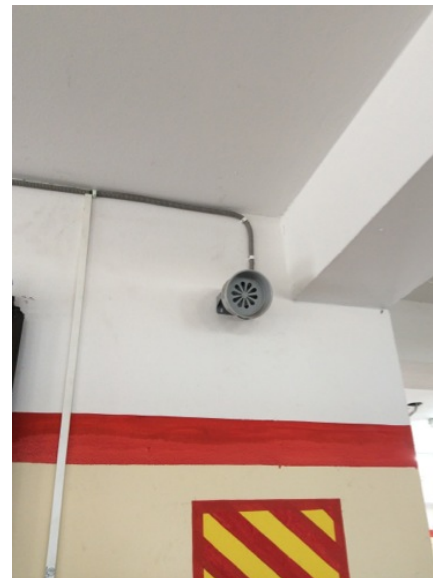
| F-14 | Fire Protection | The fire alarm system is antiquated, not a listed system, and does not provide alarm and notification features consistent with acceptable standards. | Replace the fire alarm system with a new, listed addressable fire alarm system in accordance with NFPA 72. | Design within 4 months, install within 9 months |

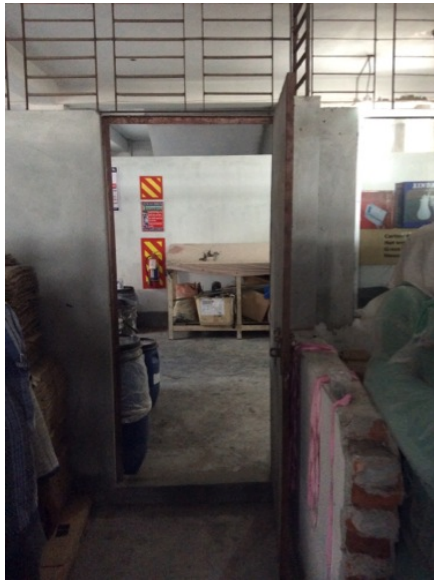
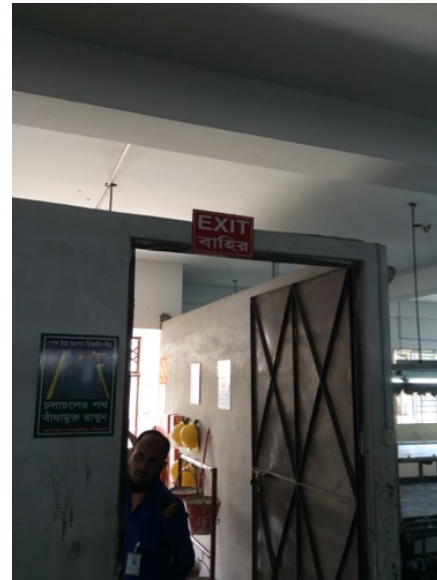
| F-17 | Egress Lighting | Exit signs in the storage room on the ground floor did not provide exits. | Provide exit signs above all exits to the exterior and all doors to the exit stairs. | Within 1 month |

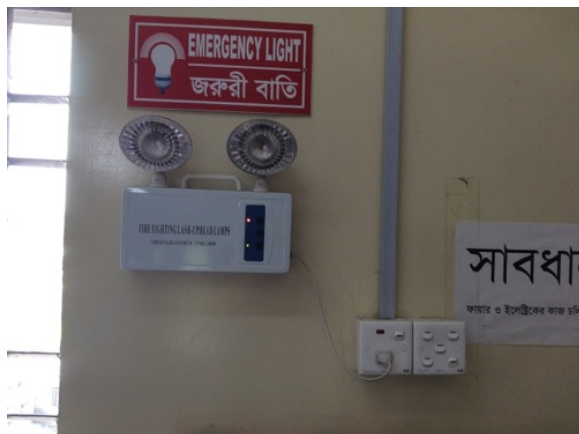
| F-18 | Egress Lighting | Manual on-off switches in several locations are provided for emergency lighting / exit signage units. | Remove manual on/off switches from emergency lighting / exit signage units to prevent them from being switched off. | Within 1 month |
