# **FIRE SAFETY INSPECTION REPORT**

**Factory Name: Daeyu Fashions Ltd**

**ACCORD ID: 23436**

**ADDRESS: 731, Bhannara , Mouchak , Kaliakoir , Gazipur**

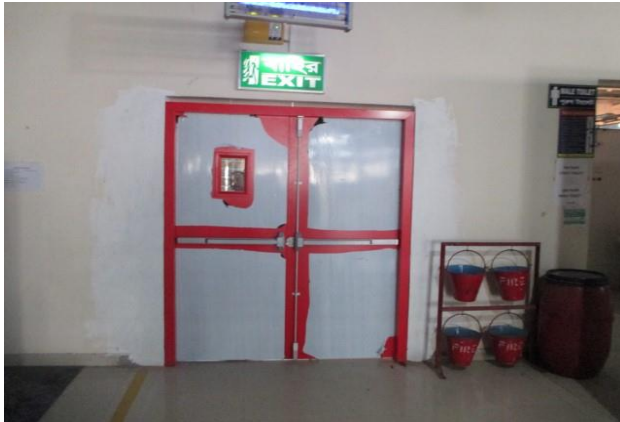
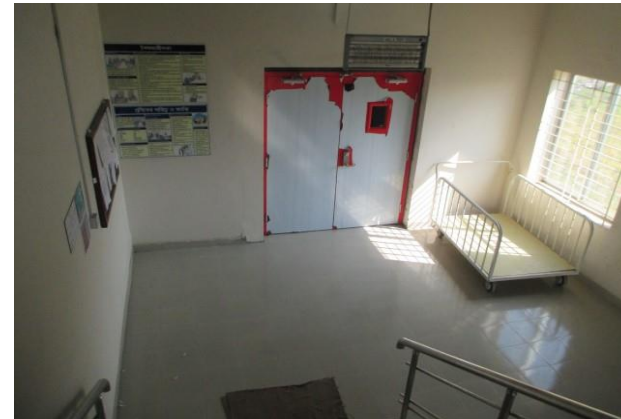
| 1 | Fire Rated Construction | <p>The exit stair enclosures are separated from work areas and other spaces on each floor by fire-rated construction. Fire Doors have been provided with proper hour rating. But doors are kept open and installation of magnetic hold open device to interface with Fire Alarm System have been done but the devices are not interfaced with any approved FACP. Moreover Exit stair enclosures have unprotected openings within 10 feet towards production floor at two stairs.</p> | <p>The exit stair enclosure shall be provided with a minimum 1-hr fire resistance rating for buildings with 3 or fewer stories and a minimum of 2-hr. fire resistance rating for buildings 4 or more stories. Provide 0.75 hr. fire rated door and seal all penetrations and openings by 1 hr. fire rated fire rated barrier construction for building with 3 or fewer stories. Provide 1.5 hr. fire rated door and seal all penetrations and openings by 2 hr. fire rated fire rated barrier construction for building with 4 or more stories.</p> <p>Provide a fire-resistive rated assembly between the exterior exit stairs and the building up to 10 ft. beyond the end of the stair to achieve the required separation. The rated assembly shall be approved and/or designed by a qualified fire protection engineer.</p> <p>Ensure that the fire doors are self-closing and positive latching and that they are provided with fire exit (panic) hardware where serving production floors. If fire doors are required to be held open for functional reasons, provide automatic closing devices tied to the fire alarm system.</p> | Within 3 months |

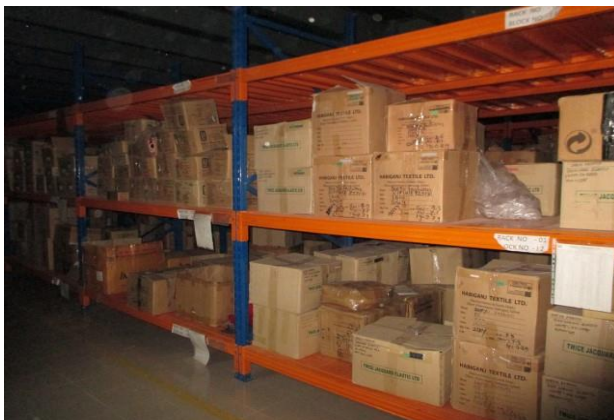
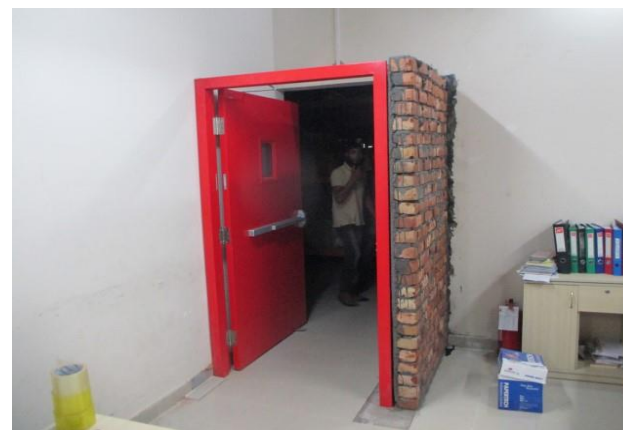
| 2 | Fire Rated Construction | <p>Rooms used for combustible storage are not separated by fire rated construction.</p> <p>Location: wastage go down shed at ground floor adjacent to the mail building</p> | <p>Separate the dedicated storage rooms by minimum 1-hr fire-rated construction. Provide 0.75 hr. fire rated door and seal all penetrations and openings by 1 hr. fire rated fire rated barrier construction.</p> | Within 3 months |

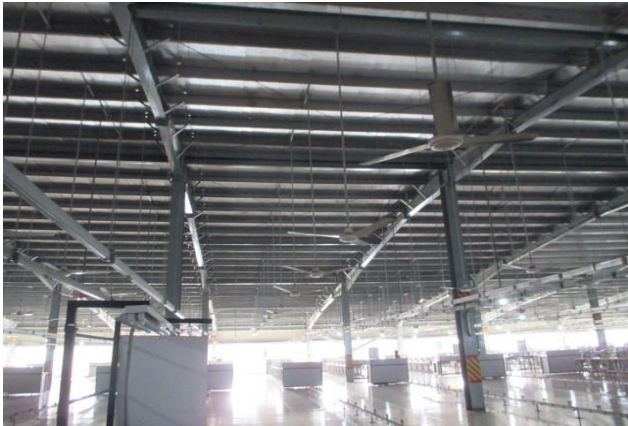
| 4 | Still structure | Since the structure is steel-composite type and all the RCC panels are resting on the steel columns and girders. Hensch, each floor of the building is not separated by a fire resistive rated construction barriers. | Provide fire-resistive rated construction barriers between floors following Section 4.4 and Table 4.4.1 of the Accord Standard or Table 3.3.1 and Table 4.1.1 from BNBC Part 4. Consult a qualified fire protection engineer to design the rated construction barriers. | within 4 months |

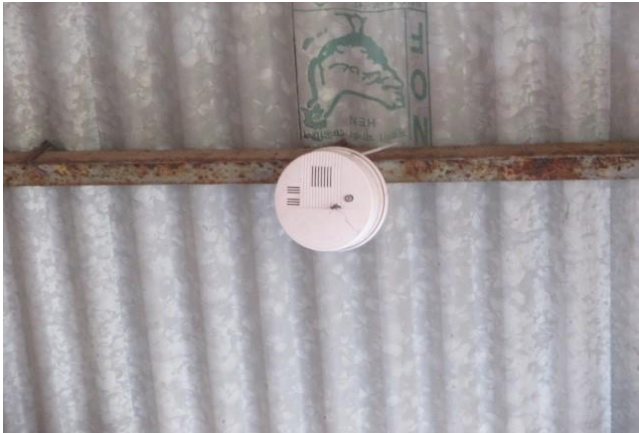
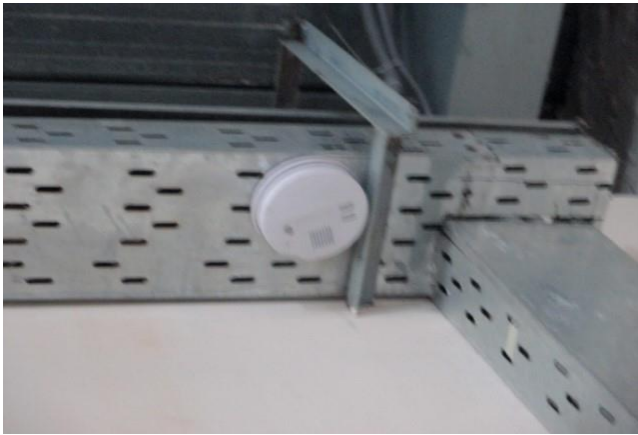
| 6 | Fire Detection and Alarm System | The building is equipped with single-station smoke alarms. Smoke alarm activation sounds only a local alarm and does not provide automatic fire alarm notification of occupants. | Remove single-station smoke alarms. Provide automatic smoke detection throughout the building, tied into the fire alarm system, in accordance with NFPA 72. | Design within 3 months and installation within 9 months |

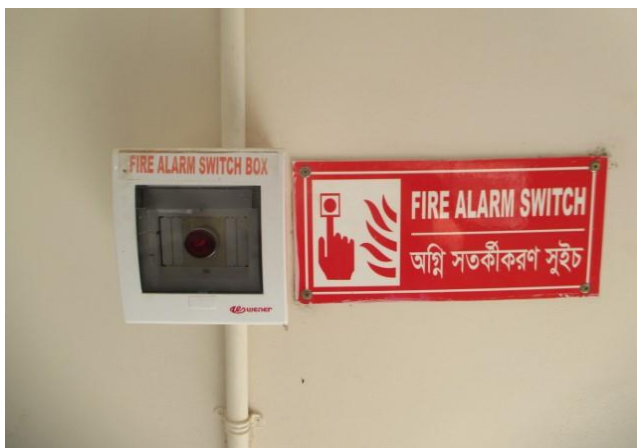
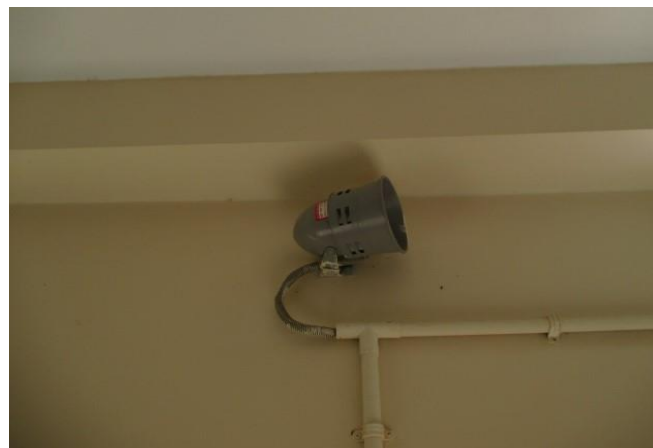
| 7 | Fire Detection and Alarm System | Activation of the fire alarm system by a manual fire alarm station provides automatic occupant notification only on the floor of alarm and not throughout the building. | Configure the fire alarm system to initiate automatic occupant notification on all floor levels to facilitate whole-building evacuation upon any manual fire alarm station activation. | Design within 3 months and installation within 9 months |
