FIRE SAFETY INSPECTION REPORT

**AMAN FASHIONS AND DESIGN LTD.
NALAM, MIRZANAGAR, ASHULIA**

ACC   **RD**
on Fire and Building Safety in Bangladesh

June 17, 2014

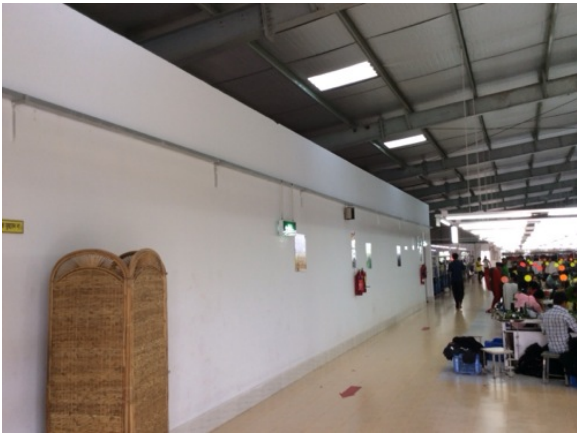
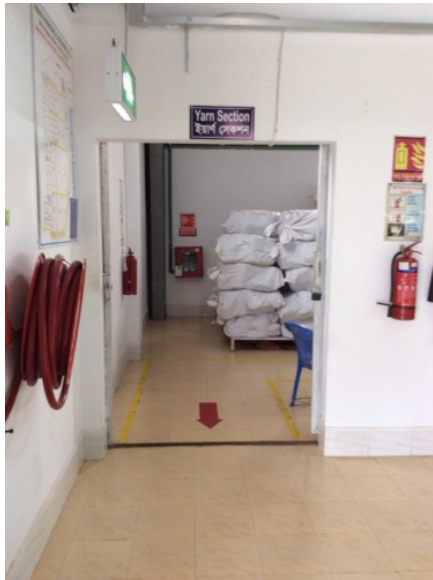
No.	Category	Finding	Recommendation	Remediation Timeframe
F-1	Fire Rated Construction	The dedicated storage area (Yarn store) was not separated from the adjacent working areas by means of fire rated construction (non-rated door and unprotected openings)	Provide dedicated storage rooms separated by minimum 1-hr fire-rated construction.	Within 3 months

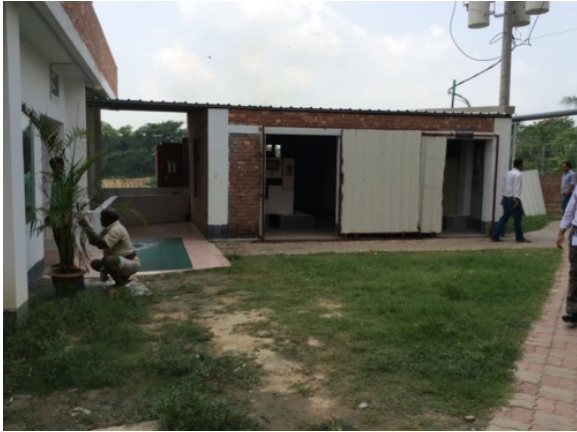
F-2	Fire Rated Construction	The boiler room is not separated from the discharge pathway of the dining area by fire-rated construction (openings, non-rated doors, penetrations).	Separate the boiler room from the discharge pathway of the dining area by a minimum 2-hr fire-rated construction. Seal and/or protected all openings to maintain the required fire separations	Within 3 months

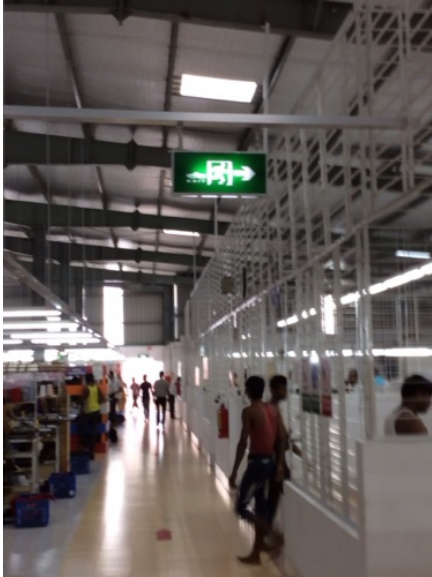
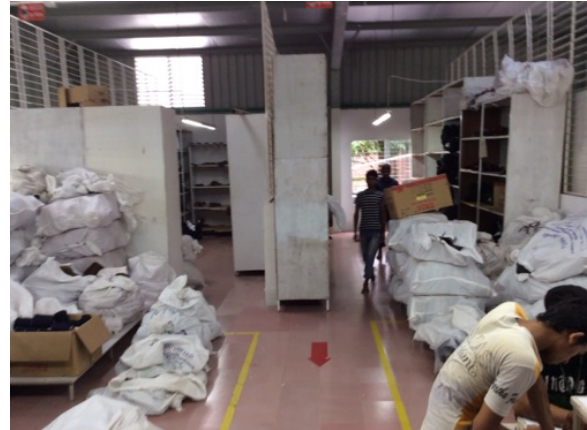
F-3	Fire Rated Construction	Transient storage areas (Distribution rooms) were not separated from the adjacent working by means of fire-rated separation (unprotected openings and non-rated door).	<p>Provide dedicated storage rooms separated by minimum 1-hr fire-rated construction.</p> <p>Where separate storage rooms are not feasible, provide defined storage areas and limit the storage arrangement as follows:</p> <ul style="list-style-type: none"> - Maximum height of 2.4m and maximum area of 23m² - If sprinkler protected: maximum height of 3.66m and maximum area of 93m² <p>Separate areas of unenclosed combustible storage by a minimum clear distance of 3m.</p>	Within 3 months
-----	-------------------------	--	--	-----------------

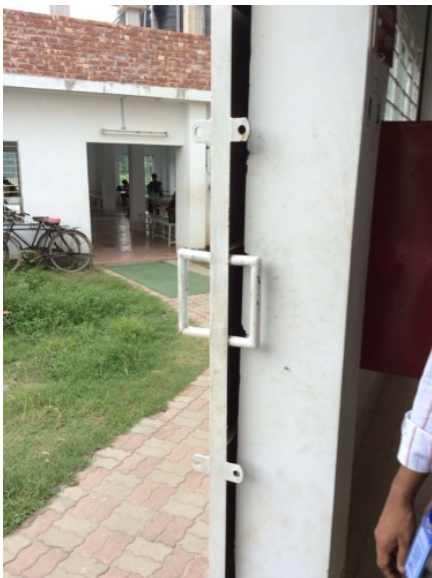
F-4 Egress

Egress doors / gates with locking features are provided along egress routes and at all building exits

Remove locking features from all egress doors / gates.

Immediate

If locks are required for security reasons, utilize special door locking features complying with NFPA 101.

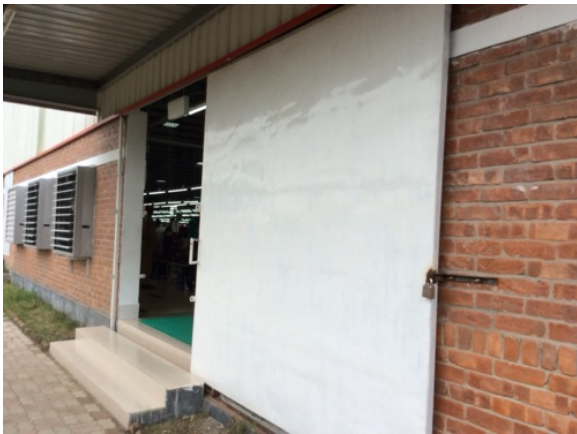
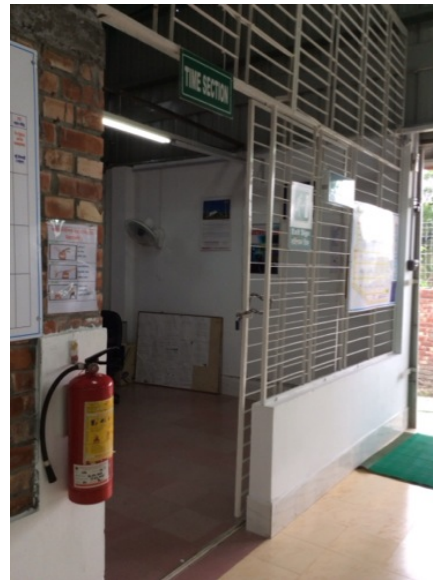
F-5	Egress	Sliding doors are provided along egress routes and at all building exits	Replace all gates / sliding doors along the means of egress with side-hinged, swinging egress doors.	Within 1 month
-----	--------	--	--	----------------

If locks are required for security reasons, utilize special door locking features complying with NFPA 101.

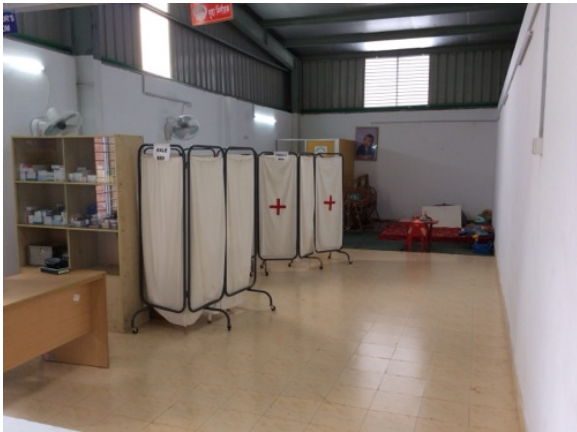
F-6	Egress	The day-care room does not have direct access to a building exit.	Provide a minimum 2-hr fire-rated exit corridor between the day-care room and exit stair.	Within 3 months
-----	--------	---	---	-----------------
