# FIRE SAFETY INSPECTION REPORT

## Tamishna Fashion Wear Ltd. (New Building)

ACCORD ID: 23640

Date: 08 July 2019

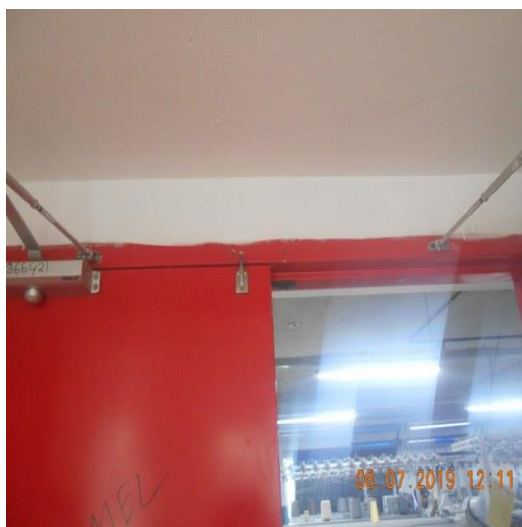
| No. | Category | Finding | Recommendation | Remediation Timeframe |
|---|---|---|---|---|
| F-1 | Fire Rated Construction | A double leaf fire door at 3 <sup>rd</sup> floor has co-ordination problem between the leaves. A damaged door coordinator has been observed. | Provide a listed door co ordinator for pair doors. Ensure proper coordination between pair leaves through proper maintenance to maintain required fire rating of 2-hr. | Within 3 months |

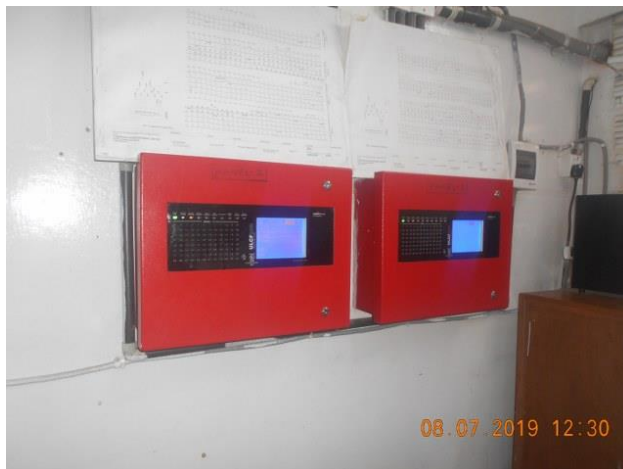
| F-2 | Egress | Fire detection & alarm system installation requires detailed review to confirm compliance with NFPA 72 and ACCORD standards. | Submit as-built testing records, listing information and other relevant documentation to the ACCORD for review and approval, modification shall have to be done as per the reviewed design (if required). Upon approval & installation/ modification the owner shall contact the Accord prior to conducting the final acceptance testing of the fire detection & alarm system installation. | Within 4 months |

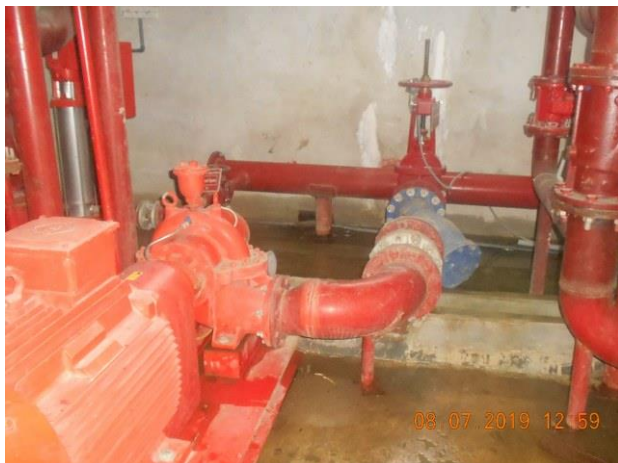
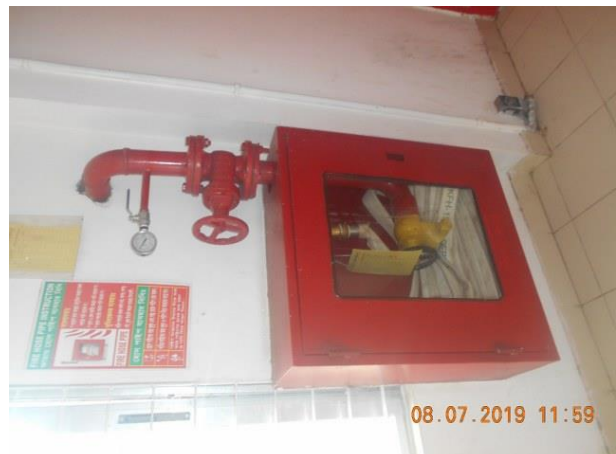
F-3 Egress Fire pump, water supply standpipe system installation requires detailed review to confirm compliance with NFPA 14, 20, 22, 25 and ACCORD standards.

Submit as built drawings, Within 4 months testing records, listing information and other relevant documentation to the ACCORD for review and approval, modification shall have to done as per the reviewed design (if required) upon approval & installation/modification the owner shall contact the Accord prior to conducting the final acceptance testing of the standpipe system installation.

Also inspect, test and maintain the standpipe system & fire pumps, and keep written records on-site, in accordance with NFPA 14, 20, 25 and ACCORD standards.
