FIRE SAFETY INSPECTION REPORT

Factory Name: Logos Apparels Ltd. Unit -2

ACCORD ID: 23269

**ADDRESS: Telerchala, Mouchak, Kaliakoir, Gazipur
24.015631, 90.303197**

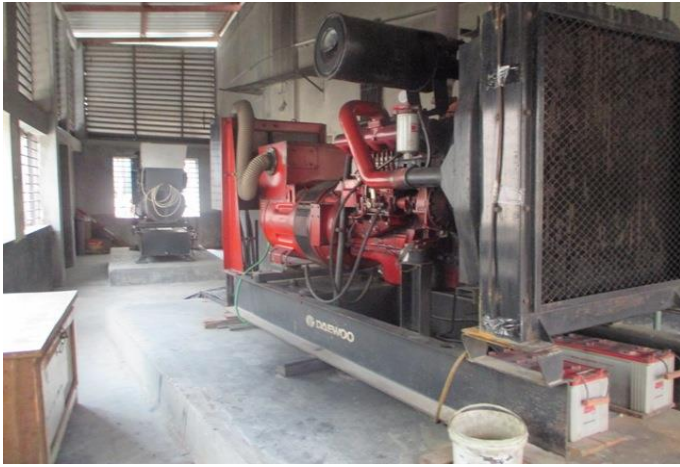
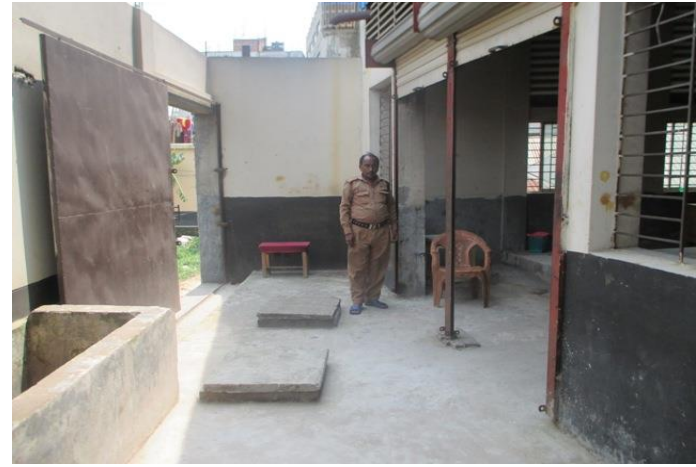
SI No.	Category	Findings	Required Action	Remediation Time Frame
1	Fire Rated Construction	Generator is not separated from the rear egress discharge at Ground Floor Utility Shed Building	Provide minimum 2-Hr Fire Separation to each occupancy surrounding generator	Within 3 months

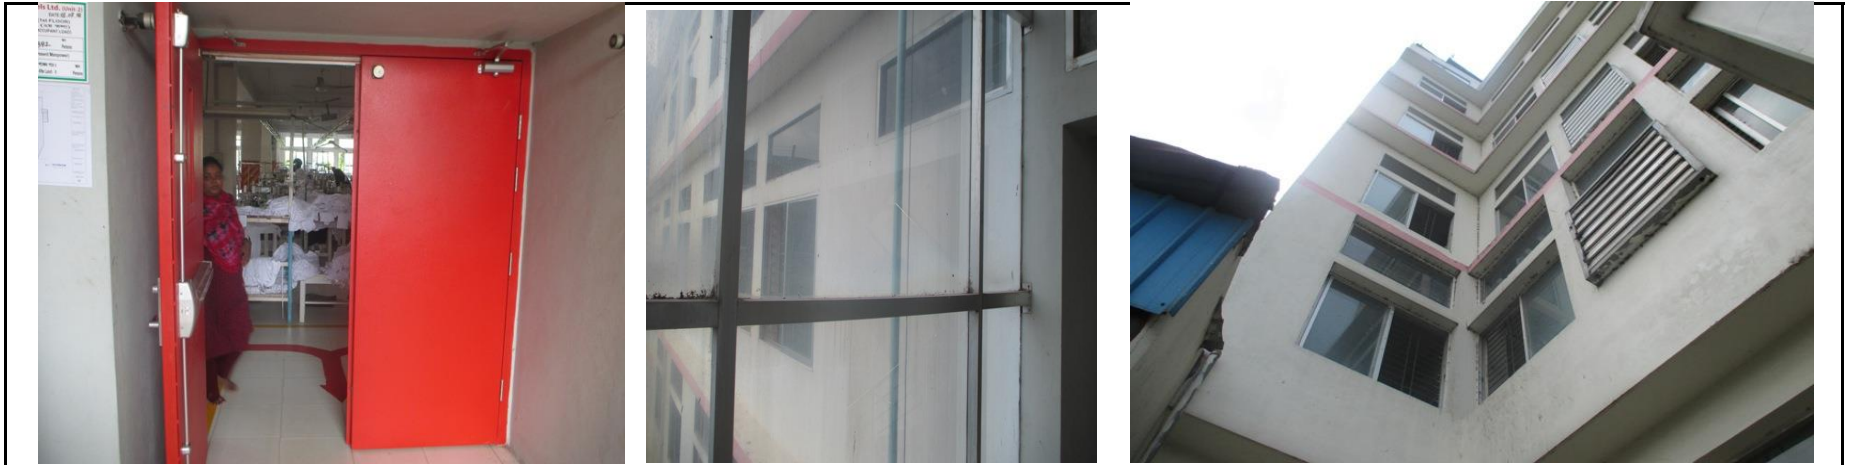
2	Fire Rated Construction	<p>The exit stair enclosures are separated from work areas and other spaces on each floor by fire-rated construction. Fire Doors have been provided with proper hour rating. But doors are kept open and installation of magnetic hold open device to interface with Fire Alarm System have been done but the devices are not interfaced with any approved FACP. Moreover Exit stair enclosures have unprotected openings within 10 feet towards production floor at two stairs.</p>	<p>The exit stair enclosure shall be provided with a minimum 1-hr fire resistance rating for buildings with 3 or fewer stories and a minimum of 2-hr. fire resistance rating for buildings 4 or more stories. Provide 0.75 hr. fire rated door and seal all penetrations and openings by 1 hr. fire rated fire rated barrier construction for building with 3 or fewer stories. Provide 1.5 hr. fire rated door and seal all penetrations and openings by 2 hr. fire rated fire rated barrier construction for building with 4 or more stories.</p> <p>Provide a fire-resistive rated assembly between the exterior exit stairs and the building up to 10 ft. beyond the end of the stair to achieve the required separation. The rated assembly shall be approved and/or designed by a qualified fire protection engineer.</p> <p>Ensure that the fire doors are self-closing and positive latching and that they are provided with fire exit (panic) hardware where serving production floors. If fire doors are required to be held open for functional reasons, provide automatic closing devices tied to the fire alarm system.</p>	Within 3 months

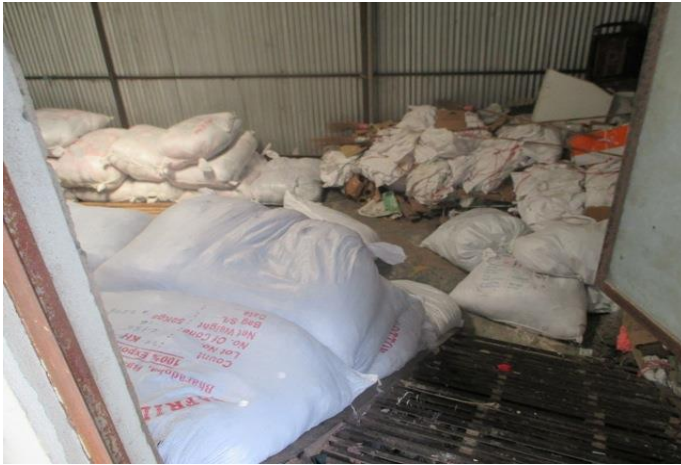
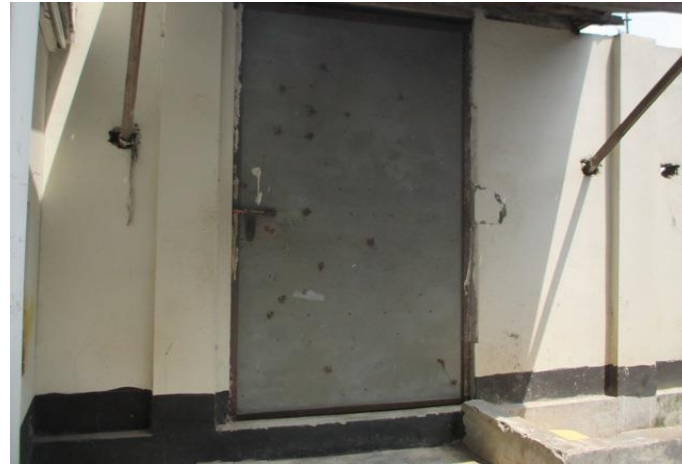
3	Fire Rated Construction	<p>Rooms used for combustible storage are not separated by fire rated construction. Location: wastage go down shed at ground floor adjacent to the mail building</p>	<p>Separate the dedicated storage rooms by minimum 1-hr fire-rated construction. Provide 0.75 hr. fire rated door and seal all penetrations and openings by 1 hr. fire rated fire rated barrier construction.</p>	Within 3 months
---	-------------------------	---	---	-----------------

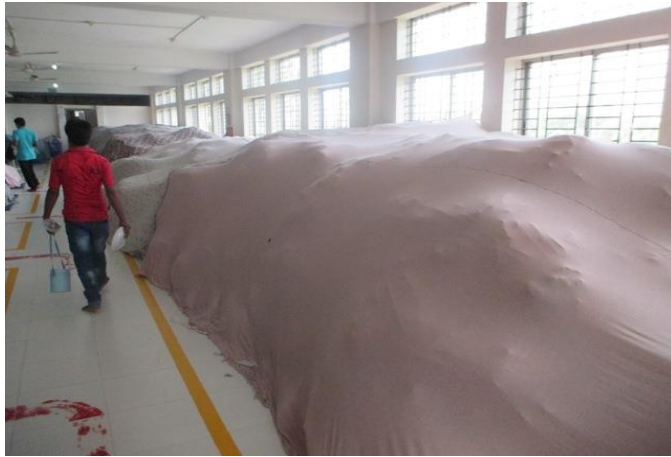
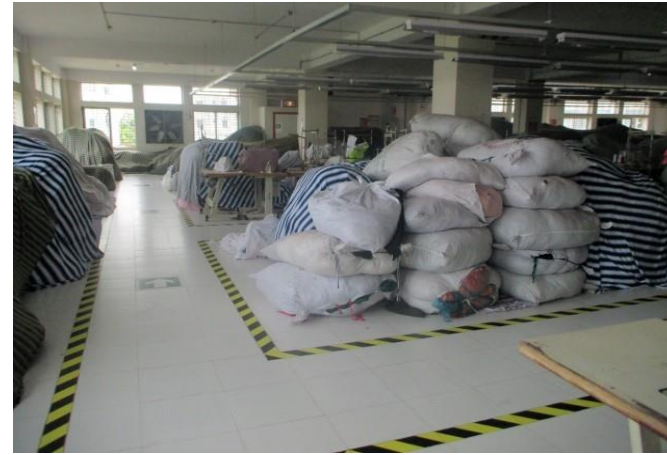
4	Fire Rated Construction	Areas used for in-process storage of combustible materials are open to the surrounding occupancy (specify the occupancy/area, location)	<p>Provide defined storage areas and limit the storage arrangement as follows:-</p> <ol style="list-style-type: none"> 1. General Condition: Maximum height of 2.4m and maximum area of 23m². Separate areas of unenclosed combustible storage by a minimum clear distance of 3m. 2. If sprinkler protected: maximum height of 3.66m and maximum area of 93m². Separate areas of unenclosed combustible storage by a minimum clear distance of 3m. <p style="text-align: center;">or</p> <ol style="list-style-type: none"> 3. Enclose the storage area from the surrounding occupancy with a minimum 1 hour construction. 	Within 3 months
---	-------------------------	---	---	-----------------

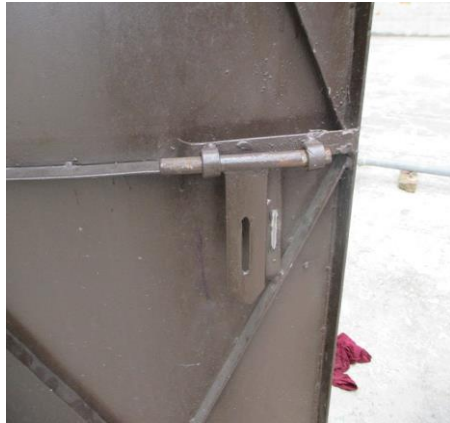
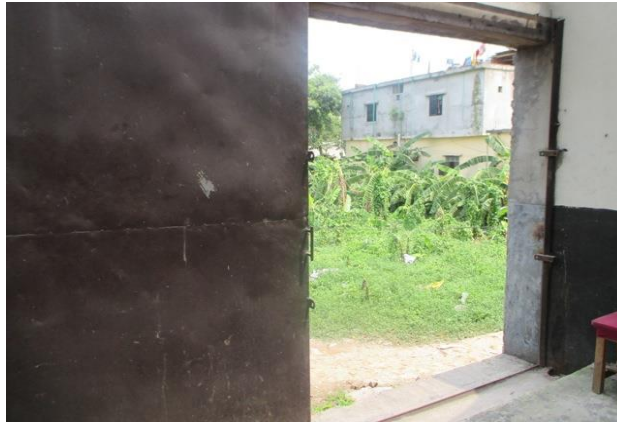
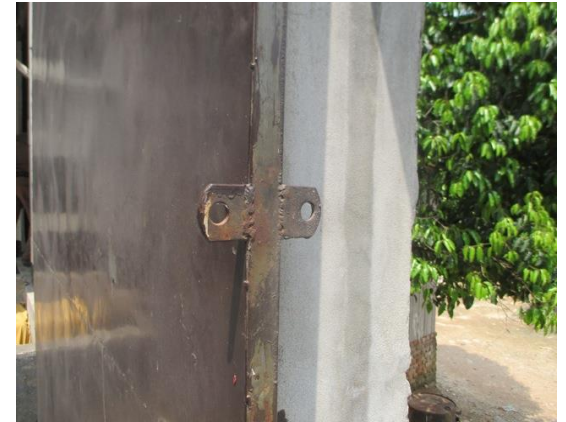
5	Egress	Doors along means of egress are provided with non compliant locking system.	<ol style="list-style-type: none"> 1. Remove all non compliant locking features from egress doors. 2. If locks are required for security reasons, utilize special door locking features complying with NFPA 101. 3. Doors may be locked where the latch and lock are disengaged with one motion where the occupant load does not exceed 49 persons. 4. Doors may be provided with locking hardware from the ingress side provided that a panic bar is installed on any door with an occupant load exceeding 49 persons. 	Immediate
---	--------	---	---	-----------

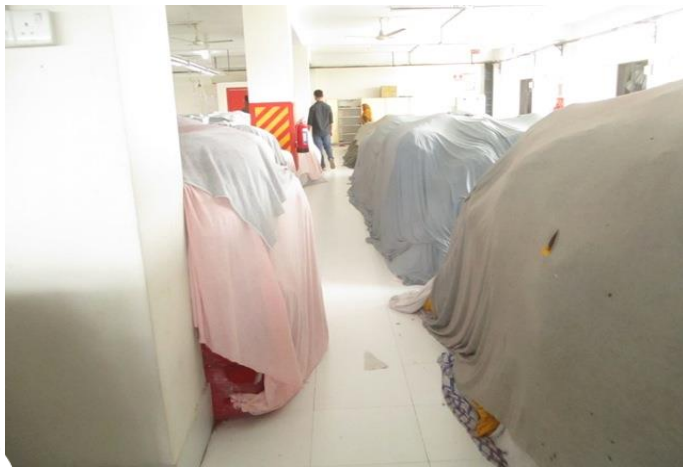
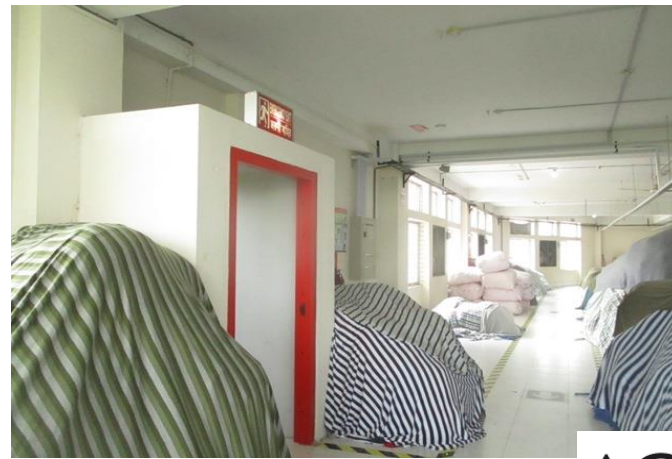
6	Egress	Aisles along means of egress has interrupted by obstruction/storage.	Means of egress shall be maintained continuously free and clear of all obstructions/storage. Or Keep egress paths and stairs clear of storage.	Immediate
---	--------	--	--	-----------

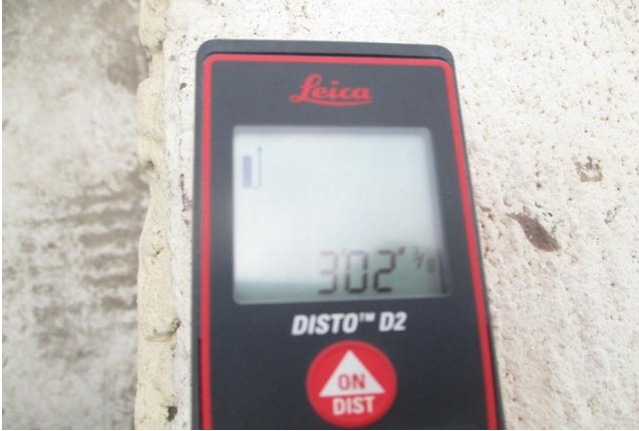
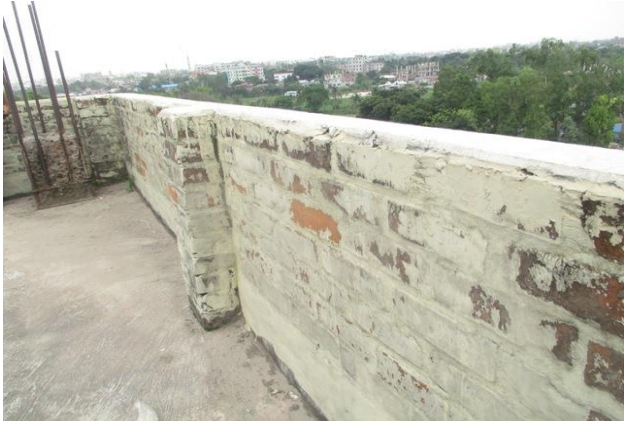
7	Egress	Parapets or guards are not provided in occupiable roof less than 42 inches	Provide parapets or guards with a minimum height of 1067mm (42 inch.).	within 1 month
<div style="display: flex; justify-content: space-around;">

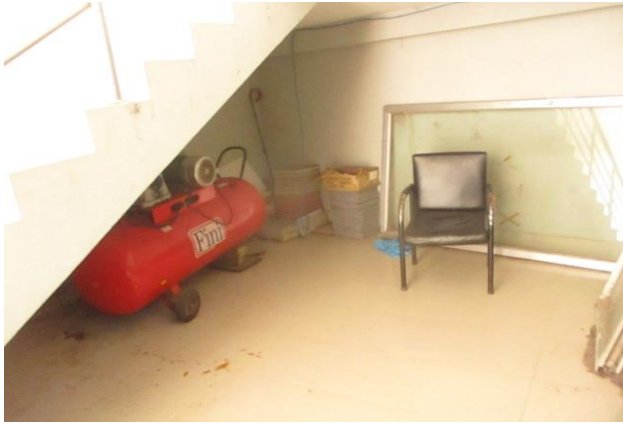
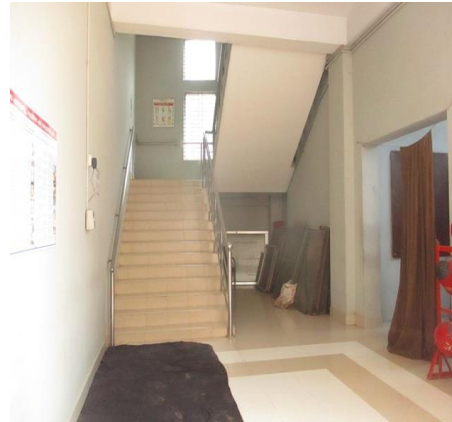
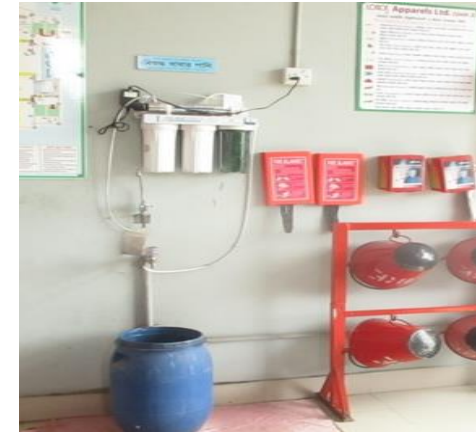
</div>				
8	Egress	Storage (Debris, Air compressor, Drinking water section) were located in the exit stair.	Remove all kind of storage from the exit stairs.	Immediate

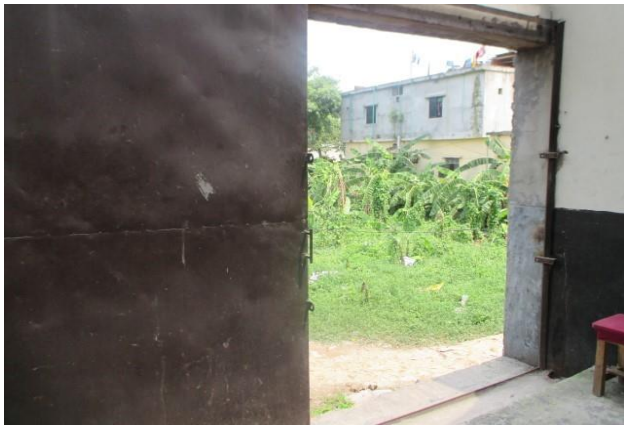
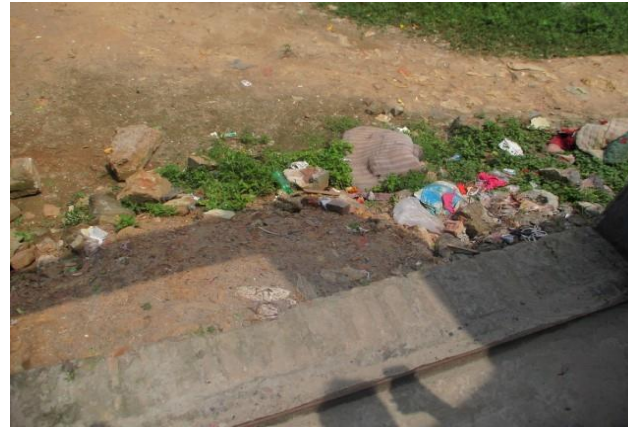
9	Egress	The exit discharge path of East middle exit stair is totally unusable. Location: southeast exit discharge path.	Make a road / egress path for smooth discharge of occupants. Means of egress shall be maintained continuously free and clear of all obstructions.	Immediate
---	--------	---	---	-----------

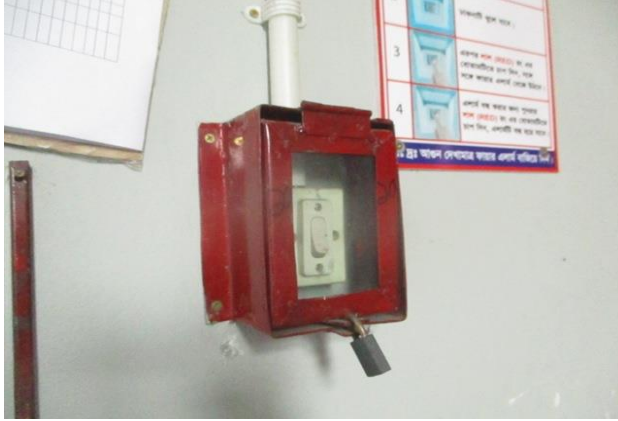
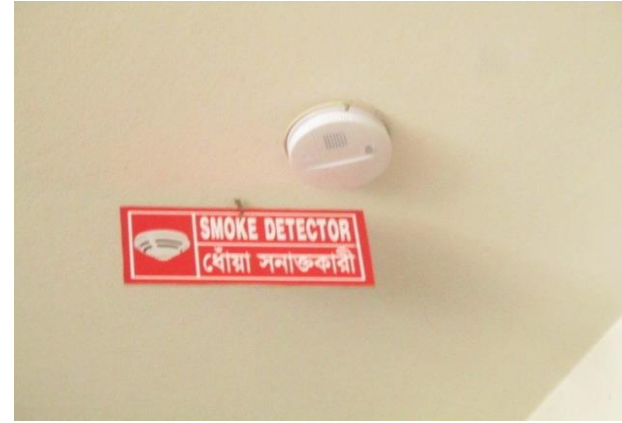
10	Fire Detection and Alarm System	The Fire Alarm System is antiquated and not listed. Reviewed design of fire alarm system was not found during inspection	Submit the as-built design of fire alarm system to Accord in accordance with NFPA 72. Installation of the system should be as per the reviewed design.	Design within 3 months and installation within 9 months
----	---------------------------------	--	--	---

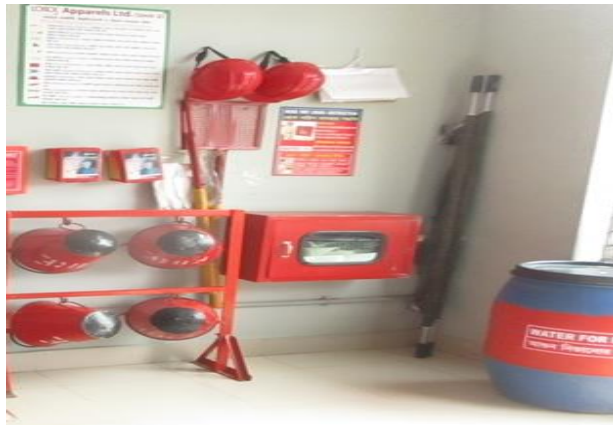
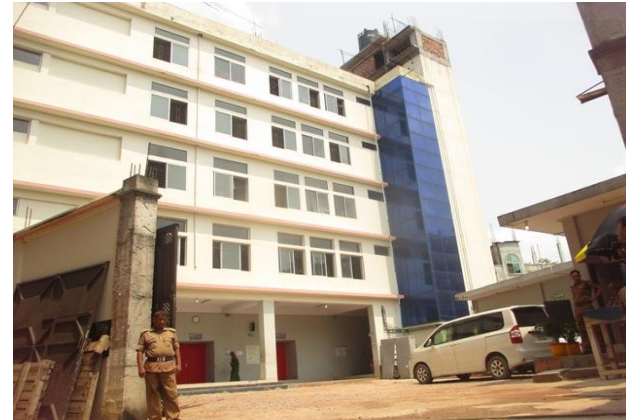
12	Fire Protection System	The existing factory building with an occupiable floor greater than 10 m (33 ft) above the finished grade is not protected with an approved standpipe system. Reviewed design was not found during follow-up inspection	Submit the as-built design of fire fighting system to Accord in accordance with NFPA 14 & installation should be as per the reviewed design	Design within 3 months and installation within 9 months
----	------------------------	---	---	---
