# **FIRE SAFETY INSPECTION REPORT**

**CHANTIK GARMENTS LTD.**

**KUMKUMARI, GOURIPUR, ASHULIA, SAVAR, DHAKA**

May 17, 2014

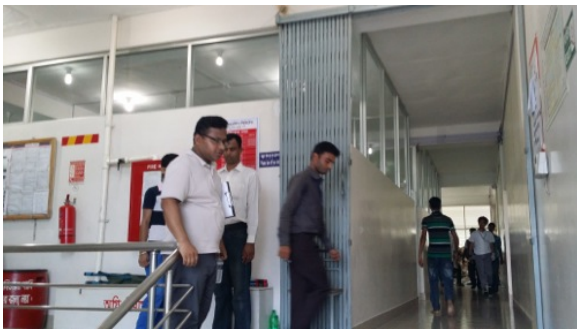
No.	Category	Finding	Recommendation	Remediation Timeframe
F-1	Fire Rated Construction	The exit stairs are not separated from work areas, and other spaces on each floor by fire-rated construction. This was reflected throughout the building on all floors.	<p>Provide minimum 1.5-hr fire rated doors and seal all unprotected openings to separate the exit stairs from work areas and other building spaces on all floor levels. Ensure that the fire doors are self-closing and positive latching and that they are provided with fire exit (panic) hardware where serving production floors.</p> <p>If fire doors are required to be held open for functional reasons, provide automatic-closing devices tied to the fire alarm system.</p>	Within 3 months

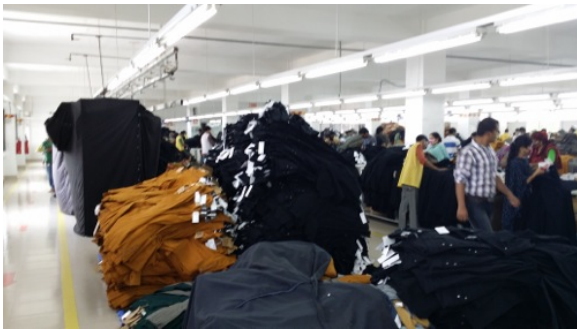
F-2	Fire Rated Construction	Areas used for combustible storage are not separated by fire-rated construction. This was reflected throughout the building on various floors.	Provide dedicated storage rooms separated by minimum 1-hr fire-rated construction.  Where separate storage rooms are not feasible, provide defined storage areas and limit the storage arrangement as follows: - Maximum height of 2.4m and maximum area of 23m <sup>2</sup> - If sprinkler protected: maximum height of 3.66m and maximum area of 93m <sup>2</sup>  Separate areas of unenclosed combustible storage by a minimum clear distance of 3m.	Within 3 months
-----	-------------------------	--	--	-----------------

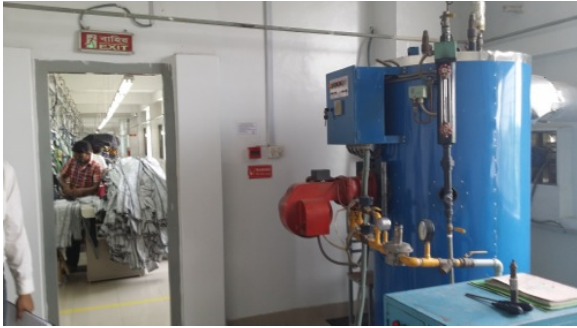
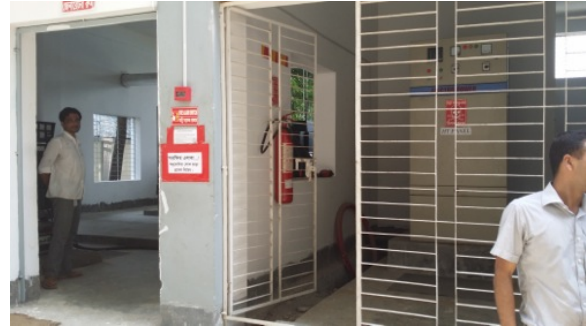
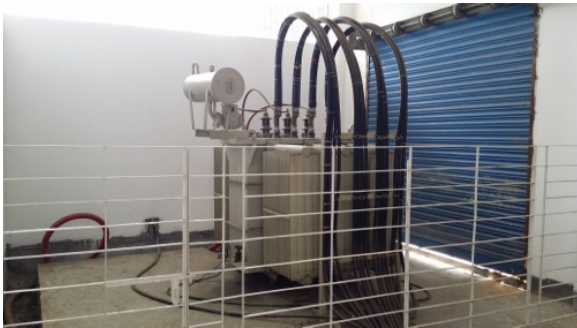
F-3	Fire Rated Construction	The boiler, generator, and transformer room located on the ground floor, is not separated by fire-rated construction, openings, non-rated doors, and penetrations.	Separate the boiler, generator, and transformer room by a minimum 2-hr fire-rated construction. Seal and/or protected all openings to maintain the required fire separations	Within 3 months
-----	-------------------------	--	--	-----------------

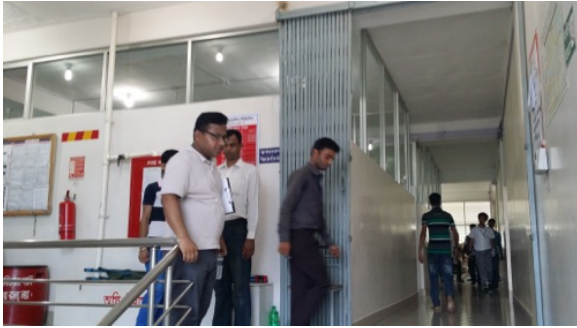
F-4	Fire Rated Construction	Unsealed penetrations and openings are located in exit stair enclosures, specifically located in the north stairwell, on second floor.	Seal all penetrations and openings in exit stair enclosure walls to maintain the fire separation.	Within 3 months
-----	-------------------------	--	---	-----------------

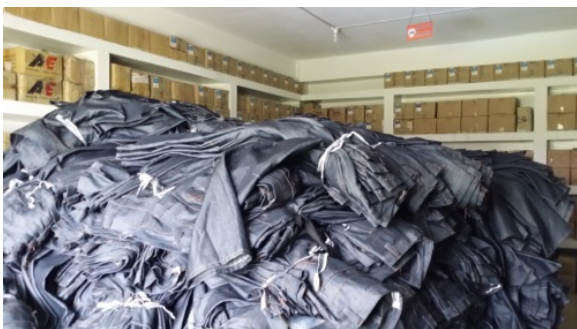
F-5	Fire Rated Construction	Storerooms used for combustible storage are not separated by fire-rated construction. This was reflected throughout the building on various floors.	Provide dedicated storage rooms separated by minimum 1-hr fire-rated construction.	Within 3 months
-----	-------------------------	---	--	-----------------

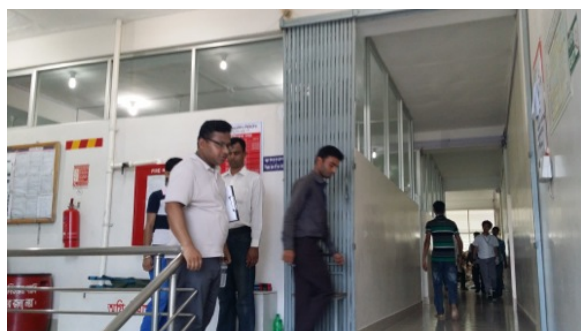
F-6	Egress	Egress doors / gates with locking features are provided at building exits, exit stairs, along egress routes, and exit discharge. This was reflected throughout the building on all floors.	Remove locking features from all egress doors / gates.  If locks are required for security reasons, utilize special door locking features complying with NFPA 101.	Immediate
-----	--------	--	--	-----------

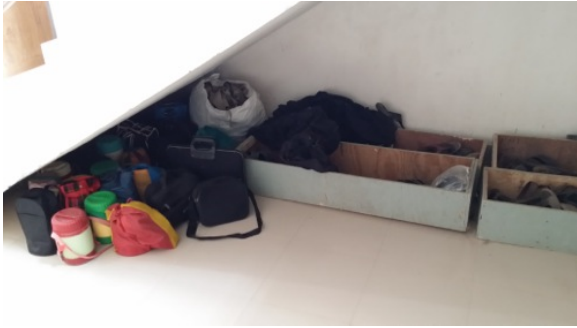
F-7	Egress	Storage areas were located in all exit stairwells on the ground floor, underneath the stairs.	Remove all storage from exit stairs and egress paths.	Immediate
-----	--------	---	---	-----------

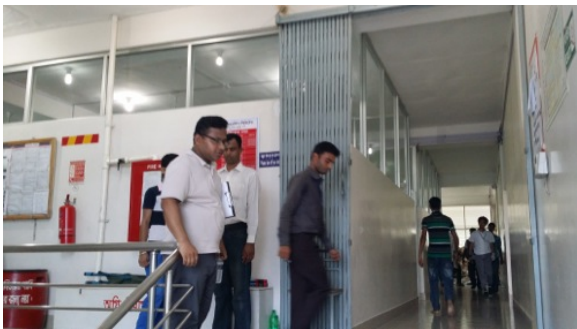
F-8	Egress	Collapsible gates / sliding doors are provided at building exits, exit stairs, along egress routes, and exit discharge. This was reflected throughout the building on all floors.	Replace all gates / sliding doors along the means of egress with side-hinged, swinging egress doors.  If locks are required for security reasons, utilize special door locking features complying with NFPA 101.	Within 1 month
-----	--------	---	--	----------------

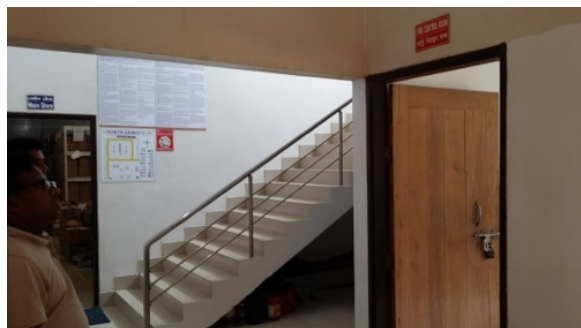
F-9	Egress	Handrails on both sides were not provided in each exit stairwell.	Provide handrails on at least one side of exit stair.	Within 3 months
-----	--------	---	---	-----------------

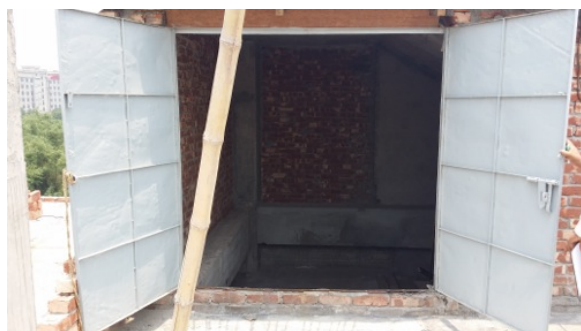
F-10	Egress	Non rated exit fire doors on the roof floor within all exit stairwells does not swing in the direction of egress travel.	Modify the egress door to swing in the direction of egress travel.	Within 3 months
------	--------	--	--	-----------------

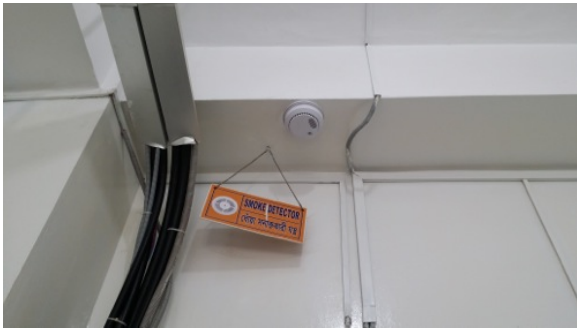
F-12	Fire Protection	The building is equipped with single-station smoke alarms. Smoke alarm activation sounds only a local alarm and does not provide automatic fire alarm notification of occupants.	Replace the single-station smoke alarms. Provide automatic smoke detection throughout the building in accordance with NFPA 72.	Within 6 months
------	-----------------	--	--	-----------------

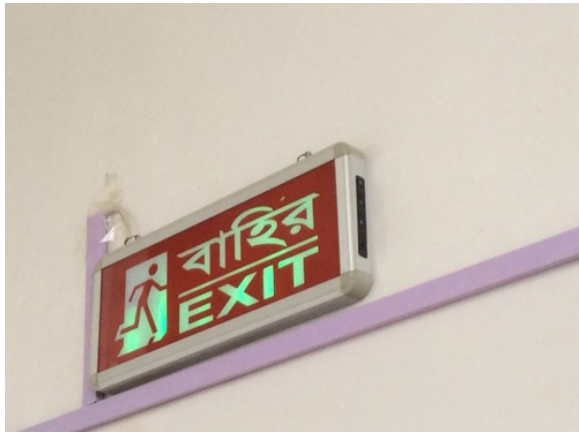
F-13	Egress Lighting	Manual on-off switch is provided for emergency lighting units. This was reflected throughout the building in various locations.	Remove manual on/off switches from emergency lighting units to prevent them from being switched off.	Within 1 month
------	-----------------	---	--	----------------

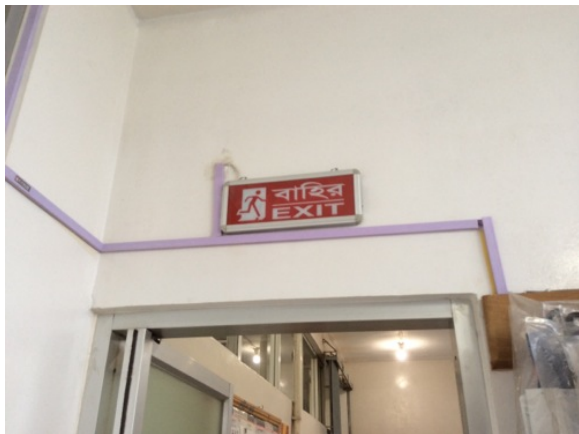
F-14	Egress Lighting	Exit signage not illuminated (burned out, broken, etc.). This was reflected throughout the building on various floors.	Regularly inspect all exit signage and replace/install lights as needed to illuminate signs.	Within 1 month
------	-----------------	--	--	----------------
