# FIRE SAFETY INSPECTION REPORT

**Croydon-Kowloon Designs Ltd**

**Plot# 285-288, Dhaka EPZ (Extension Area), Ganakbari, Ashulia, Savar, Dhaka**

**Date: 08 July, 2019**

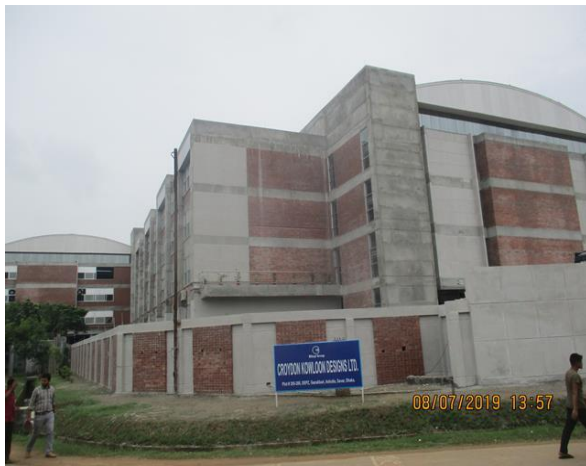
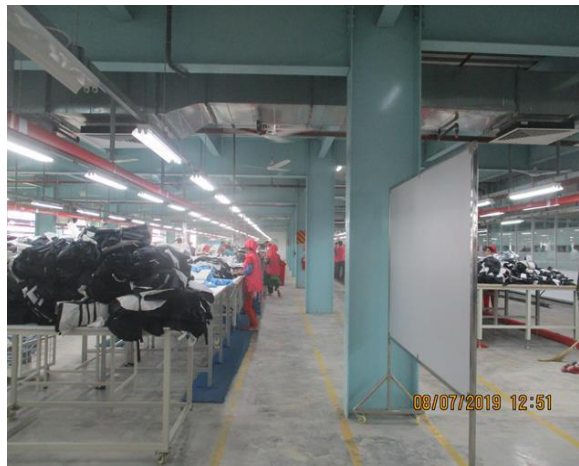
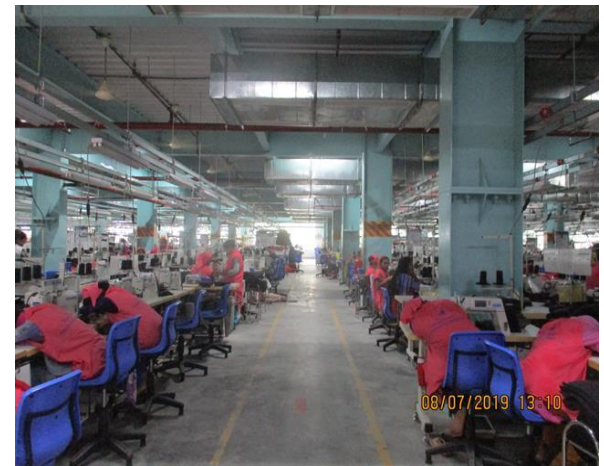
| SI No. | Category | Findings | Required Action | Remediation Time Frame |
|---|---|---|---|---|
| F-01 | Fire Rated Construction | The main structural element of the building is constructed by steel (Except stair enclosure portion) which is non-rated and were found in exposed condition without any fire protection. | The building shall be type-I construction. So, provide require rating in the structural elements of the building. Consult with a qualified fire protection engineer. BNBC 2006-Table 3.2.4 | Within 6 months |

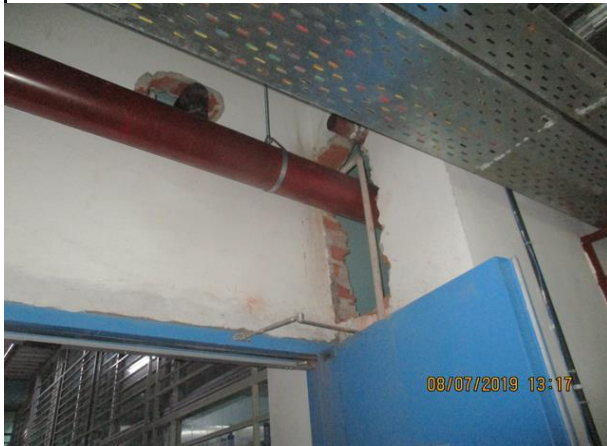
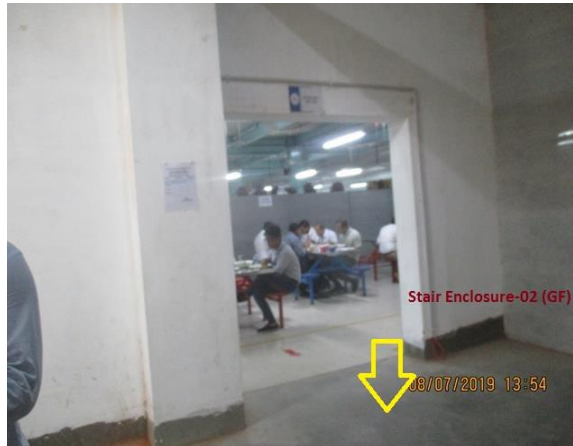
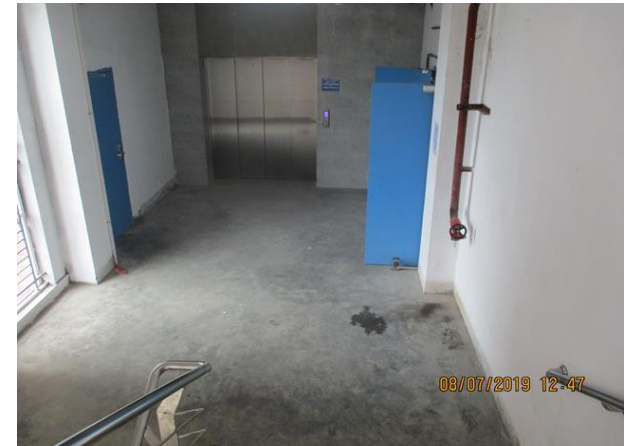
| F-02 | Fire Rated Construction | <p>The exit stairs are not separated from work areas and other spaces on each floor by fire rated construction. Fire rated door was not installed with stair-2 on ground floor installed fire doors were non-functional, unprotected penetrations were available in the fire rated wall of enclosure.</p> | <p>The exit stair enclosure shall be provided with a minimum 1-hr fire resistance rating for buildings with 3 or fewer stories and a minimum of 2-hr. fire resistance rating for buildings 4 or more stories. Provide 0.75 hr. fire rated door and seal all penetrations and openings by 1 hr. fire rated fire rated barrier construction for building with 3 or fewer stories. Provide 1.5 hr. fire rated door and seal all penetrations and openings by 2 hr. fire rated fire rated barrier construction for building with 4 or more stories.</p> <p>Ensure that the fire doors are self-closing and positive latching and that they are provided with fire exit (panic) hardware where serving production floors. If fire doors are required to be held open for functional reasons, provide automatic closing devices tied to the fire alarm system.</p> | Within 3 months |

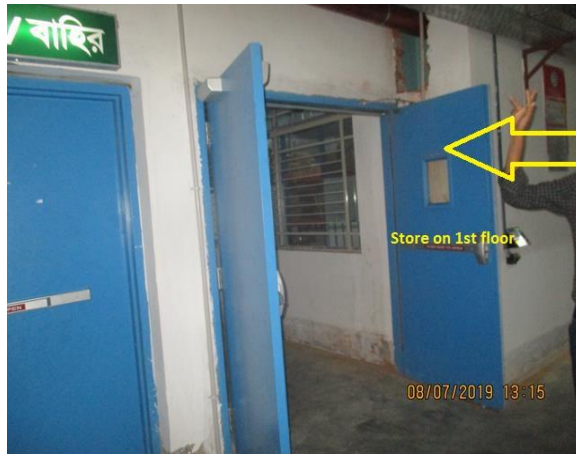
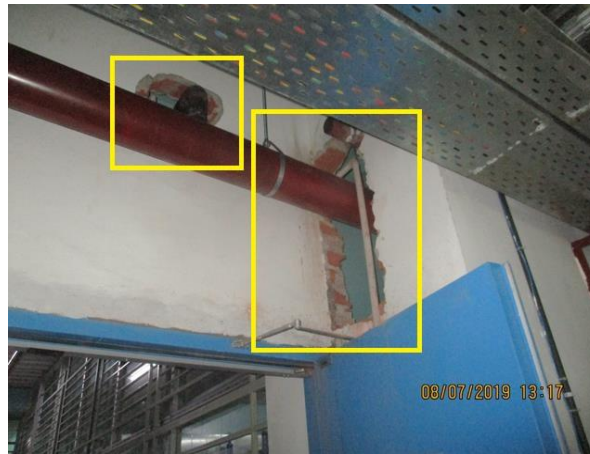
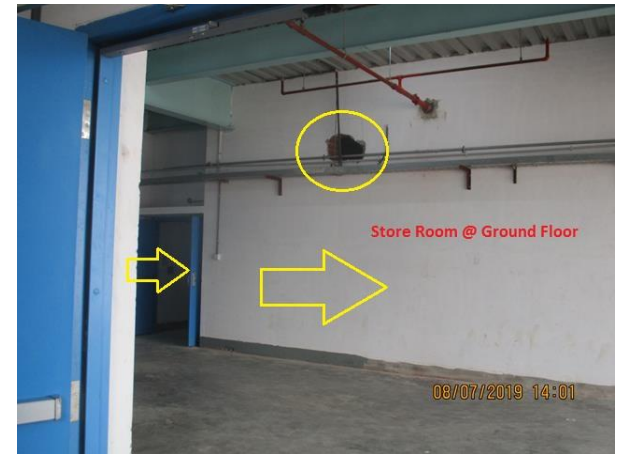
| F-03 | Fire Rated Construction | <p>Rooms used for combustible storage are not separated by fire rated construction due to unprotected penetrations of in fire wall and non-functionality of fire rated doors. The doors were kept open using magnetic door hold open device incorporating interfacing facility with fire alarm system but the fire alarm system installation was not complete.</p> <p><b>Location:</b> Ground and 1st floor.</p> | <p>Separate the dedicated storage rooms by minimum 1-hr fire-rated construction. Provide 0.75 hr. fire rated door and seal all penetrations and openings by 1 hr. fire rated fire rated barrier construction.</p> | Within 3 months |

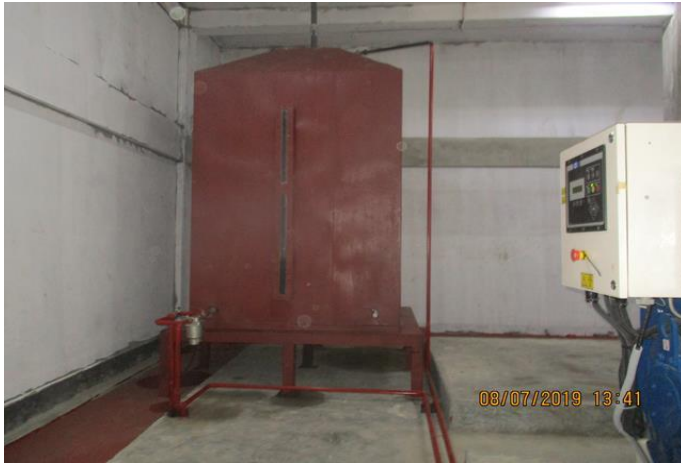
| F-04 | Fire Rated Construction | Diesel fuel storage (8000 L) was located inside the generator room. | Remove all diesel fuel storage from the generator room and relocate to the exterior such that the diesel fuel storage is at least 10 ft from required egress paths. If located along egress paths or in a utility building, separate the diesel fuel storage with 2- hr fire rated construction. | Within 3 months |

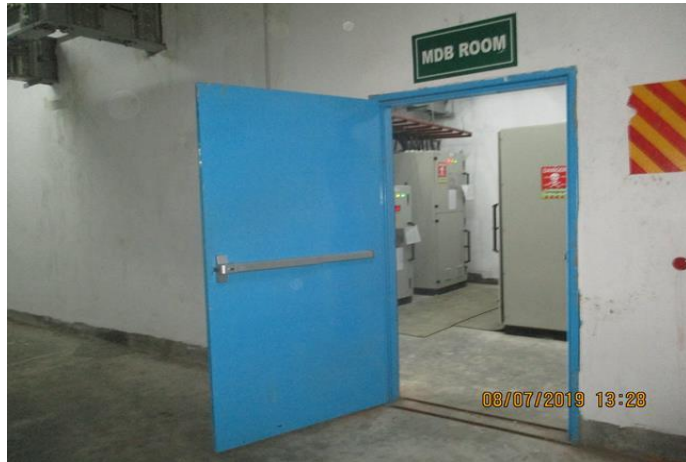
| F-05 | Fire Rated Construction | <p>MDB room was properly separated by fire rated construction but the installed fire rated door was not functional as required.</p> <p><b>Location:</b> Ground floor of the main building.</p> | <p>Ensure that the fire doors are self-closing and positive latching and that they are provided with fire exit (panic) hardware where serving production floors.</p> <p>If fire doors are required to be held open for functional reasons, provide automatic closing devices tied to the fire alarm system.</p> | Within 3 months |

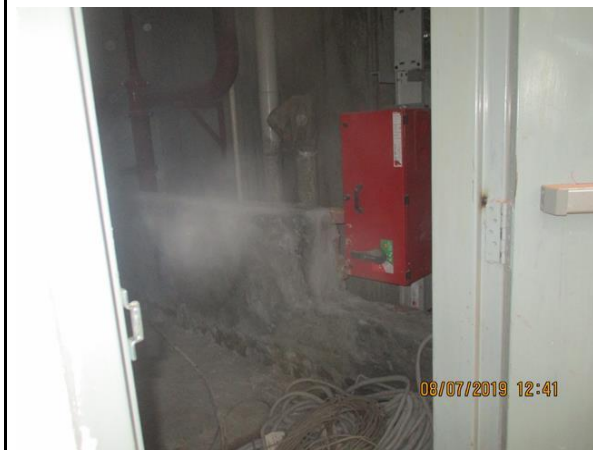
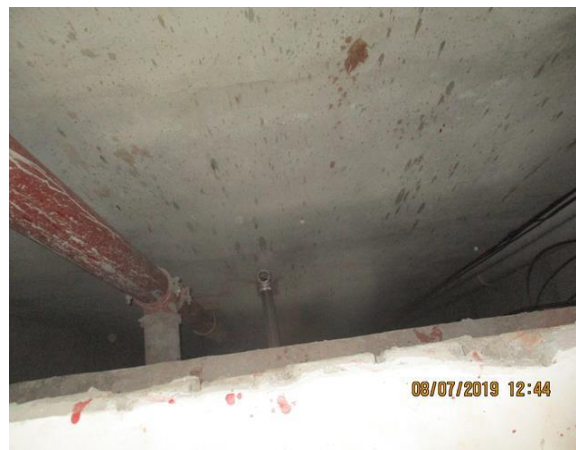
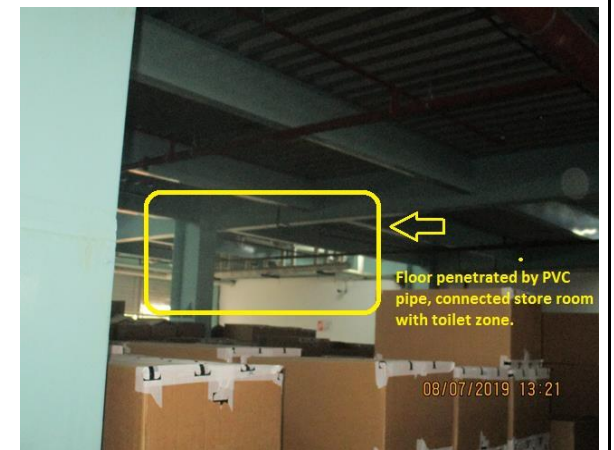
| F-07 | Fire Rated Construction | <p>Unsealed penetrations and openings are located in the fire-rated floor/ceiling assemblies.</p> <p><b>Location:</b> Utility riser on every floor and PVC pipe connected with store and toilet.</p> | Seal all penetrations and openings in floor/ceiling assemblies to maintain the fire separation at least by 2-hr. The used sealer shall be 3rd party certified and installation shall be as per manufacturer's datasheet. | Within 1 months |

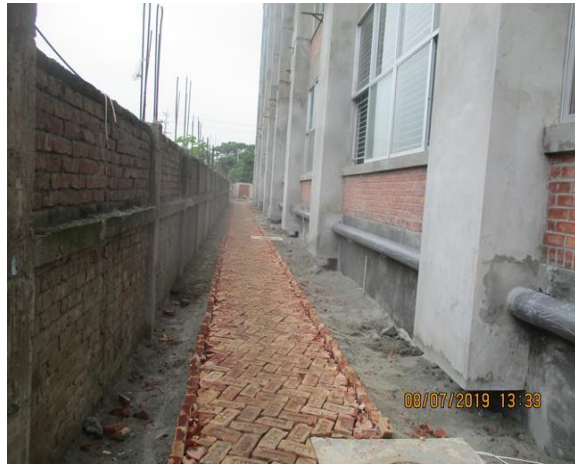
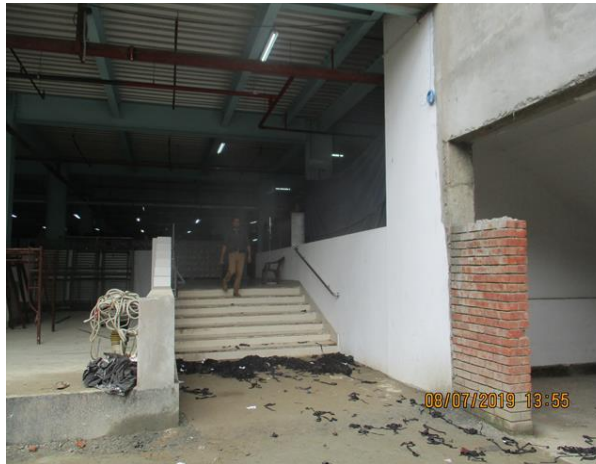
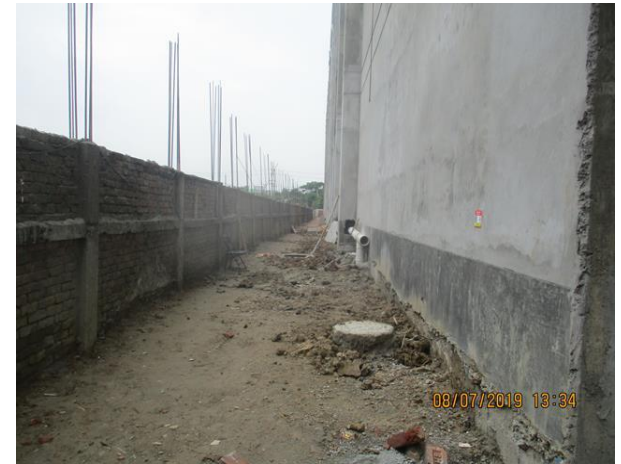
| F-08 | Fire Rated Construction | The egress court for southside & north-east side (stair-2) were less than 10 ft. wide but not separated from the building interior. | Seal all penetrations and openings to the interior of the building along the discharge path up to a height of 10 ft. to provide a minimum 2-hr fire separation. | Within 3 months |

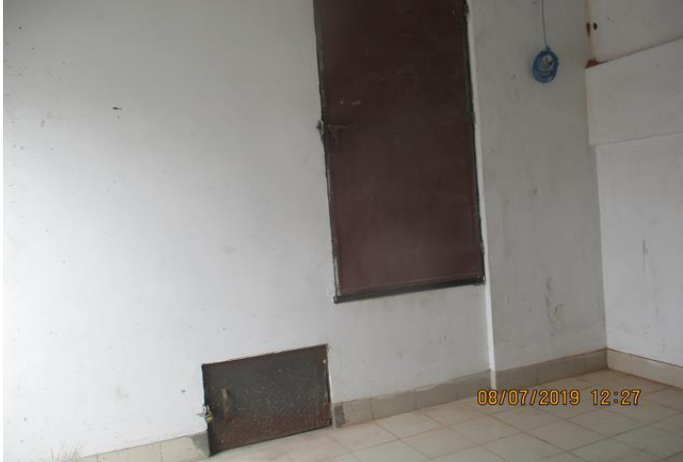
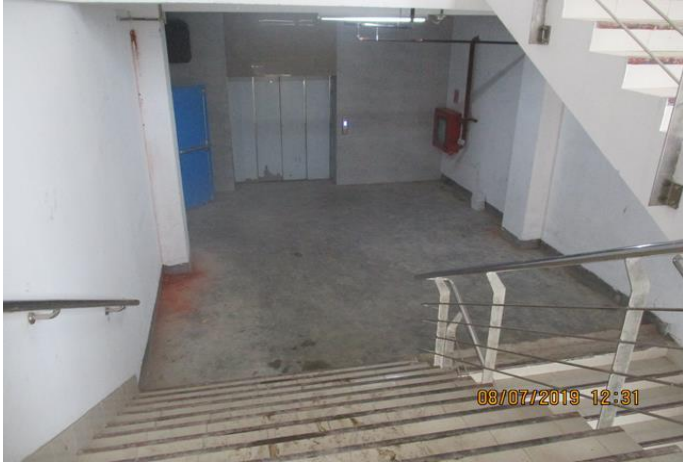
| F-09 | Fire Rated Construction | Elevator machine rooms were directly open to the stair enclosure without any fire separation. | Either redirect the door opening of machine room towards open roof or provide 1.5 hour fire rated opening protective assemblies. The selected assemblies shall be recognized 3rd party certified. | Within 3 months |

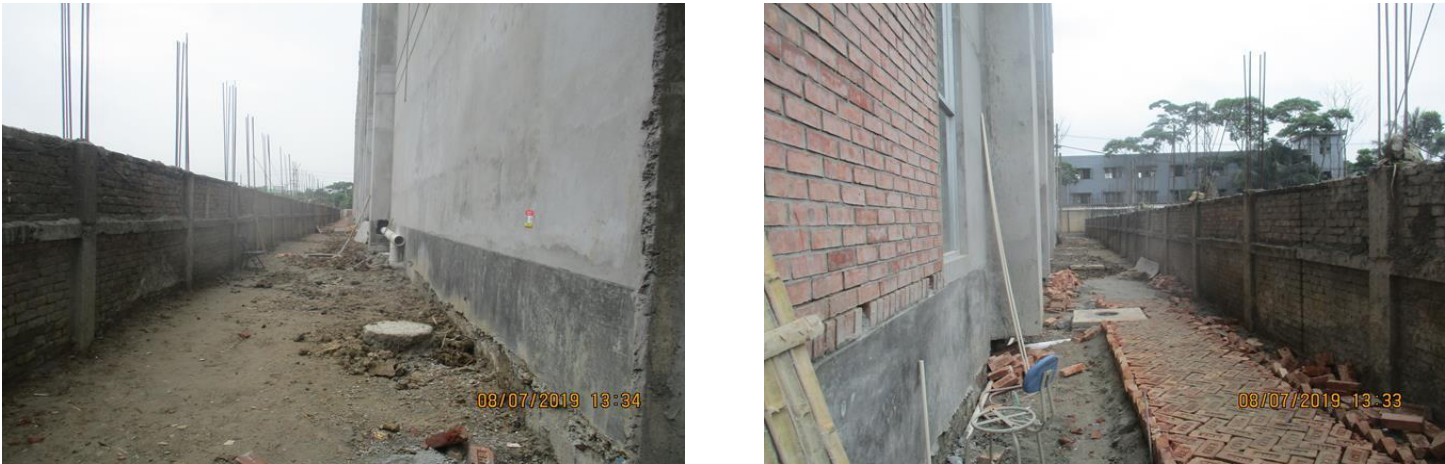
| F-10 | Means of Egress | Egress court on south side were temporarily obstructed as the path was in under construction process. | Finish the construction work immediately as the egress path shall be unobstructed all the time for safe evacuation during any emergency. | Immediately |

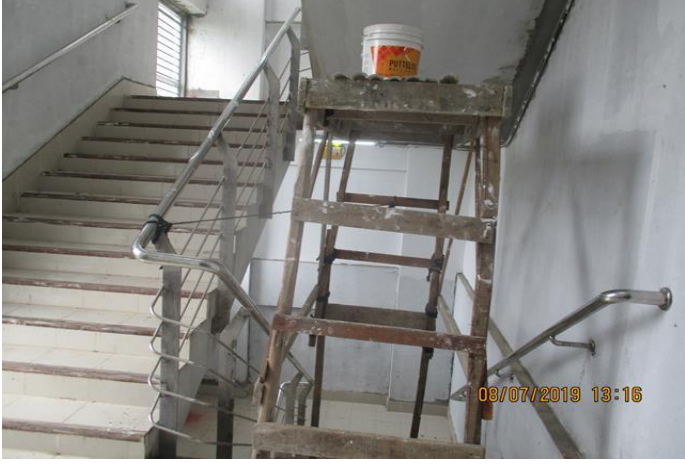
| F-11 | Means of Egress | Obstructions was located inside of exit stair-3 on 2nd floor. | Remove all obstructions from exit stairs and egress paths. | Immediate |

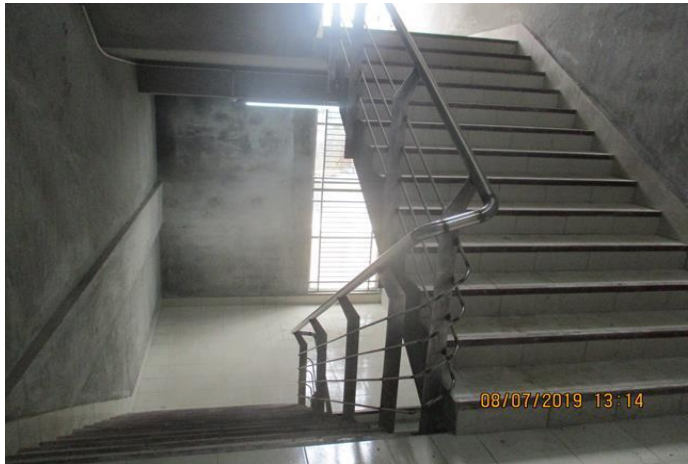
| F-12 | Means of Egress | Handrails were not provided on both sides of the southeast stair (stair-04) on all floors. | Provide handrails on both sides of the exit stair. Intermediate handrails shall be provided when the stair width exceeds 2.2 m (87 in.). New handrails shall have a minimum height of 865 mm (34 in.) and a maximum height of 965 mm (38 in.) as measured from the leading edge of the tread. | Within 1 month |

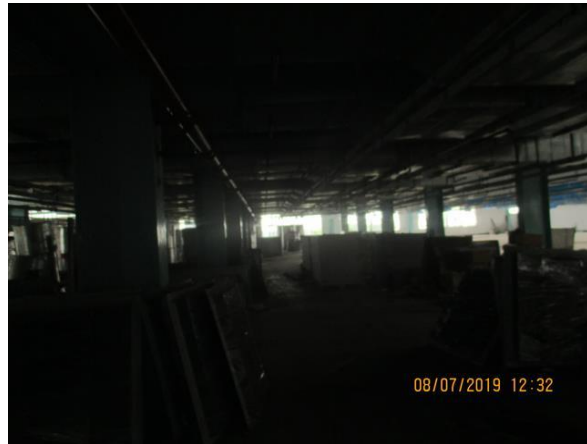
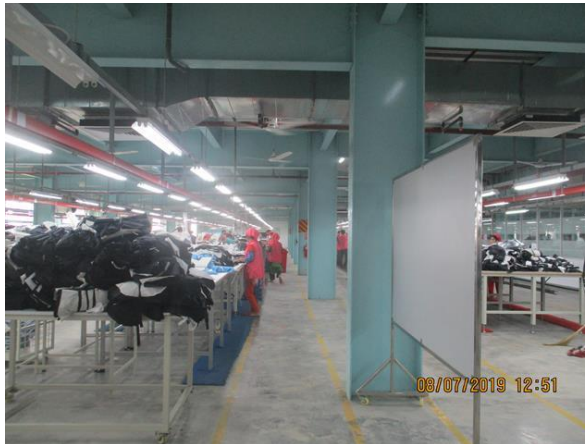
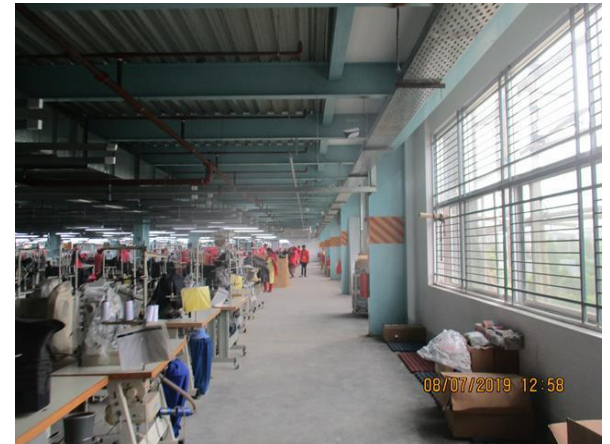
| F-13 | Egress Lighting | Based on the number and location of emergency lights observed, adequate illumination levels are not anticipated along egress routes and at exit stairs on all floors. | Test the emergency lighting system on each floor and provide additional emergency fixtures to supply adequate illumination along the means of egress. Provide a minimum illumination of 10 lux at the floor level within exit stairs and along exit discharge paths and a minimum 2.5 lux along exit access aisles. | Within 3 months |

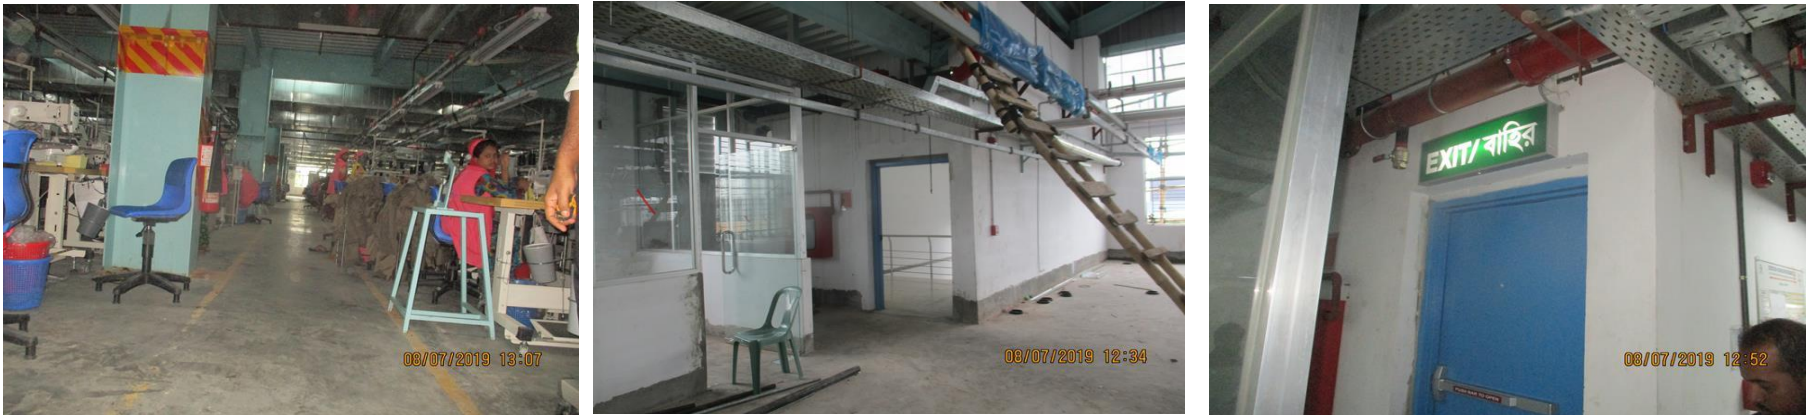
| F-14 | Egress Lighting | Exit sign not provided at every exit and other required location. | <p>Lighted exit signs shall be placed at entrance to an exit.</p> <p>Additional exit signs shall be placed throughout the facility anywhere the continuation of the egress is not obvious.</p> <p>Lighted exit signs shall be provided with either battery backup or uninterruptable power supply systems and shall be continuously illuminated.</p> | Within 1 month |

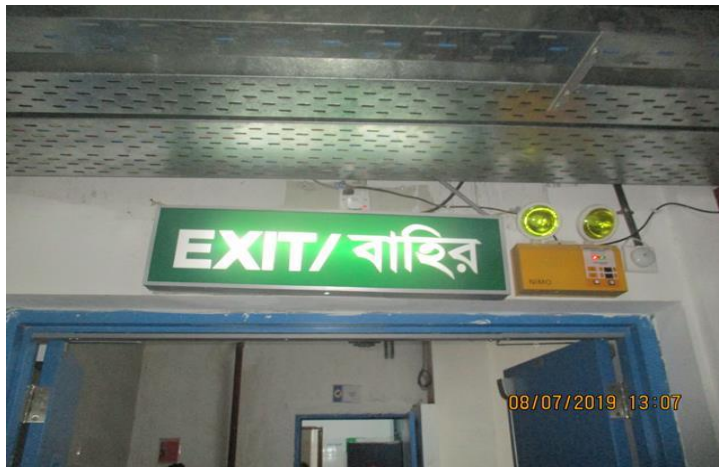
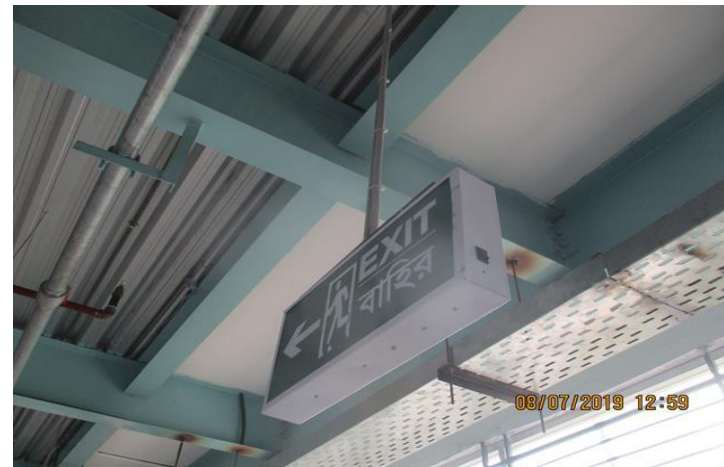
| F-15 | Egress Lighting | Manual on-off switch was provided for every exit signage. | Remove manual on/off switches from exit signage units to prevent them from being switched off. | Within 1 month |

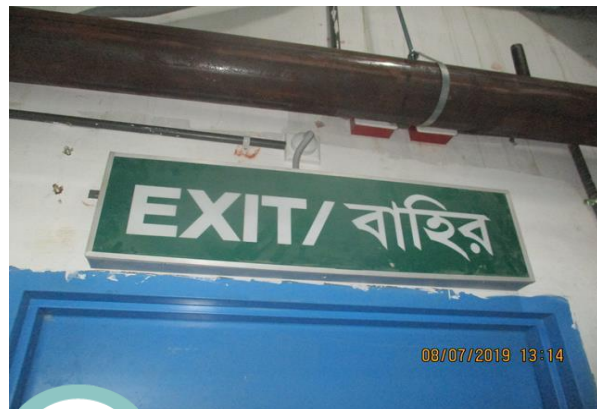
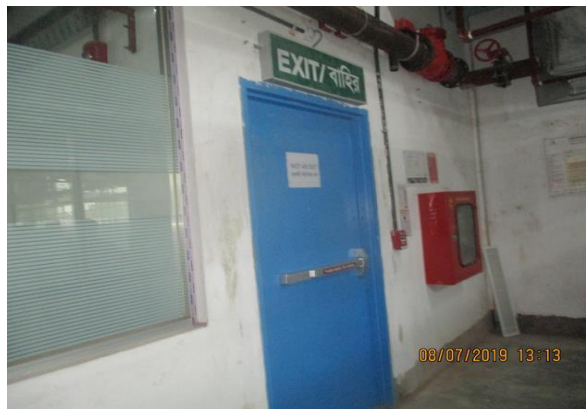
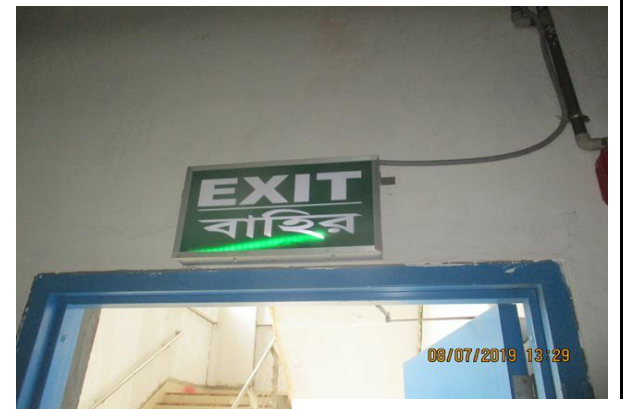
| F-16 | Egress Lighting | Exit signage was not functional (Non illuminated, broken etc.). | Regularly test the emergency lighting system/Exit signage on each floor and replace/repair lights as needed. | Within 1 month |

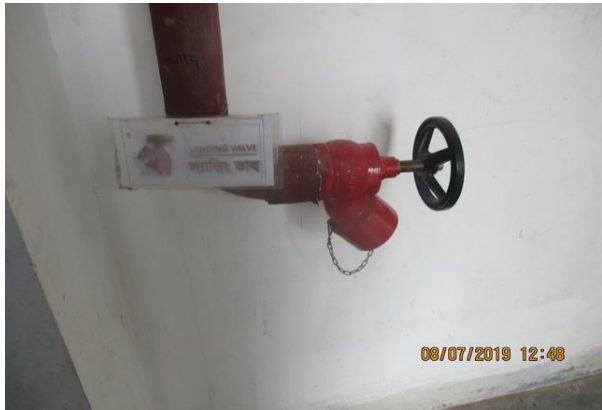
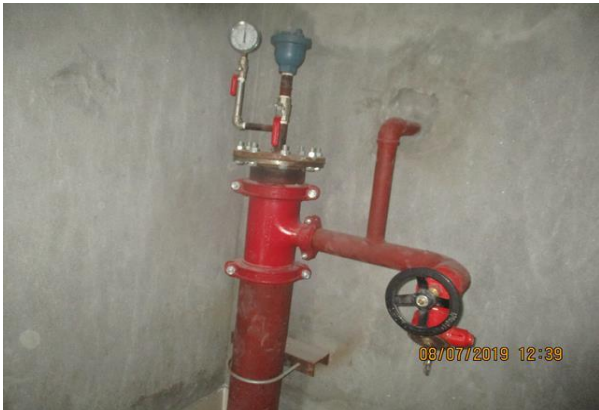
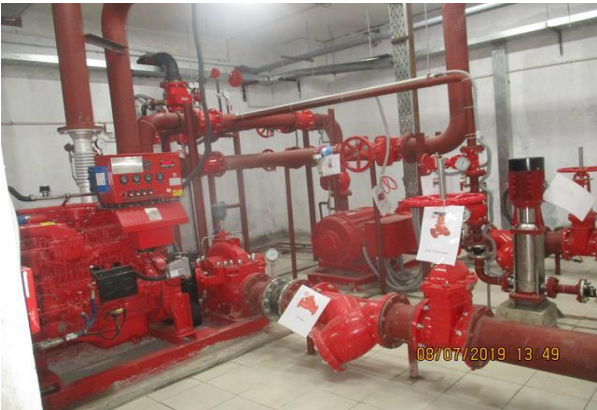
| F-18 | Fire Protection System | <p>The highest occupied floor level measured more than 10 m where required standpipe system was not installed in accordance with the ACCORD standard.</p> <p><b>Note:</b> Class-III standpipe system along with automatic sprinkler system was found under installation.</p> | <p>Provide class-III standpipe system althrough the building as per NFPA-14.</p> <p>Fire Pump installation shall comply NFPA-20.</p> <p>Prior final installation or modification submit drawing to ACCORD for review.</p> <p>Class-I standpipe system along with automatic sprinkler system accepted as per ACCORD Standard.</p> | Design Submission within 1 month installation within 4 months. |

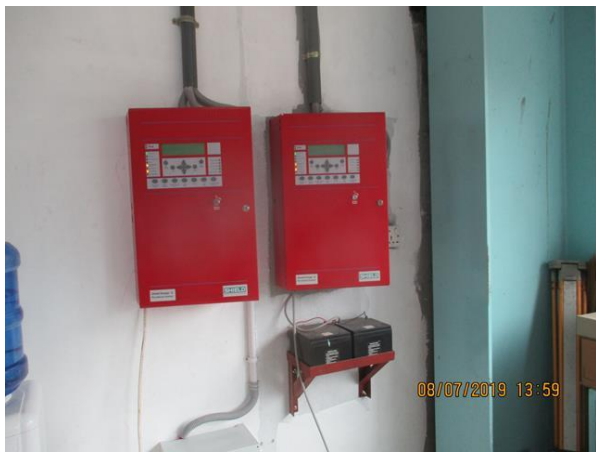
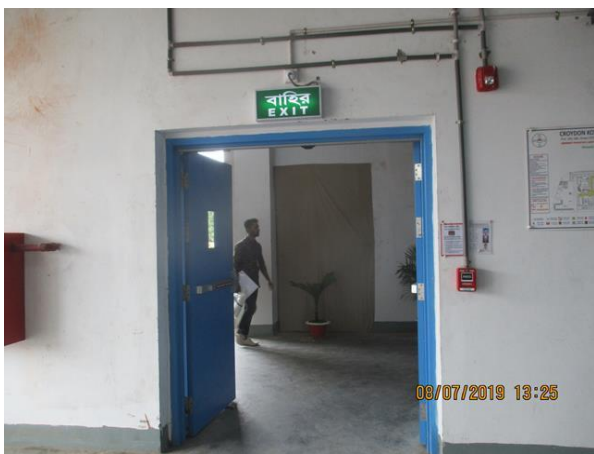
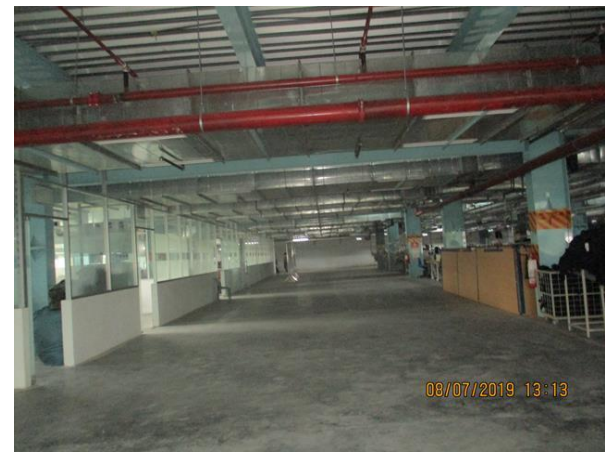
| F-20 | Fire Detection & Alarm System | The addressable detection and fire alarm system was not installed as per the requirement which was under installation process. | <p>The fire detection &amp; alarm system shall be installed as per NFPA-72, as automatic sprinkler system is considered as the replacement of detector so the sprinkler system installation shall be complaint as per NFPA-13 and the interfacing of sprinkler system with fire alarm system must be following NFPA-72.</p> <p>Prior installation or modification submit drawing to ACCORD for review.</p> | Design Submission within 1 month installation within 4 months. |
