# **FIRE SAFETY INSPECTION REPORT**

**Artistic Design Ltd.(Extension)**

**ACCORD ID: 23779**

**Date: 18 August 2019**

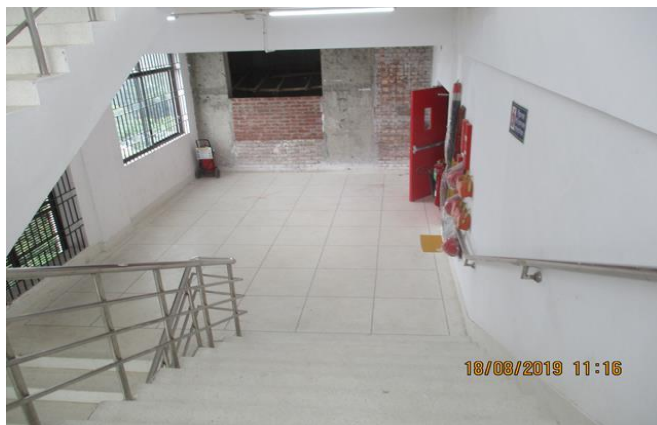
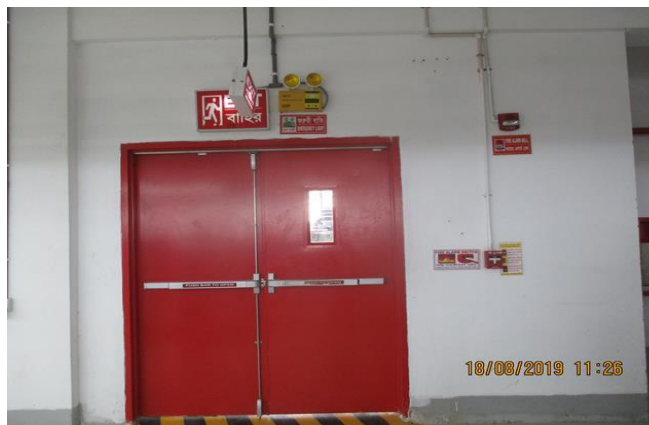
| SI No. | Category | Findings | Required Action | Remediation Time Frame |
|---|---|---|---|---|
| F-01 | Fire Rated Construction | Fire rated doors (A few number) were not functioning properly. | Ensure that the fire doors are self-closing and positive latching and that they are provided with fire exit (panic) hardware where serving production floors. If fire doors are required to be held open for functional reasons, provide automatic closing devices tied to the fire alarm system. | Within 3 months |

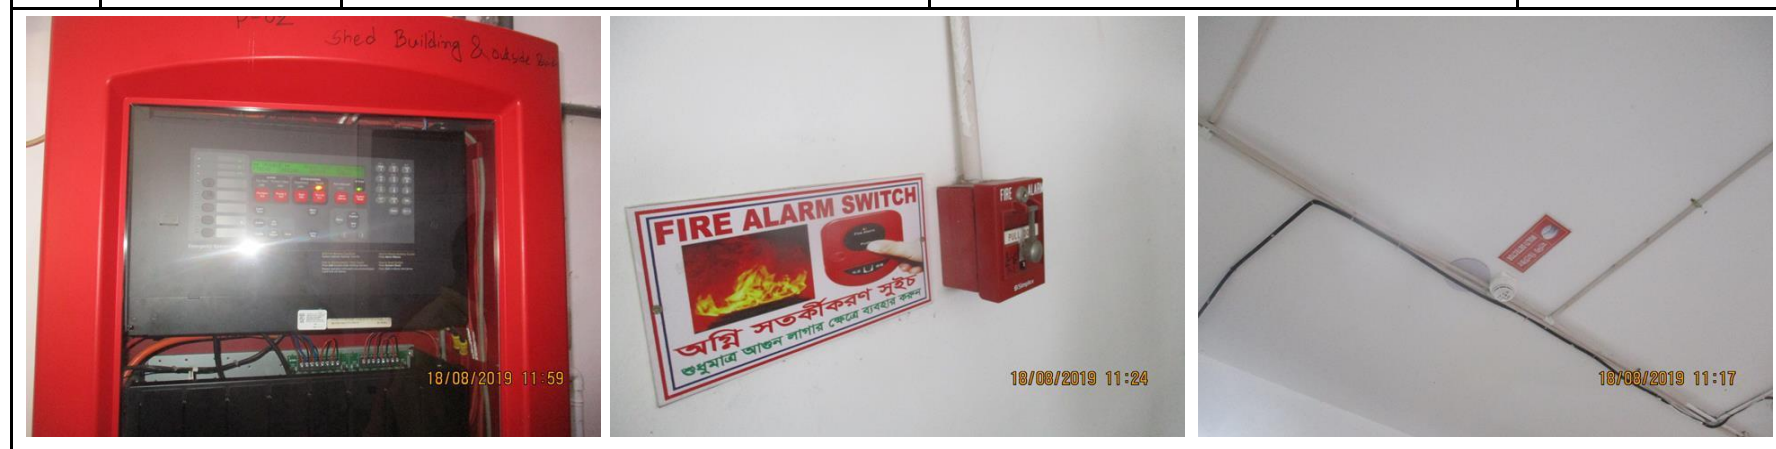
| F-02 | Fire Alarm & Detection System | The addressable fire detection and alarm system is installed for the building but the compliance level shall be verified as per relevant Standard. | Submit the Fire Detection and Alarm system design to ACCORD for review and modify the system as per the recommendation. The equipment shall be listed and 3rd party certified. The installation shall be as per NFPA -72. | Design within 2 months, install/modification within 4 months |

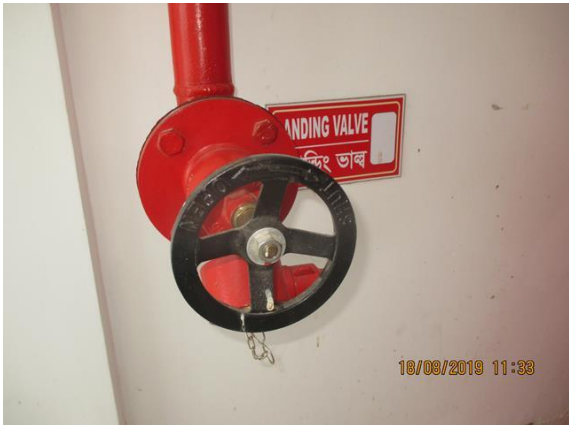
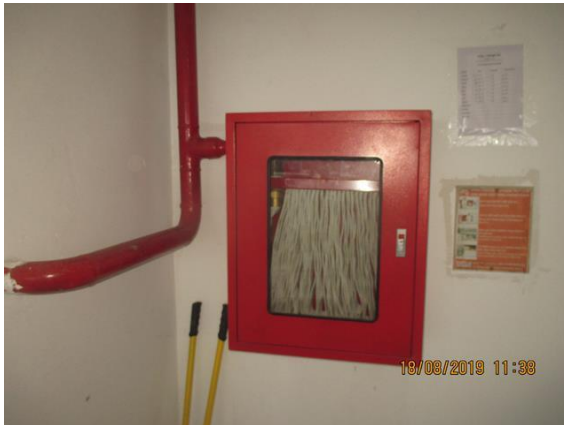
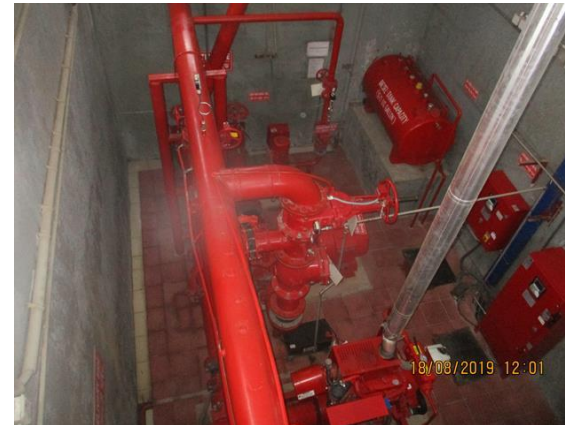
| F-04 | Fire Protection System | The highest occupied floor of existing building is more than 10 m (33 ft.) above grade where standpipe system is mandatory and installed but the compliance level shall be verified as per relevant Standard. | Submit the standpipe system design to ACCORD for review and modify the system as per recommendation. The equipment shall be listed and 3rd party certified. The installation shall be as per NFPA-14, 20, 22 and 24. | Design within 2 months, install/modification within 4 months |
