# **FIRE SAFETY INSPECTION REPORT**

**Factory Name: Network Apparels Ltd. Extended Building**

**ACCORD ID: 23788**

**Date: 04 August, 2019.**

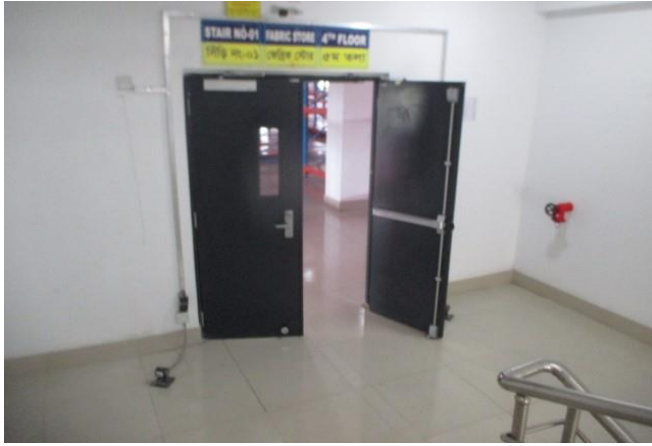
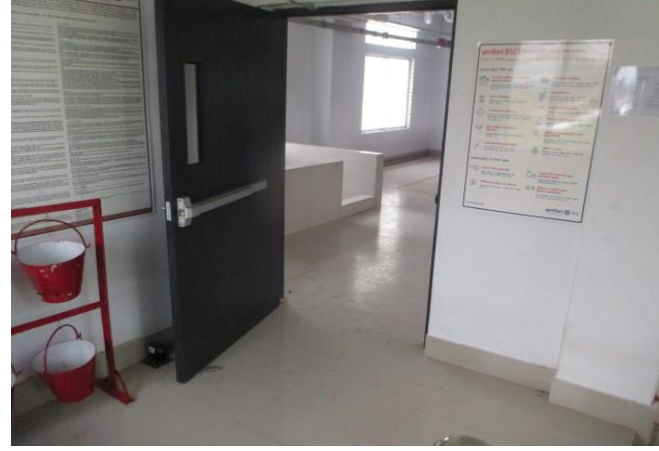
| SI No. | Category | Findings | Required Action | Remediation Time Frame |
|---|---|---|---|---|
| 1 | Fire Rated Construction | The exit stair enclosures are separated from work areas and other spaces on each floor by fire-rated construction. Fire Doors have been provided with proper hour rating. But doors are kept open and installation of magnetic hold open device to interface with Fire Alarm System have been done but the devices are not interfaced with any approved FACP. Moreover Exit stair enclosures have unprotected openings within 10 feet towards production floor at two stairs. | <p>The exit stair enclosure shall be provided with a minimum 1-hr fire resistance rating for buildings with 3 or fewer stories and a minimum of 2-hr. fire resistance rating for buildings 4 or more stories. Provide 0.75 hr. fire rated door and seal all penetrations and openings by 1 hr. fire rated fire rated barrier construction for building with 3 or fewer stories. Provide 1.5 hr. fire rated door and seal all penetrations and openings by 2 hr. fire rated fire rated barrier construction for building with 4 or more stories.</p> <p>Provide a fire-resistive rated assembly between the exterior exit stairs and the building up to 10 ft. beyond the end of the stair to achieve the required separation. The rated assembly shall be approved and/or designed by a qualified fire protection engineer.</p> <p>Ensure that the fire doors are self-closing and positive latching and that they are provided with fire exit (panic) hardware where serving production floors. If fire doors are required to be held open for functional reasons, provide automatic closing devices tied to the fire alarm system.</p> | Within 3 months |

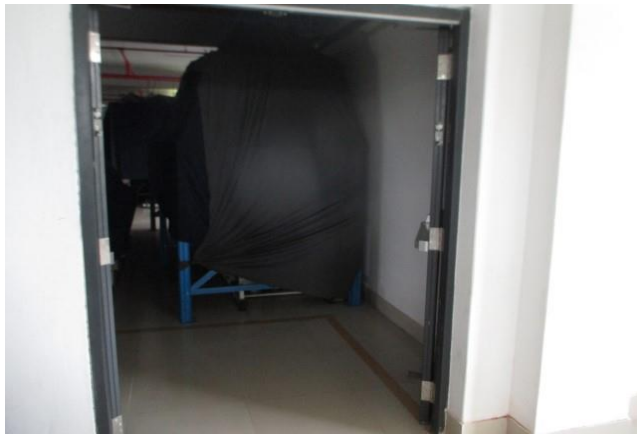
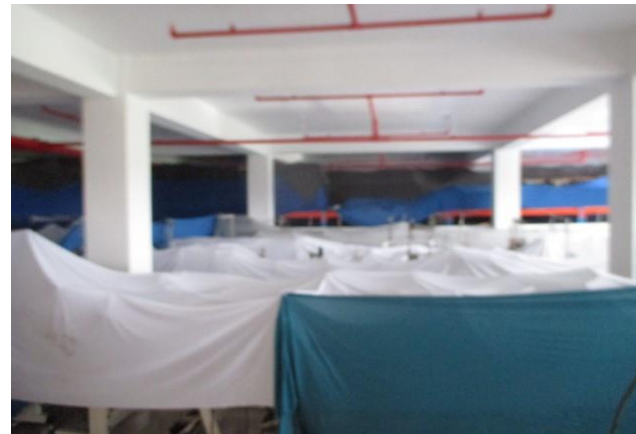
| 2 | Fire Rated Construction | <p>Rooms used for combustible storage are not separated by fire rated construction.</p> <p>Location: wastage go down shed at ground floor adjacent to the mail building</p> | <p>Separate the dedicated storage rooms by minimum 1-hr fire-rated construction. Provide 0.75 hr. fire rated door and seal all penetrations and openings by 1 hr. fire rated fire rated barrier construction.</p> | Within 3 months |

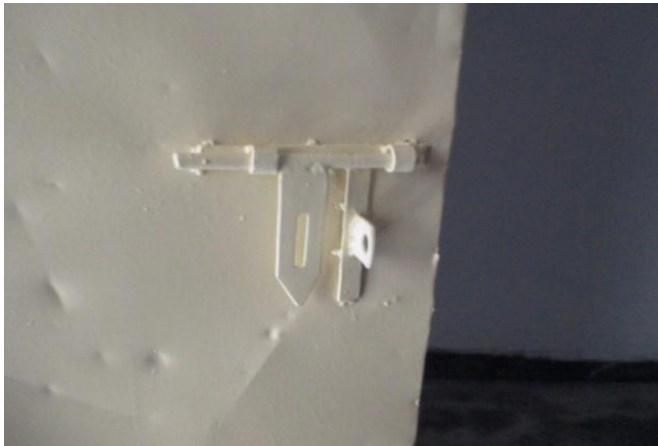
| 3 | Locking system of egress doors | Doors along means of egress are provided with non compliant locking system. | <ol style="list-style-type: none"> <li>1. Remove all non compliant locking features from egress doors.</li> <li>2. If locks are required for security reasons, utilize special door locking features complying with NFPA 101.</li> <li>3. Doors may be locked where the latch and lock are disengaged with one motion where the occupant load does not exceed 49 persons.</li> <li>4. Doors may be provided with locking hardware from the ingress side provided that a panic bar is installed on any door with an occupant load exceeding 49 persons.</li> </ol> | Immediately |

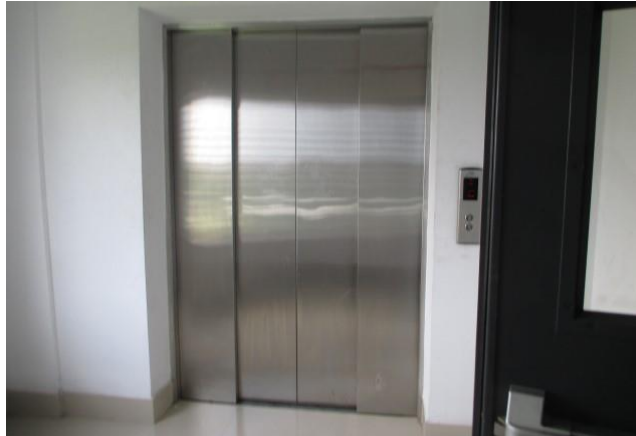
| 4 | Elevator | Unsealed elevator shafts are located in the exit stair case. | Provide a minimum 2-hr fire-rated shaft to separate the utility risers from each floor level and seal all penetrations in floor/ceiling assemblies to maintain the fire separation. | within 3 months |

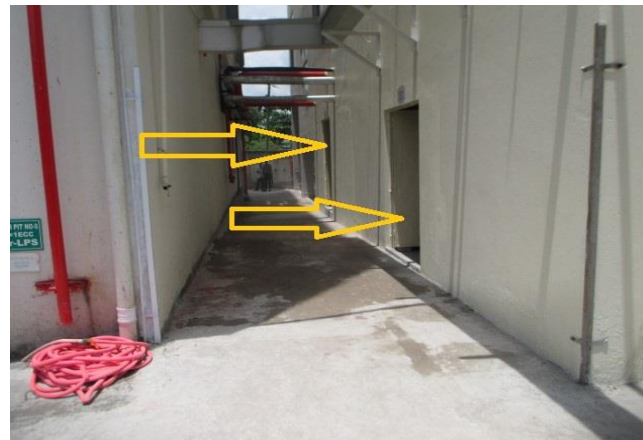
| 5 | Egress Court/<br>Unprotected<br>Exterior Discharge<br>Path | The exit discharge path [serving __exit] is less than 10 ft wide and is not separated from the building interior. | Seal all penetrations and openings to the interior of the building along the discharge path, up to a height of 10 ft. to provide a minimum 1-hr fire separation.<br><br>Alternatively, provide a second remote discharge path to the public way (only include this if feasible). | within 3 months |

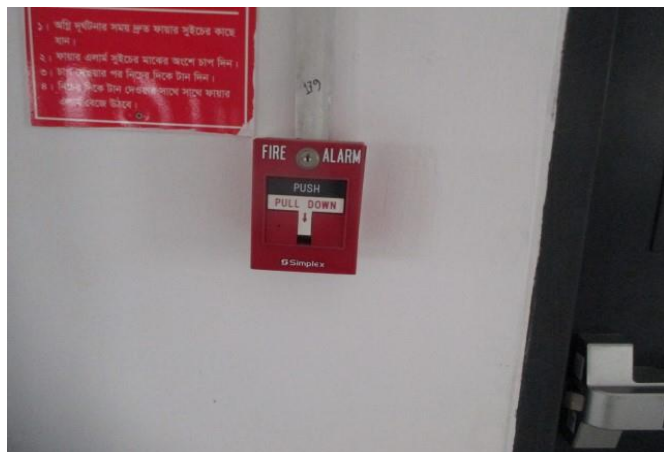
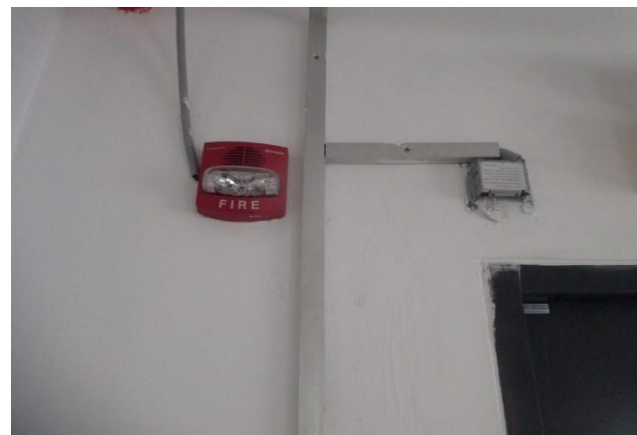
| 7 | Fire Detection and Alarm System | The existing fire alarm & detection system is not installed properly. Still few areas are out of detection system. | Submit the as-built design/drawing of fire alarm & detection system to Accord for review. | Within 06 Months<br>(Design review & Modification of the system) |
