# **FIRE SAFETY INSPECTION REPORT**

**Factory Name: Kaniz Fashions Limited**

**ACCORD ID: 23756**

**ADDRESS: Plot no. A80 (part), A81 & A82, BSCIC Industrial Area, Konabari, 1700, Gazipur**

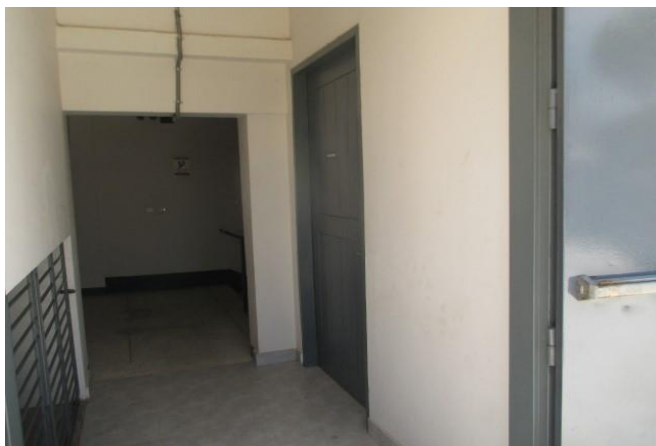
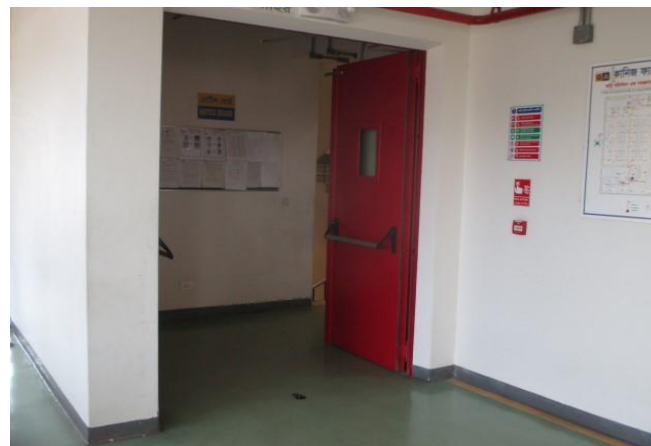
| SI No. | Category | Findings | Required Action | Remediation Time Frame |
|---|---|---|---|---|
| 1 | Fire Rated Construction | The exit stair enclosures are separated from work areas and other spaces on each floor by fire-rated construction. Fire Doors have been provided with proper hour rating. But doors are kept open and installation of magnetic hold open device to interface with Fire Alarm System have been done but the devices are not interfaced with any approved FACP. Moreover Exit stair enclosures have unprotected openings within 10 feet towards production floor at two stairs. | <p>The exit stair enclosure shall be provided with a minimum 1-hr fire resistance rating for buildings with 3 or fewer stories and a minimum of 2-hr. fire resistance rating for buildings 4 or more stories. Provide 0.75 hr. fire rated door and seal all penetrations and openings by 1 hr. fire rated fire rated barrier construction for building with 3 or fewer stories. Provide 1.5 hr. fire rated door and seal all penetrations and openings by 2 hr. fire rated fire rated barrier construction for building with 4 or more stories.</p> <p>Provide a fire-resistive rated assembly between the exterior exit stairs and the building up to 10 ft. beyond the end of the stair to achieve the required separation. The rated assembly shall be approved and/or designed by a qualified fire protection engineer.</p> <p>Ensure that the fire doors are self-closing and positive latching and that they are provided with fire exit (panic) hardware where serving production floors. If fire doors are required to be held open for functional reasons, provide automatic closing devices tied to the fire alarm system.</p> | Within 3 months |

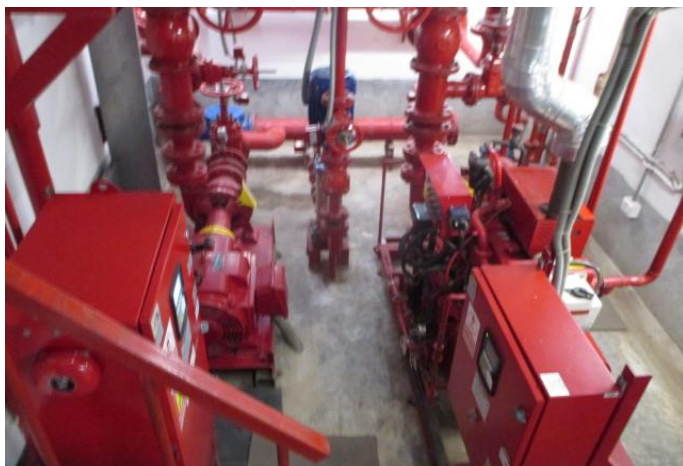
| 2 | Fire Rated Construction | The fire pump room is not provided with adequate fire separation. | Provide fire pump room with 2 hr rated fire separation when not sprinklered and 1 hr rated fire separation when provided with automatic sprinklers in accordance with NFPA 20 Or, Physically separate the pump room from the protected building by a minimum of 50 ft. (15.3 m) in accordance with NFPA 20 | Within 3 months |

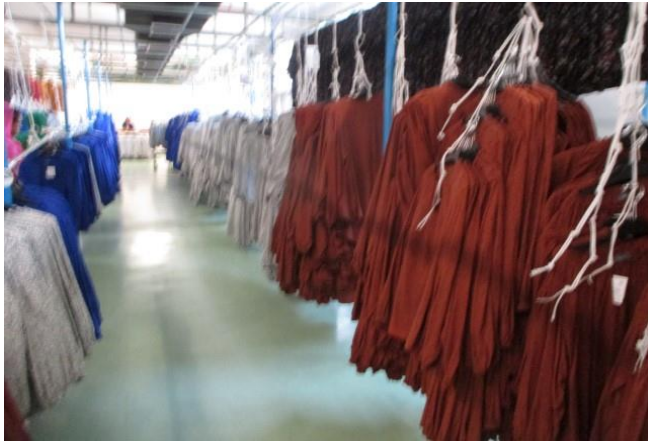
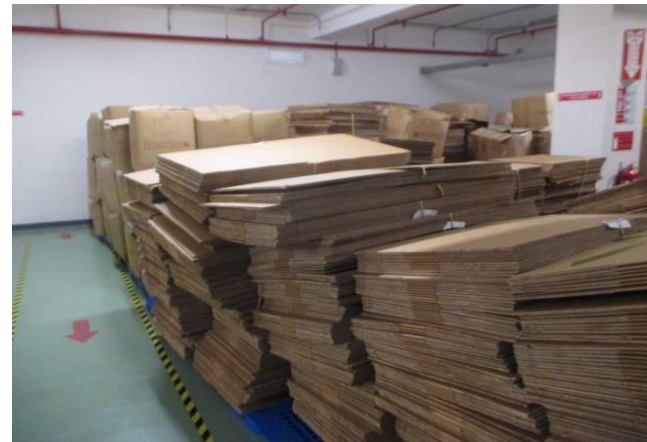
| 3 | Fire Rated Construction | <p>Rooms used for combustible storage are not separated by fire rated construction.</p> <p>Location: wastage go down shed at ground floor adjacent to the mail building</p> | <p>Separate the dedicated storage rooms by minimum 1-hr fire-rated construction. Provide 0.75 hr. fire rated door and seal all penetrations and openings by 1 hr. fire rated fire rated barrier construction.</p> | Within 3 months |

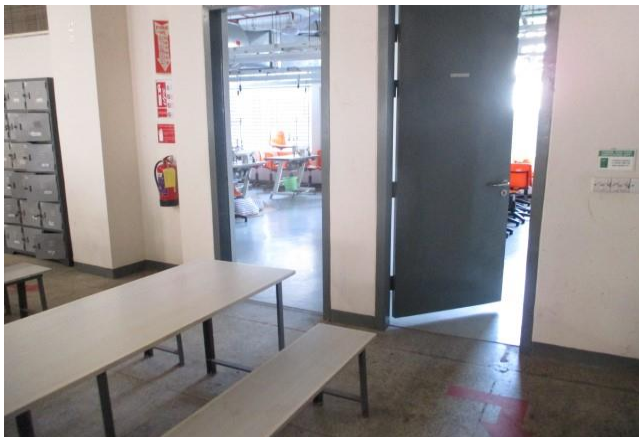
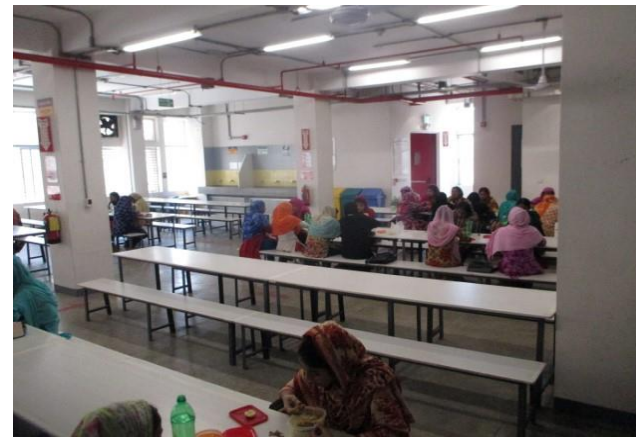
| 4 | Fire Rated Construction | Dining area is not separated from other occupancies with fire rated assemblies. | Re-locate the dining area or separate the dining area from other occupancies with 2-hr fire rated construction. | Within 3 months |

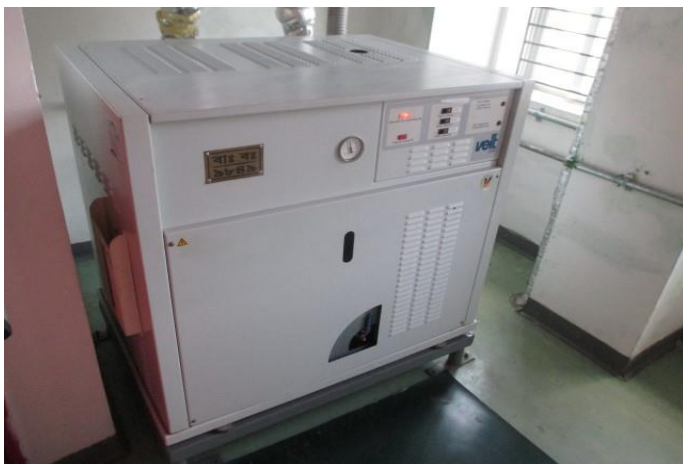
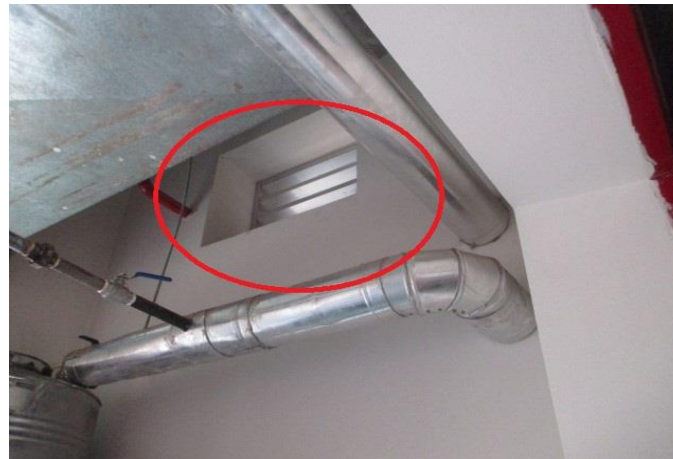
| 5 | Boiler or furnace room | Boiler or furnace room is not properly separated by fire rated construction with other Occupancies/Areas (specify the occupancy/area, location and construction materials of room). | <p>1. Boilers or other heat producing equipment shall be separated from other occupancies by a minimum 1-hr (2-hr for highrise building) fire rated construction (wall, floor, slab etc). Seal all penetrations and openings (door, window etc.) should be protected by 0.75-hr (45 min) fire rated materials to maintain the fire separation if required. All exhaust systems shall discharge to the exterior of the building in a safe location.</p> <p>Or</p> <p>Relocate it to exterior of the building and maintain a minimum 3m (10 ft.) spatial separation distance from the building.</p> | Within 3 months |

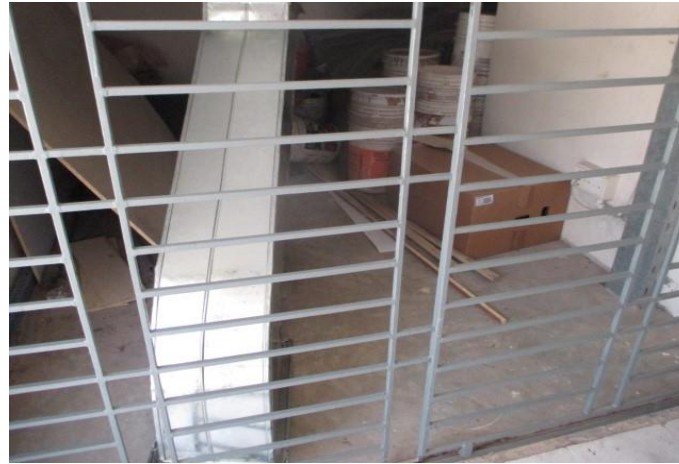
| 6 | Storage in Exit Stair | Storage was located in the exit stair. | Remove all storage from exit stairs. | Immediately |

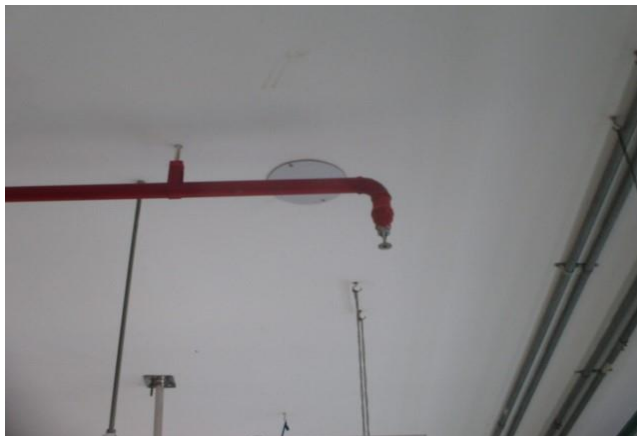
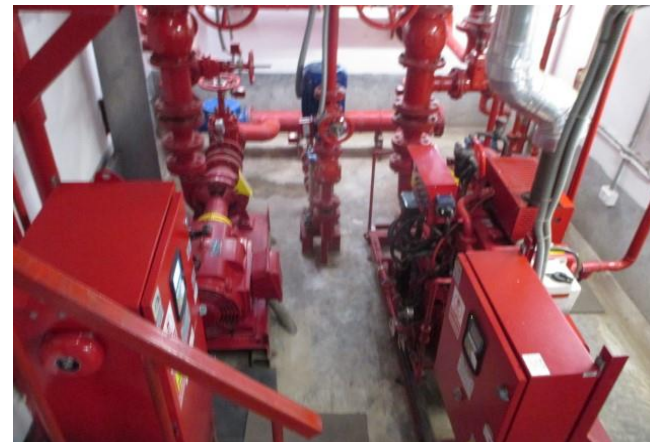
| 7 | Fire Protection System | The high-rise building has an occupied floor greater than 23 meter (75 feet) and is not provided with automatic sprinkler protection. The large occupant loads, heavy fuel loading, and anticipated extended egress times warrant sprinkler protection. | Provide an automatic sprinkler protection throughout the building in accordance with NFPA 13. | Design within 04 Months & Installation Within 09 Months |

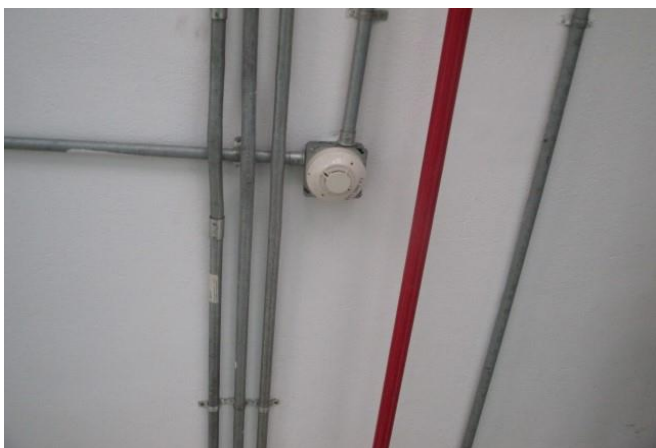
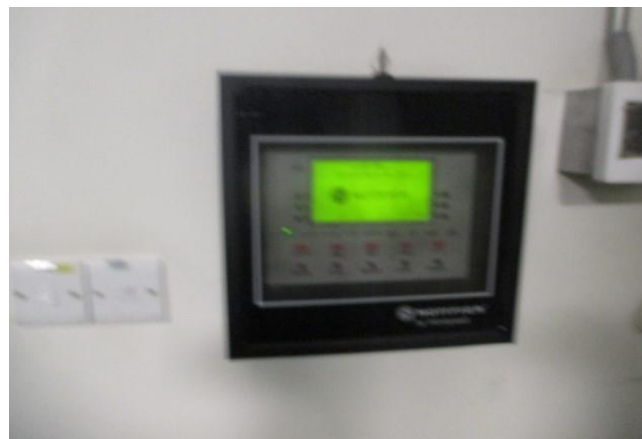
| 9 | Fire Detection and Alarm System | The existing fire alarm & detection system is not installed properly. Still few areas are out of detection system. | Submit the as-built design/drawing of fire alarm & detection system to Accord for review. | Within 06 Months<br>(Design review & Modification of the system) |
