FIRE SAFETY INSPECTION REPORT

Apparel Today Ltd. New

ACCORD ID: 23802

Date: 23 September, 2019

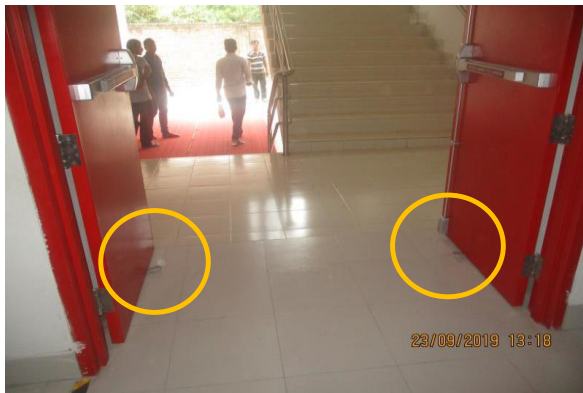
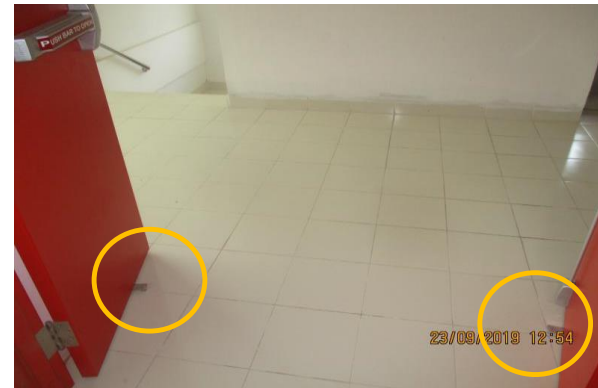
SI No.	Category	Findings	Required Action	Remediation Time Frame
1	Fire Rated Construction	The exit stairs are not separated from [work areas, other spaces] on each floor by fire rated construction.	<p>Provide minimum 1.5-hr fire rated doors and seal all unprotected openings to separate the exit stairs from work areas and other building spaces on all floor levels. Ensure that the fire rated doors are self-closing and positive latching and that they are provided with fire exit (panic) hardware where serving production floors.</p> <p>If fire rated doors are required to be held open for functional reasons, provide automatic closing devices tied to the fire alarm system.</p>	Within 3 months

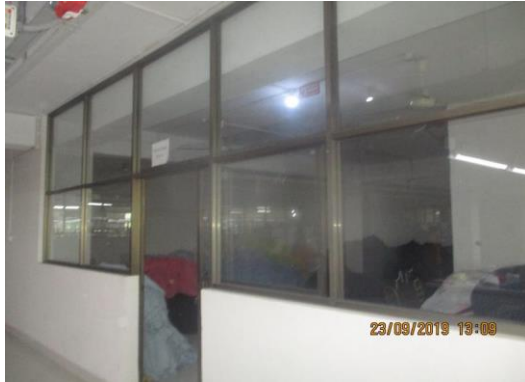
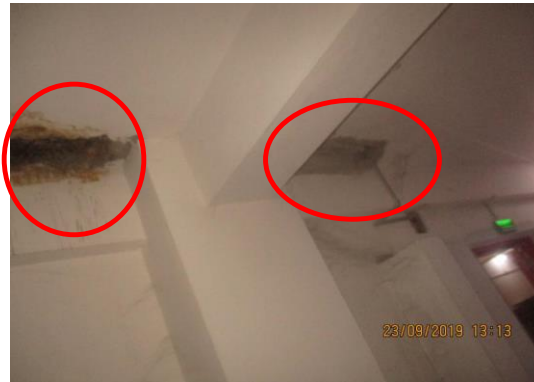
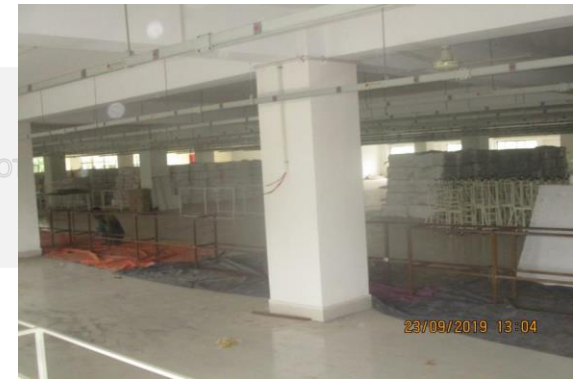
2	Fire Rated Construction	Rooms used for combustible storage are not separated by fire rated construction properly.	Provide dedicated storage room separated by minimum 1-hr fire-rated construction.	Within 3 months
---	-------------------------	---	---	-----------------

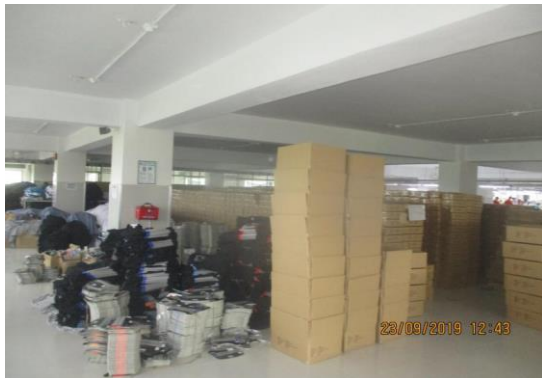
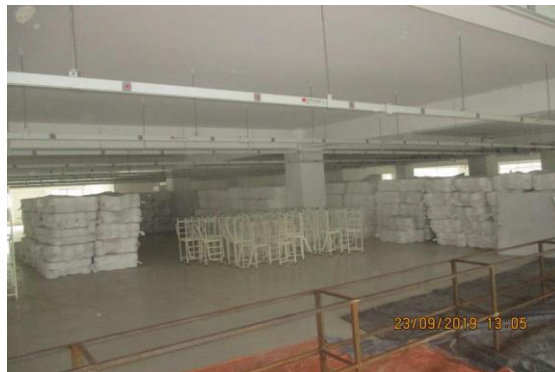
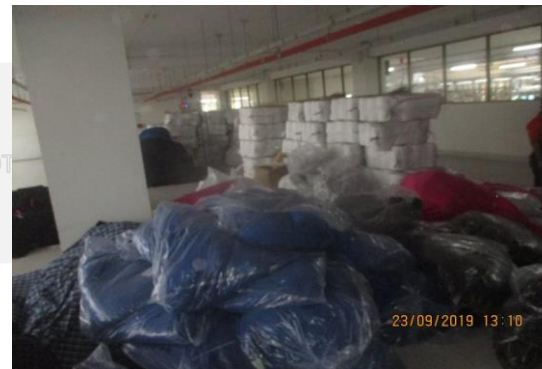
3	Fire Rated Construction	Areas used for combustible storage are not separated by fire rated construction.	<p>Provide dedicated storage rooms separated by minimum 1-hr fire-rated construction.</p> <p>Where separate storage rooms are not feasible, provide defined storage areas and limit the storage arrangement as follows:</p> <ul style="list-style-type: none"> - Maximum height of 2.4m and maximum area of 23m² - If sprinkler protected: maximum height of 3.66m and maximum area of 93m² <p>Separate areas of unenclosed combustible storage by a minimum clear distance of 3m.</p>	Within 3 months
---	-------------------------	--	--	-----------------

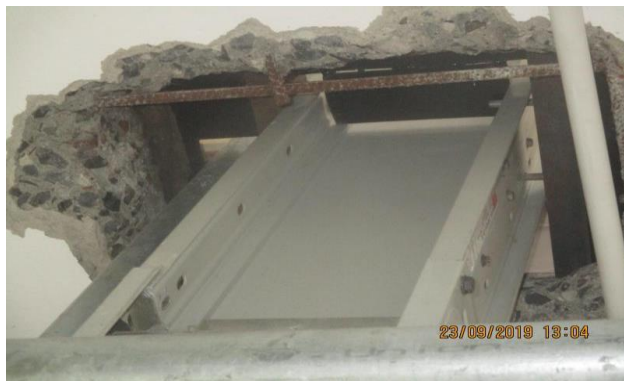
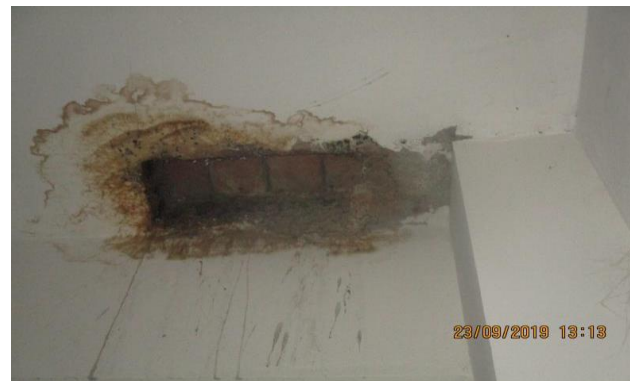
4	Fire Rated Construction	Unsealed penetrations and openings are located in the fire rated floor/ceiling assemblies.	Seal all penetrations and openings in floors/ceiling assemblies to maintain the fire separation.	Within 3 months
---	-------------------------	--	--	-----------------

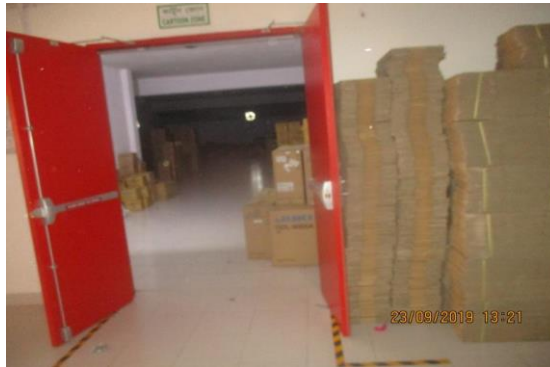
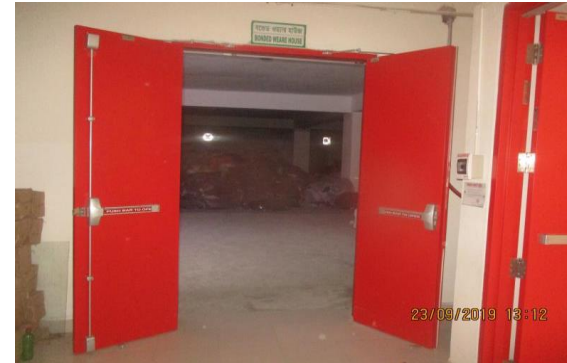
5	Egress	Common path of egress travel exceeds 23 meter (75 feet). Location: Ground floor (Bonded warehouse & Finished goods/carton zone)	Reconfigure the egress arrangement to reduce the maximum common path of travel to not more than 23 meter (75 feet). Or, Provide additional remote exit to meet the common path of travel.	within 3 months
---	--------	--	---	-----------------

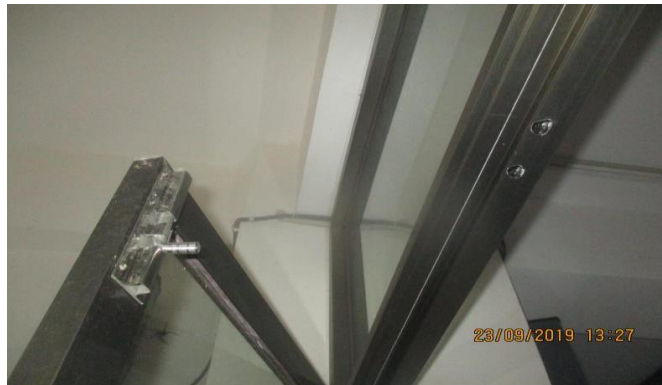
6	Egress	Egress doors/gates with locking features not complying with NFPA101 are provided at Ground floor (Knitting).	Remove non-compliant locking features from all egress doors/gates. If locks are required for security reasons, utilize specialized door locking features complying with NFPA101.	Immediate
---	--------	--	---	-----------

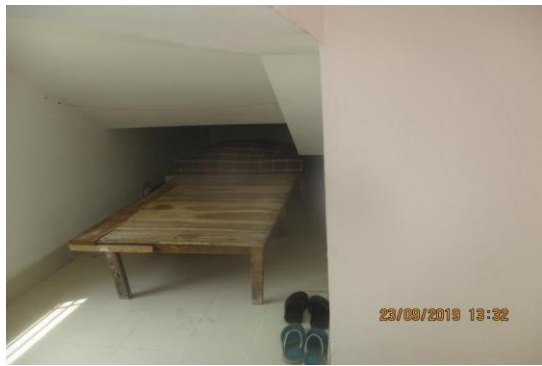
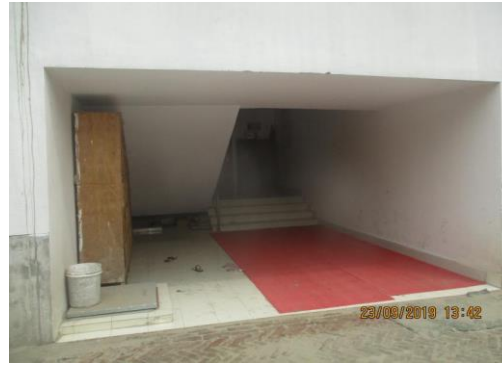
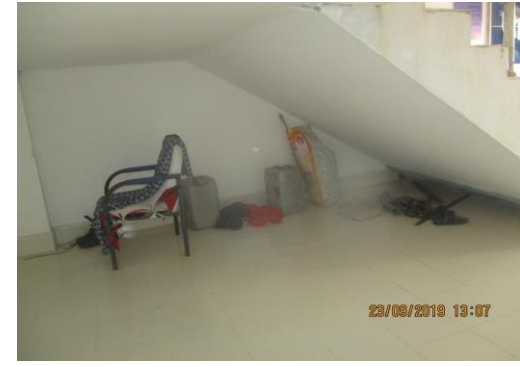
7	Egress	Fire evacuation map is not posted at the entrance of all exit stair.	Fire evacuation maps shall be posted at the entrance to each exit stair.	Within 1 month
8	Egress	Storage was located in exit stairs.	Remove storage from the exit stairs and egress path	Immediate

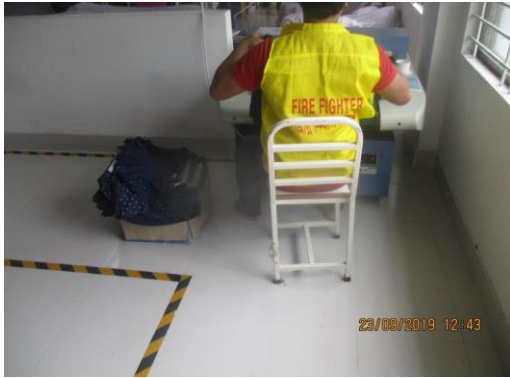
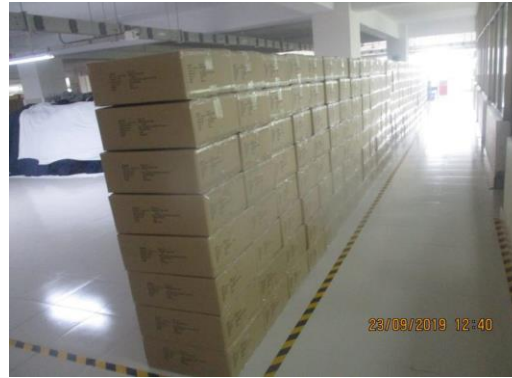
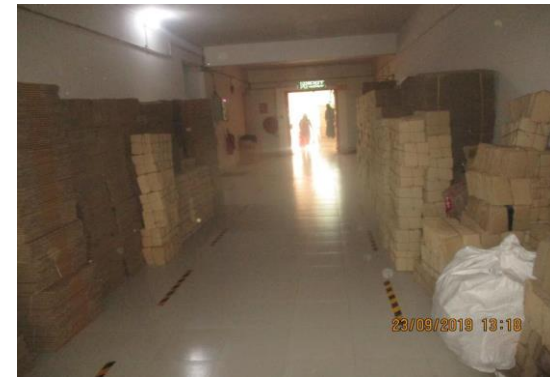
9	Egress	Storage was located in the egress path.	Keep egress path and stair clear of storage	Immediate
---	--------	---	---	-----------

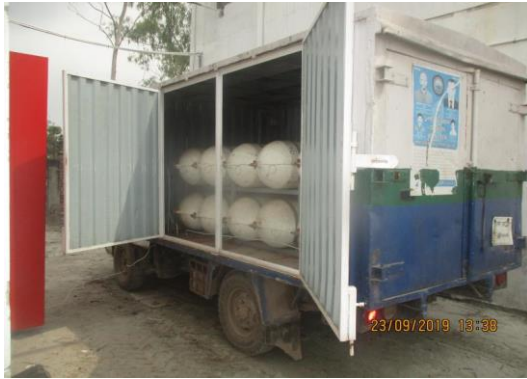
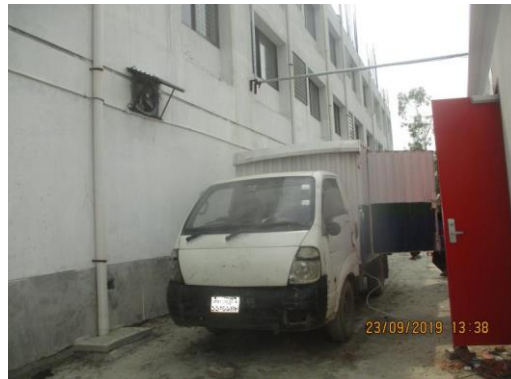
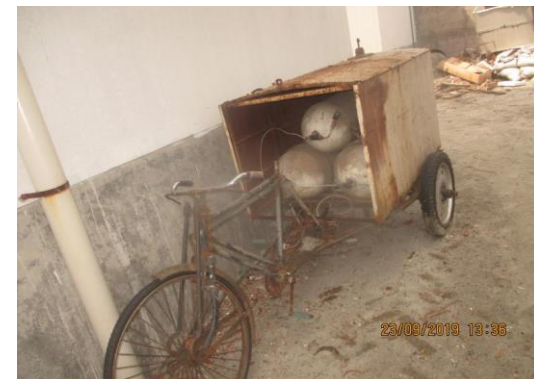
10	Egress	Building did not have stair designation signs or occupant load signs at the required locations.	Provide stair designation signs and occupant load signs at the required locations.	Within 1 month
11	No Parapets or Guards	Parapets or guards are not provided in occupiable roof.	Provide parapets or guards with a minimum height of 42 in. for all occupiable roof areas.	Within 2 months
12	Storage/Use of CNG	Liquefied or compressed gas cylinders are located within the factory.	The storage or use of liquefied or compressed flammable gas cylinders shall be prohibited within the factory building & shall be removed immediately. In the case of storage shall be maintaining fire separation as per BNBC Table 3.2.2 with compliant and sufficient ventilation.	Within 1 month

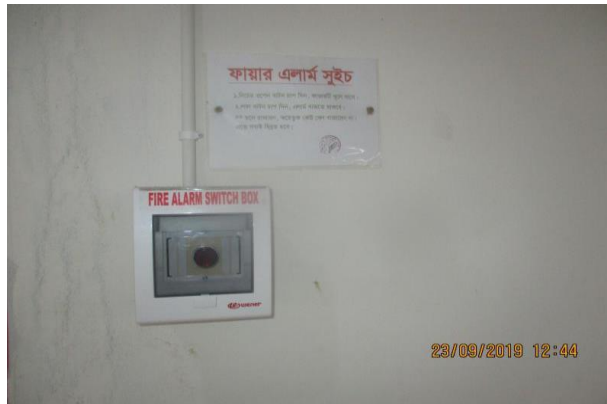
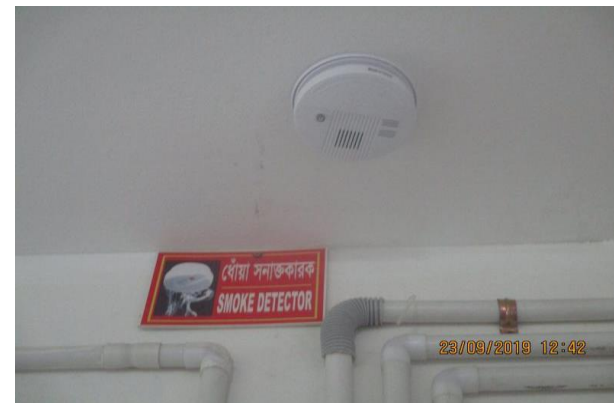
13	Fire Detection and Alarm System	The fire detection and alarm system is antiquated, not a listed system and does not provide alarm and notification features consistent with acceptable standards.	Replace the fire detection system with a new, listed addressable fire detection system in accordance with NFPA 72.	Design within 2 months, Install within 6 months
----	---------------------------------	---	--	---
