# FIRE SAFETY INSPECTION REPORT

## Torque Fashions Limited. (Sheds 7, 9-13)

**ACCORD ID: 23787**

**Date: 1st September, 2019**

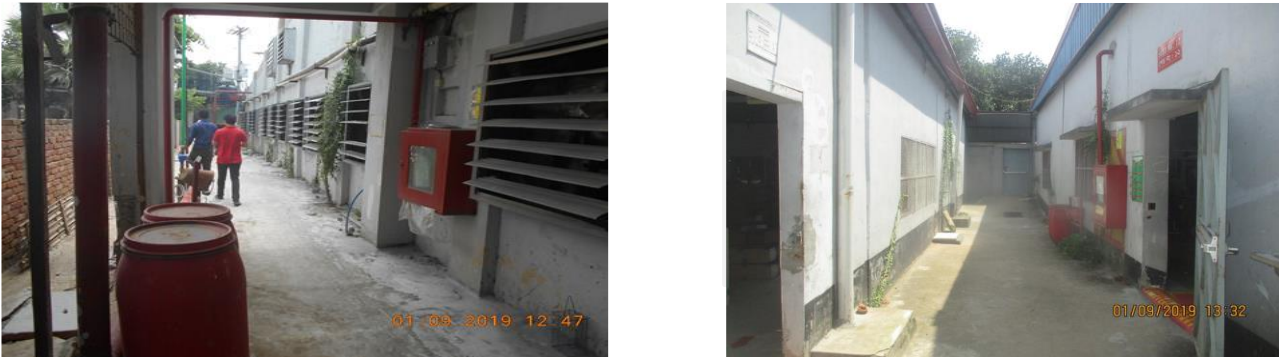
| Sl No. | Category | Findings | Required Action | Remediation Time Frame |
|---|---|---|---|---|
| 1 | Fire Rated Construction | The exit discharge path is less than 10 ft wide and is not separated from the building interior.<br>(Shed 7,12,13) | Seal all penetrations and openings to the interior of the building along the discharge path, up to a height of 10 ft. to provide a minimum 1-hr fire separation.<br><br>Alternatively, provide a second remote discharge path to the public way (only include this if feasible). | Within 3 months |

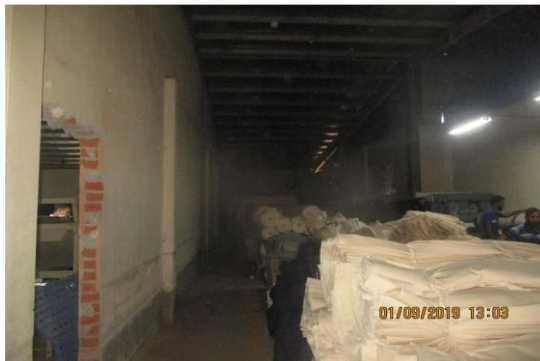
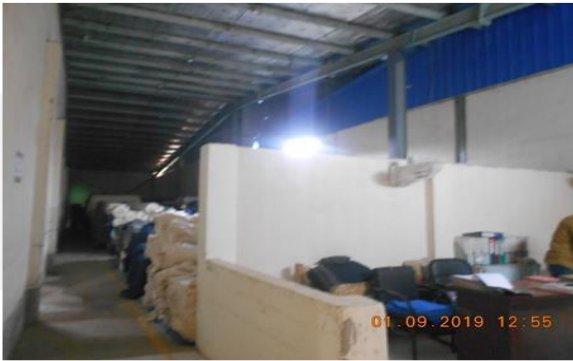
| Sl No. | Category | Findings | Required Action | Remediation Time Frame |
|---|---|---|---|---|
| 2 | Fire Rated Construction | Areas used for storage of combustible materials are open to the surrounding occupancy. | <p>Provide defined storage areas and limit the storage arrangement as follows:-</p> <ol style="list-style-type: none"> <li>1. General Condition: Maximum height of 2.4m and maximum area of 23m<sup>2</sup>. Separate areas of unenclosed combustible storage by a minimum clear distance of 3m.</li> <li>2. If sprinkler protected: maximum height of 3.66m and maximum area of 93m<sup>2</sup>. Separate areas of unenclosed combustible storage by a minimum clear distance of 3m.</li> </ol> <p>or</p> <ol style="list-style-type: none"> <li>3. Enclose the storage area from the surrounding occupancy with a minimum 1 hour construction.</li> </ol> | Within 3 months |

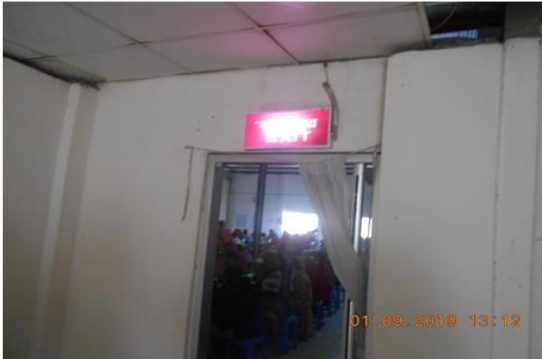
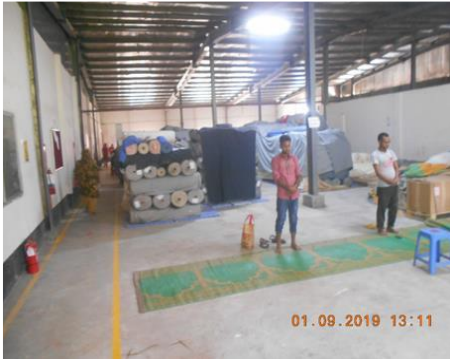
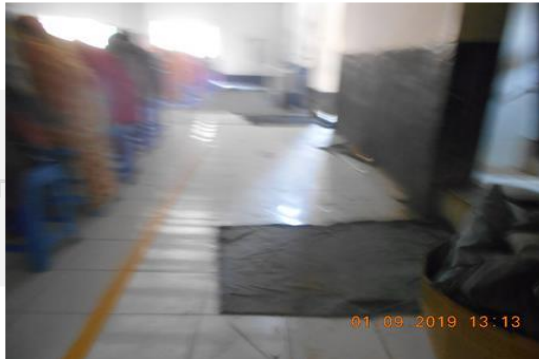
| Sl No. | Category | Findings | Required Action | Remediation Time Frame |
|---|---|---|---|---|
| 3 | Fire Rated Construction | <p>Dinning and prayer space are not separated from storage and production area by Fire rated construction.</p> <p>Location: Shed-10</p> | Remove dinning space from this location or, alternatively, provide minimum 2-hour fire rated separation. | Within 3 months |

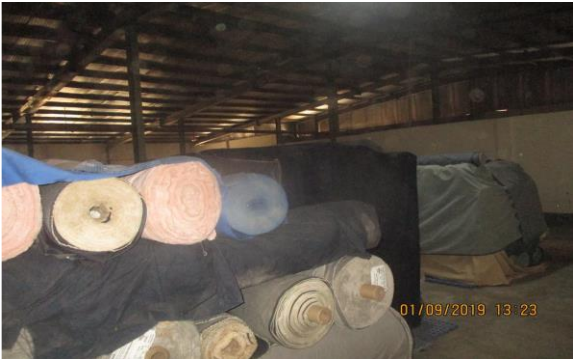
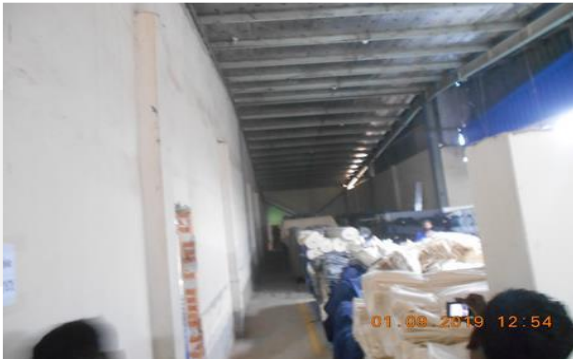
| Sl No. | Category | Findings | Required Action | Remediation Time Frame |
|---|---|---|---|---|
| 4 | Fire Rated Construction | <p>Rooms used for storage of combustible materials are not separated from the surrounding occupancy/areas.<br/>Location: Shed: 9</p> | <p>Rooms used for storage of combustible materials shall be separated from the surrounding occupancy with a minimum 1 hour construction.</p> | <p>within 3 months</p> |

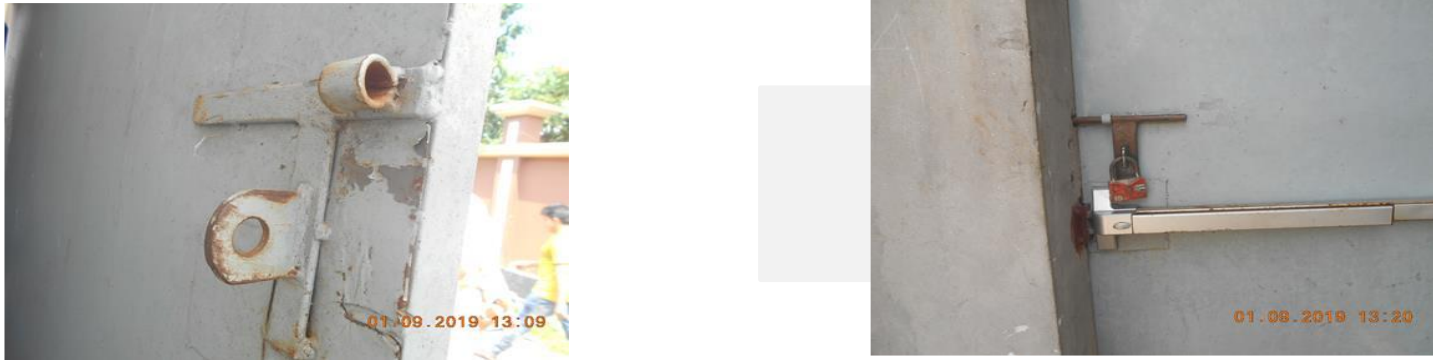
| Sl No. | Category | Findings | Required Action | Remediation Time Frame |
|---|---|---|---|---|
| 6 | Egress | Egress doors/gates with locking features not complying with NFPA101 are provided at Shed 9 & 11. | Remove locking features from all egress doors/gates.<br>If locks are required for security reasons, utilize specialized door locking features complying with NFPA101. | Immediate |

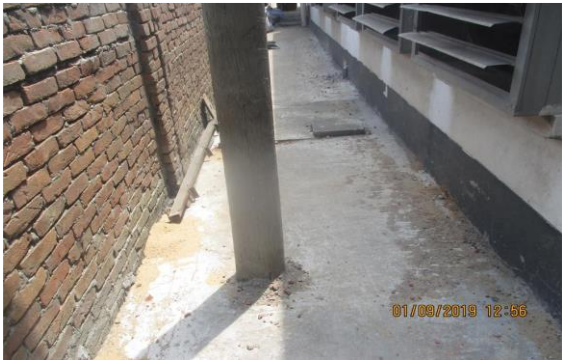
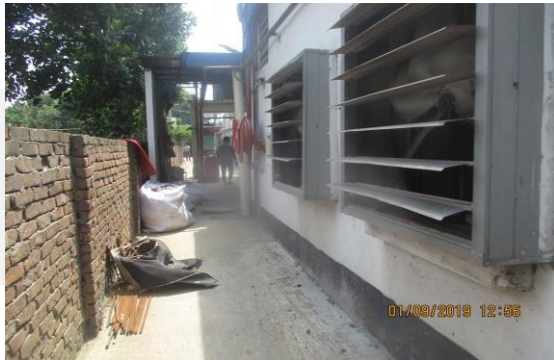
| Sl No. | Category | Findings | Required Action | Remediation Time Frame |
|---|---|---|---|---|
| 7 | Egress | The egress path along means of egress has interrupted by obstruction/storage. | Means of egress shall be maintained continuously free and clear of all obstructions/storage.<br>Or<br>Keep egress paths and stairs clear of storage. | Within 1 month |

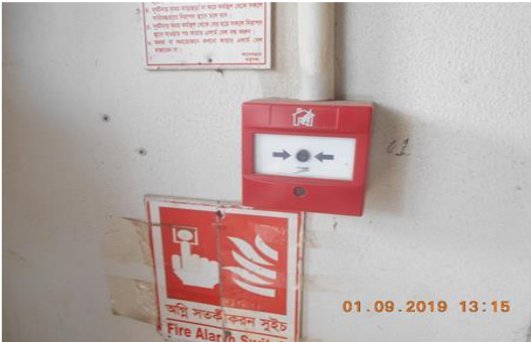
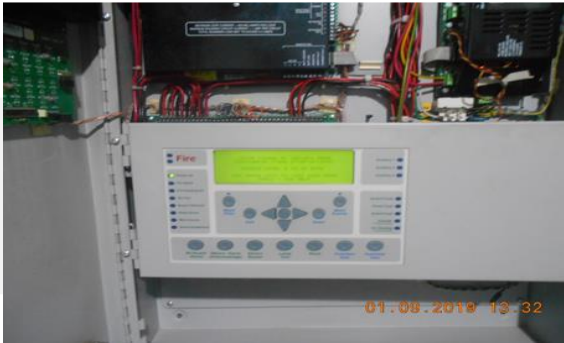
| Sl No. | Category | Findings | Required Action | Remediation Time Frame |
|---|---|---|---|---|
| 10 | Fire Alarm System | Fire detection system installation requires detailed review to confirm compliance with NFPA 72 and ACCORD standards. | Submit as-built drawings, testing records, equipment certification and other relevant documentation to the ACCORD for review and approval. | Design within 2 months, Install within 4 months (If modification required) |

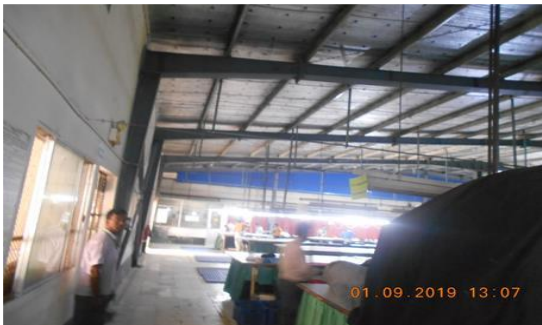
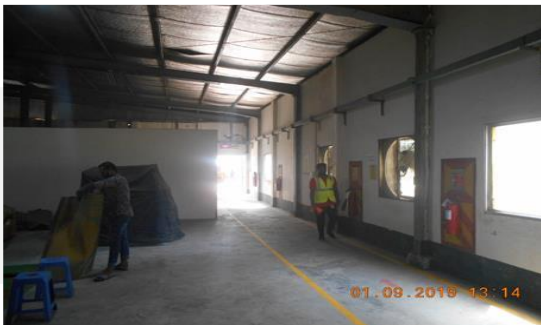
| Sl No. | Category | Findings | Required Action | Remediation Time Frame |
|---|---|---|---|---|
| 12 | Inadequate Lighting | Based on the number and location of emergency lights observed, adequate illumination levels are not anticipated along egress routes. | Test the emergency lighting system on each floor and provide additional emergency fixtures to provide adequate illumination along the means of egress. Provide a minimum illumination of 10 lux at the floor level within exit stairs and exit discharge paths and minimum 2.5 lux along exit access aisles. | Within 3 months |
