# Pretty Sweater Limited

Plot no#222, Gacha, Chayadhana, National University, Gazipur – 1704, Dhaka.  
(23.957626, 90.381326)

# Observations

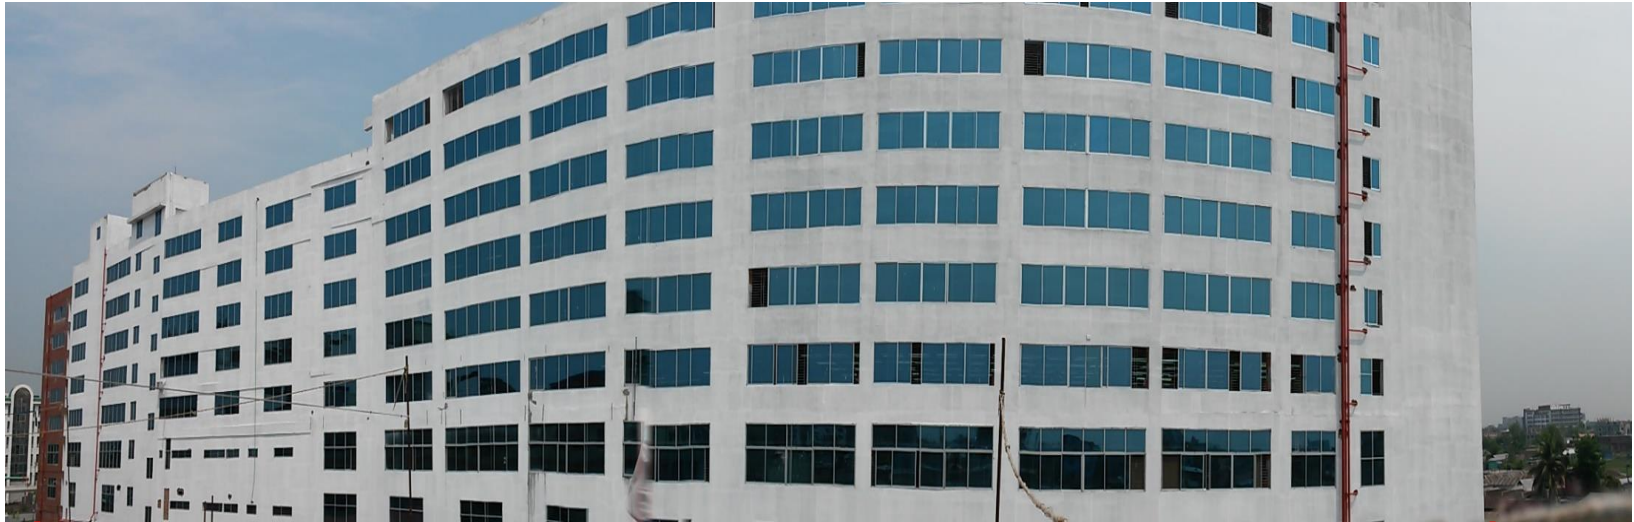
157.56 metres

No provision made for building movements resulting from thermal expansion/contraction, differential settlement and/or long-term shrinkage.

**Observation** -No Movement joints in structure or  
3 Facade

**ITEM 1:** No provision in building for movement (expansion/contraction)

| Item No. | Observation | Recommended Action Plan | Recommended Timeline |
|---|---|---|---|
| 1 | No provision in building for movement (expansion/contraction) | Factory Engineer to calculate building movements/stresses resulting from thermal expansion/contraction, differential settlement and/or long-term shrinkage on existing Structure and Facade. DEA to be updated to include thermal loads. | 6-weeks |
| 2 | No provision in building for movement (expansion/contraction) | Factory Engineer to carry out remedial works to prevent structural damage to building and façade, if required. | 6-months |

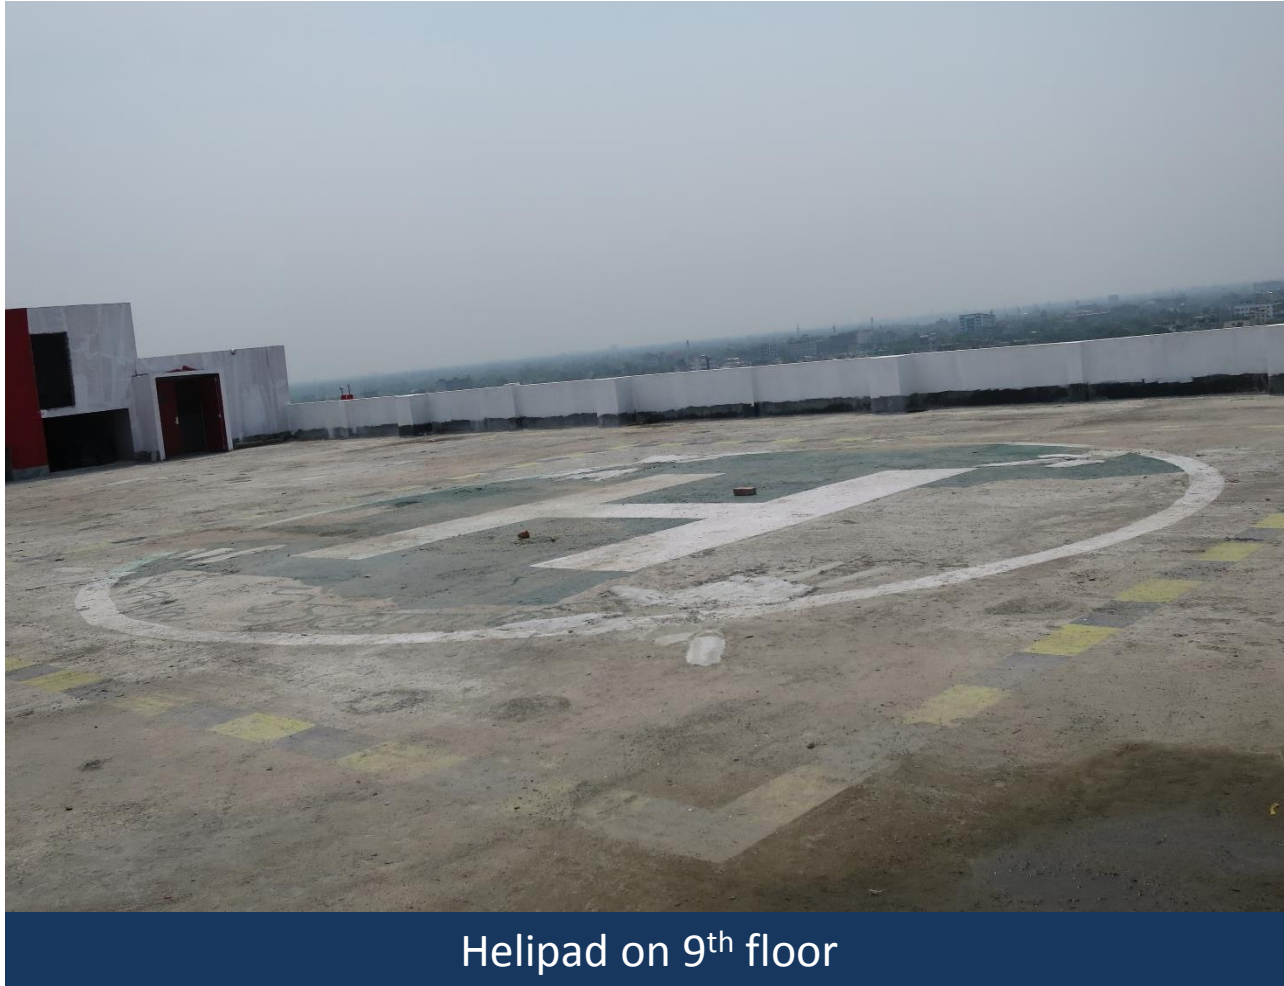
## Helicopter Loading not defined

**ITEM 2:** Helicopter loading on Roof Slab

| Item No. | Observation | Recommended Action Plan | Recommended Timeline |
|---|---|---|---|
| 3 | Helicopter loading on Roof Slab | Factory Engineer to calculate imposed loads resulting from helicopter landing/take-off on roof slab, in consultation with Bangladesh Aviation Authority regarding load limitations of use for this Helipad | 6-weeks |
| 4 | Helicopter loading on Roof Slab | DEA to be updated to include these loads. | 6-weeks |
| 5 | Helicopter loading on Roof Slab | Factory Engineer to specify maximum allowable imposed loads on Helipad. | 6-months |

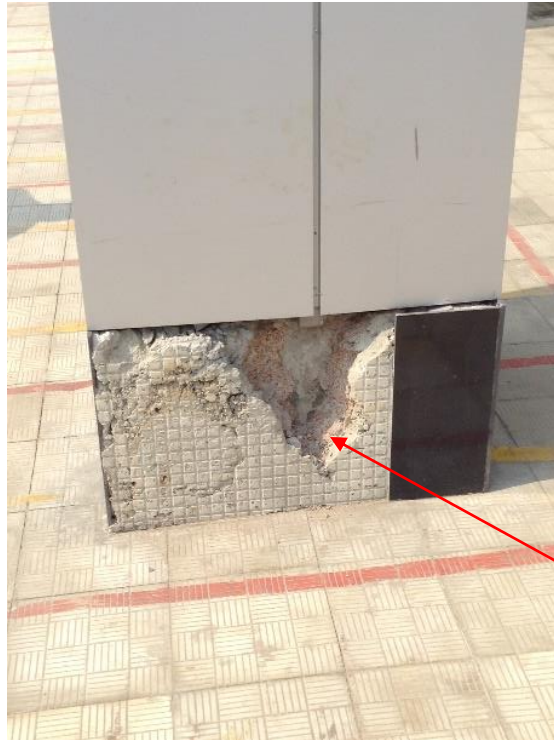
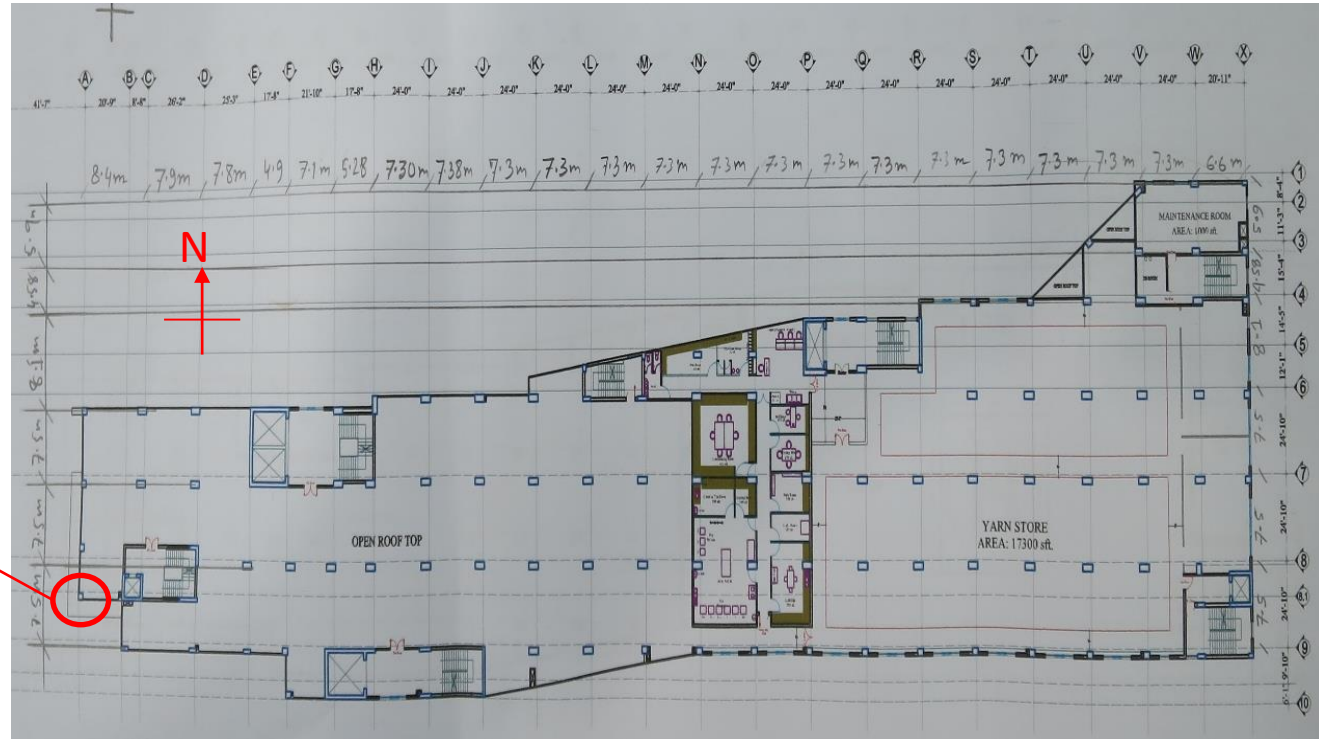
Ground Floor column

**ITEM 3:** Damaged Column at Entrance

| Item No. | Observation | Recommended Action Plan | Recommended Timeline |
|---|---|---|---|
| 6 | Damaged Column at Entrance | Factory Engineer to arrange for damaged column to be inspect by structural engineer. Following inspection Factory Engineer to repair damaged column as specified by structural engineer. | 6-weeks |
