# **FIRE SAFETY INSPECTION REPORT**

**CHORKA TEXTILE LIMITED (EXTENSION-2)**

**ACCORD ID: 23867**

**Kazirchor, Danga, Palash, Norshingdi  
(23.896373, 90.572771)**

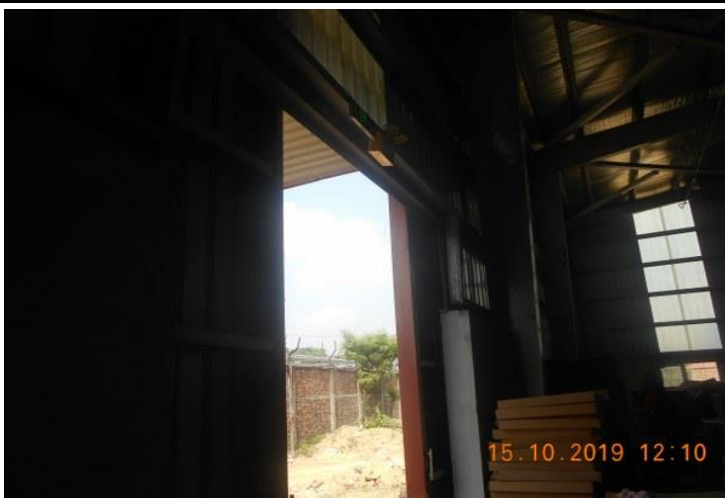
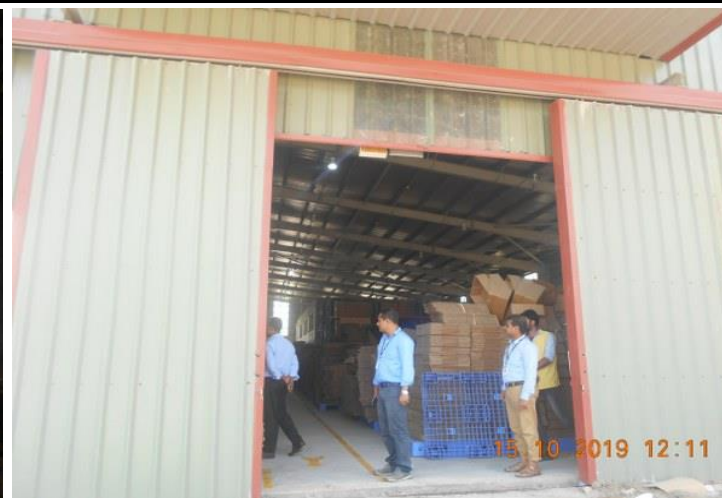
| Sl No. | Category | Findings | Required Action | Remediation Time Frame |
|---|---|---|---|---|
| 1 | Egress | Sliding doors are provided at exits. | Replace all sliding doors along the means of egress with side-hinged, swinging egress doors.<br>If locks are required for security reasons, utilize specialized door locking features complying with NFPA101. | Within 1 month |

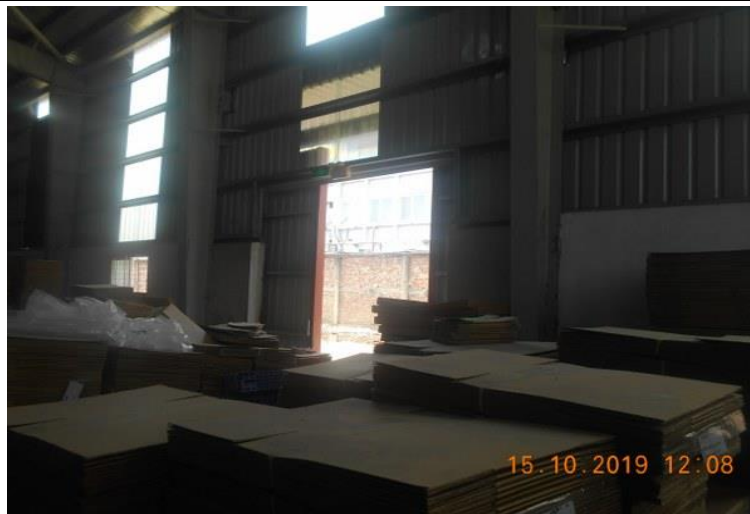
| 2 | Egress | Storage were located in several egress paths. | Keep egress path and stair clear of storage | Immediate |
