# **FIRE SAFETY INSPECTION REPORT**

**TIME SWEATER LTD.**

**ACCORD ID: 12191**

**KUTUBAIL, KATHERPUL, FATULLA**

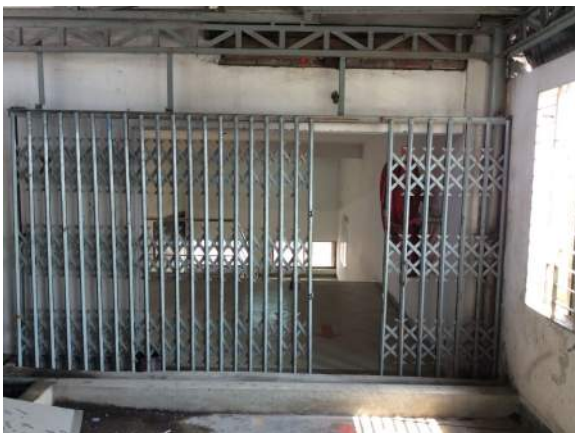
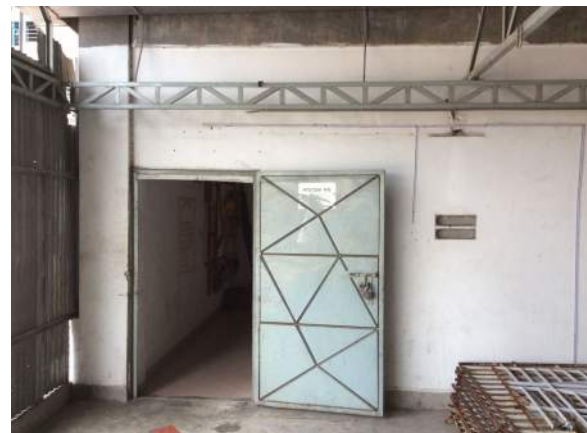
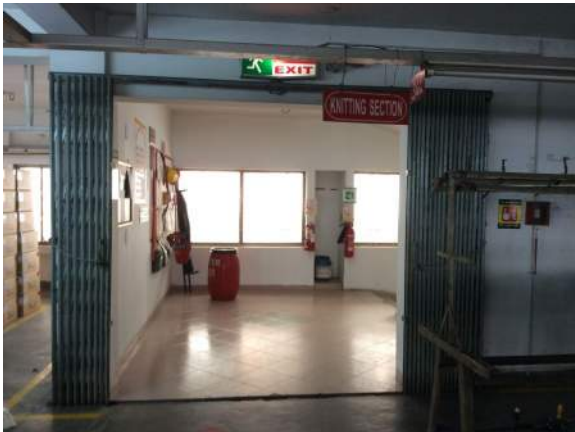
| F-1 | Fire Rated Construction | The exit stairs are not separated from work areas and other spaces on each floor by fire-rated construction. | <p>Provide minimum 1.5-hr fire rated doors for buildings that are 4 or more stories. Seal all unprotected openings to separate the exit stairs from work areas and other building spaces on all floor levels. Ensure that the fire doors are self-closing and positive latching and that they are provided with fire exit (panic) hardware where serving production floors.</p> <p>If fire doors are required to be held open for functional reasons, provide automatic-closing devices tied to the fire alarm system.</p> <p>Once fire doors are installed, every door in a stair enclosure serving more than 5 stories shall be provided with re-entry unless it meets ACCORD standard 6.8.3.1.</p> | Within 3 months |

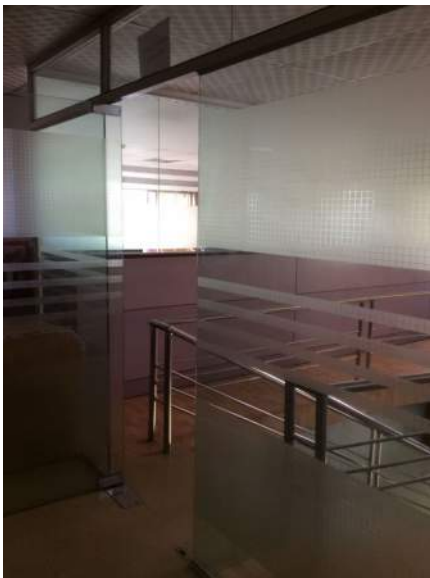
| F-2 | Fire Rated Construction | The south exit stair enclosure is not separated from work areas, other spaces on ground and first floors by fire-rated construction. | The exit stair enclosure shall be provided with a minimum 2-hr fire resistance rating for buildings 4 or more stories. | Within 3 months |

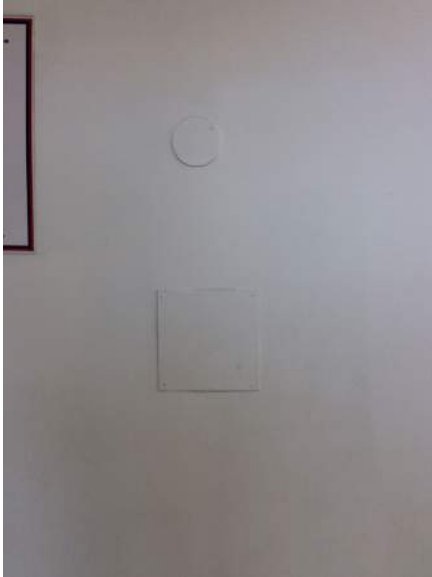
| F-3 | Fire Rated Construction | Unsealed penetrations and openings are located in east exit stair enclosure. | Seal all penetrations and openings in exit stair enclosure walls to maintain the fire separation. | Within 3 months |

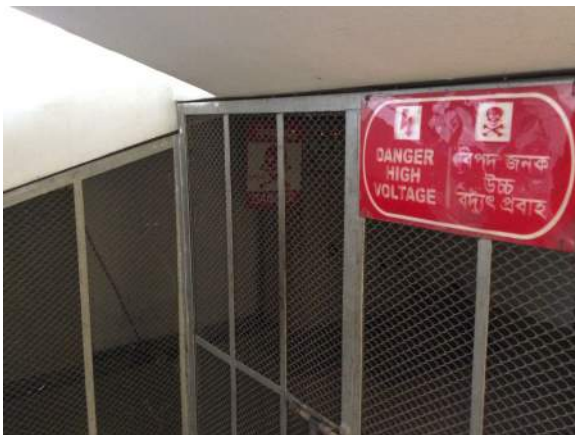
| F-4 | Fire Rated Construction | Electrical panels were located in the east exit stair enclosure. | Remove and re-locate all electrical panels from exit stair enclosures. | Within 3 months |

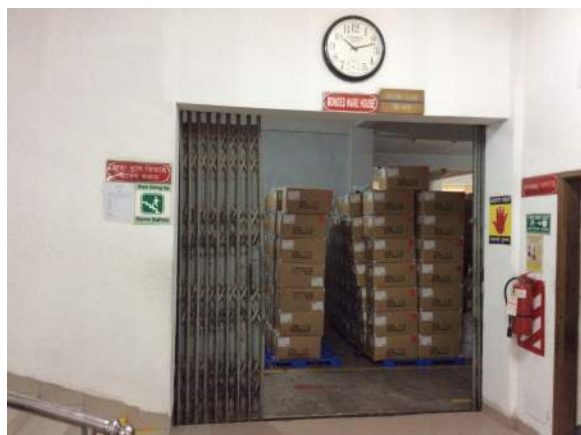
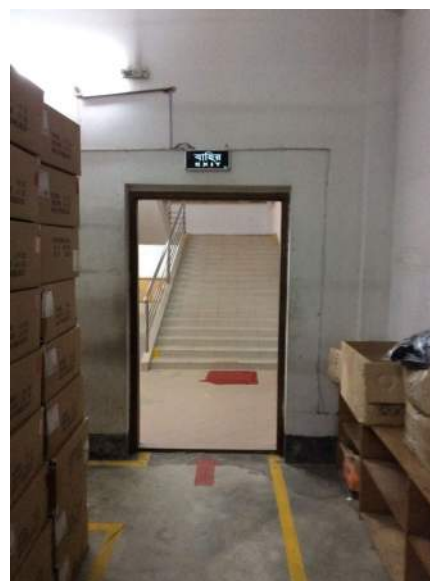
| F-5 | Fire Rated Construction | Storage room discharges directly into west exit stair enclosure. | Openings from exit enclosure to storage spaces shall be provided with a vestibule with fire rated construction and openings. | Within 3 months |

Provide a 1.5 hr. fire rated door on the exit stair side and a 1-hr. fire rated door on the storage room side. Ensure that the fire rating of the vestibule construction matches that of the exit stair enclosure.

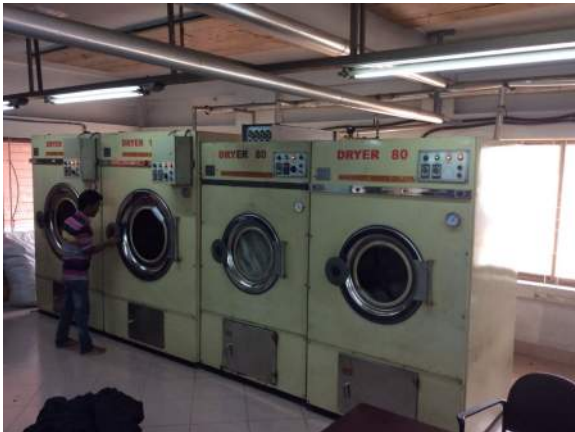
| F-6 | Fire Rated Construction | The industrial dryers are not separated by fire-rated construction on the second floor. | Separate the industrial dryer area by a minimum 2-hr fire-rated construction. Seal and/or protect all openings to maintain the required fire separations. Provide proper ventilation and consult with a qualified engineer. | Within 3 months |

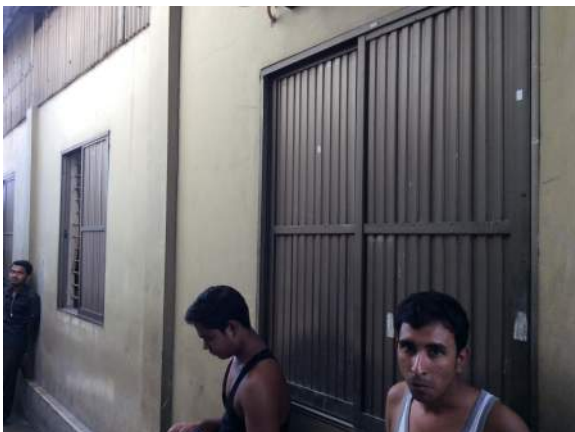
| F-7 | Fire Rated Construction | The boiler shed is not separated by fire-rated construction due to openings on the egress court. | Separate the boiler shed by a minimum 1-hr fire-rated construction for non-high rise. Seal and/or protect all openings to maintain the required fire separations. When located to the exterior of a building, 3m (10 ft.) separation is required. Provide proper ventilation and consult a qualified engineer. | Within 3 months |

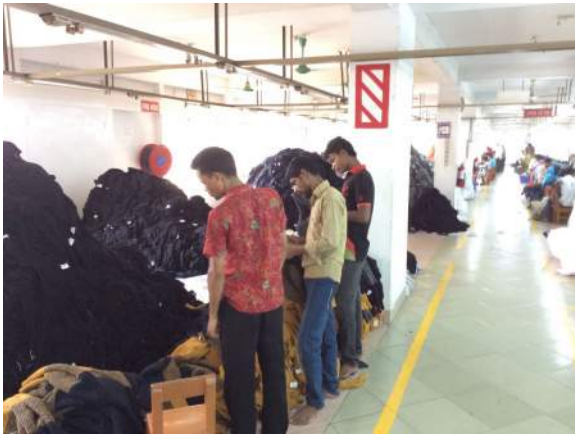
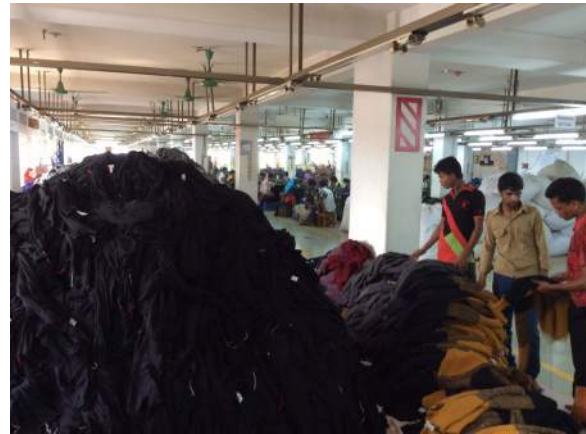
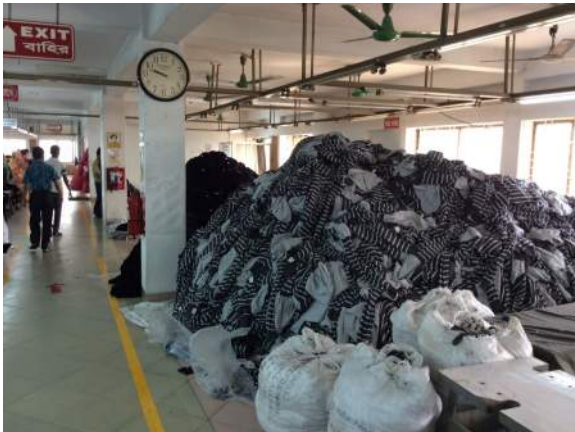
| F-8 | Fire Rated Construction | Areas used for combustible storage open to the factory are not separated by fire-rated construction on ground, first, second and third floors. | <p>Provide defined storage areas and limit the storage arrangement as follows:</p> <ul style="list-style-type: none"><li>- Maximum height of 2.45m (8ft.) and maximum area of 23m<sup>2</sup> (250 ft<sup>2</sup>)</li><li>- If sprinkler protected: maximum height of 3.66m (12ft.) and maximum area of 93m<sup>2</sup> (305ft<sup>2</sup>)</li></ul> <p>Separate areas of unenclosed combustible storage by a minimum clear distance of 3m (10ft.).</p> | Within 3 months |

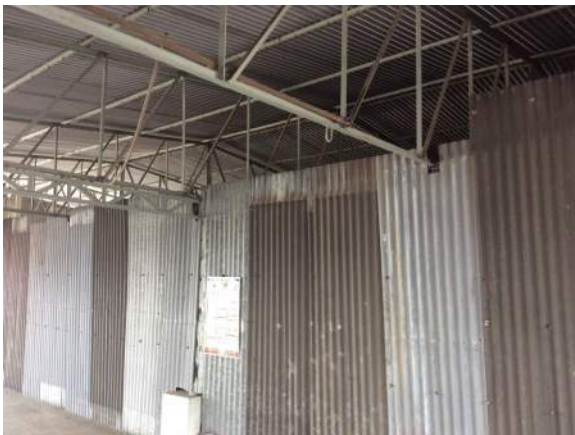
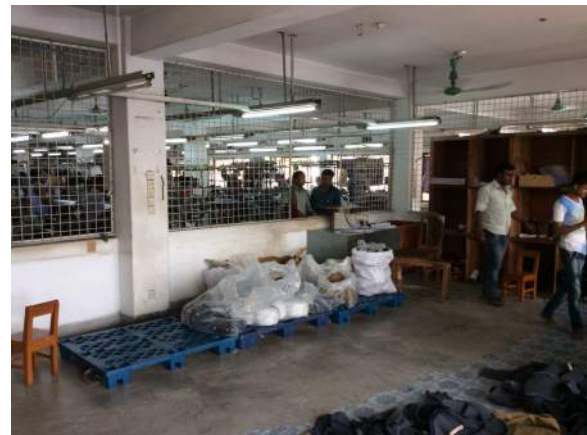
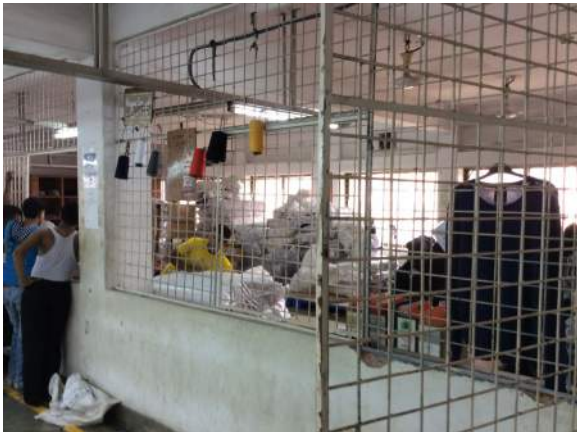
| F-9 | Fire Rated Construction | Rooms used for combustible storage are not separated by fire-rated construction ground, fourth, fifth floors and roof top. | <p>Provide dedicated storage rooms separated by minimum 1-hr fire-rated construction.</p> <p>Where separate storage rooms are not feasible, provide defined storage areas and limit the storage arrangement as follows:</p> <ul style="list-style-type: none"><li>- Maximum height of 2.45m (8ft.) and maximum area of 23m<sup>2</sup> (250 ft<sup>2</sup>)</li><li>- If sprinkler protected: maximum height of 3.66m (12ft.) and maximum area of 93m<sup>2</sup> (305ft<sup>2</sup>)</li></ul> <p>Separate areas of unenclosed combustible storage by a minimum clear distance of 3m (10ft.).</p> | Within 3 months |

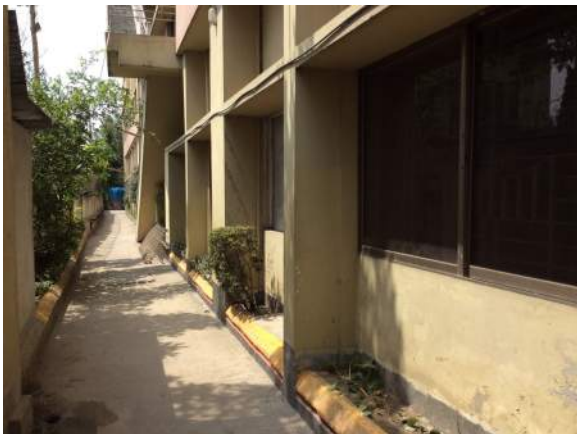
| F-10 | Fire Rated Construction | The exit discharge path serving the east exit is less than 3 m (10 ft.) wide and is not separated from the building interior. | Seal all penetrations and openings to the interior of the building along the discharge path, up to a height of 10 ft., to provide a minimum 1-hr fire separation. | Within 6 months |

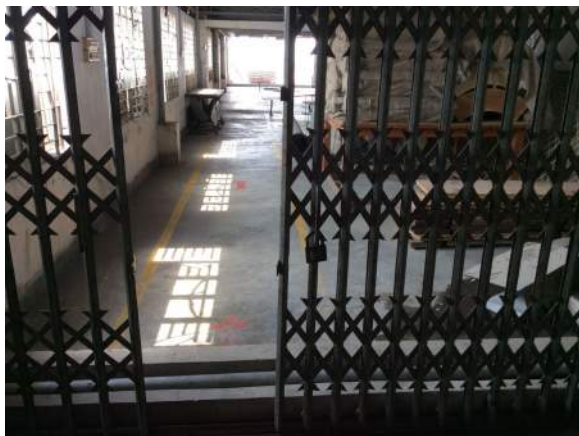
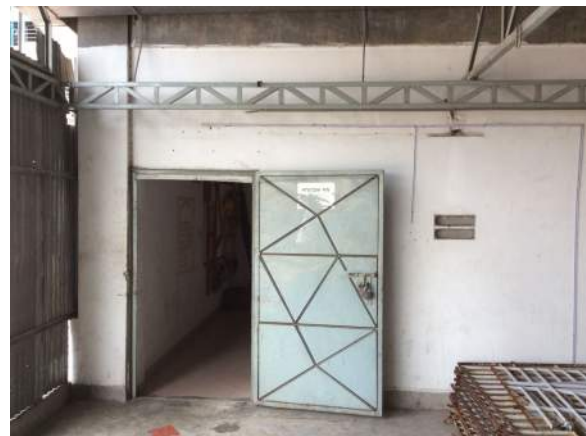
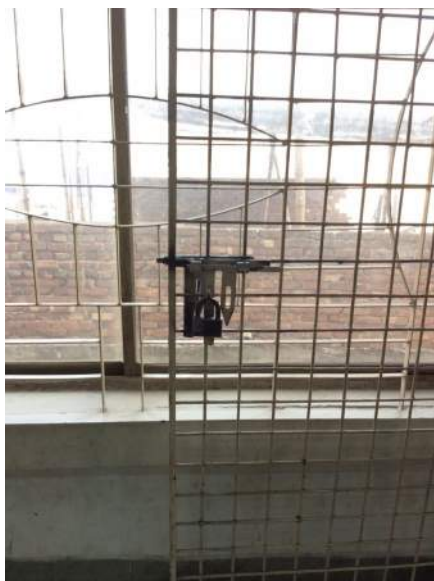
| F-12 | Egress | Egress doors with locking features are provided at exit stairs and along egress routes. Egress gates with locking features are provided at building exits and exit stairs. All gates/doors were not open and unlocked during the inspection. | Remove locking features from all egress doors and gates.<br><br>If locks are required for security reasons, utilize special door locking features complying with NFPA 101 and ACCORD standard 6.8.2. | Immediately |

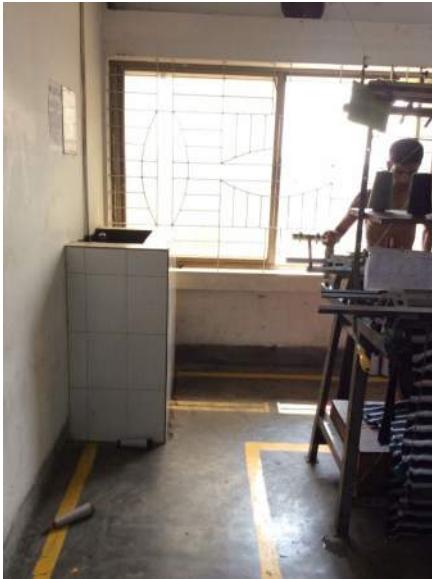
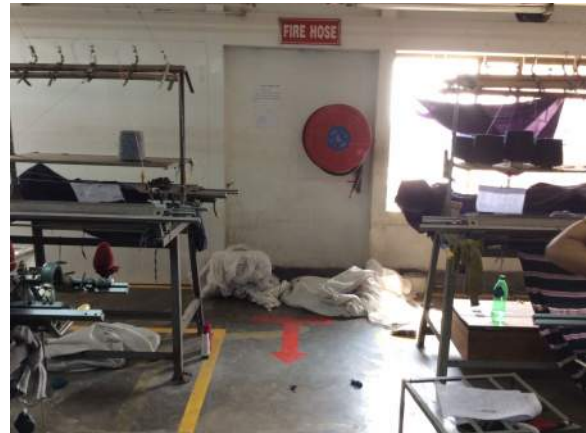
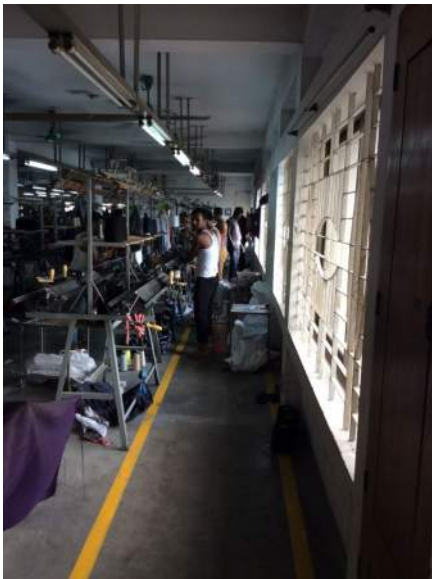
| F-13 | Egress | Storage and obstructions were located in the egress paths on ground, first, fourth and fifth floors. | Keep egress paths and stairs clear of storage and obstructions. | Immediately |

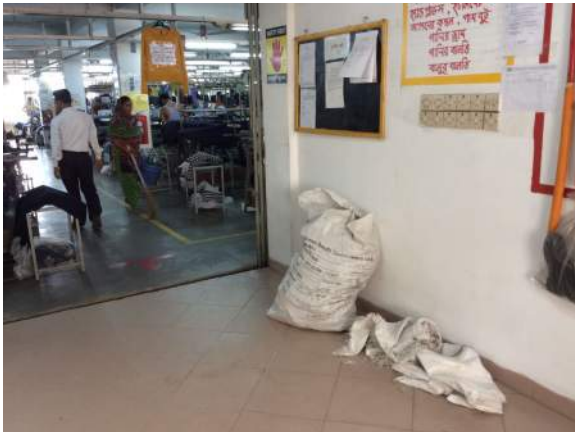
| F-14 | Egress | Storage was located in the west exit stair. | Remove all storage from exit stairs and egress paths. | Immediately |

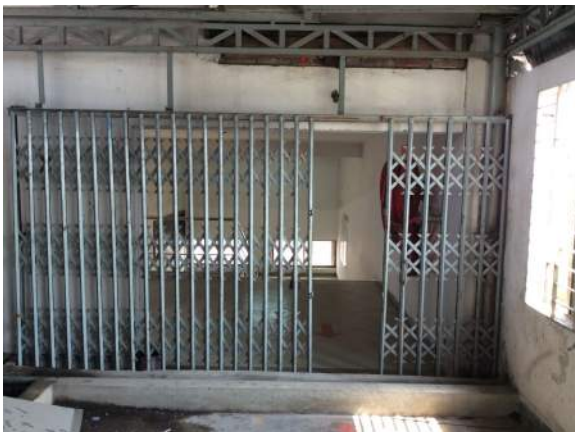
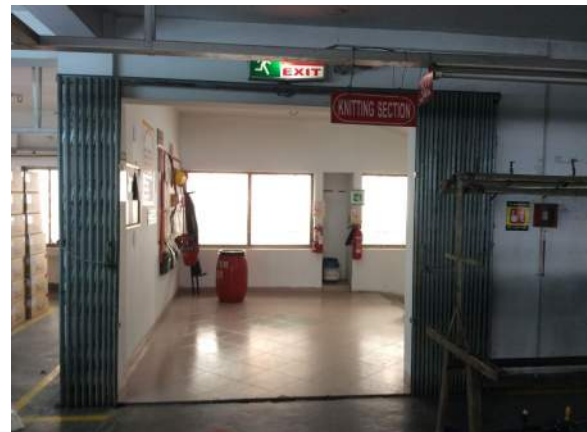
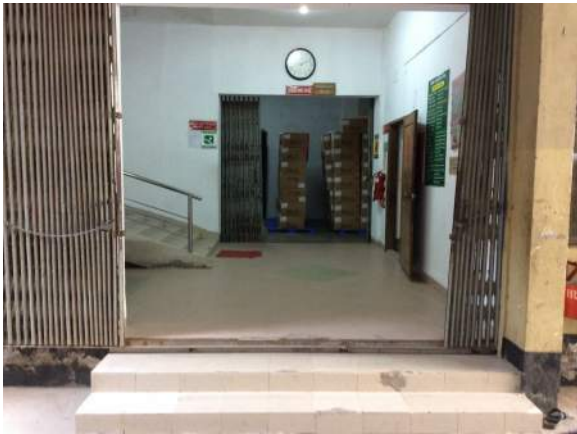
| F-15 | Egress | Collapsible gates are provided at building exits and exit stairs. Sliding doors are provided along egress routes. | Replace all gates and sliding doors along the means of egress with side-hinged, swinging egress doors in accordance with ACCORD standard 6.8.1. | Within 1 month |

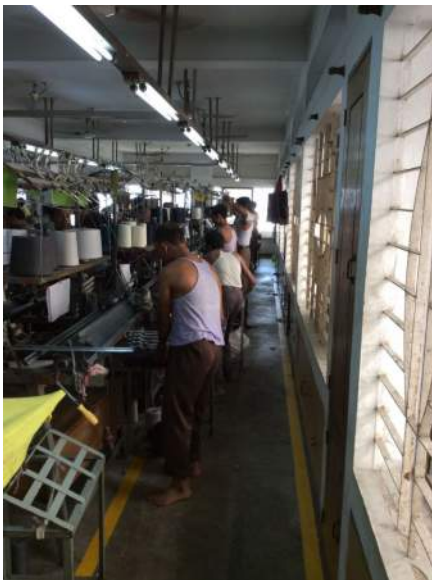
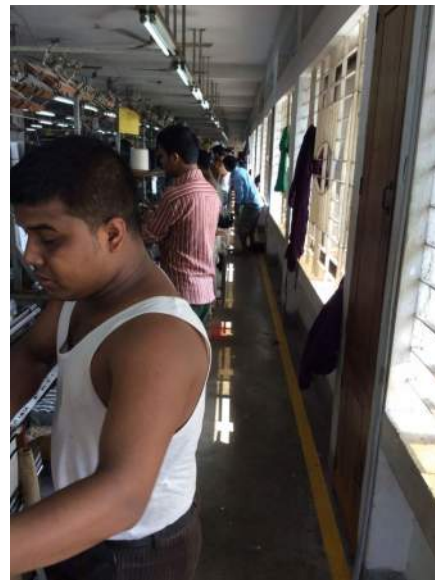
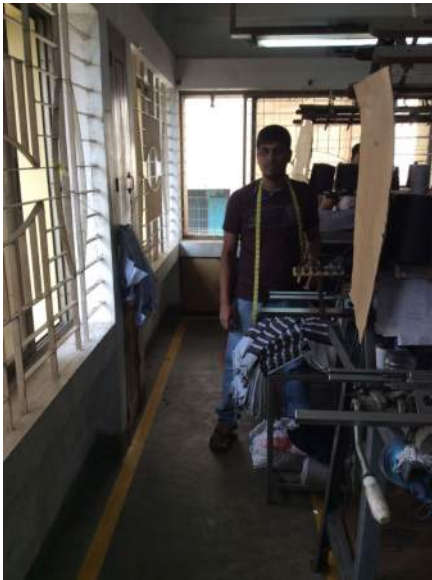
| F-16 | Egress | The width of egress aisles is less than 36-in. on ground, third, fourth and fifth floors. | Provide minimum aisle widths of 36-in. | Within 3 months |

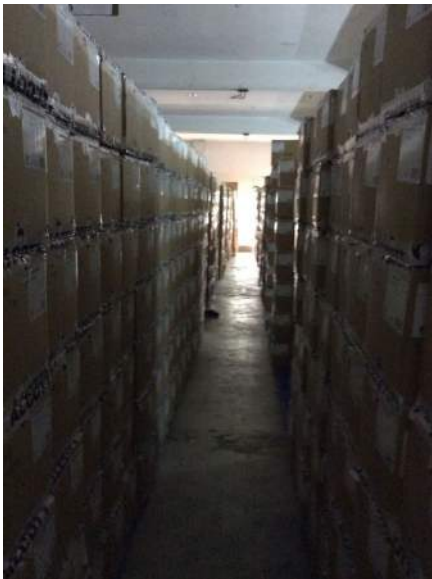
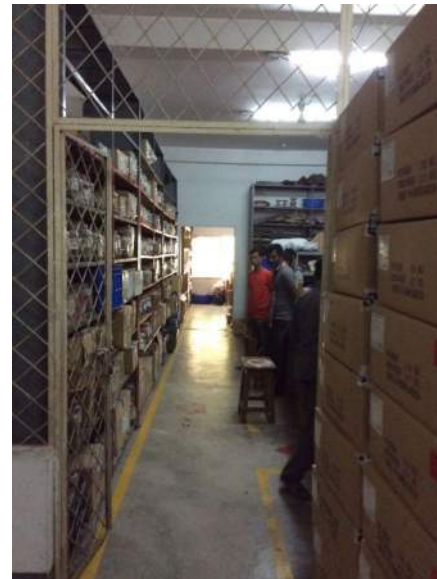
| F-17 | Egress | Dead-end aisles exceed 15 m (50 ft.) on the ground floor. | Reconfigure the egress arrangement to reduce the maximum dead-end distance to not more than 15 m (50 ft.). | Within 3 months |

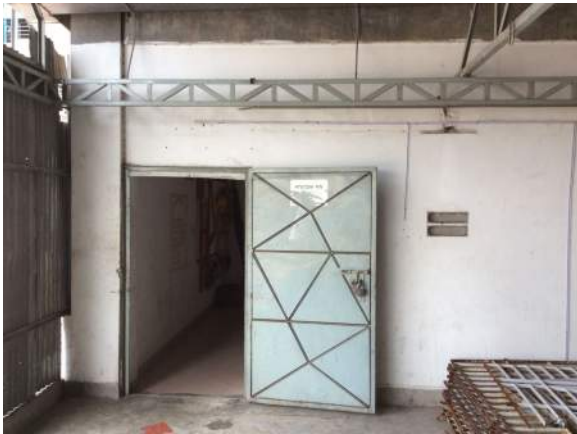
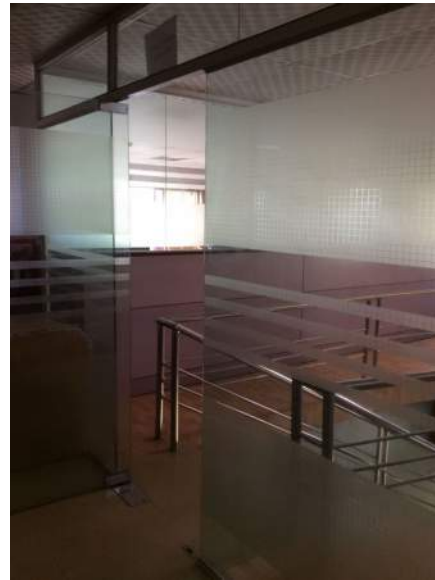
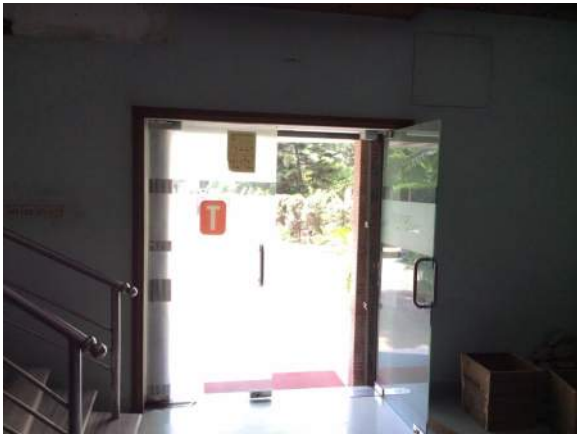
| F-18 | Egress | Exit stair doors on first floor and roof top and egress door serving 50 or more occupants on the ground floor do not swing in the direction of egress travel. | Modify the egress doors to swing in the direction of egress travel. | Within 3 months |

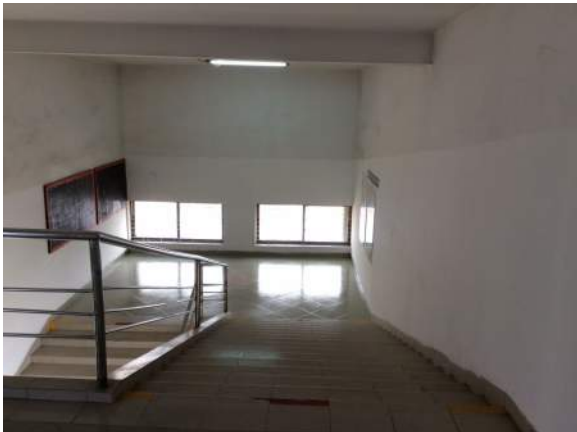
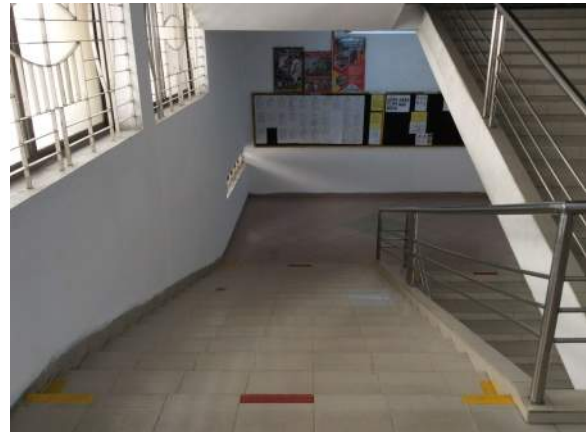
| F-19 | Egress | Handrails are not provided on both sides of the exit stairs. | Provide handrails on both sides of the exit stairs. New handrails shall have a minimum height of 865 mm (34 in.) and a maximum height of 965 mm (38 in.) as measured from the leading edge of the tread. Intermediate handrails shall be provided when the stair width exceeds 2.2 m (87 in.) | Within 3 months |

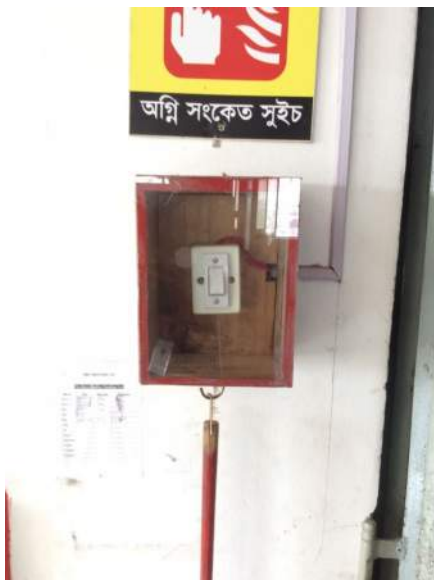
| F-20 | Fire Protection | The fire alarm system is antiquated, not a listed system and does not provide alarm and notification features consistent with acceptable standards. | Replace the fire alarm system with a new, listed addressable fire alarm system in accordance with NFPA 72. | Design within 4 months, install within 9 months |

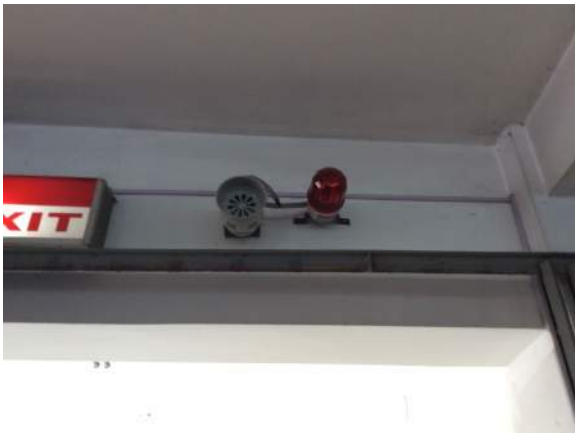
| F-26 | Fire Protection | Visible and audible notification was not provided for the building in accordance with NFPA 72. | Provide visible and audible notification for the building in accordance with NFPA 72. | Within 3 months |

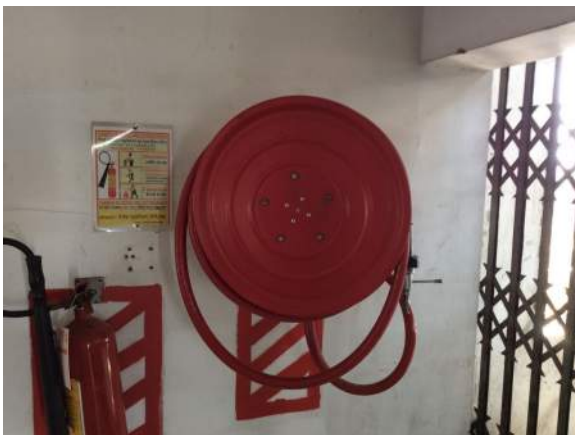
| F-28 | Fire Protection | The required standpipe system is not installed in accordance with the ACCORD standard. | Install a new standpipe system in accordance with ACCORD standard 5.4 and NFPA 14. | Within 6 months |

A class III system shall be installed in buildings with the highest occupiable floor 10 m (33 ft.) above grade or more. A class I system shall be permitted in buildings protected throughout by an approved automatic sprinkler system.

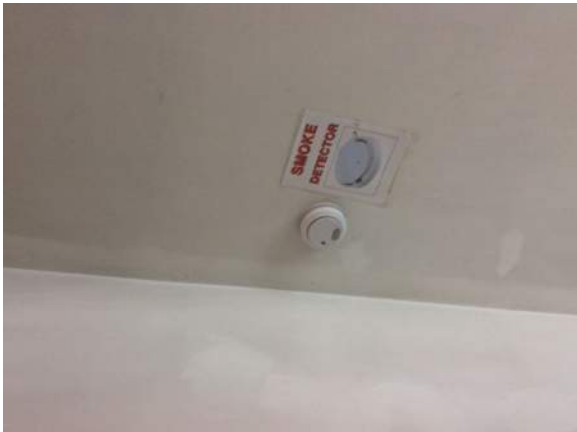
| F-29 | Fire Protection | The building is equipped with single-station smoke alarms. Smoke alarm activation sounds only a local alarm and does not provide automatic fire alarm notification of occupants. | Remove single-station smoke alarms. Provide automatic smoke detection throughout the building, tied into the fire alarm system, in accordance with NFPA 72. | Within 9 months |

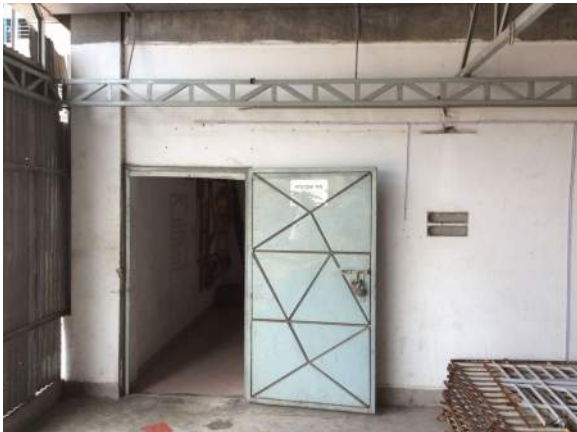
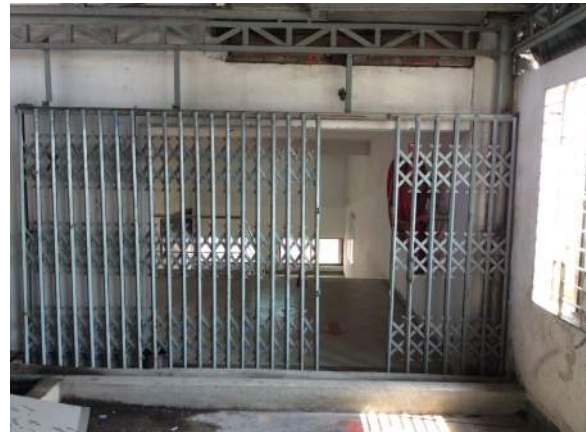
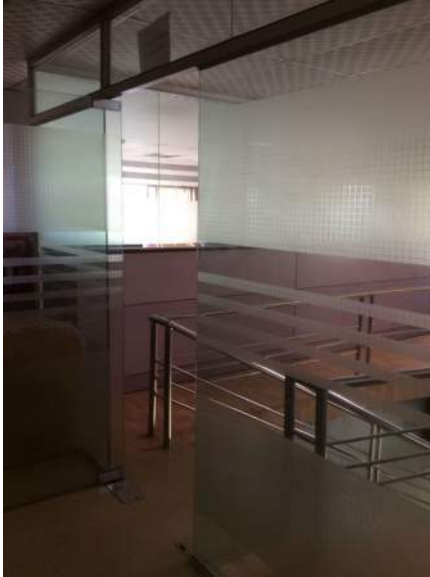
| F-30 | Egress Lighting | Exit signage was not provided at a building and floor exits. | Provide exit signs above all building exits to the exterior, all doors to the exit stairs and along all paths of travel where a change of direction is not obvious. | Within 1 month |
