# FIRE SAFETY INSPECTION REPORT

**Factory Name: RAM APPAREL LTD.**

## Fire Safety Inspection Report

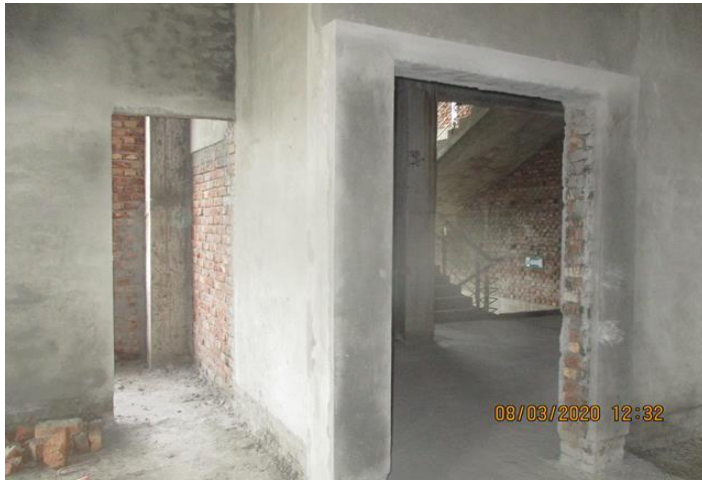
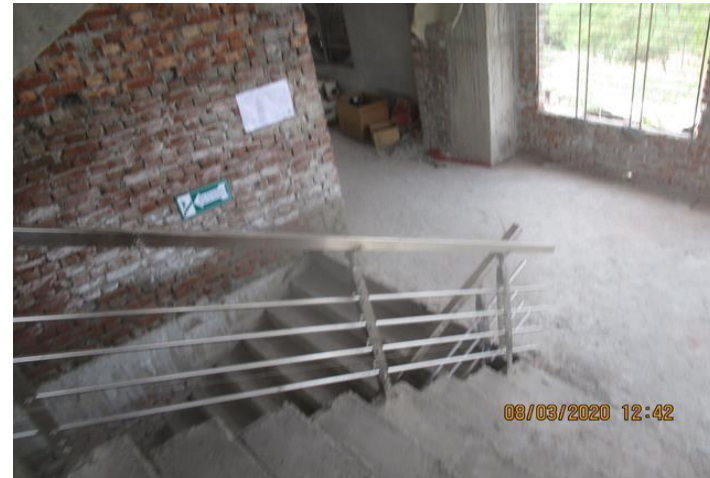
| SI No. | Category | Findings | Required Action | Remediation Time Frame |
|---|---|---|---|---|
| 1 | Fire-Rated Construction | The exit stairs are not separated from [work areas, other spaces] on each floor by fire-rated construction | <p>Stair shall be enclosed with a minimum 2-hr fire-rated construction. Seal all unprotected openings and provide minimum 1.5 -hr fire rated doors to separate the exit stairs from work areas and other building spaces on all floor levels. Ensure that the fire doors are self-closing, positive latching and that they are provided with fire exit (panic) hardware where serving production floors.</p> <p>If fire doors are required to be held open for functional reasons, provide automatic-closing devices tied to the fire alarm system.</p> | Within 3 months |

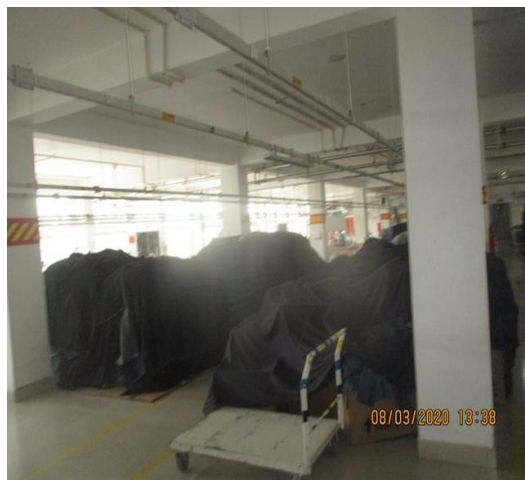
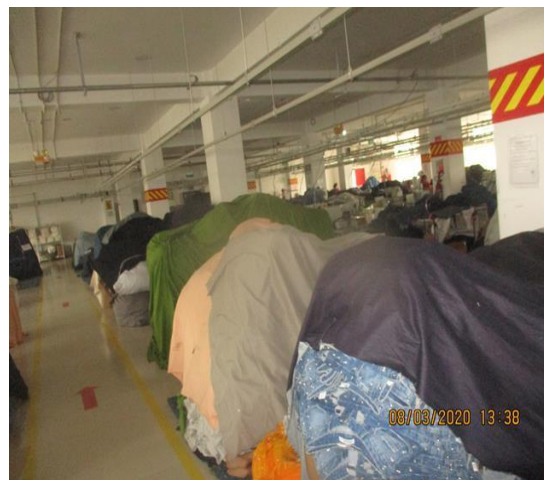
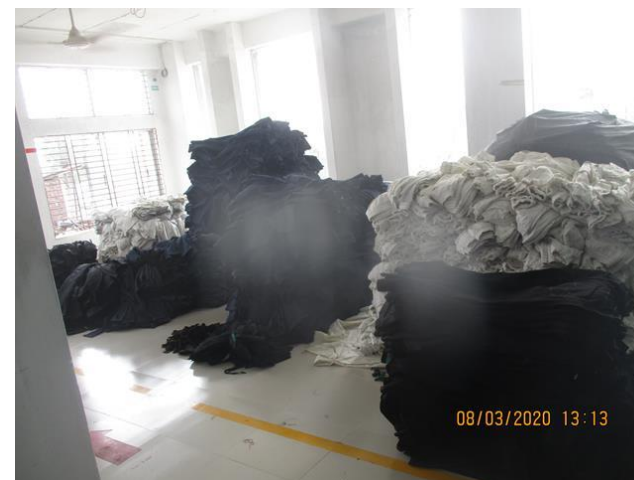
| 2 | Fire-Rated Construction | Areas used for in-process storage of combustible materials are open to the surrounding occupancy. | <p>Provide defined storage areas and limit the storage arrangement as follows:-</p> <ol style="list-style-type: none"> <li>1. General Condition: Maximum height of 2.4m and maximum area of 23m<sup>2</sup>. Separate areas of unenclosed combustible storage by a minimum clear distance of 3m.</li> <li>2. If sprinkler protected: maximum height of 3.66m and maximum area of 93m<sup>2</sup>. Separate areas of unenclosed combustible storage by a minimum clear distance of 3m.</li> </ol> <p>or</p> <ol style="list-style-type: none"> <li>3. Enclose the storage area from the surrounding occupancy with a minimum 1 hour construction.</li> </ol> | Within 3 months |

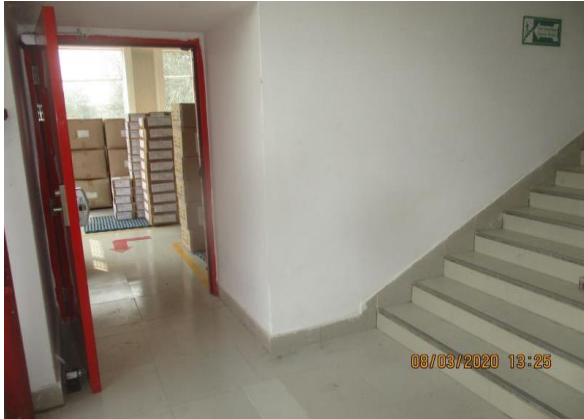
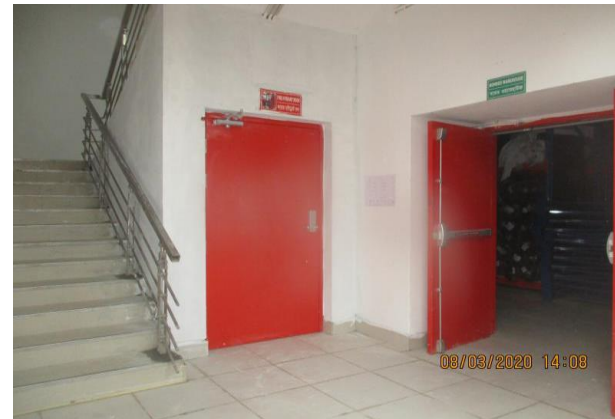
| 3 | Fire-Rated Construction | Storage room discharges directly into exit stair enclosures. | Openings from exit enclosure to storage spaces shall be provided with a vestibule with fire rated construction and openings. Provide a 1.5 hr. fire rated door on the exit stair side and +M6a 1-hr. fire rated door on the storage room side. Ensure that the fire rating of the vestibule construction matches that of the exit stair enclosure. | Within 3 months |

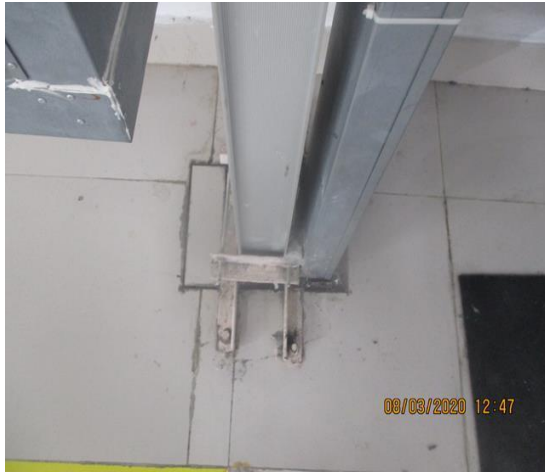
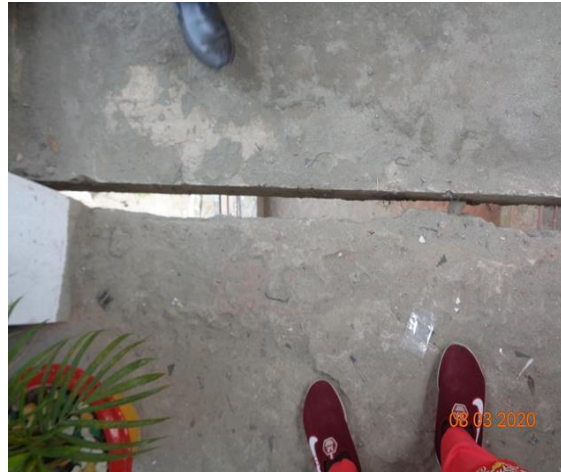
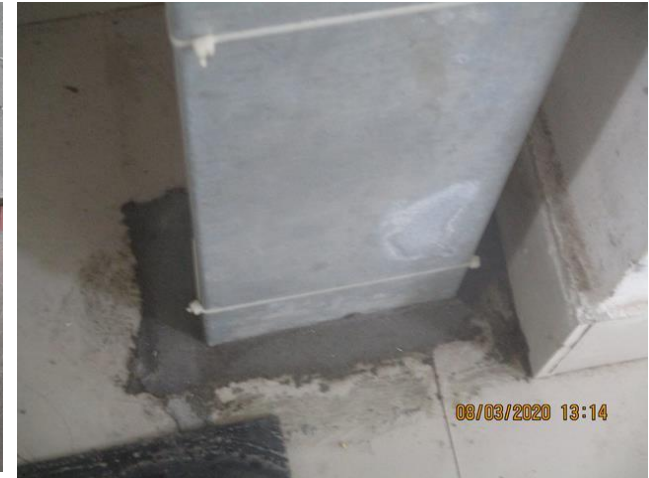
| 4 | Fire-Rated Construction | Penetrations through floor/ceiling assemblies are found unsealed. | Seal all penetrations and openings in floor/ceiling (full thickness of the floor/ceiling: minimum 3 hr) assemblies by third-party certified fire rated materials to maintain the fire resistance rating. Provide a minimum 2-hr fire rated shaft to separate the utility risers from each floor if required. | Within 3 months |

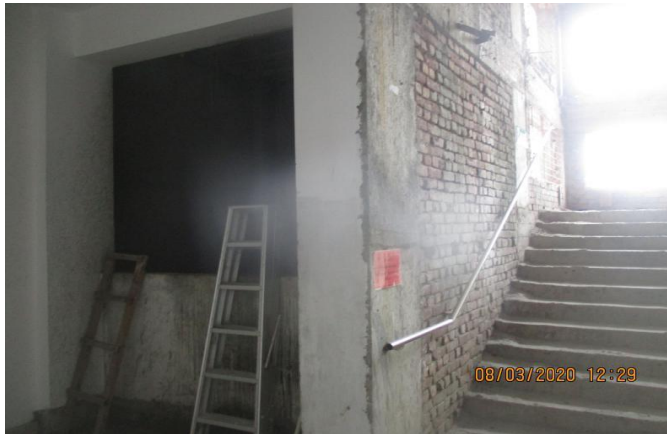
| 5 | Fire-Rated Construction | Unsealed penetrations and openings are located in the exit stair enclosures | Seal all penetrations and openings in exit stair enclosure walls to maintain the fire separations. | Within 3 months |

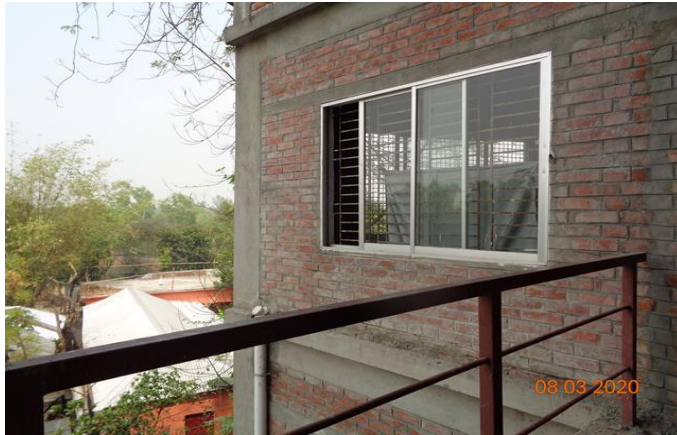
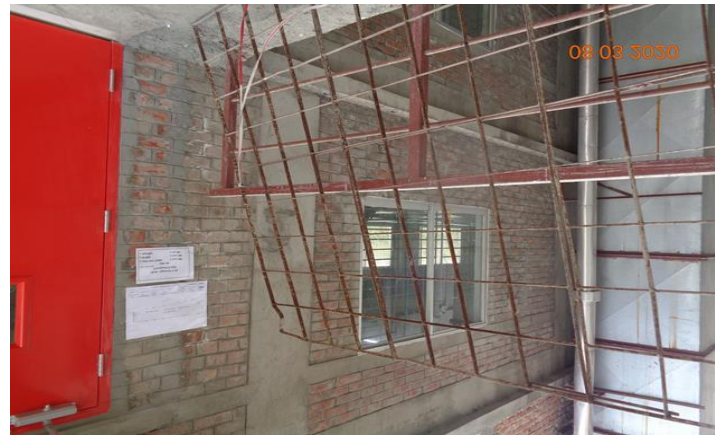
| 7 | Fire-Rated Construction | The North-East Exit discharge path is less than 10ft wide and is not separated from the building interior. | Seal all penetrations and openings to the interior of the building along the discharge path, up to a height of 10 ft, to provide a minimum 1-hr fire separation. Alternatively, provide a second remote discharge path to the public way (only include this if feasible). | Within 3 months |

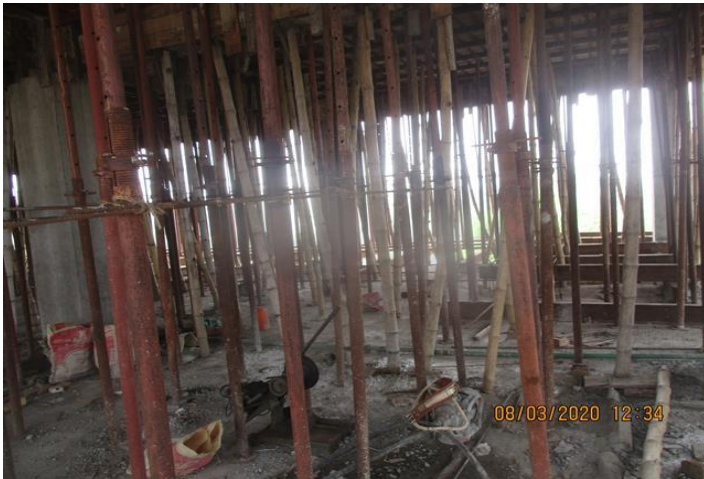
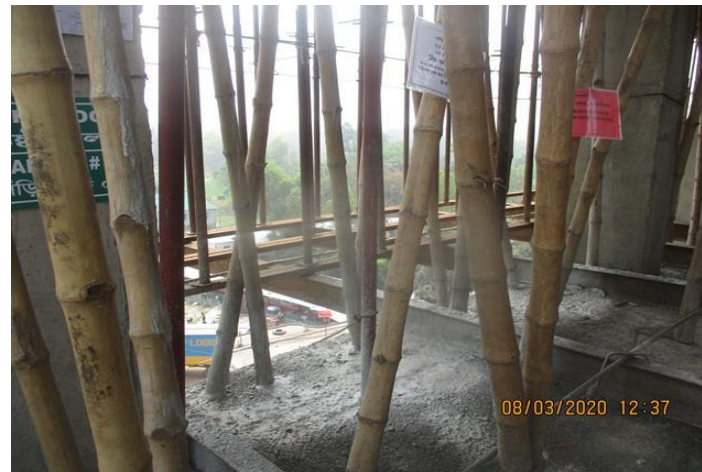
| 8 | No Parapets or Guards | The occupiable roof was not provided with an adequate guard rail. | All occupiable roofs shall be provided with parapets or guards with a minimum height of 1067 mm (42 in.) | Within 3 months |

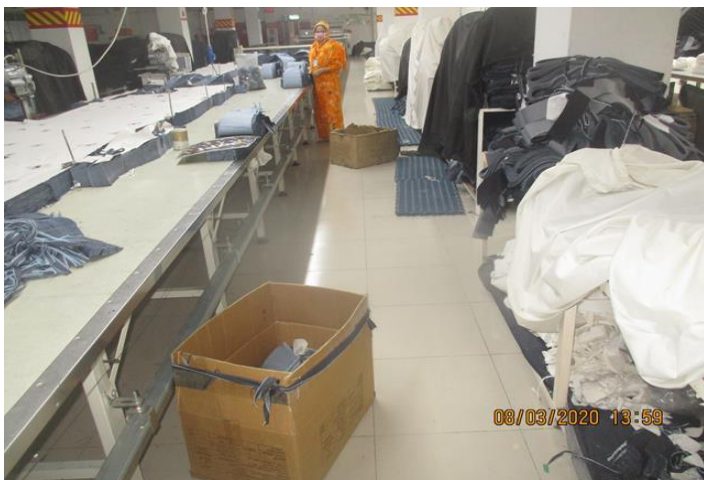
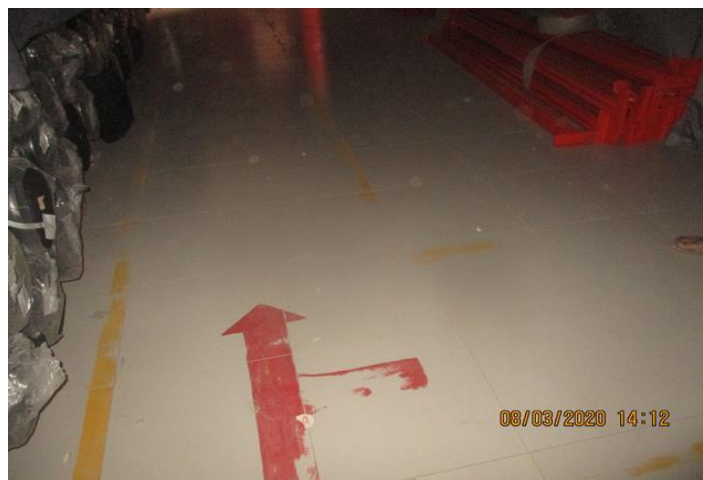
| 9 | Egress | Width of aisles is less than 0.9m (36-in.) and aisles mark is not provided at cutting Section, Bonded wear house. | Aisles shall be provided with a minimum unobstructed clear-width of 0.9 m (36 in.). | Within 3 months |

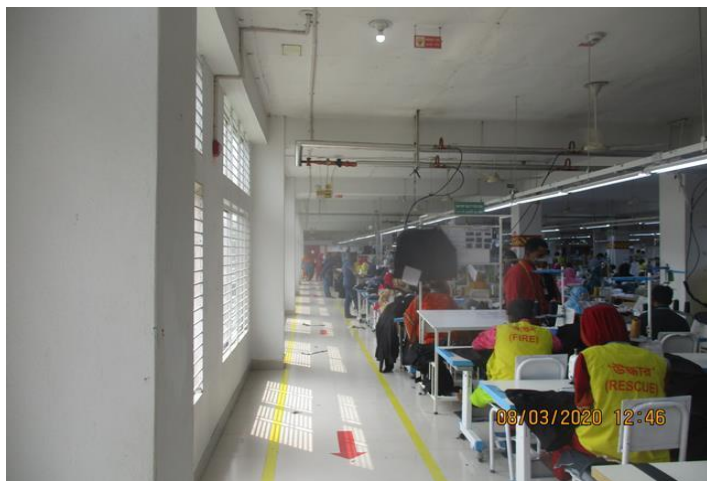
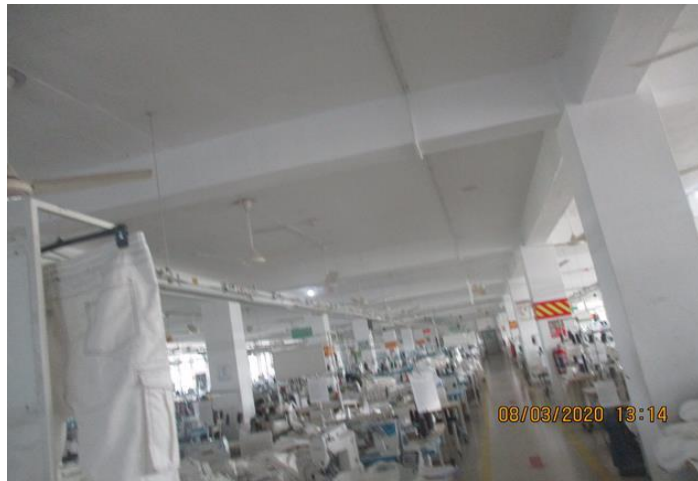
| 11 | Egress Lighting | Based on the number and location of emergency lights observed, adequate illumination levels are not anticipated along egress routes at sewing section | Test the emergency lighting system on each floor and provide additional emergency fixtures to supply adequate illumination along the means of egress. Provide a minimum illumination of 10 lux at the floor level within exit stairs and along exit discharge paths and a minimum 2.5 lux along exit access aisles. | Within 3 months |

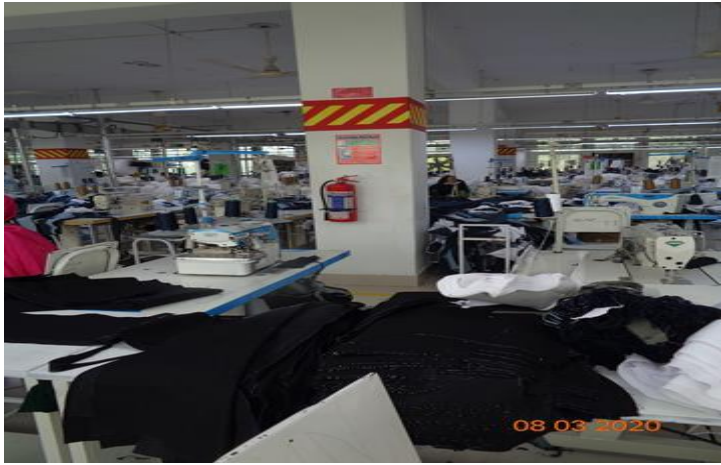
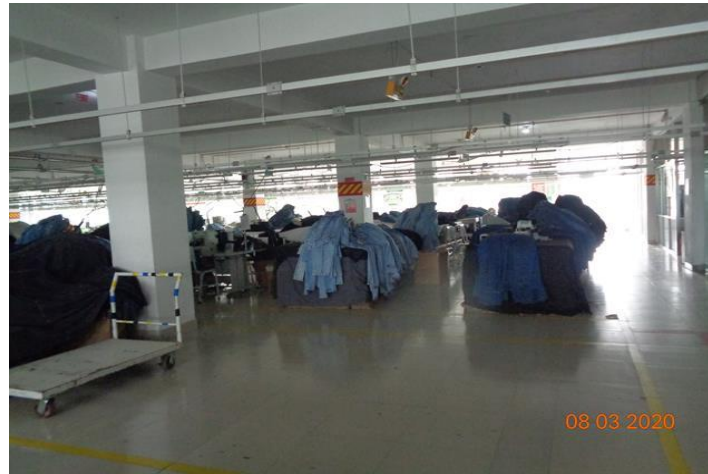
| 12 | Egress Lighting | Directional signs are not provided where direction of the path of travel to an exit has changed. | Illuminated directional signs shall be provided where there is a change in the direction for the path of travel and the direction to an exit is not obvious. | Within 3 months |

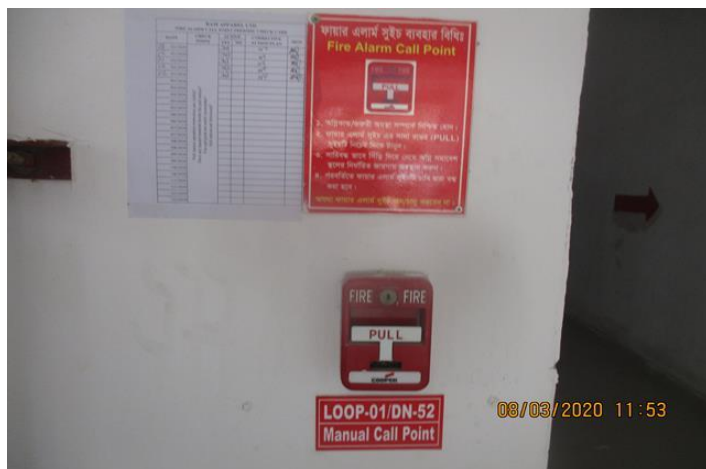
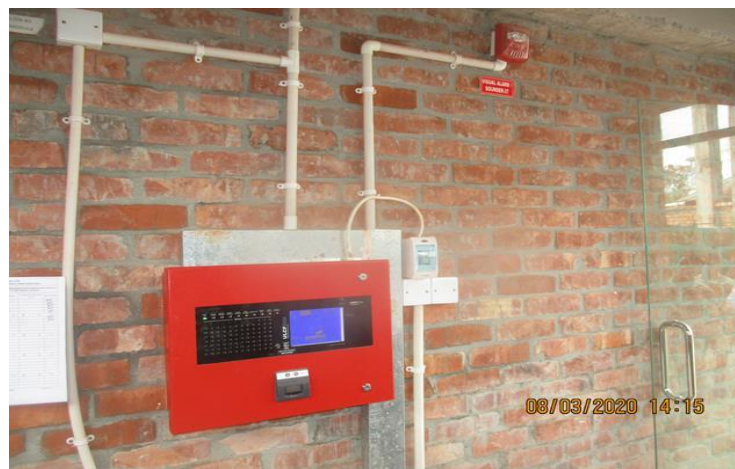
| 14 | Fire Alarm and Detection | The factory has installed an addressable fire alarm & detection system which is required to be reviewed and verified. | Submit as-built drawings, testing records, equipment certification and other relevant documentation to the ACCORD for review and approval, modification (if required) shall have to done as per the reviewed design and NFPA-72 .&Upon approval & modification (if required) the owner shall verify the system by ACCORD for final acceptance. | Design within 2 months, Install within 4 months |

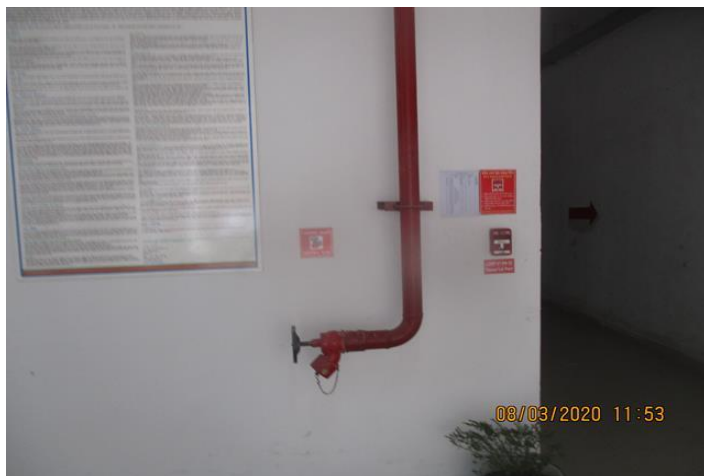
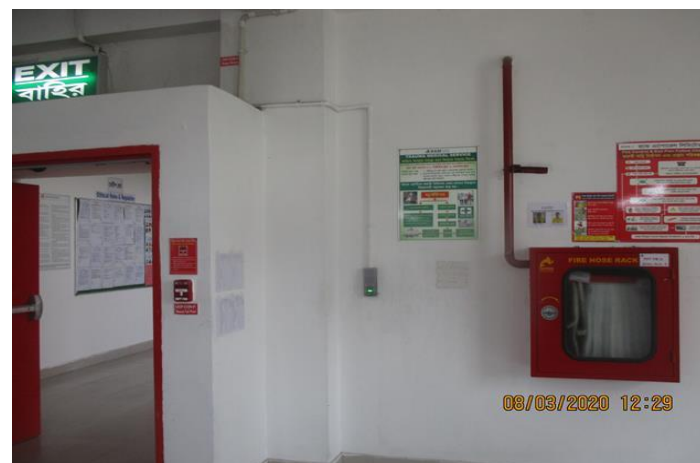
| 16 | Fire Protection | The highest occupied floor of existing building is more than 10 m (33 ft.) above grade where standpipe system is mandatory and factory has installed standpipe system along with Class-I standpipe which is required to be reviewed and verified. | Submit as-built drawings, testing records, equipment certification and other relevant documentation to the ACCORD for review and approval, modification (if required) shall have to done as per the reviewed design and NFPA-14, 20, 22. | Design within 2 months, Install within 6 months |

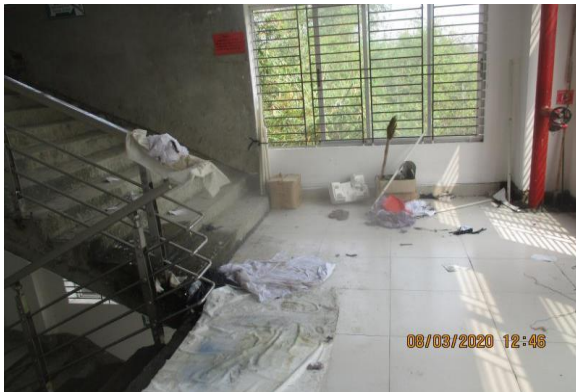
| 22 | Egress | Storage was located in exit stair. | Remove storage from the exit stairs and egress path | Immediate |
