# **FIRE SAFETY INSPECTION REPORT**

**Factory Name: Sadia Fashion Wears Ltd.**

**ACCORD ID: 23933**

**Date: 04-Feb-2020**

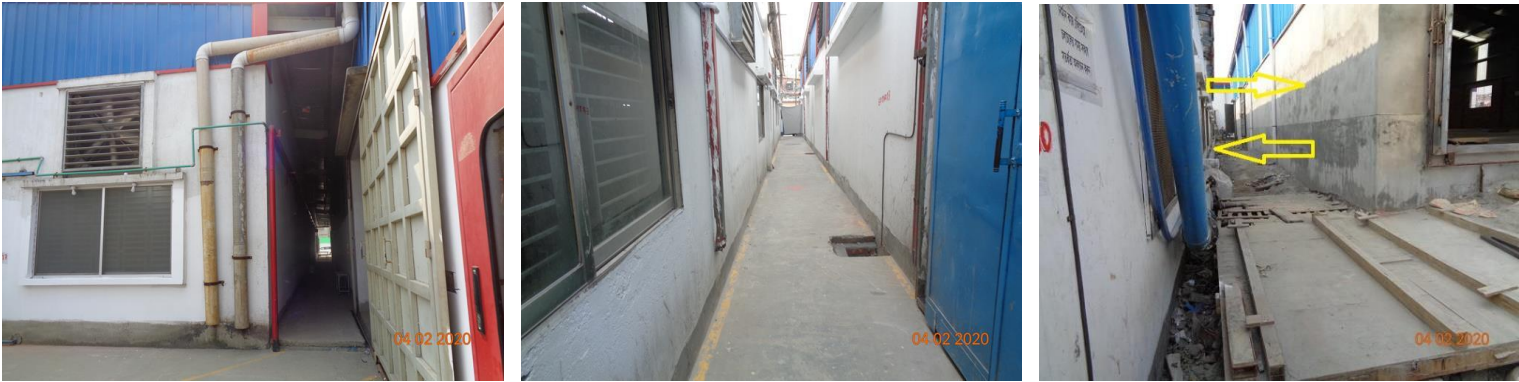
| SI No. | Category | Findings | Required Action | Remediation Time Frame |
|---|---|---|---|---|
| 1 | Fire Rated Construction | The exit discharge path is less than 10 ft. wide and is not separated from the building. Location: Between building-1 & 2; Between building-3 & 4; Between building-4 & 5. | Seal all penetrations and openings to the interior of the building along the discharge path, up to a height of 10 ft. to provide a minimum 1-hr fire separation.<br><br>Alternatively, provide a second remote discharge path to the public way (only include this if feasible). | Within 3 months |

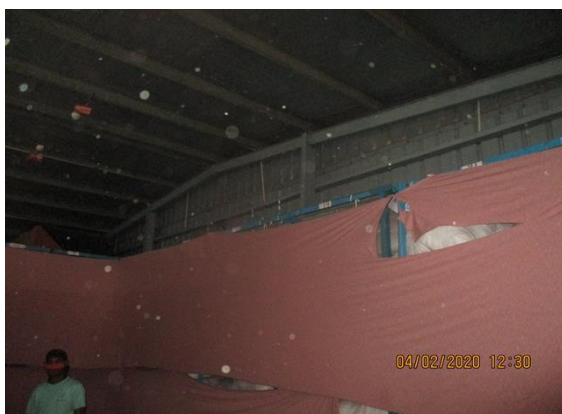
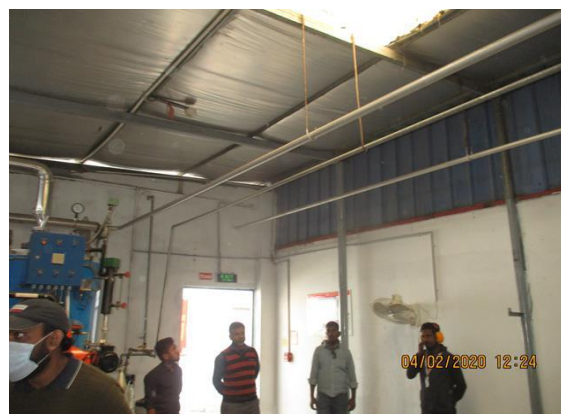
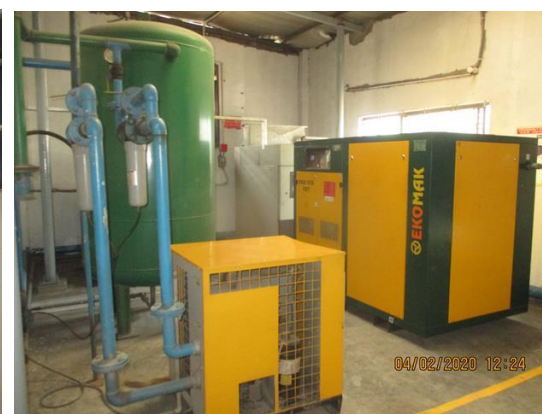
| 2 | Fire Rated Construction | The boiler and air compressor rooms are not separated by fire rated construction from cutting shed (openings, non-rated doors, penetrations). Also, Boiler and compressor are not separated by fire rated construction from each other. | Separate the boiler and air compressor rooms by a minimum 2-hr fire-rated construction from cutting shed as well as from each other. Seal and/or protected all openings to maintain the required fire separations. | Within 3 months |

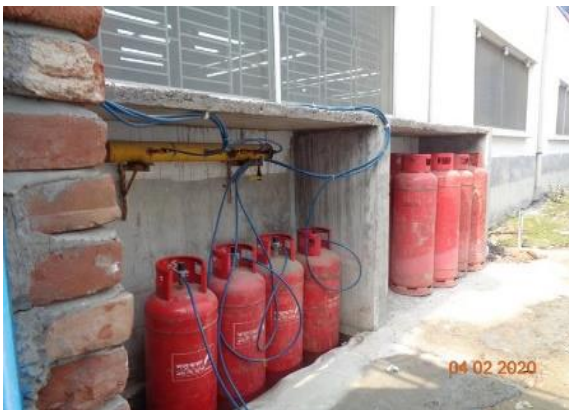
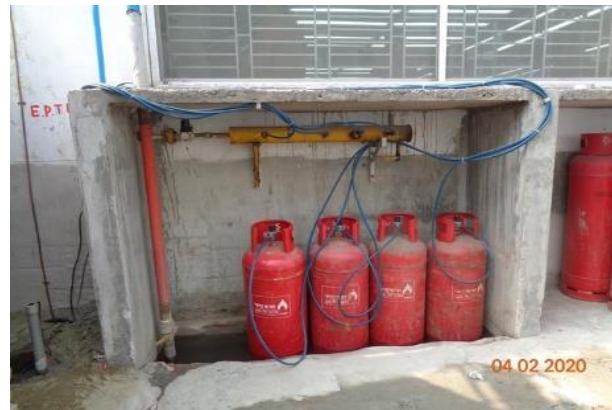
| 3 | Fire Rated Construction | Liquefied or compressed gas (LPG/CNG) cylinders were located within the factory on the ground floor. Location: Between building-1 & 5. | The storage or use of liquefied or compressed flammable gas cylinders shall be prohibited within the factory building. Remove the LPG/CNG cylinder which is used as a fuel source from the factory premises/compound. | Immediately |

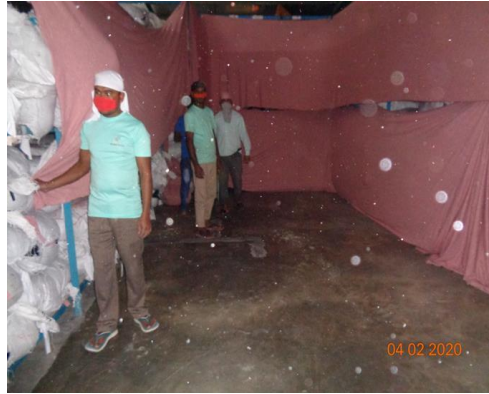
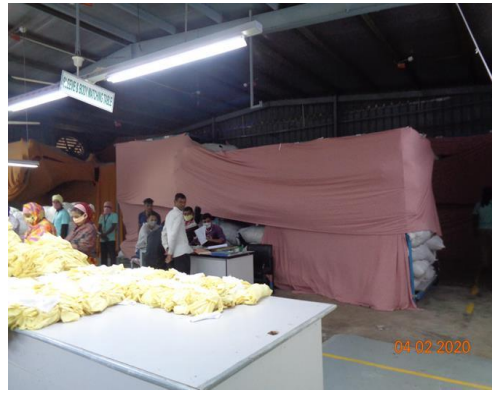
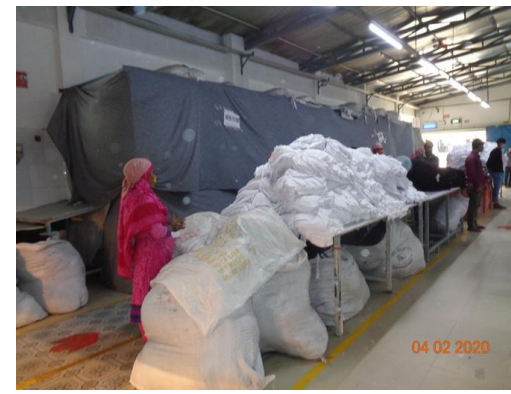
| 4 | Fire Rated Construction | Storage rooms and process areas used for combustible storage are not separated by fire rated construction. Location: Building-1, 3 & 4. | Provide dedicated storage rooms separated by minimum 1-hr fire-rated construction. Where separate storage rooms are not feasible, provide defined storage areas and limit the storage arrangement as follows: - Maximum height of 2.45m (8ft.) and maximum area of 23m <sup>2</sup> (250 ft <sup>2</sup> ) – If sprinkler protected: maximum height of 3.66m (12ft.) and maximum area of 93m <sup>2</sup> (1,000 ft <sup>2</sup> ). Separate areas of unenclosed combustible storage by a minimum clear distance of 3m (10ft.). | Within 3 months |

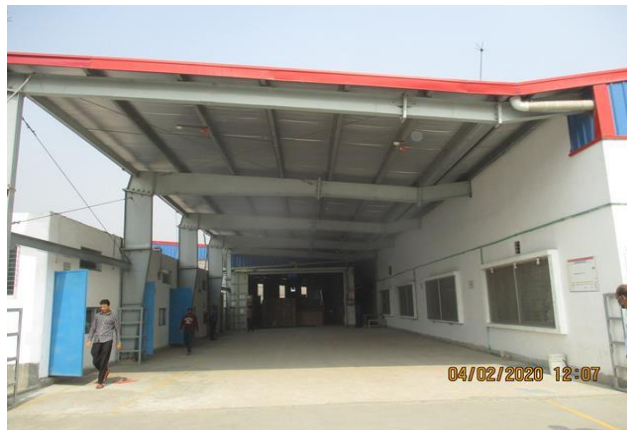
| 5 | Fire Rated Construction | Building-2 exit discharge to the interior of the covered area between the exterior wall of building-1 and the exterior wall of an adjacent building. | Modify exit to discharge directly outside or Provide 2- hr fire-rated exit passageway leading directly outside (vestibules to separate any storage areas). | Within 3 months |

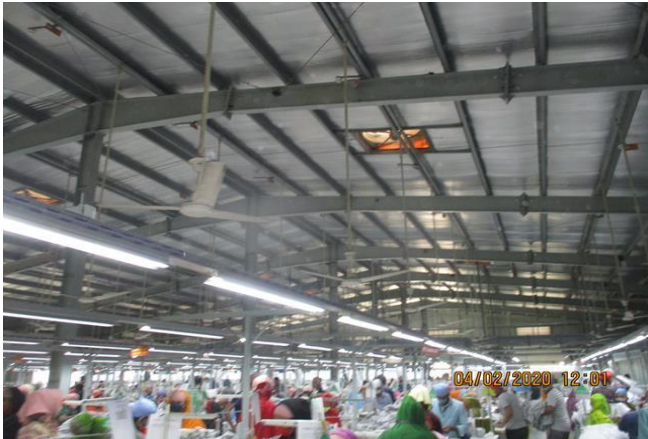
| 6 | Fire Rated Construction | The newly constructed production shed building-1 is not fire rated construction. | Newly construction building shall be Type-1 & Type-2 construction in accordance with Accord building standard 3.5.2.1 and BNBC part-2 Table-3.2.4. Provide fire-resistive rated construction barriers following Section 4.4 and Table 4.4.1 of the Accord Standard or Table 3.3.1 and Table 4.1.1 from BNBC Part 4. Consult a qualified fire protection engineer to design the rated construction barriers. | Within 4 months |

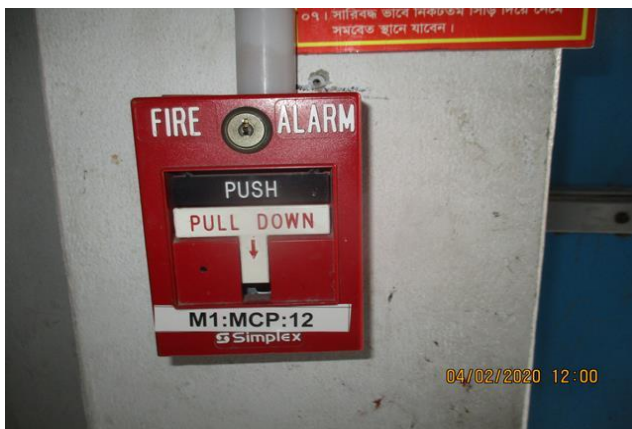
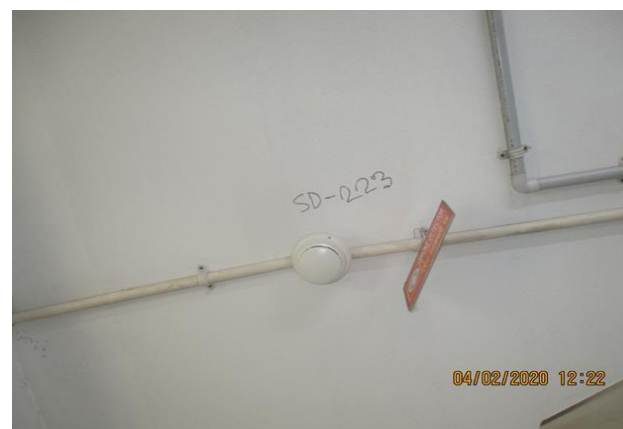
| 7 | Fire Detection | An addressable fire alarm system has installed in the factory building premises. Fire detection system installation requires to detailed review to confirm compliance with NFPA 72 and Accord standard. | Submit as-built drawings, testing records, equipment certification and other relevant documentation to the Accord for review and approval. | Design submission (Within 2 months),<br>Modification within 4 months (if required) |

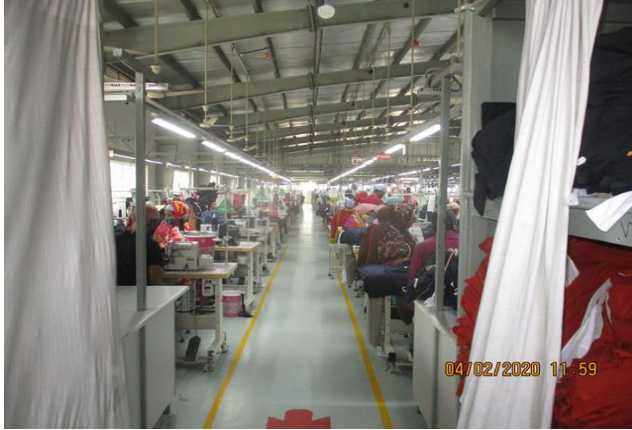
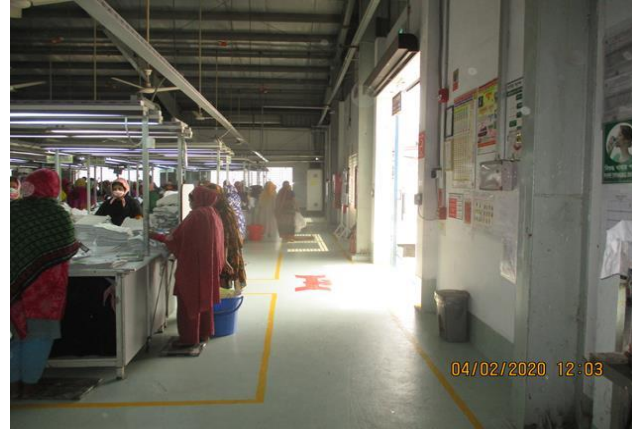
| 11 | Directional exit sign | Exit sign with directional arrow are not provided at the factory buildings. | Illuminated directional signs shall be provided where there is a change in the direction for the path of travel and the direction to an exit is not obvious. | Within 1 month |

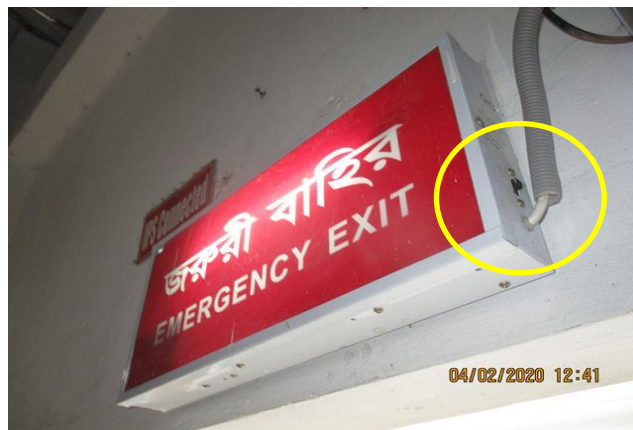
| 12 | Egress Lighting | Manual on-off switch is provided for emergency lighting / exit sign units in all factory buildings. | Remove manual on/off switches from emergency lighting / exit signage units to prevent them from being switched off. | Within 1 month |
