# INITIAL FIRE SAFETY INSPECTION REPORT

## Logos Apparels Ltd. (Building #4)

RSC ID: 23986

Date: 25 November 2020

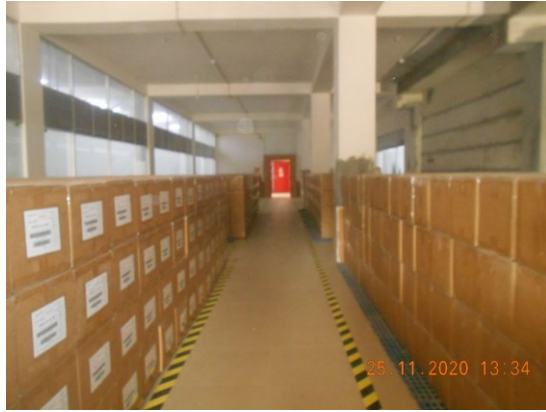
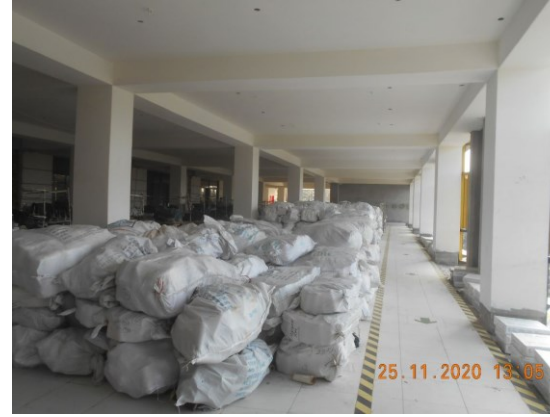
SI No.	Category	Findings	Required Action	Remediation Time Frame
1	Fire Rated Construction	Areas used for combustible storage are not separated by fire-rated construction.	<p>Provide dedicated storage rooms separated by minimum 1-hr fire-rated construction.</p> <p>Where separate storage rooms are not feasible, provide defined storage areas and limit the storage arrangement as follows:</p> <ul style="list-style-type: none"> <li>- Maximum height of 2.4m and maximum area of 23m<sup>2</sup></li> <li>- If sprinkler protected: maximum height of 3.66m and maximum area of 93m<sup>2</sup></li> </ul> <p>Separate areas of unenclosed combustible storage by a minimum clear distance of 3m.</p>	Within 3 months

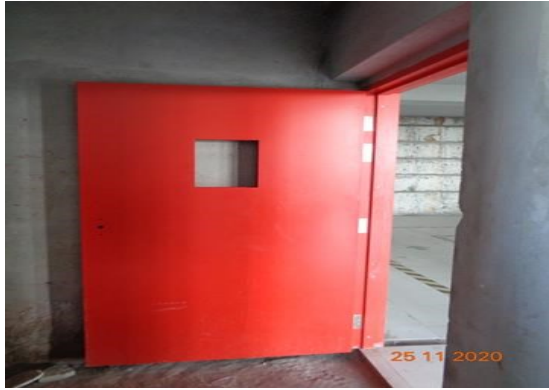
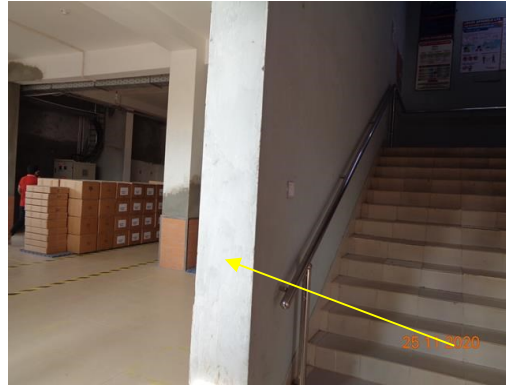
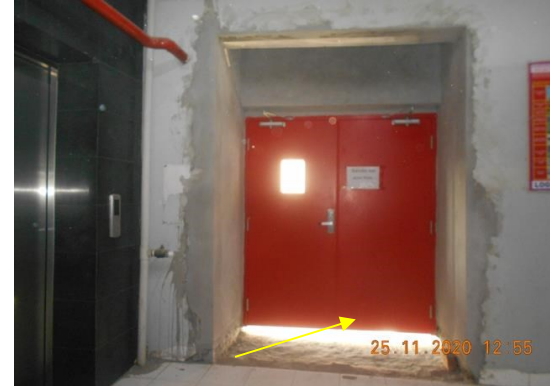
2	Fire Rated Construction	Exit stairs are not separated from work areas and other spaces on each floor by fire rated construction due to unprotected openings and penetrations.	<p>Separate the exit stairs from work areas and other building spaces on all floor levels by minimum 2-hr fire rated construction. Provide minimum 1.5-hr fire rated doors and seal all unprotected openings and penetrations to maintain the fire separation. The clearance under the bottom of a fire door shall be a maximum of 3/4 in. (19 mm). Ensure that all fire doors are self-closing and positive latching, and are provided with fire exit (panic) hardware where serving production floors or assembly occupancies. Provide vestibules to separate any storage areas. If fire doors are required to be held open for functional reasons, provide automatic-closing devices tied to the fire alarm system. Once fire doors are installed, every door in a stair enclosure serving more than 5 stories shall be provided with re-entry unless it meets ACCORD standard 6.8.3.1.</p>	Within 3 months

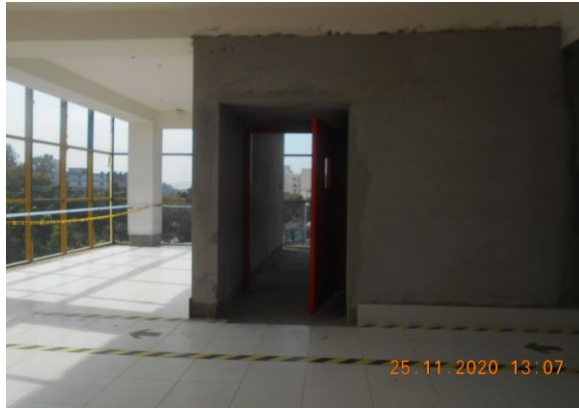
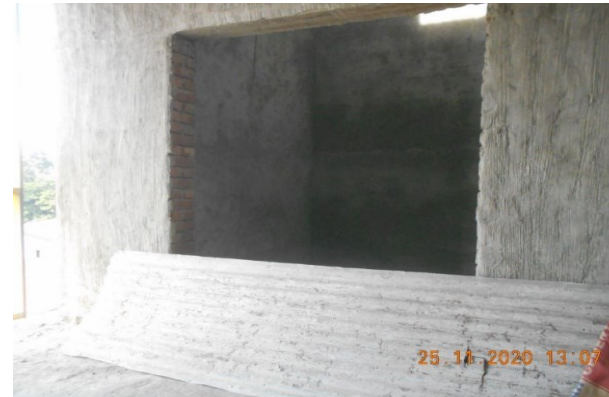
3	Fire Rated Construction	Unsealed elevator shafts are located inside the working place at all floors of building. Installation of fire door is going on.	Provide a minimum 2-hr fire-rated elevator shaft to separate from each floor level and seal all penetrations in floor/ceiling assemblies to maintain the fire separation.	Within 3 months
---	-------------------------	---	---	-----------------

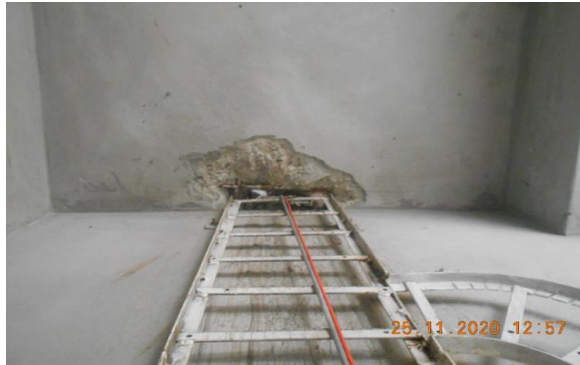
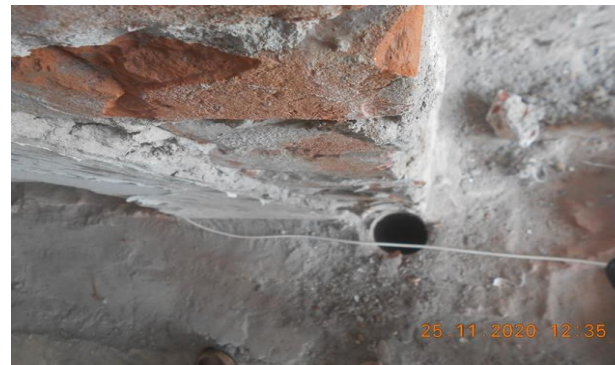
4	Fire Rated Construction	Penetrations through floor/ceiling assemblies are found unsealed.	Seal all penetrations and openings in floor/ceiling (full thickness of the floor/ceiling) assemblies by fire rated materials to maintain the fire resistance rating. Provide a minimum 2-hr fire rated shaft to separate the utility risers from each floor if required.	Within 3 months
---	-------------------------	---	--	-----------------

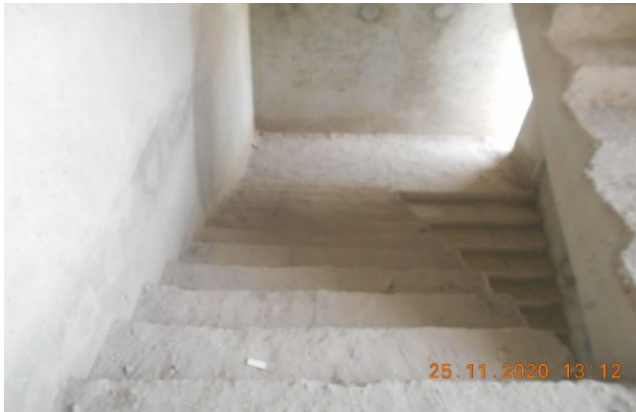
9	Egress	Width of new exit stair (Stair-3) is less than 1.5m (60in.).	Provide minimum clear and unobstructed exit stair width of 1.5 m (60 in.) in accordance with Accord standard 6.5.6.2.1.	Within 1 month
---	--------	--	---	----------------

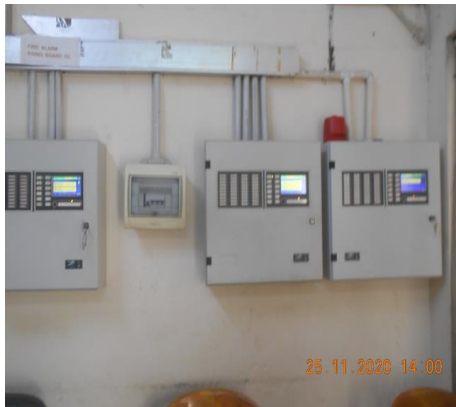
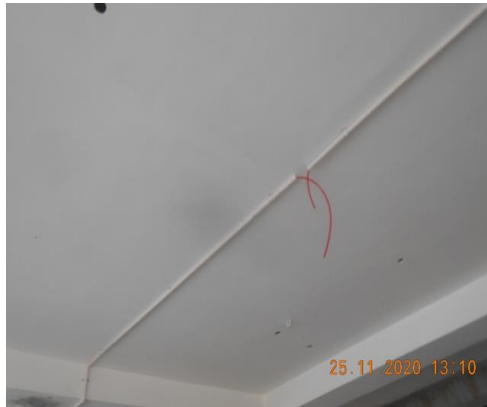
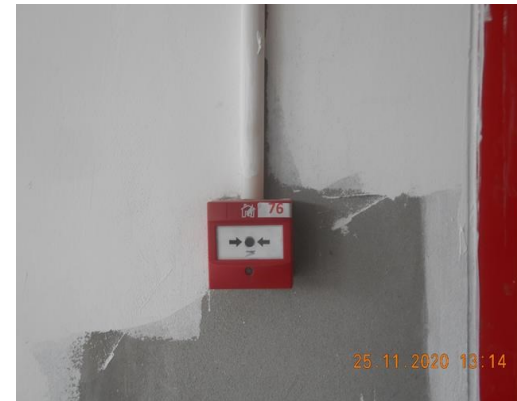
10	Fire Alarm & Detection system	Installation of fire alarm system is going on. Fire detection system installation requires detailed review to confirm compliance with NFPA 72.	Complete the fire alarm installation as per NFPA 72. Submit drawings, testing records, equipment certification and other relevant documentation to the RSC for review and approval.	Within 6 months
----	-------------------------------	--	---	-----------------

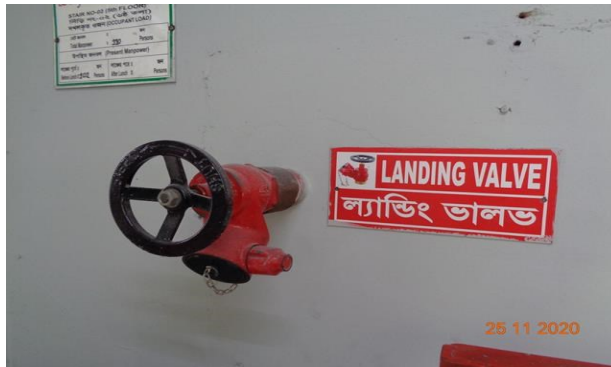
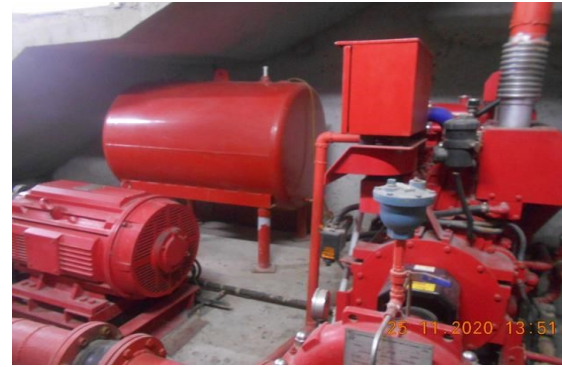
11	Fire Alarm & Detection system (ITM)	Inspection, testing, and maintenance for the fire alarm system is not in accordance with NFPA 72.	Inspect, test and maintain the fire alarm system, and keep written records on-site, in accordance with NFPA 72.	Within 7 months
12	Fire Protection	The existing factory building with an occupiable floor greater than 10 m (33 ft) above the finished grade is not protected with an approved standpipe system. Standpipe system installation requires detailed review to confirm compliance with NFPA 14.	Provide standpipe system throughout the building in accordance with NFPA 14. Submit drawings, testing records, equipment certification and other relevant documentation to the RSC for review and approval.	Within 6 months

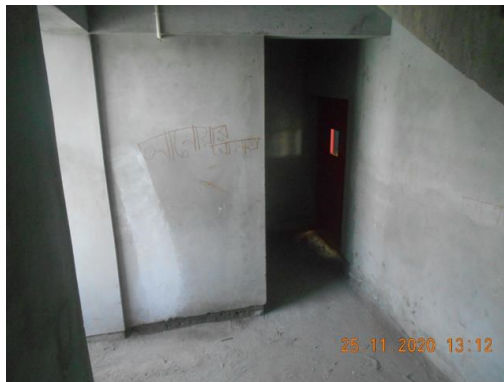
15	Egress	Fire evacuation maps is not posted at the entrance of all exit stair.	Fire evacuation maps shall be posted at the entrance to each exits and exit stairs.	Within 1 month
----	--------	---	---	----------------

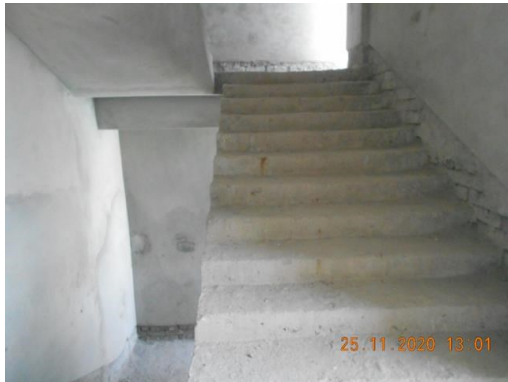
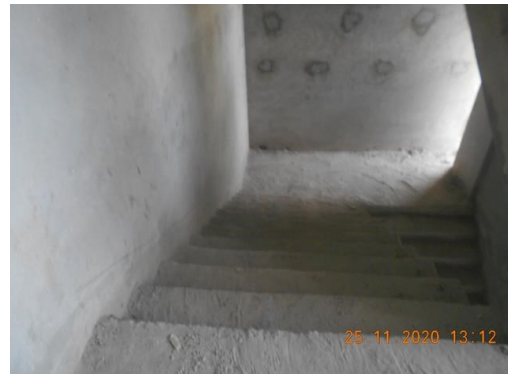
16	Egress	Handrails are not provided in the exit stair-3.	Provide handrails on both side of exit stair having a minimum height 34 in. as measured from the leading edge of the tread.	Within 1 month
----	--------	---	---	----------------

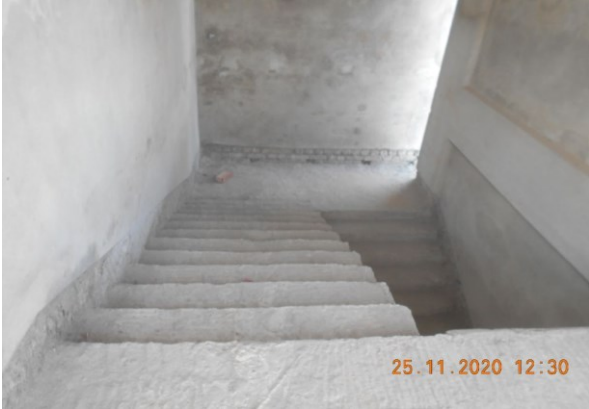
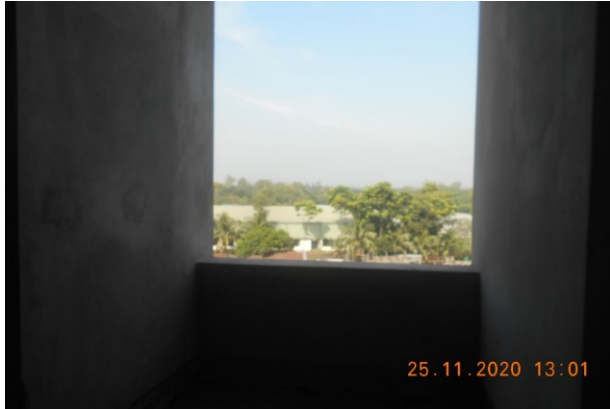
17	Egress	Guards are not provided in several locations and found less than 42 in.	Guards shall be provided at all open sides of means of egress that exceed 760 mm (30 in.) above the floor or finished ground below. New guards shall have a minimum height of 1067 mm (42 in.).	Within 1 month

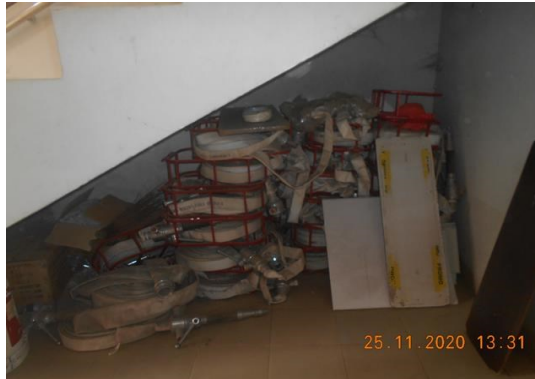
18	Egress	Storage was located in exit stair ( Exit stair enclosure 1).	Remove storage from the exit stairs and egress path	Immediate
----	--------	--	---	-----------
