# INITIAL FIRE SAFETY INSPECTION REPORT

**Factory Name: Fashion Asia Ltd. (New Unit)**

**ADDRESS: Tepirbari, Sreepur, Gazipur**

**Date: 03 December 2020**

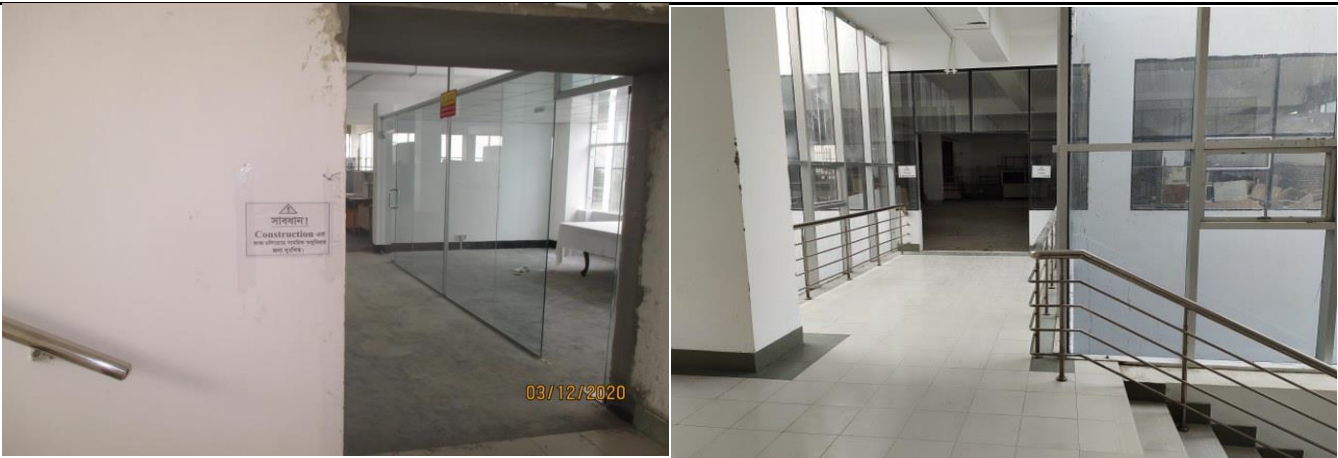
| SI No. | Category | Findings | Required Action | Remediation Time Frame |
|---|---|---|---|---|
| 1 | Fire Rated Construction | The exit stairs are not separated from [work areas, other spaces] on each floor by fire-rated construction. | <p>Provide minimum 1.5-hr fire rated doors and seal all unprotected openings to separate the exit stairs from work areas and other building spaces on all floor levels. Ensure that the fire doors are self-closing and positive latching and that they are provided with fire exit (panic) hardware where serving production floors.</p> <p>If fire doors are required to be held open for functional reasons, provide automatic-closing devices tied to the fire alarm system. Openings from exit enclosure to storage spaces shall be provided with a vestibule with fire rated construction and openings. Provide a 1.5-hr. fire rated door on the exit stair side and a 1-hr. fire rated door on the storage room side. Ensure that the fire rating of the vestibule construction matches that of the exit stair enclosure.</p> | Within 3 months |

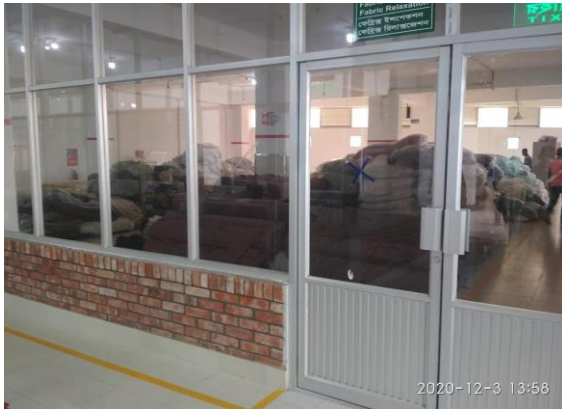
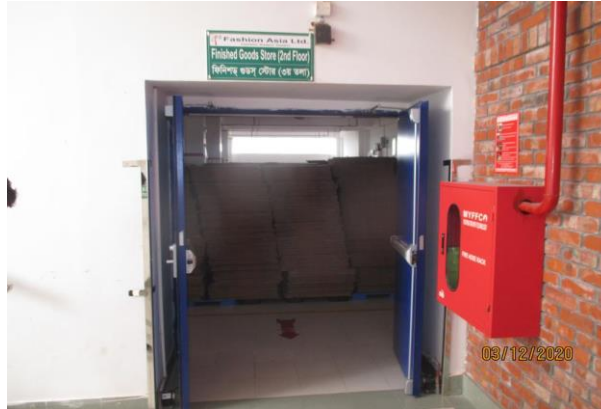
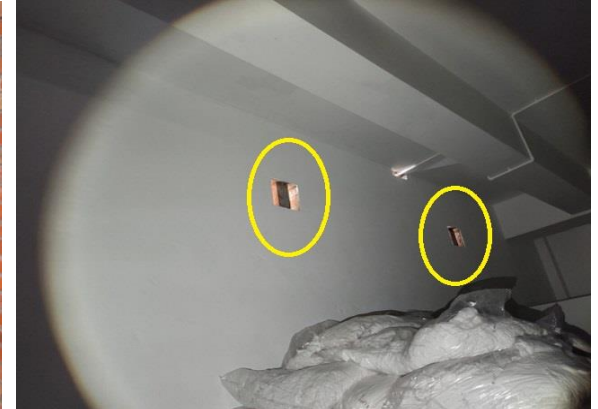
| 2 | Fire Rated Construction | Areas used for combustible storage are not separated by fire-rated construction. | <p>Provide dedicated storage rooms separated by minimum 1-hr fire-rated construction. Seal all penetrations to maintain required fire separation.</p> <p>Where separate storage rooms are not feasible, provide defined storage areas and limit the storage arrangement as follows:-</p> <p>Maximum height of 2.4m and maximum area of 23m<sup>2</sup>- If sprinkler protected: maximum height of 3.66m and maximum area of 93m<sup>2</sup> Separate areas of unenclosed combustible storage by a minimum clear distance of 3m.</p> | Within 3 months |

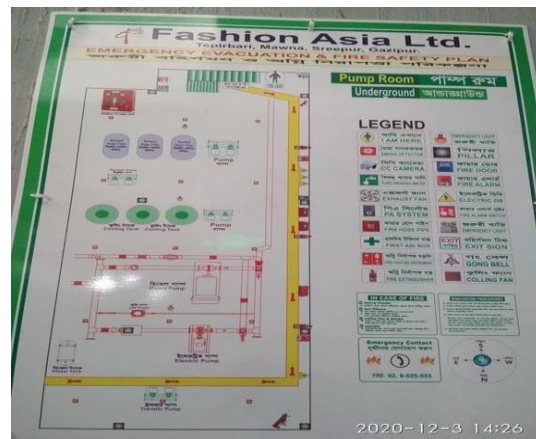
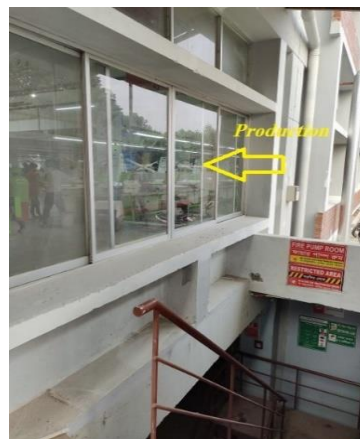
| 3 | Fire Rated Construction | The fire pump room is not provided with adequate fire separation | <p>Provide fire pump room with 2 hr rated fire separation when not sprinklered and 1 hr rated fire separation when provided with automatic sprinklers in accordance with NFPA 20.</p> <p>Or,</p> <p>Physically separate the pump room from the protected building by a minimum of 50 ft (15.3 m) in accordance with NFPA 20</p> | Within 3 months |

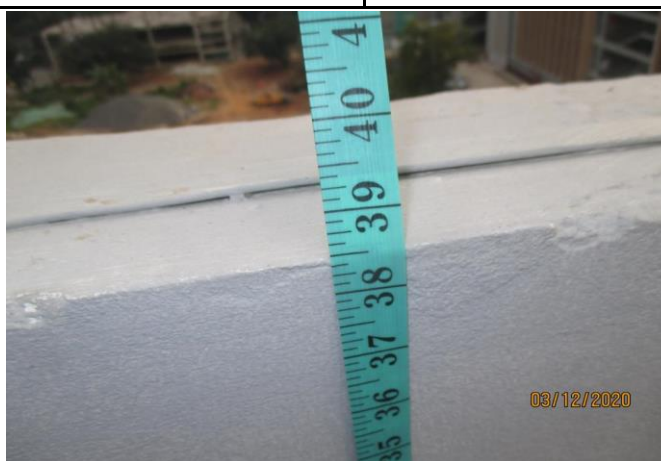
| 4 | Parapets | Parapets or guards are provided in occupied roof which is less than 1067mm (42 inch.). | Provide parapets or guards with a minimum height of 1067mm (42 inch.). | Within 3 months |

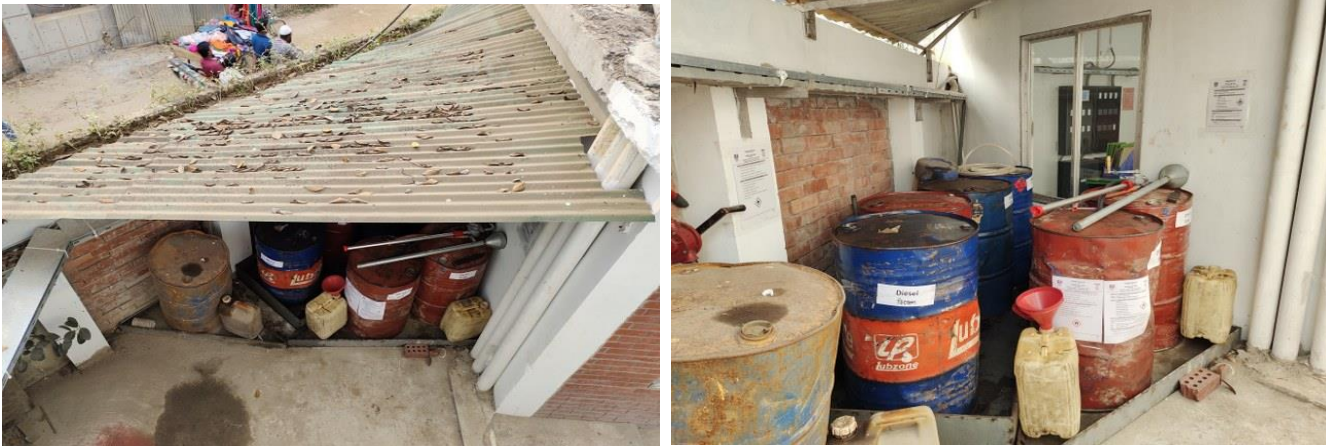
| 5 | Fire Rated Construction | Unprotected diesel fuel storage was located adjacent to the fire alarm control panel room. | <p>Relocate the diesel storage to the exterior such that it is at least 10 ft. away from the egress paths or any delicate occupancy.</p> <p>Or,</p> <p>Separate the diesel fuel storage by 2-hr. fire rated construction. There shall be no diesel fuel storage in a factory production building.</p> | Within 1 month |

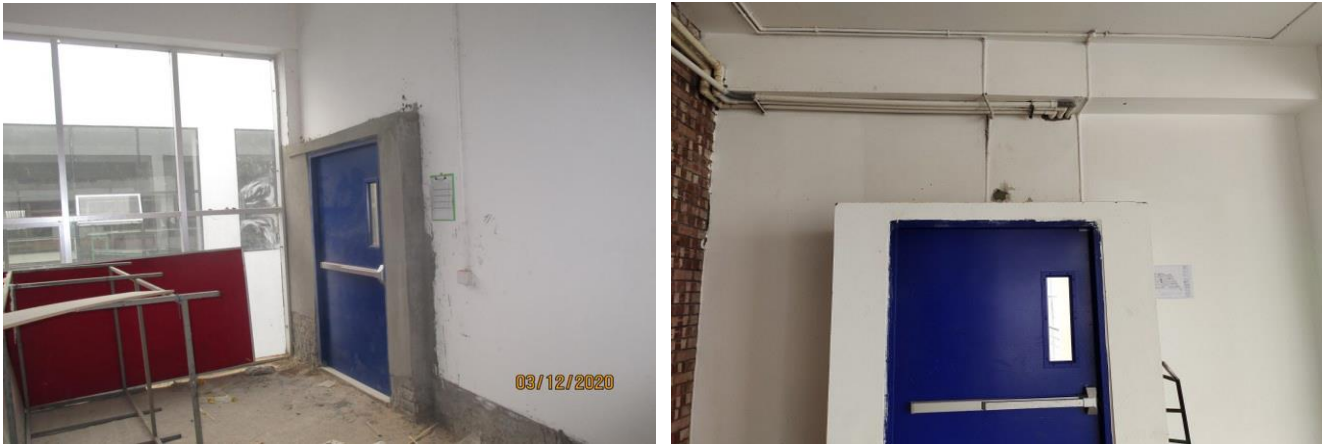
| 6 | Egress lighting | Exit sign not provided at all required exits. | <p>Lighted exit signs shall be placed at entrance to an exit. Additional exit signs shall be placed throughout the facility anywhere the continuation of the egress is not obvious.</p> | Within 1 month |

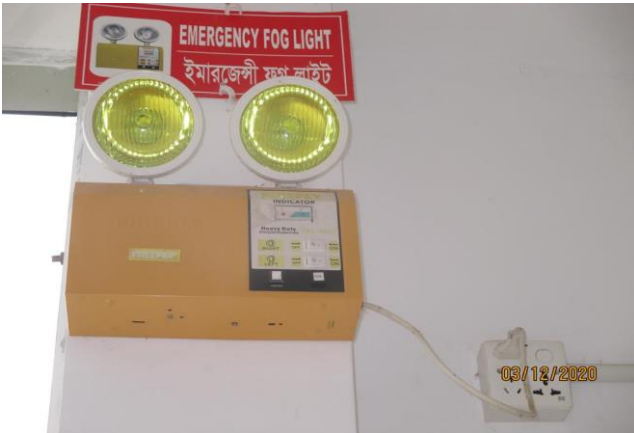
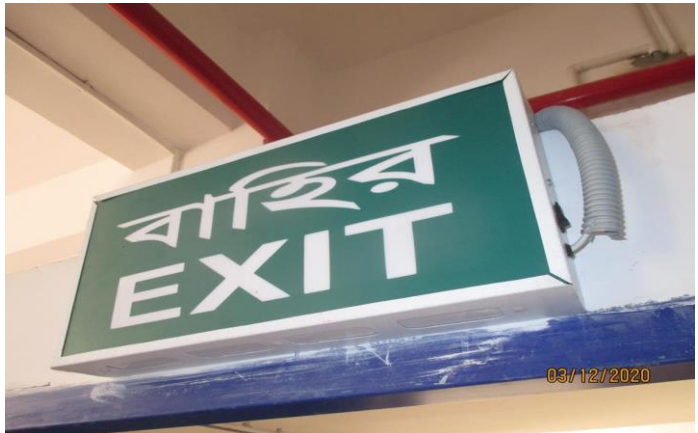
| 8 | Egress lighting | Manual on-off switch is provided for emergency lighting and exit signage units. | Remove manual on/off switches from emergency lighting and exit signage units to prevent them from being switched off. | Within 1 month |

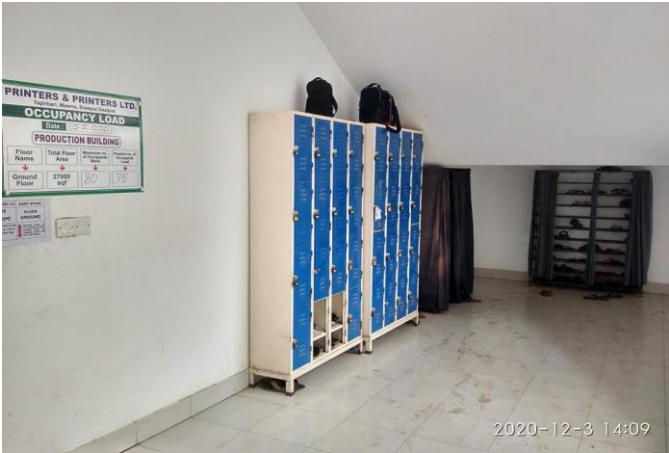
| 9 | Egress | Storage was located in the exit stair enclosure. | Factory shall Keep exit stair, exit stair enclosure and all egress paths clear of storage | Immediate |

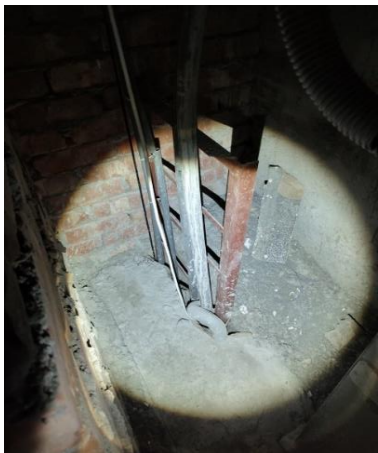
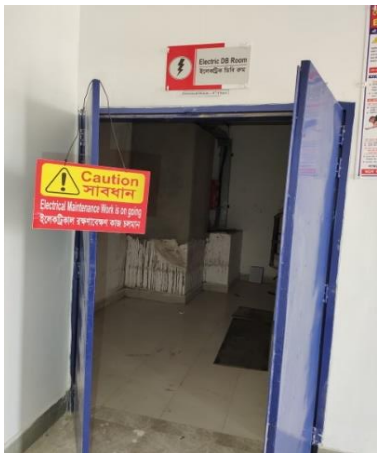
| 10 | Egress | <p>Penetrations through fire rated floor/ceiling assemblies are not properly sealed.</p> <p>Location: BBT Risers (South-West Electric DB Room)</p> | <p>Seal all penetrations and openings in floor/ceiling (full thickness of the floor/ceiling or thickness required to maintain desired rating ) assemblies by listed fire stop materials to maintain the required fire resistance rating of 2-hr.</p> <p>or,</p> <p>Enclose the riser room by minimum 2-hour fire rated construction.</p> | Within 1 month |

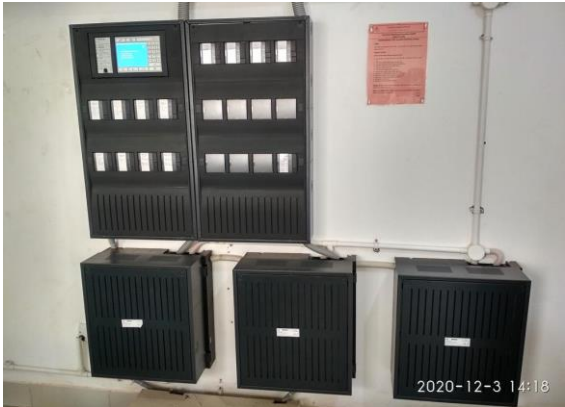
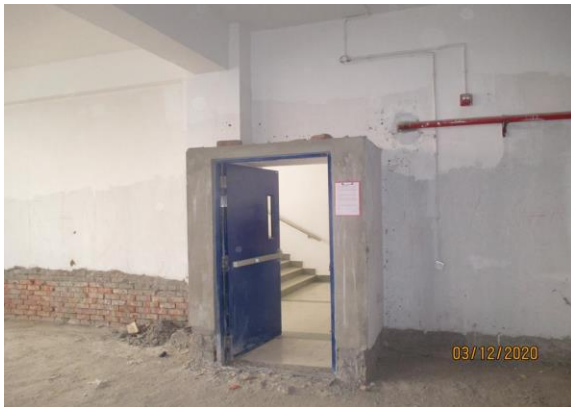
| 11 | Fire Detection & Protection | The installed fire detection and alarm system has not been reviewed from the RSC. | Submit the as-built drawing to the RSC for review. Once reviewed install or modify automatic smoke detection system throughout the building, tied into the fire alarm system, in accordance with NFPA 72 and the Accord standard. | Design within 3 months, Install within 9 months |

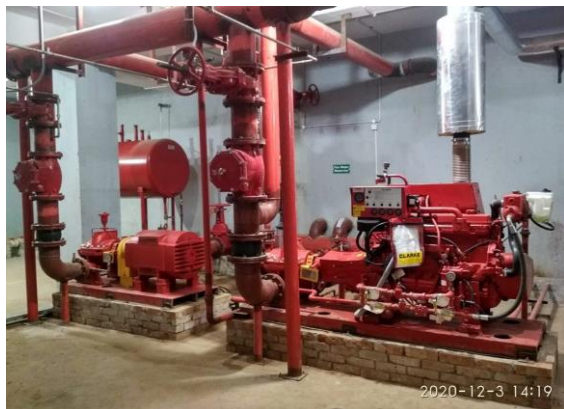
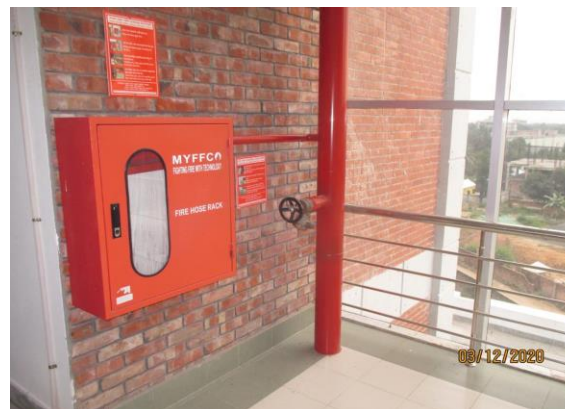
| 14 | Fire Detection & Protection | Fire pump & water supply system installation requires detailed review to confirm compliance with NFPA 20, 22, 25 and ACCORD standards. | <p>Submit as built drawings, testing records, listing information and other relevant documentation to the RSC for review and approval, modification shall have to done as per the reviewed design (if required).</p> <p>Upon approval &amp; installation/modification the owner shall contact the RSC prior to conducting the final acceptance testing of the standpipe system installation.</p> <p>Also inspect, test &amp; maintain fire pumps &amp; water supply system and keep written records on-site, in accordance with NFPA 20, 22, 25 and ACCORD standards.</p> | Design within 3 months. Install within 6 months |
