INITIAL FIRE SAFETY INSPECTION REPORT

Manel Fashion Ltd.

RSC ID: 24187

Date: 26-Jan-2021

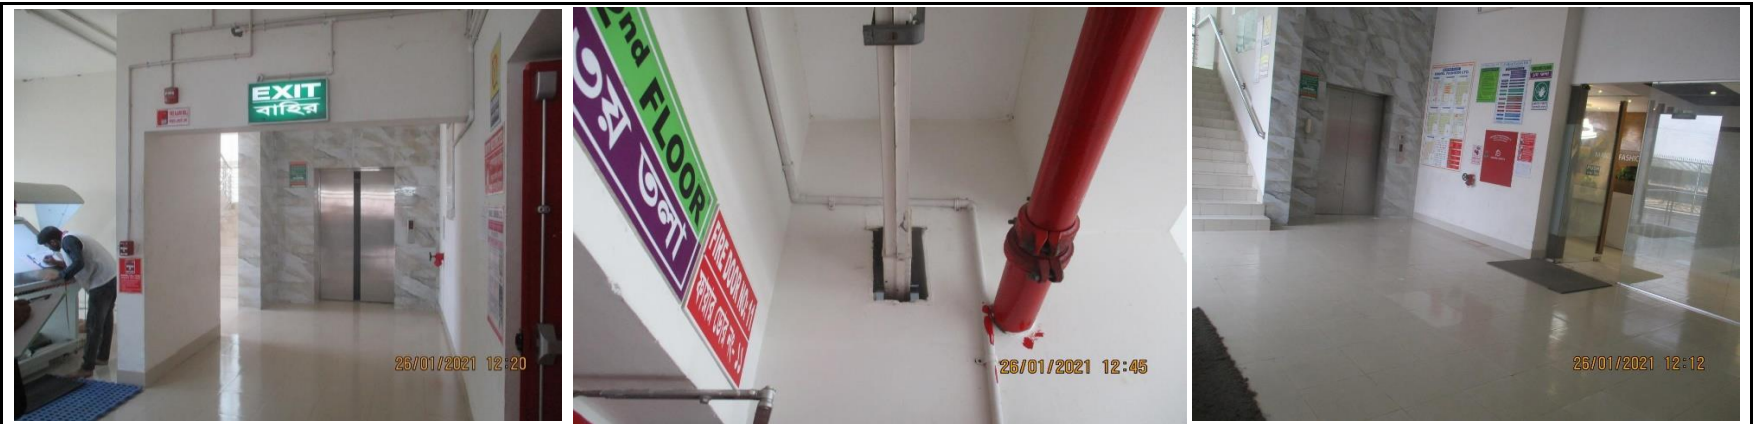
Sly No.	Category	Findings	Required Action	Remediation Time Frame
F-1	Fire Rated Construction	Exit Enclosures are not properly fire separated due to some unprotected penetration and openings. Moreover, the Stenter machine and office were inside of stair-1 on the 6th floor.	Provide minimum 2-hr fire rated separation exit enclosure. Provide minimum 1.5-hr fire rated doors and seal all unprotected openings and penetration to separate the exit stairs from work areas and other building spaces on all floor levels. Ensure that the fire doors are self-closing and positive latching and that they are provided with fire exit (panic) hardware where serving production floors. If fire doors are required to be held open for functional reasons, provide automatic closing devices tied to the fire alarm system.	Within 3 months

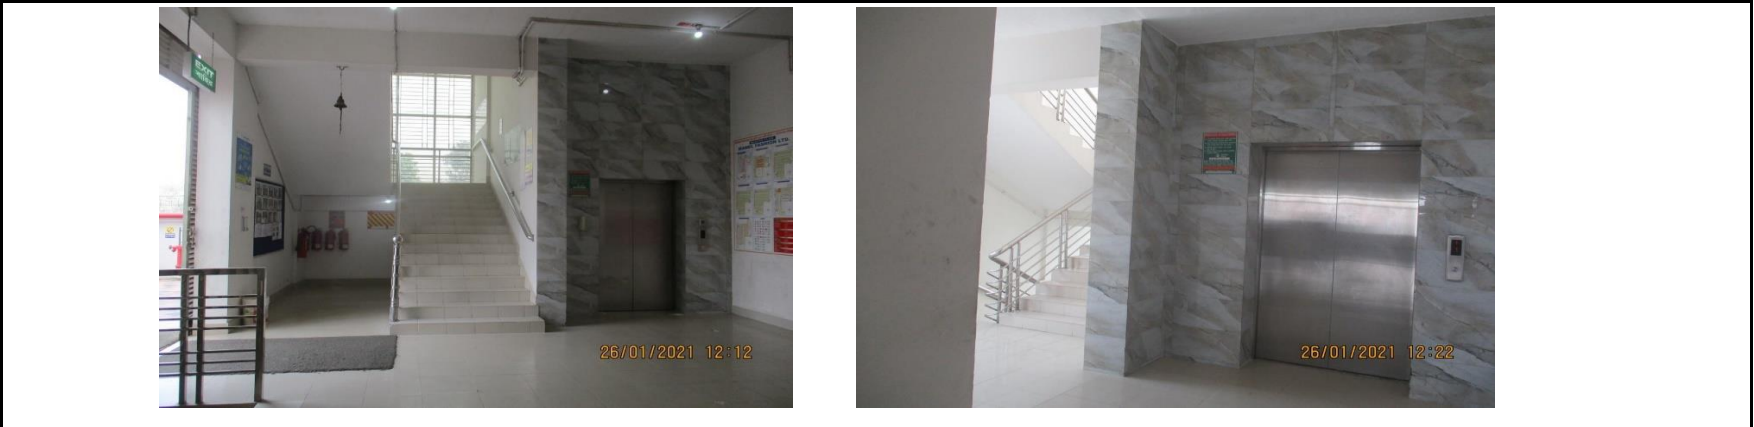
F-2	Fire Rated Construction	Elevator shafts are directly open into the inside of stair-1.	For new construction, elevators shall not open into an exit enclosure as per ACCORD-6.14.3. So, separate the stair enclosure from elevator shaft although the building.	Within 3 months
-----	-------------------------	---------------------------------------------------------------	-------------------------------------------------------------------------------------------------------------------------------------------------------------------------	-----------------

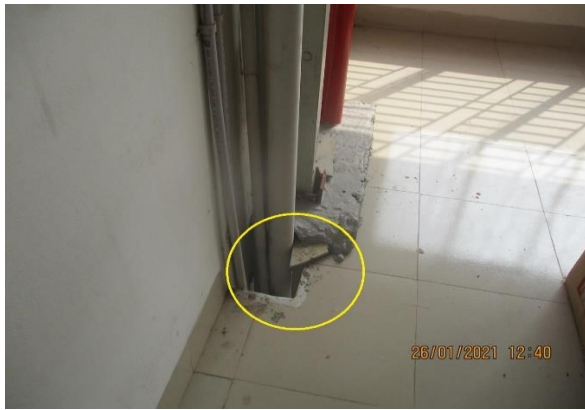
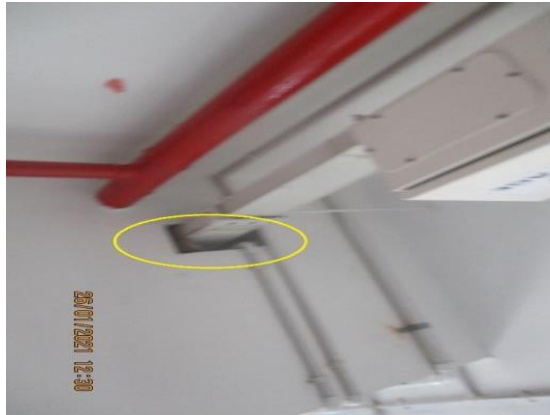
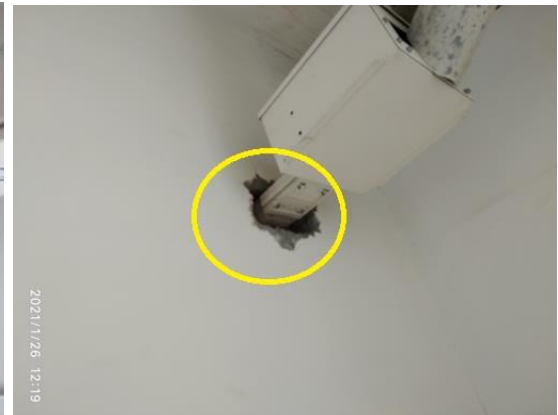
F-3	Fire Rated Construction	<p>Penetrations in floor/ceiling assemblies are found unsealed on each level of all floors. Location: Busbar on all floors of main building.</p>	<p>Seal all penetrations and openings in floor/ceiling (full thickness of the floor/ceiling) assemblies by minimum 3-hr fire-rated materials to maintain the required fire-resistance rating.</p> <p>Provide a minimum 2-hr fire-rated shaft to separate the utility risers from each floor if required.</p>	Within 3 months
-----	-------------------------	---------------------------------------------------------------------------------------------------------------------------------------------------------------	--------------------------------------------------------------------------------------------------------------------------------------------------------------------------------------------------------------------------------------------------------------------------------------------------------------	-----------------

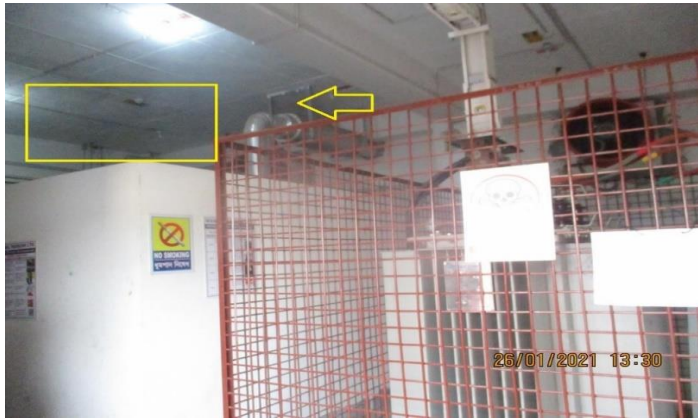
F-4	Fire Rated Construction	There was no internal separation in-between generator and Substation on the ground floor of Utility Building.	<p>Generator room shall be separated from the transformer by a minimum 2-hr fire-rated construction (wall, floor, slab, etc.). Seal all penetrations and openings (door, window, etc.) shall be protected by 1.5-hr fire-rated materials to maintain the fire separation is required. All exhaust systems shall discharge to the exterior of the building in a safe location.</p> <p>Or, Relocate the Transformer to the exterior of the building and maintain a minimum 3m (10 ft.) spatial separation distance from the building.</p>	Within 3 months
-----	-------------------------	---------------------------------------------------------------------------------------------------------------	-----------------------------------------------------------------------------------------------------------------------------------------------------------------------------------------------------------------------------------------------------------------------------------------------------------------------------------------------------------------------------------------------------------------------------------------------------------------------------------------------------------------------------------------	-----------------

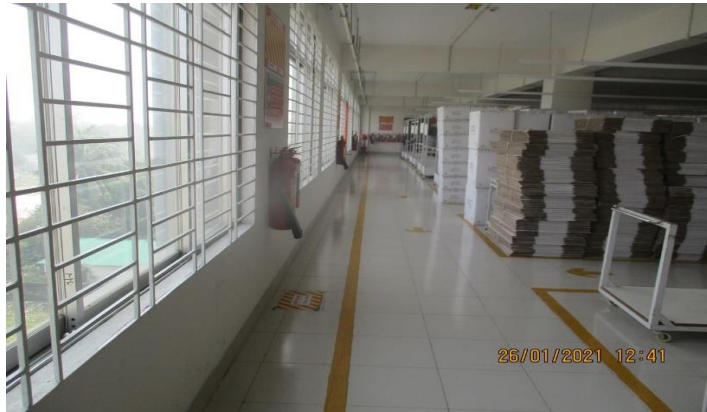
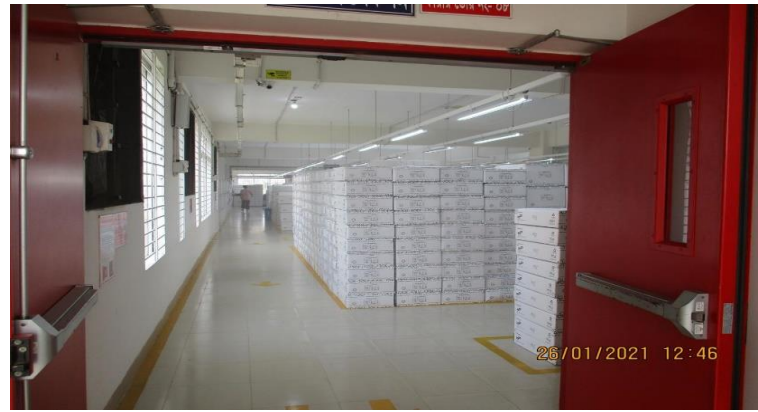
F-5	Fire Rated Construction	Areas used for in-process storage of combustible materials are open to the surrounding occupancy which are not separated by fire rated construction at 1st floor & 3rd floor of production building.	<p>Provide dedicated storage rooms separated by minimum 1-hr fire-rated construction.</p> <p>Or,</p> <p>Where separate storage rooms are not feasible, Provide defined storage areas and limit the storage arrangement as follows:-</p> <ol style="list-style-type: none"> 1. General Condition: Maximum height of 2.4m and maximum area of 23m². Separate areas of unenclosed combustible storage by a minimum clear distance of 3m. 2. If sprinkler protected: maximum height of 3.66m and maximum area of 93m². Separate areas of unenclosed combustible storage by a minimum clear distance of 3m. 	Within 3 months
-----	-------------------------	------------------------------------------------------------------------------------------------------------------------------------------------------------------------------------------------------	------------------------------------------------------------------------------------------------------------------------------------------------------------------------------------------------------------------------------------------------------------------------------------------------------------------------------------------------------------------------------------------------------------------------------------------------------------------------------------------------------------------------------------------------------------------------------------------------------------------------------------------------------	-----------------

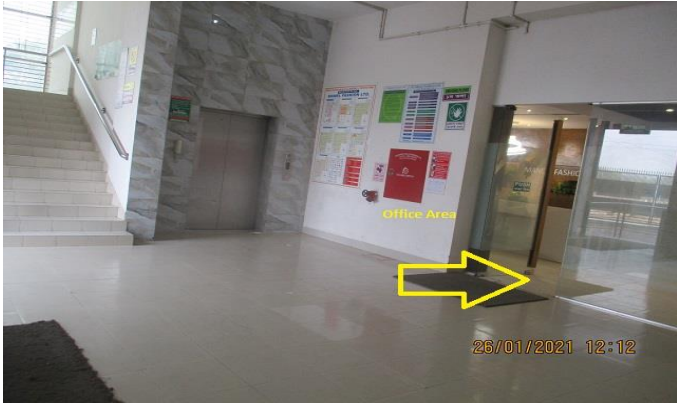
F-6	Fire Rated Construction	The exit discharge path (Passageway) for stair-1 was not separated from the building interior (Office Portion). Location: Ground floor.	Provide a minimum 2-hr fire separation in-between passageway and office area on the ground floor. If any door opening required ensure those are minimum 1.5 hr. fire rated and listed.	Within 3 months

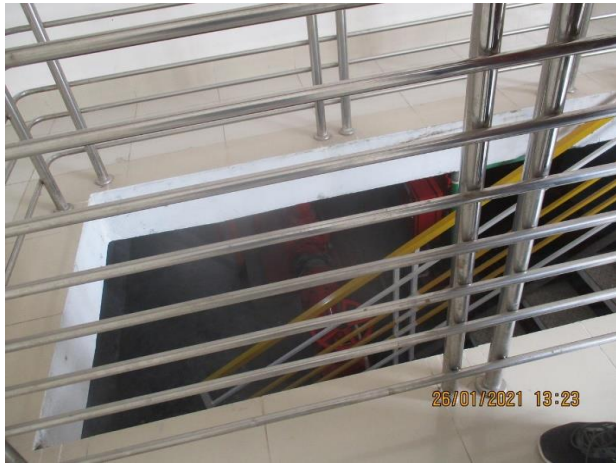
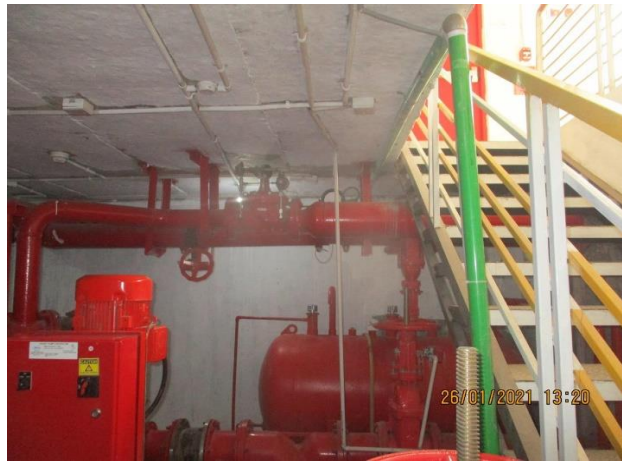
F-8	Fire Rated Construction	The fire pump room was not properly separated from Stair-3 by fire rated construction. Location: South side ground floor of production building.	Provide fire pump room with 2 hr. rated fire separation with 1.5 -hr. fire rated door. Or, Physically separate the pump room from the protected building by a minimum of 50 ft. (15.3 m) in accordance with NFPA 20.	Within 3 months

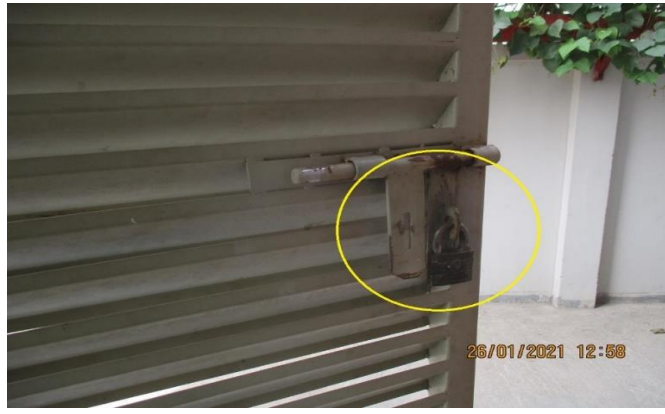
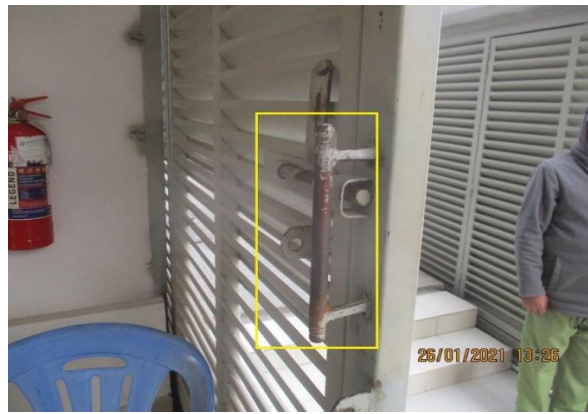
F-09	Means of Egress	Egress gates with non-compliant locking features were provided on ground floor discharge position. Location: All exits of Production Building.	Remove locking features from all egress gates. If locks are required for security reasons, utilize special door locking features complying with NFPA 101.	Immediately
------	-----------------	---------------------------------------------------------------------------------------------------------------------------------------------------	-----------------------------------------------------------------------------------------------------------------------------------------------------------	-------------

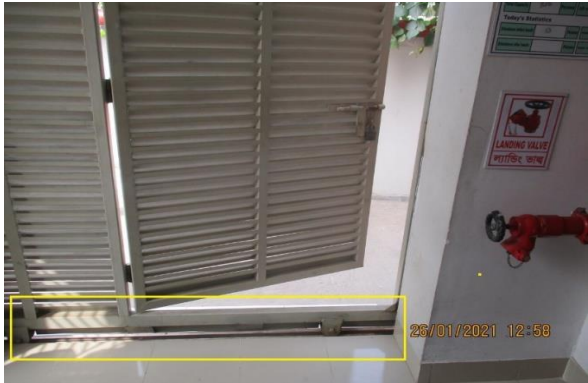
F-10	Means of Egress	The egress path along means of egress has interrupted by obstruction. Location: Bottom of pocket gate of all stair ground floor of production building.	Means of egress shall be maintained continuously free and clear of all obstructions.	Within 1 month

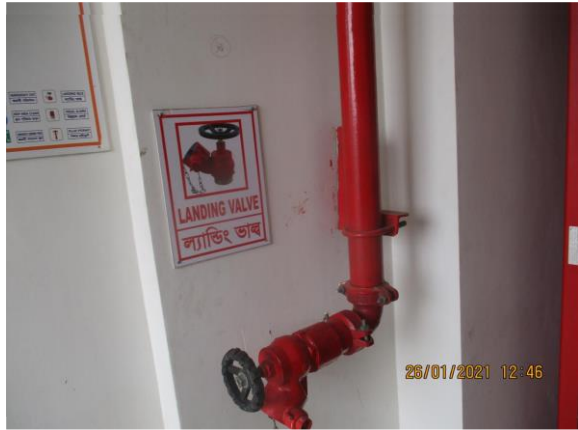
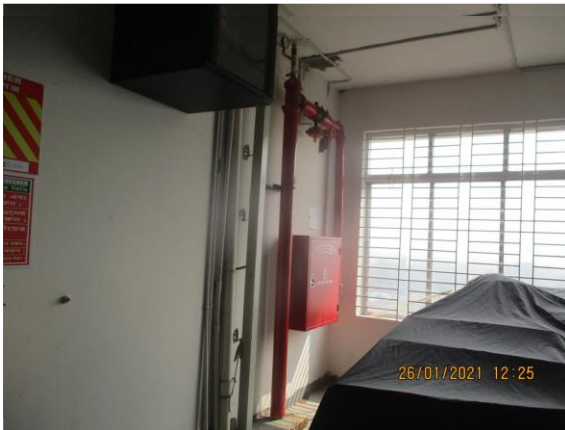
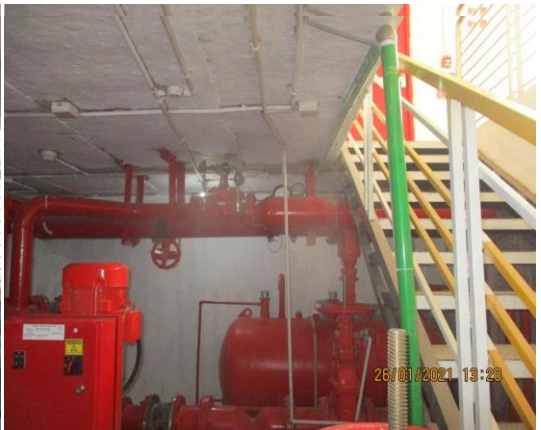
F-13	Fire Alarm & Detection System	Fire alarm system installation requires detailed review to confirm compliance with NFPA 72 and ACCORD standards.	Submit design to RSC for review and modify installation if required. Installation of Fire Alarm system should be in accordance with ACCORD standard and NFPA 72.	Design within 2 months, Install within 4 months (If modification required)
F-14	Fire Detection System(ITM of FADS)	Inspection, testing, and maintenance for the fire alarm system is not in accordance with NFPA 72 or as per Accord standard.	Inspect, test and maintain the fire alarm system, and keep written records on-site, in accordance with NFPA 72 or as per Accord standard.	Within 1 month after completing installation.
F-15	Fire Protection System(Standpipe)	The Standpipe System requires detailed review to confirm compliance with NFPA 14 and ACCORD standards. Fire Pump NFPA-20.	Submit design to RSC for review and modify installation if required. Installation of Standpipe system should be in accordance with ACCORD standard and NFPA 14, 20, 22 and 24.	Design within 2 months, Install within 4 months (If modification required)
