INITIAL FIRE SAFETY INSPECTION REPORT

Peak Apparels Ltd.

RSC ID: 24154

Fire Safety Inspection Report

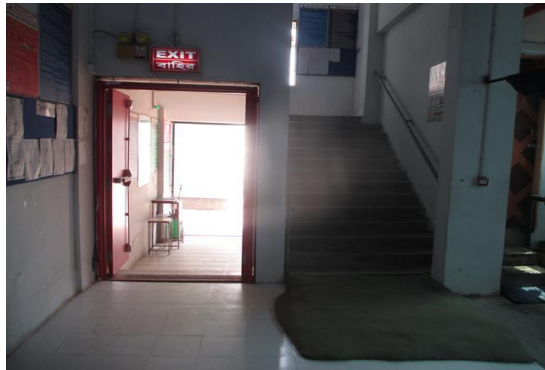
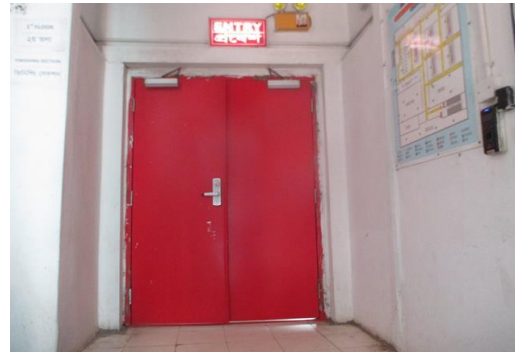
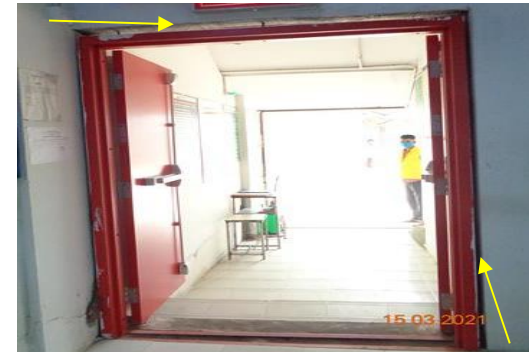
SI No.	Category	Findings	Required Action	Remediation Time Frame
1	Fire Rated Construction	Exit stairs are not separated from work areas and other spaces on each floor by fire rated construction due to unprotected openings and penetrations.	Separate the exit stairs from from work areas and other building spaces on all floor levels by minimum 2-hr fire rated construction. Provide minimum 1.5-hr fire rated doors and seal all unprotected openings and penetrations to maintain the fire separation. Ensure that all fire doors are self-closing and positive latching, and are provided with fire exit (panic) hardware where serving production floors or assembly occupancies. If fire doors are required to be held open for functional reasons, provide automatic-closing devices tied to the fire alarm system. Once fire doors are installed, every door in a stair enclosure serving more than 5 stories shall be provided with re-entry unless it meets ACCORD standard 6.8.3.1.	Within 3 months

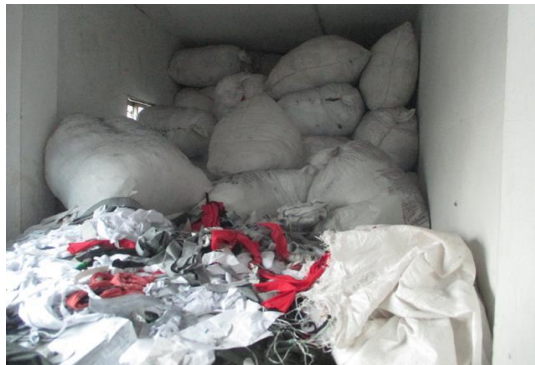
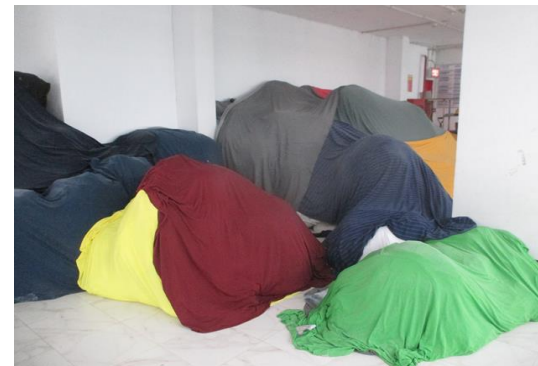
2	Fire Rated Construction	Rooms used for storage of combustible materials are not separated from the surrounding occupancy in the 5th floor.	Rooms used for storage of combustible materials shall be separated from the surrounding occupancy with a minimum 1 hour construction.	within 3 months
---	-------------------------	--	---	-----------------

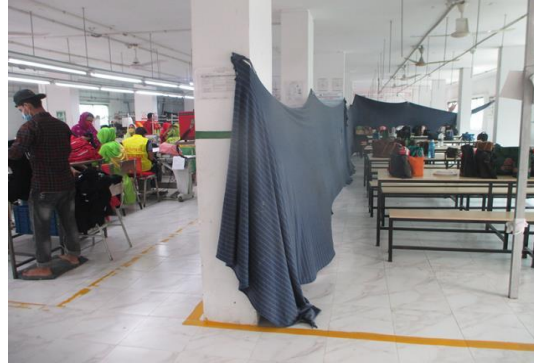
4	Fire Rated Construction	Dining area is not separataed from production area in 3rd floor.	Separate the dining area by a minimum 2-hr fire-rated construction having a direct access to exit stair. Seal and/or protected all openings to maintain the required fire separations.	within 3 months

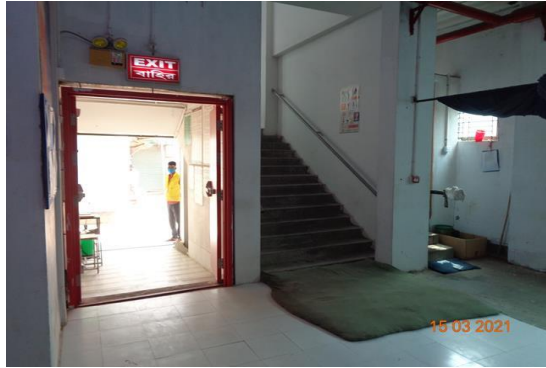
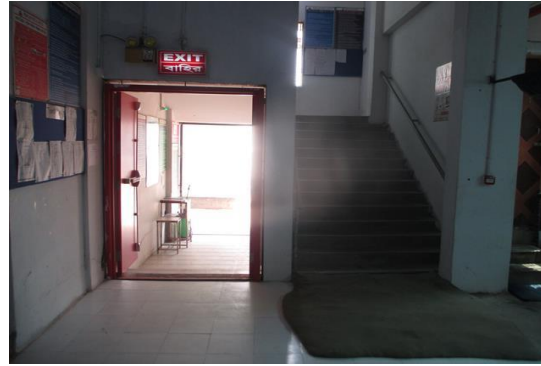
5	Fire Rated Construction	Exit stair 1 is discharge the occupants inside the building in the ground floor.	<ul style="list-style-type: none"> 1. Modify stair to discharge directly outside. Or 2. Provide 2-hr fire-rated exit passageway leading directly outside (vestibules to separate any storage areas). Or 3. Provide sprinkler protection for discharge floor in accordance with NFPA 13. 	within 3 months
---	-------------------------	--	--	-----------------

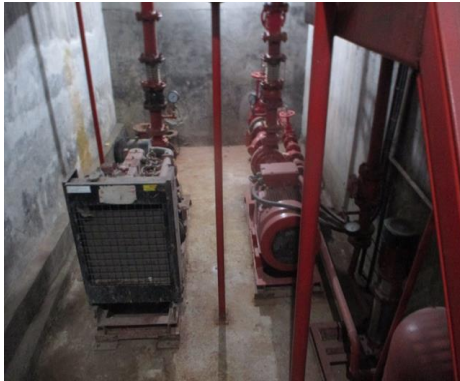
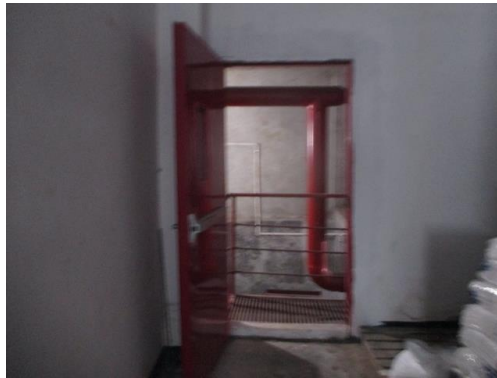
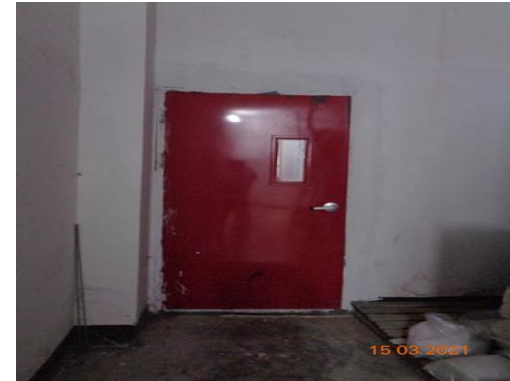
6	Fire Rated Construction	The fire pump room is not provided with adequate fire separation.	<p>Provide fire pump room with 2 hr rated fire separation when not sprinklered and 1 hr rated fire separation when provided with automatic sprinklers in accordance with NFPA 20</p> <p>Or,</p> <p>Physically separate the pump room from the protected building by a minimum of 50 ft (15.3 m) in accordance with NFPA 20</p>	within 1 months
---	-------------------------	---	--	-----------------

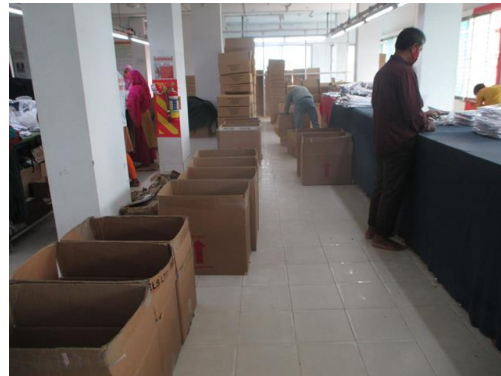
7	Egress	Aisles is missing in some places in 1st floor.	Aisles shall be provided with a minimum unobstructed clear-width of 0.9 m (36 in.).	Immediate
---	--------	--	---	-----------

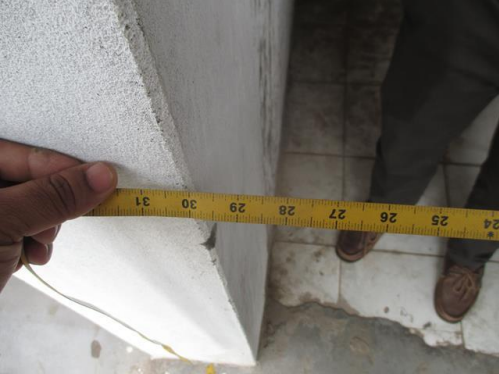
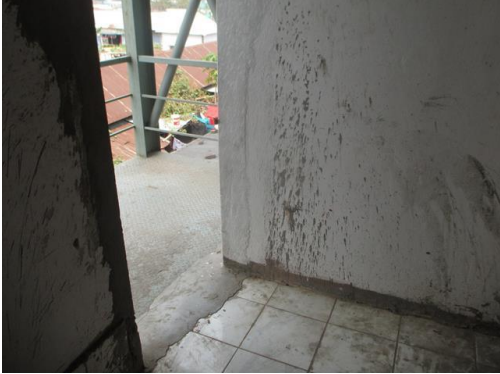
8	Narrow exit stair	Factory has only 2 stair & between them stair 2 is inadequate for the 5th, 4th, 3rd & 2nd floor (30 inches wide)	Modify the stair to have a minimum width of 0.9 m (35 inches)	Within 1 month
<div style="display: flex; justify-content: space-around;">

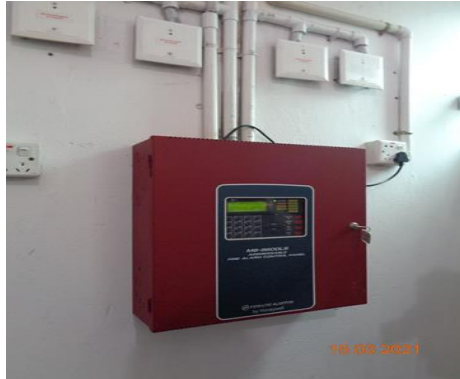
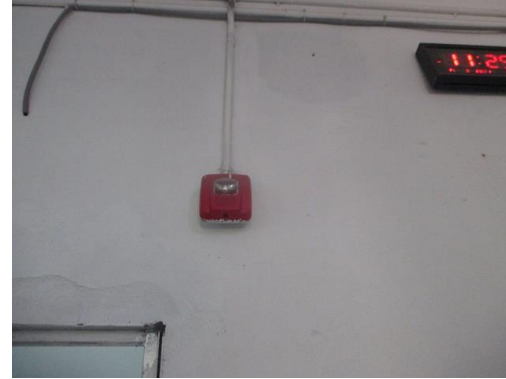
</div>				
9	Fire Alarm & Detection system	Factory installed automatic alarm and detection features throughout the building. Fire alarm & detection system installation requires detailed review to confirm compliance with NFPA 72 and ACCORD standards.	Configure the fire alarm system to initiate automatic occupant notification on all floor levels to facilitate whole-building evacuation upon any manual fire alarm station activation. Submit as-built drawings, testing records, equipment certification and other relevant documentation to the RSC for review and approval.	Within 6 months

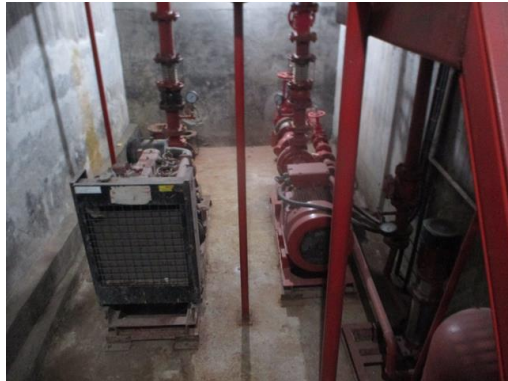
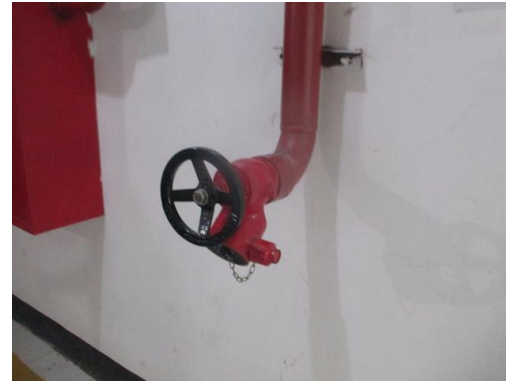
10	Fire Alarm & Detection system (ITM)	Inspection, testing, and maintenance for the fire alarm system is not in accordance with NFPA 72.	Inspect, test and maintain the fire alarm system, and keep written records on-site, in accordance with NFPA 72.	Within 7 months
11	Fire Protection	The existing factory building with an occupiable floor greater than 10 m (33 ft) above the finished grade and factory install standpipe system. Standpipe system installation requires detailed review to confirm compliance with NFPA 14.	Provide standpipe system throughout the building in accordance with NFPA 14. Submit drawings, testing records, equipment certification and other relevant documentation to the RSC for review and approval.	Within 6 months

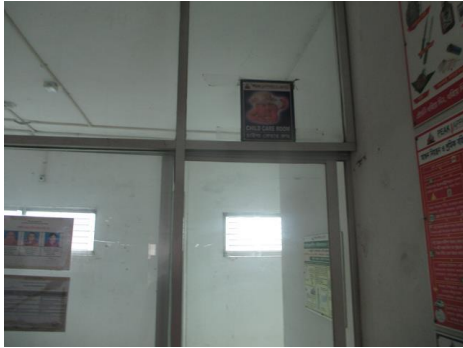
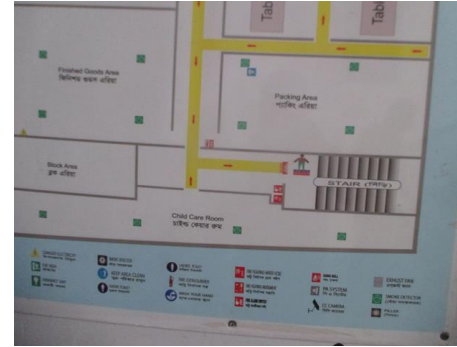
12	Fire Protection (ITM)	Inspection, testing and maintenance of the standpipe system is not in accordance with NFPA 14.	Inspect, test and maintain the standpipe system and keep written records on-site, in accordance with NFPA 14 and ACCORD standards.	Within 3 months
13	Day care care	The day care room is located at 1st floor and does not have direct access to an exit stair.	<ol style="list-style-type: none"> 1. Provide a direct access from daycare room to exit stair. [if the daycare is located at 1st floor] or 2. Provide a minimum 2-hr fire-rated exit corridor between the day-care room and exit stair. or 3. Relocate day-care room to ground floor with maximum travel distance of 9m (30 ft). 	Within 1 months

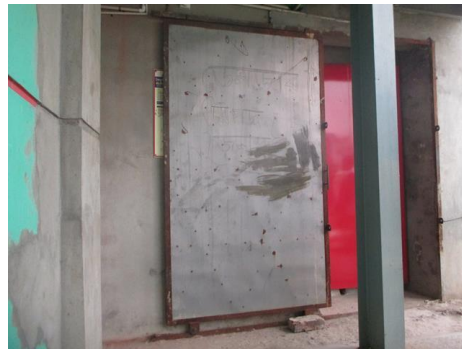
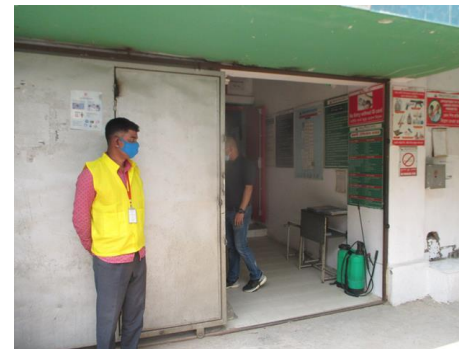
14	Egress	Sliding doors have provided along means of egress.	<p>Replace all shutter type doors & gates by the side-hinged swinging type doors.</p> <p>If locks are required for security reasons, utilize special door locking features complying with NFPA 101.</p>	1 week
----	--------	--	---	--------

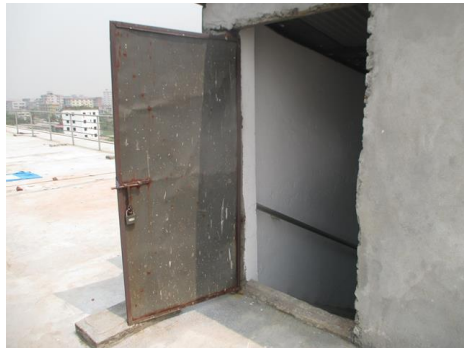
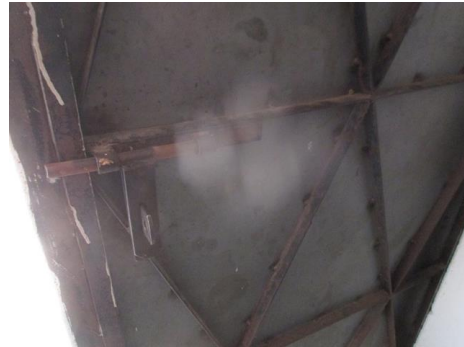
15	Egress Doors along means of egress are provided with non compliant locking system (Ground floor-main gate & roof-exit door)	<ol style="list-style-type: none"> 1. Remove all non compliant locking features from egress doors. 2. If locks are required for security reasons, utilize special door locking features complying with NFPA 101. 3. Doors may be locked where the latch and lock are disengaged with one motion where the occupant load does not exceed 49 persons. 4. Doors may be provided with locking hardware from the ingress side provided that a panic bar is installed on any door with an occupant load exceeding 49 persons. 	Immediate
----	--	---	-----------
