# INITIAL FIRE SAFETY INSPECTION REPORT

## Al-Muslim Washing Ltd. & Al-Muslim Garments Accessories Ltd.

**RSC ID: 24143**

**Date: 24-Feb-2021**

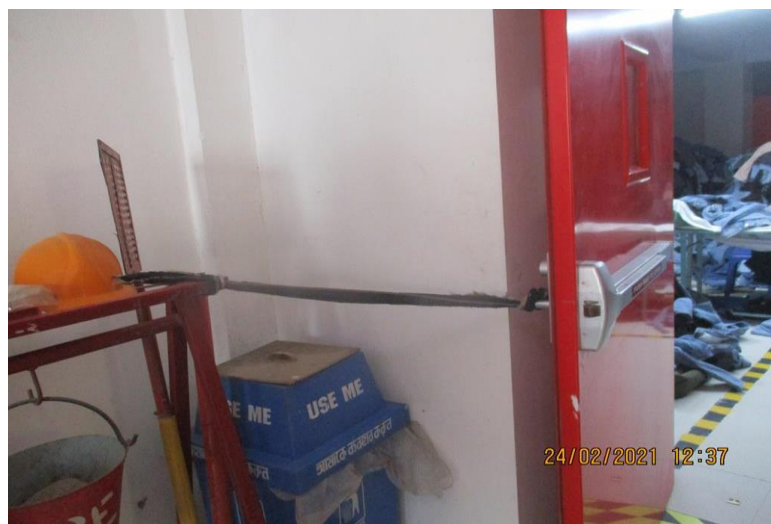
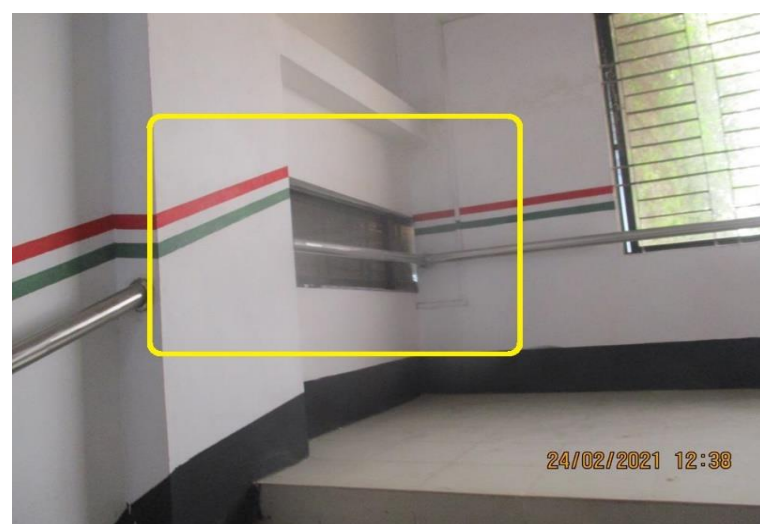
| SI No. | Category | Findings | Required Action | Remediation Time Frame |
|---|---|---|---|---|
| F-1 | Fire Rated Construction | <p>The exit enclosure are not separated from work areas, other spaces on each floor by fire-rated construction due to Non Functionality of Fire door and Unprotected Opening.</p> <p>Location - B# 2- ETP Building.</p> | <p>The exit stair enclosure shall be provided with a minimum 2-hr. fire resistance rating. Provide 1.5 hr. fire rated door and seal all penetrations and openings by 2 hr. fire rated fire rated barrier construction.</p> <p>Ensure that the fire doors are self-closing and positive latching and that they are provided with fire exit (panic) hardware where serving production floors. If fire doors are required to be held open for functional reasons, provide automatic closing devices tied to the fire alarm system.</p> | Within 3 months |

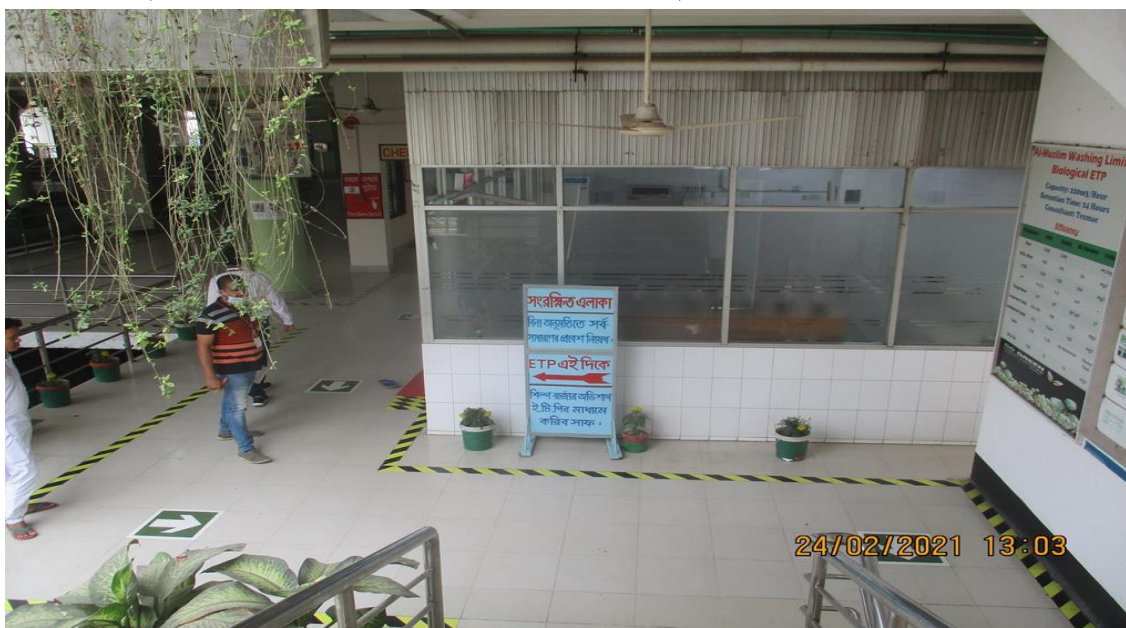
| F-2 | Fire Rated Construction | <p>None of the exit discharge the occupants directly outside of the building or to a fire rated passageway.</p> <p>Location : Ground Floor, B# 2- ETP Building</p> | All the exits shall be discharged directly outside of the building or through a minimum 2-hr fire rated passageway. | Within 3 Months |

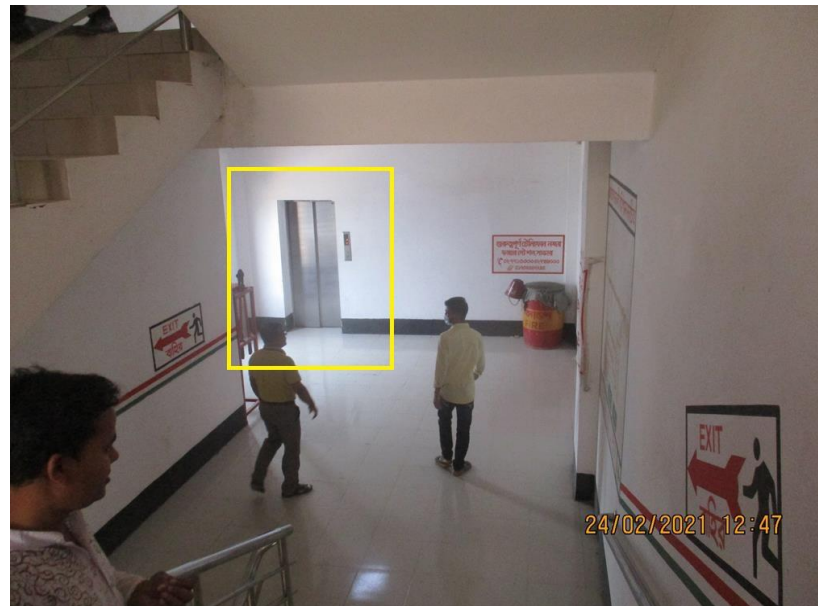
| F-3 | Fire Rated Construction | Elevator open directly inside of exit enclosure which is a violation of Accord Standard 6.14.3.<br>Location : Stair-1, B# 2- ETP Building | In new construction, elevators shall not open into an exit enclosure [Accord Building Standard 6.14.3].<br>So, rearrange the facility to provide separate enclosure for lifts. | 4 months |

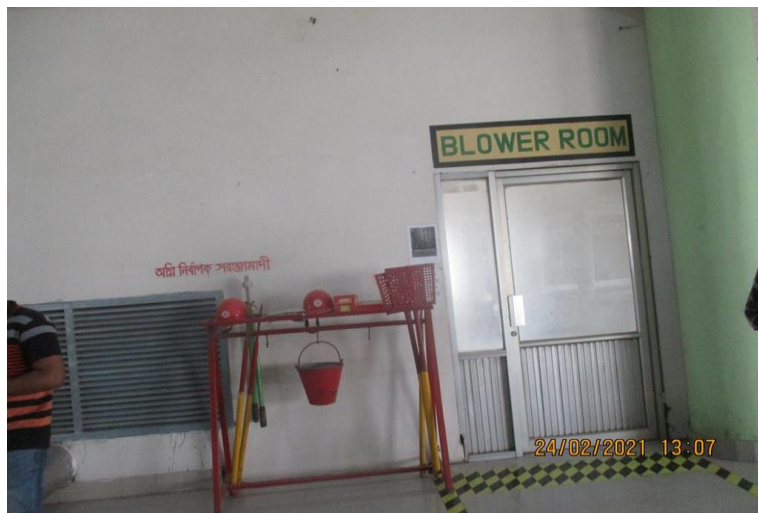
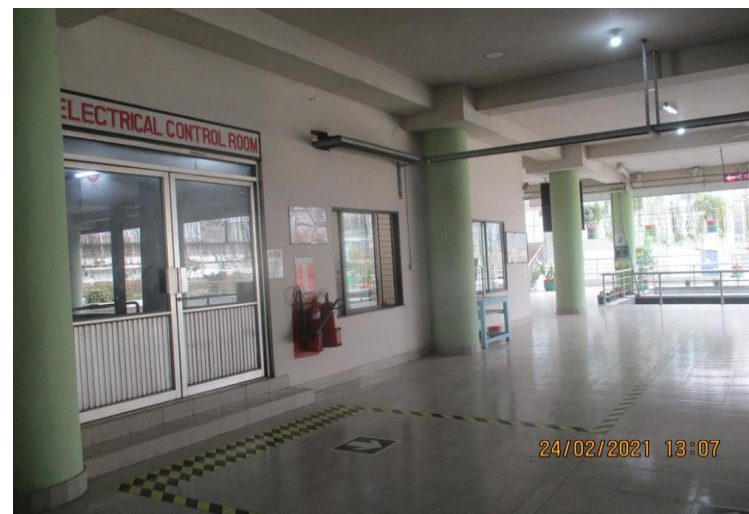
| F-4 | Fire Rated Construction | <p>Blower Rooms and Compressor Room are not separated by fire rated construction.<br/>Location : Ground Floor, B# 2- ETP Building</p> <p>Compressor Room shall be separated from other occupancies by a minimum 1-hr fire rated construction (wall, floor, slab etc.). Seal all penetrations and openings (door, window etc.) by minimum 0.75-hr (45 min) fire rated materials to maintain the fire separation if required. All exhaust systems shall discharge to the exterior of the building in a safe location.</p> <p>Or</p> <p>Relocate it to exterior of the building and maintain a minimum 3m (10 ft.) spatial separation distance from the building.</p> | Within 3 Months |

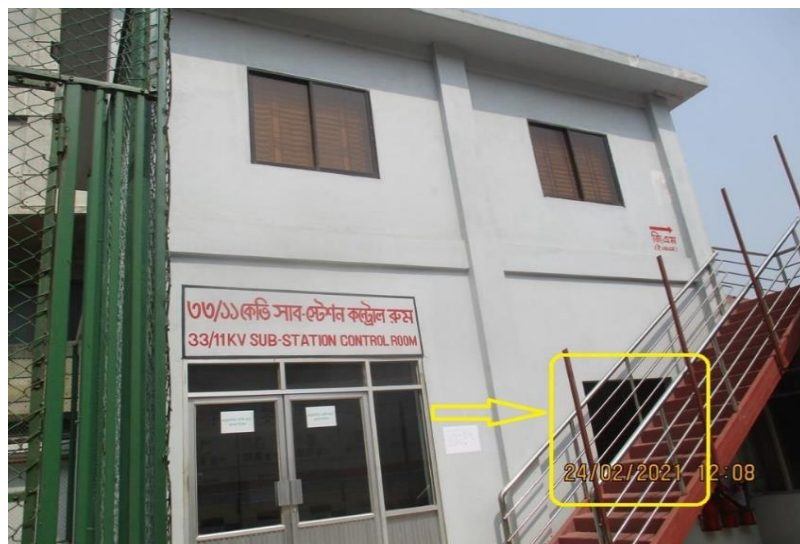
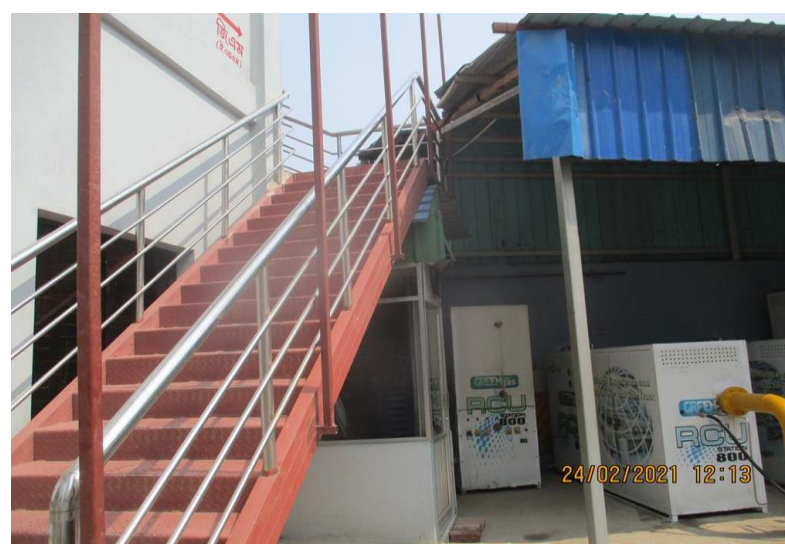
| F-5 | Fire Rated Construction | <p>Exit stair is not separated from Compressor and Substation by fire-rated construction due to unprotected openings.</p> <p>Location: B# 4- Substation Yard</p> | <p>Separate the exit stair from Compressor and Substation room by a minimum 2-hr fire-rated construction. Seal and/or protected all openings to maintain the required fire separations.</p> | Within 3 months |

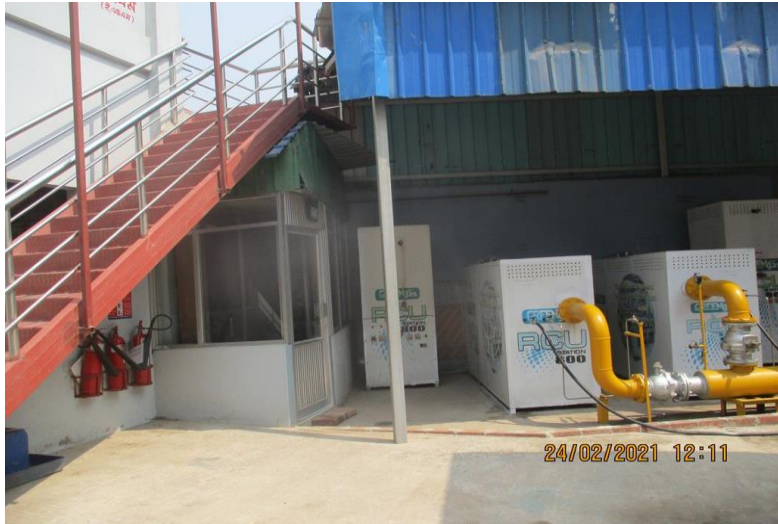
| F-6 | Fire Rated Construction | Compressor room is not separated by fire-rated construction.<br>Location: B# 4- Substation Yard | Compressor Room shall be separated from other occupancies by a minimum 1-hr fire rated construction (wall, floor, slab etc.). Seal all penetrations and openings (door, window etc.) by minimum 0.75-hr (45 min) fire rated materials to maintain the fire separation if required. All exhaust systems shall discharge to the exterior of the building in a safe location.<br>Or<br>Relocate it to exterior of the building and maintain a minimum 3m (10 ft.) spatial separation distance from the building. | Within 3 months |

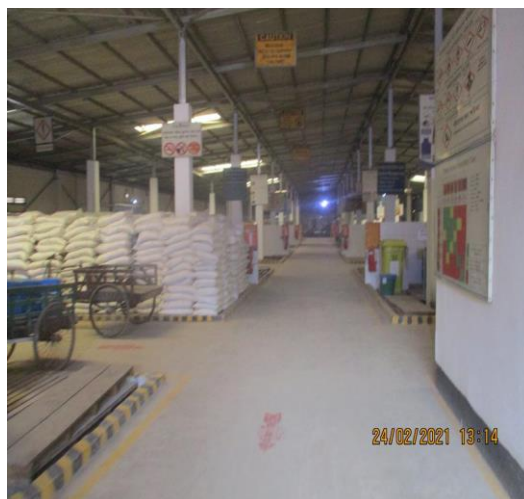
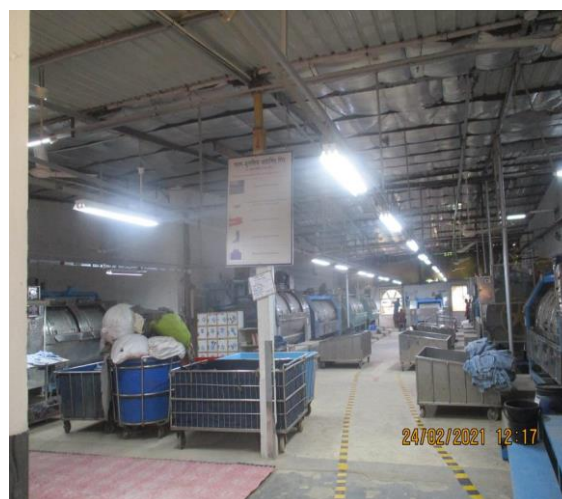
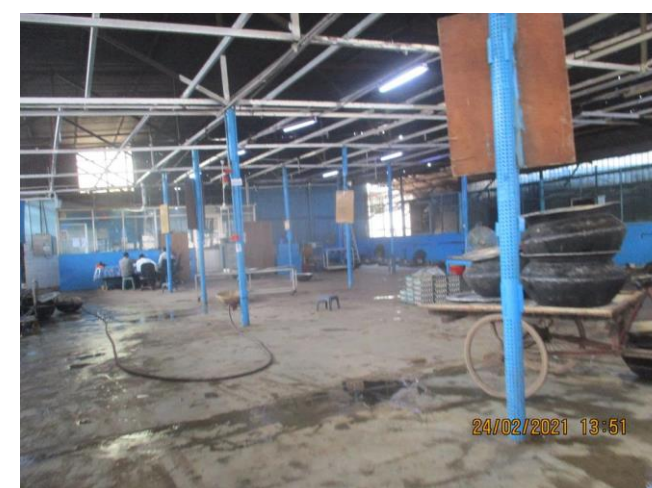
| F-7 | Fire Rated Construction | <p>The newly constructed Shed has been found steel-composite type and the steel columns and girders has been found in exposed condition without any fire protection.</p> <p>Location :</p> <p>Shed 2- Main Chemical Store,<br/>Shed 3- Waste Management Zone,<br/>Shed 4- Acid Wash ( Old Yarn Store),<br/>Shed 5- Incineration Stem Boiler,<br/>Shed 6- Generator &amp; Substation,<br/>Shed 7- Compressor and Electrical Material Store,<br/>Shed 8- kitchen and Washing Area ,</p> | <p>New constructed building shall be type-1, type-2 or type-3. Chemical store shed shall be type-1 construction. Provide required fire rating on the structural elements by following Table-3.2.4, 3.1.9 &amp; Table 4.4.1 of the Accord Standard or Table 3.3.1 of BNBC-2006. Consult a qualified fire protection engineer to design the rated construction barriers in between two floors and in structural members.</p> | Within 6 months |

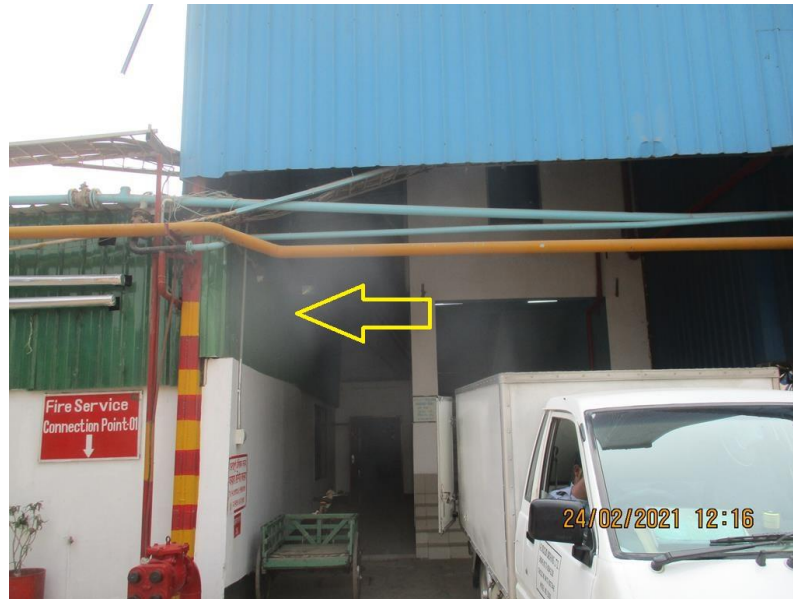
| F-8 | Fire Rated Construction | Exit stair (N-W) of 3 Stored Building Utility (RCC) has not been protected due to unprotected opening of Shed -4.<br>Location: Shed 4- Acid Wash ( Old Yarn Store) | The exit stair enclosure shall be provided with a minimum 1-hr. fire resistance rating. Provide 1 hr. fire rated separation in-between shed and stair of utility building. | Within 3 months |

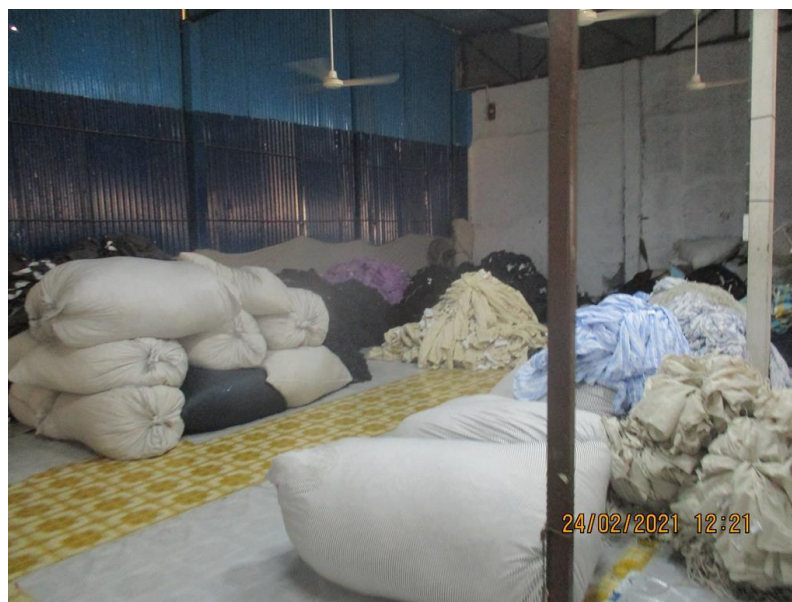
| F-9 | Fire Rated Construction | <p>Room used for combustible storage are not separated by fire rated construction.</p> <p>Location - Shed 4- Acid Wash ( Old Yarn Store) and Printing Process Store</p> | <p>Separate the storage room by a minimum 1- hr. fire-rated construction. Seal and/or protected all openings to maintain the required fire separations.</p> | <p>Within 3 months</p> |

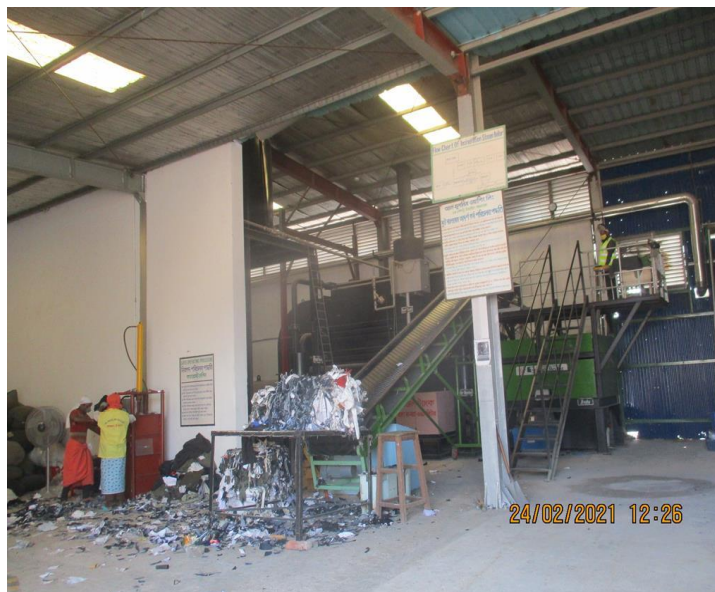
| F-10 | Fire Rated Construction | <p>The boiler room is not separated by fire rated construction (openings, non-rated doors, penetrations).</p> <p>Location: Shed 5- Incineration Stem Boiler</p> | <p>Boiler Room shall be separated from other occupancies by a minimum 1-hr fire rated construction (wall, floor, slab etc.). Seal all penetrations and openings (door, window etc.) by 0.75-hr (45 min) fire rated materials to maintain the fire separation if required. All exhaust systems shall discharge to the exterior of the building in a safe location.</p> <p>Or</p> <p>Relocate it to exterior of the building and maintain a minimum 3m (10 ft.) spatial separation distance from the building.</p> | Within 3 months |

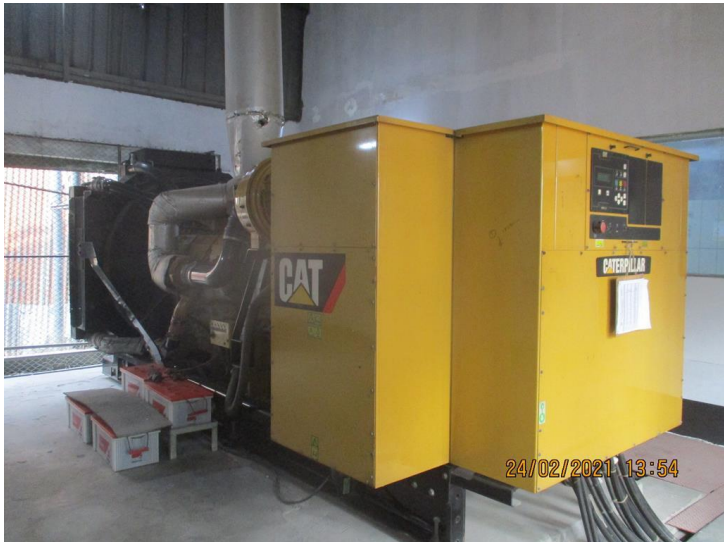
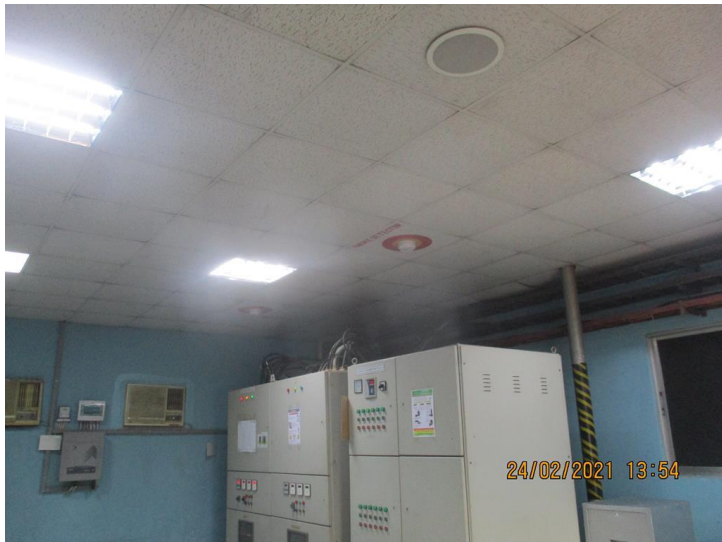
| F-11 | Fire Rated Construction | <p>The Generator and transformer room is not separated by fire rated construction (openings, non-rated doors, penetrations).</p> <p>Location : Shed 6- Generator &amp; Substation</p> | Separate the Generator and Transformer room by a minimum 2-hr fire rated construction. Seal and/or protected all fire separations. | Within 3 months |

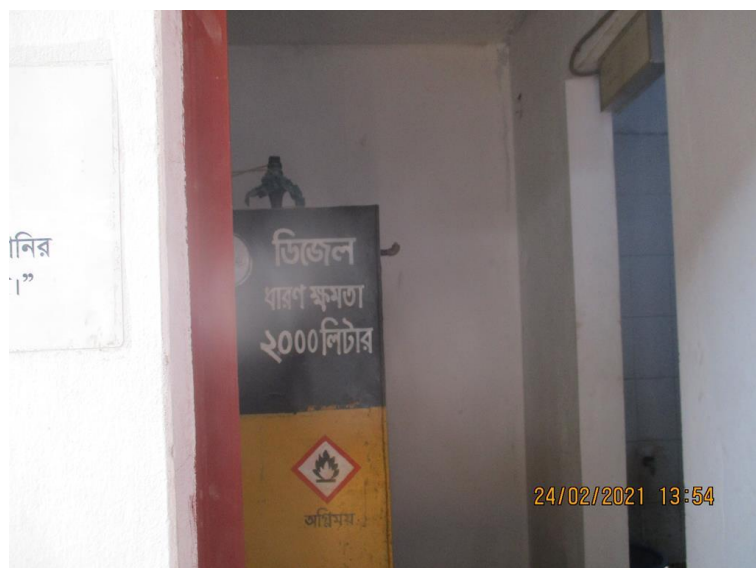
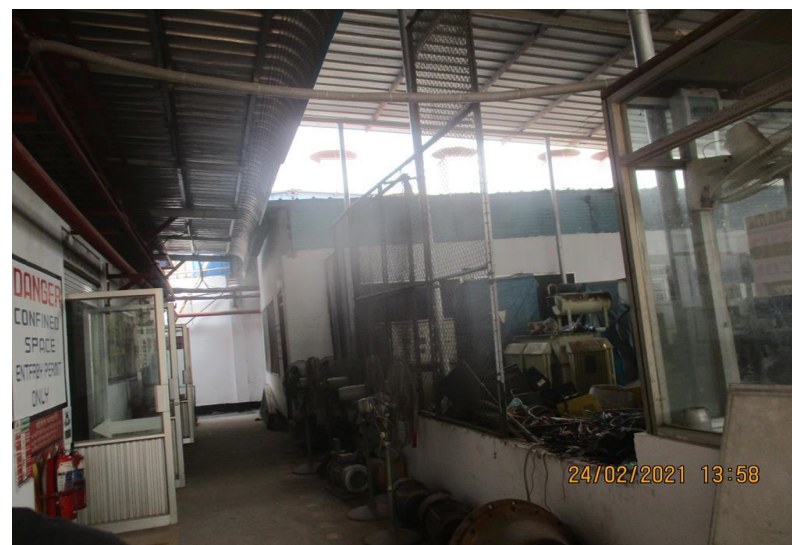
| F-12 | Fire Rated Construction | <p>Diesel fuel storage has been found with Substation and Electrical Material Store.</p> <p>Location: Shed 7- Compressor and Electrical Material Store</p> | <p>Provide minimum 2-hr fire rated construction for the diesel storage room. Additionally follow applicable local law as Petroleum Act for storing and handling of the fuel.</p> | <p>Within 1 month</p> |

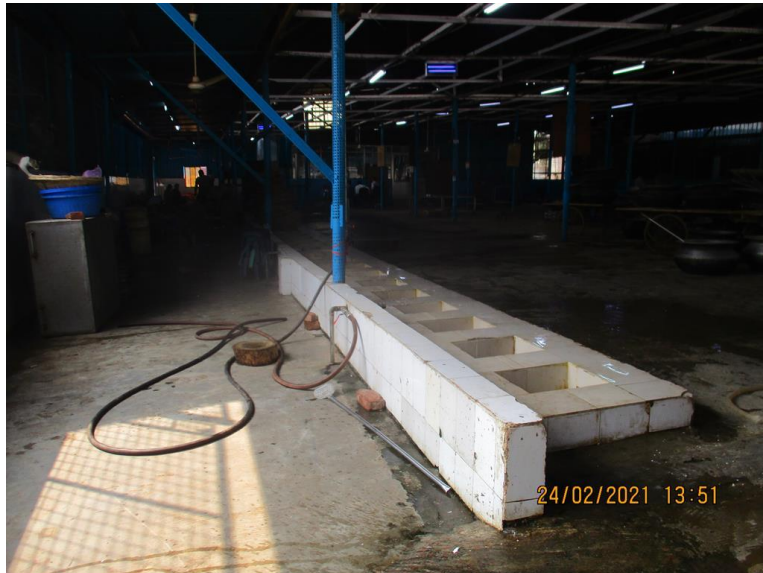
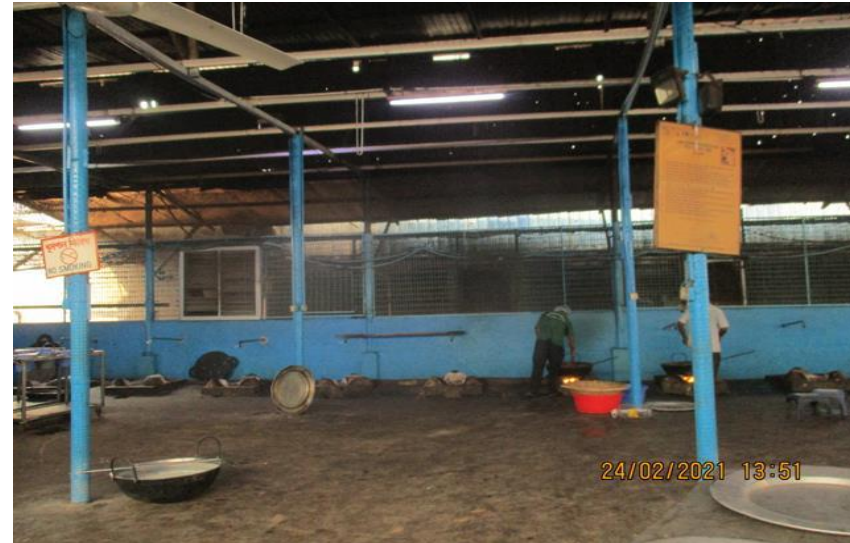
| F-13 | Fire Rated Construction | There are was a shed close to Kitchen without spatial distance or fire separation.<br>Location: Shed-8 | Kitchen shall be isolated from surrounded occupancies with minimum 9 meter spatial distance. | Within 3 Months |

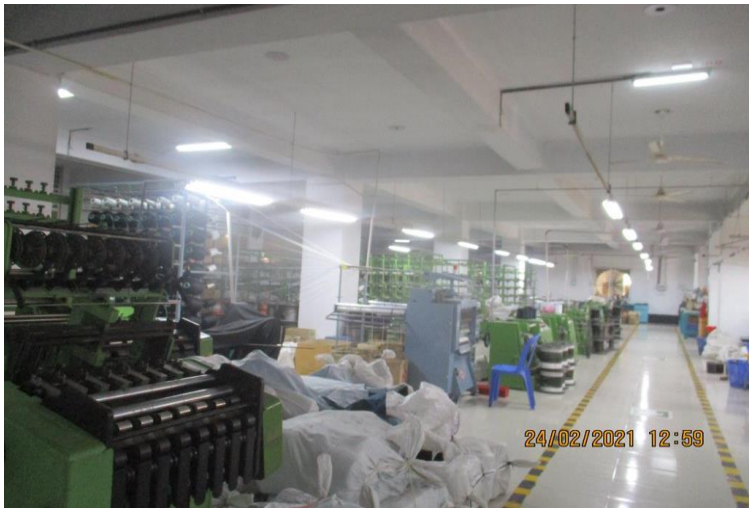
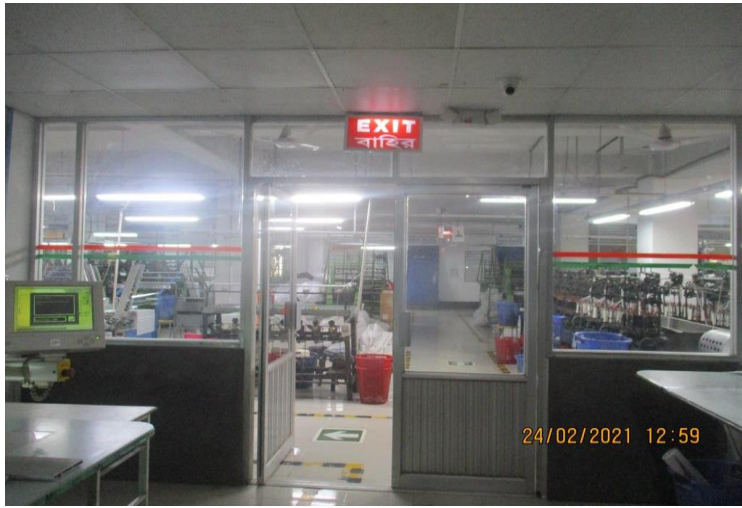
| F-14 | Egress | <p>A single means of egress has been provided from Embroidery area which discharge is inside store room without fire separation.</p> <p>Location : 1st Floor, B# 2- ETP Building</p> | <p>Single exit on 1st floor can be accepted where maximum common path of travel can be 23 m (in case of sprinkler 30 m) with maximum occupant load 30. So provide additional exit for the section which leads a fire rated vestibule/enclosure so that occupants do not discharge directly to the store room.</p> | 3 months |

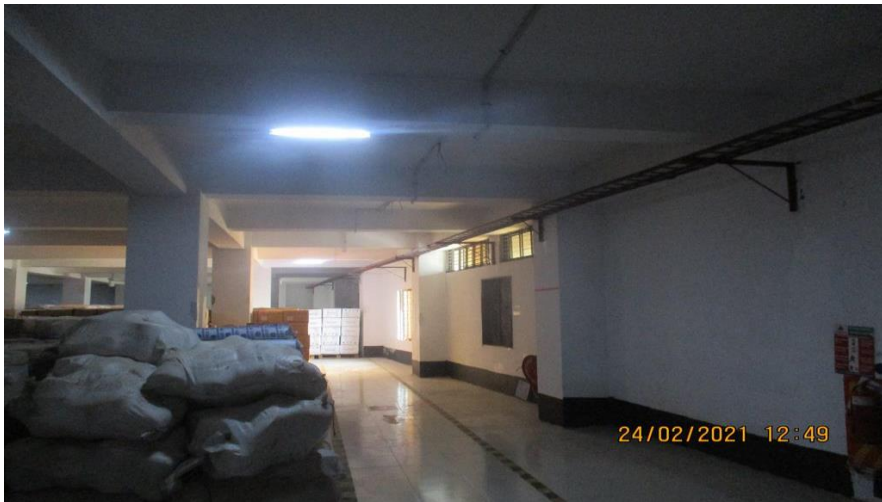
| F-15 | Egress | Common path of egress travel exceeds 23 m.<br>Location : 3rd Floor, B# 2- ETP Building | Reconfigure the egress arrangement to reduce the maximum common path of travel to not more than 23 meter. | Within 3 month |

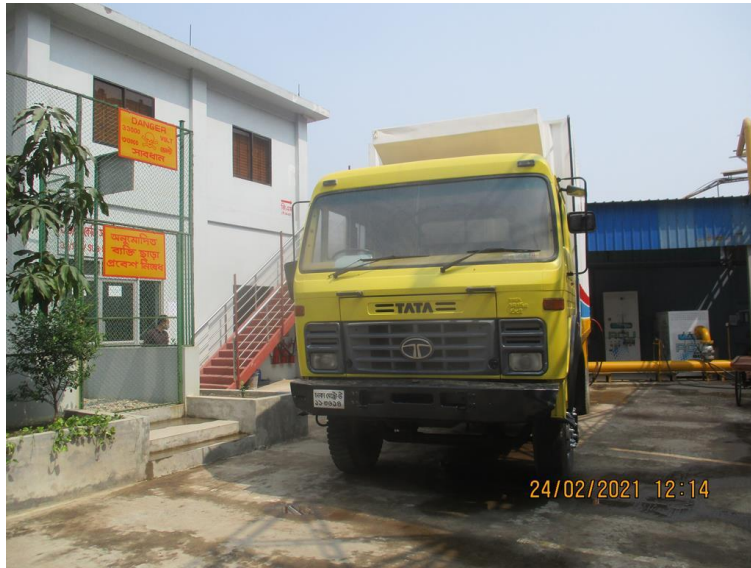
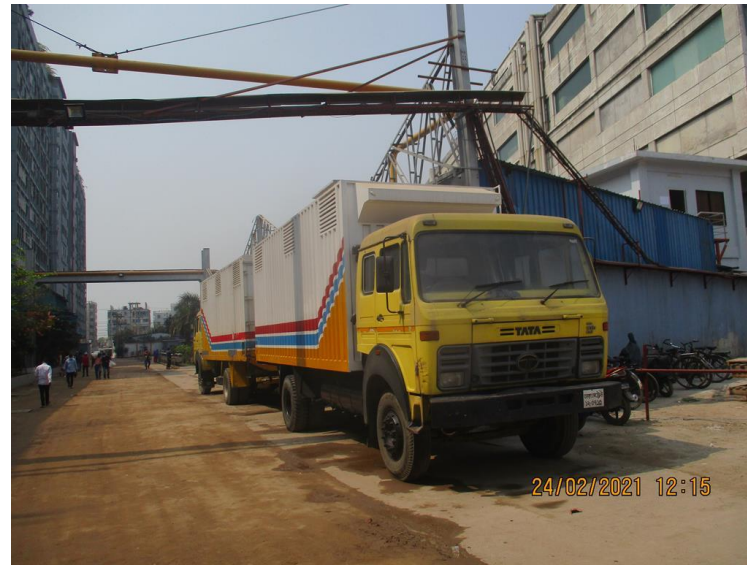
| F-16 | Egress | C.N.G Storage Van was located inside of premises adjacent with egress path.<br>Location: B# 4- Substation Yard | The storage or use of liquefied or compressed flammable gas cylinders shall be prohibited within the factory building. | Within 1 month |

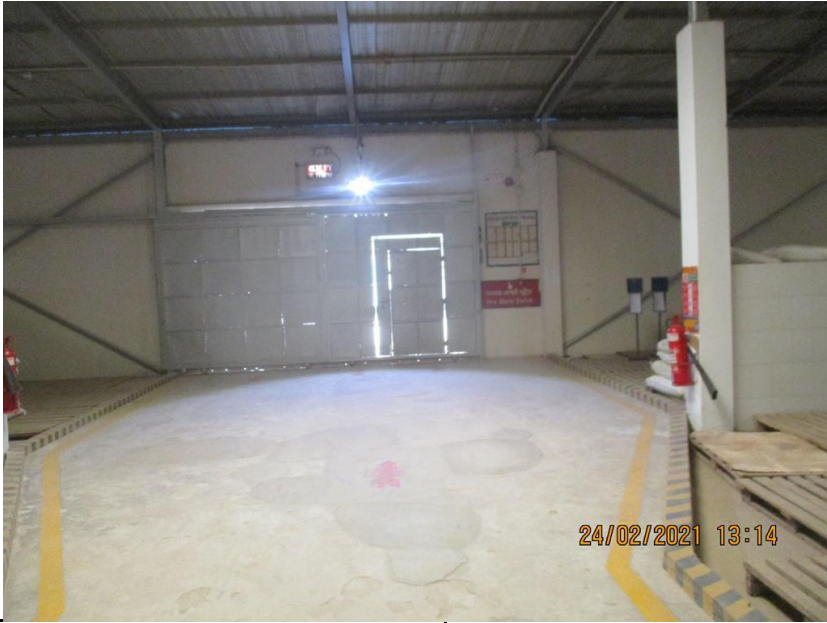
| F-17 | Egress | <p>Common path of egress travel exceeds 8 m on chemical store</p> <p>Location : Shed 2- Main Chemical Store</p> | <p>Reconfigure the egress arrangement to reduce the maximum common path of travel to not more than 8 m (25ft) for Group J (high hazard) occupancies.</p> | <p>Within 3 month</p> |

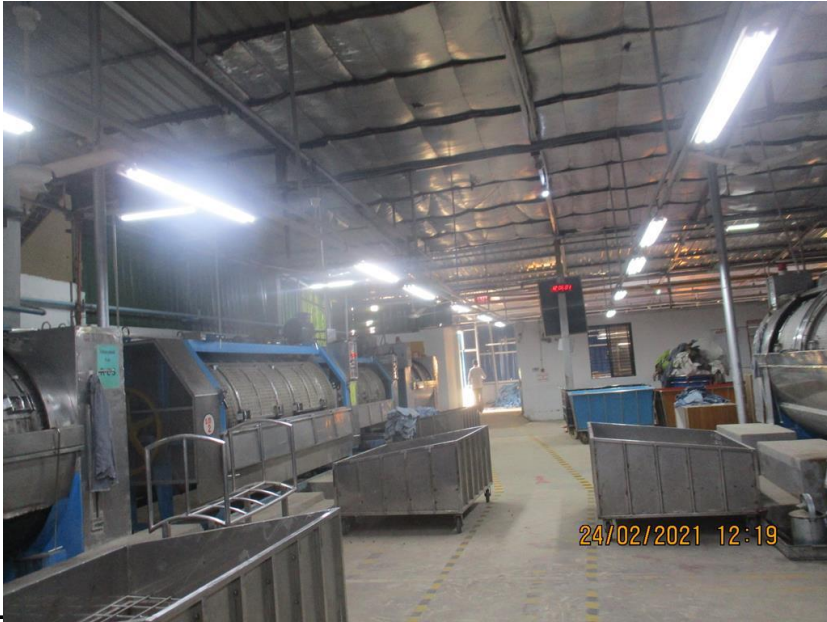
| F-18 | Egress | <p>Common path of egress travel exceeds 23 m.</p> <p>Location : Shed 4- Acid Wash ( Old Yarn Store)</p> | Reconfigure the egress arrangement to reduce the maximum common path of travel to not more than 23 meter. | Within 3 month |

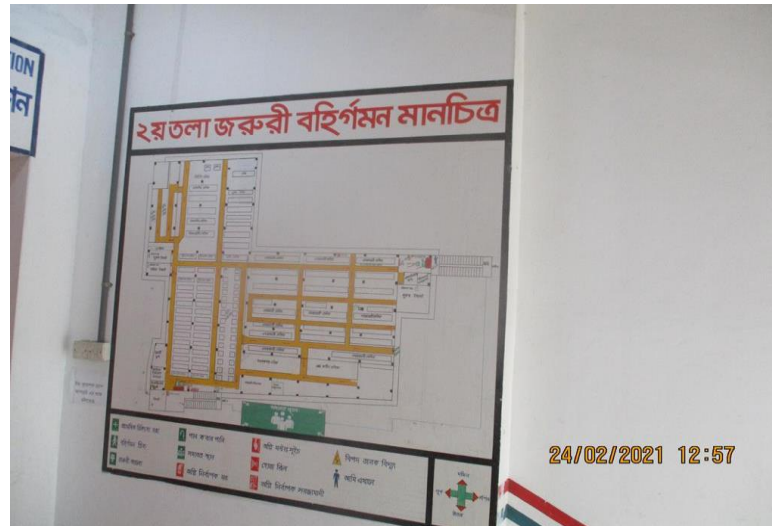
| F-19 | Egress | <p>Provided emergency evacuation plans and occupant load signs at the factory floor has been found Not Updated.</p> <p>Location: All buildings</p> | Provide updated emergency evacuation plans and occupant load signs at required locations. | Within 1 Month |

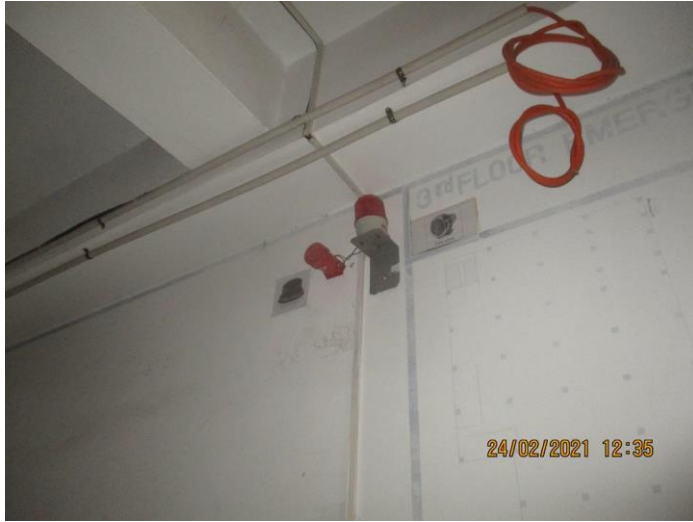
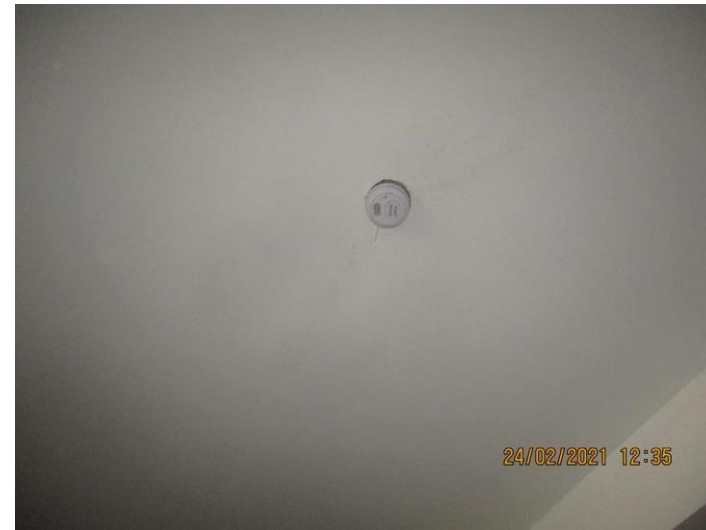
| F-23 | Fire Alarm & Detection system | The fire alarm system is antiquated, not a listed system and does not provide alarm and notification features consistent with acceptable standards.<br>Location: B# 2- ETP Building | Replace the fire alarm system with a listed addressable fire alarm system in accordance with NFPA 72. Submit drawings, calculations, equipment datasheets, certification and other relevant documentation to the RSC prior installation for review. | Design Review within 2 months and installation within 4 months. |

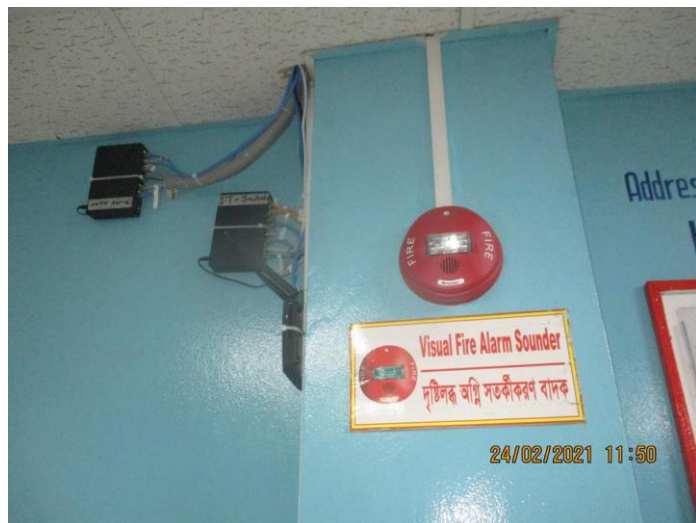
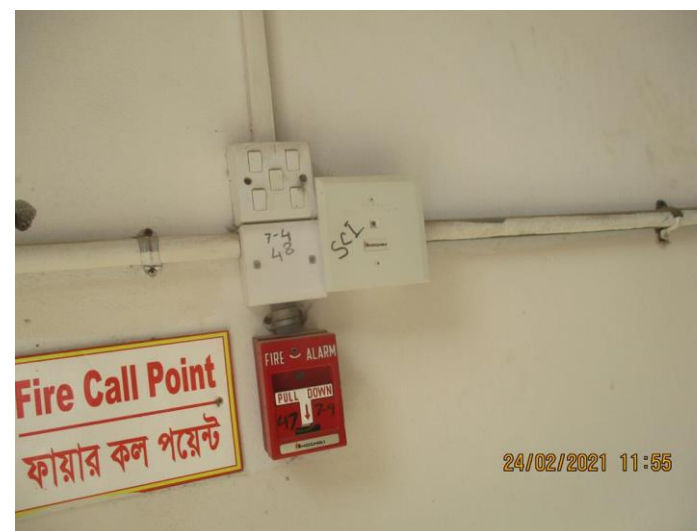
| F- 24 | Fire Alarm & Detection system | <p>Addressable Fire Alarm System installation and modification was going on.</p> <p>Location : Building 1,4, Shed-2, 3, 4, 5, 6, 7, 8, 9, 10.</p> | <p>Complete the fire alarm installation as per NFPA 72. Submit drawings, calculations, equipment datasheets, certification and other relevant documentation to the RSC prior installation for review.</p> | <p>Design Review within 2 months and installation within 4 months.</p> |

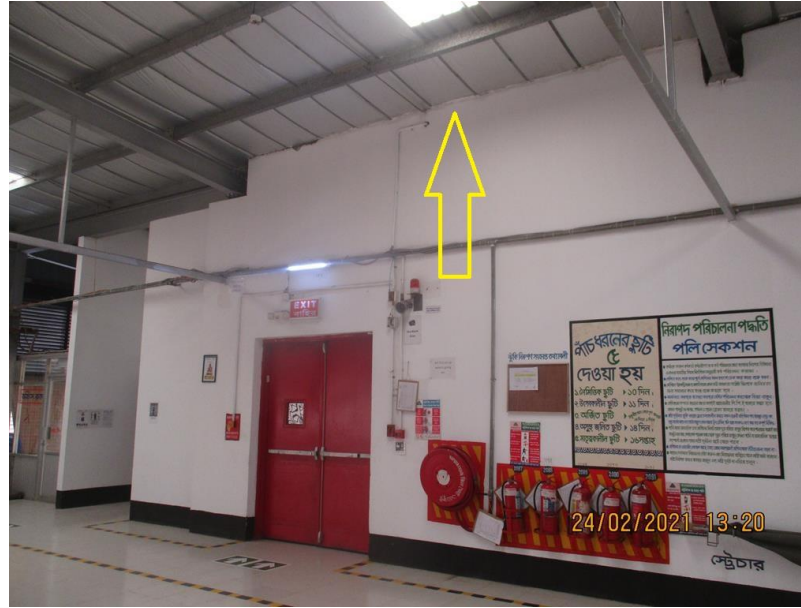
| SI No. | Category | Findings | Required Action | Remediation Time Frame |
|---|---|---|---|---|
| F-30 | Fire Rated Construction | <p>The exit enclosure are not separated from work areas, other spaces on each floor by fire-rated construction due to non rated structure.</p> <p>Location - B# 3- New Accessories</p> | <p>The exit stair enclosure shall be provided with a minimum 1-hr. fire resistance rating. Provide 1 hr. fire rated door and seal all penetrations and openings by 1 hr. fire rated fire rated barrier construction.</p> <p>Ensure that the fire doors are self-closing and positive latching and that they are provided with fire exit (panic) hardware where serving production floors. If fire doors are required to be held open for functional reasons, provide automatic closing devices tied to the fire alarm system.</p> | Within 3 months |

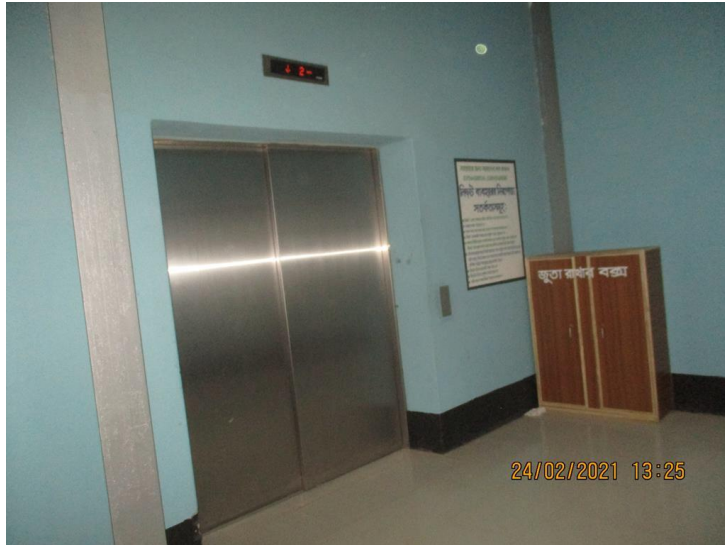
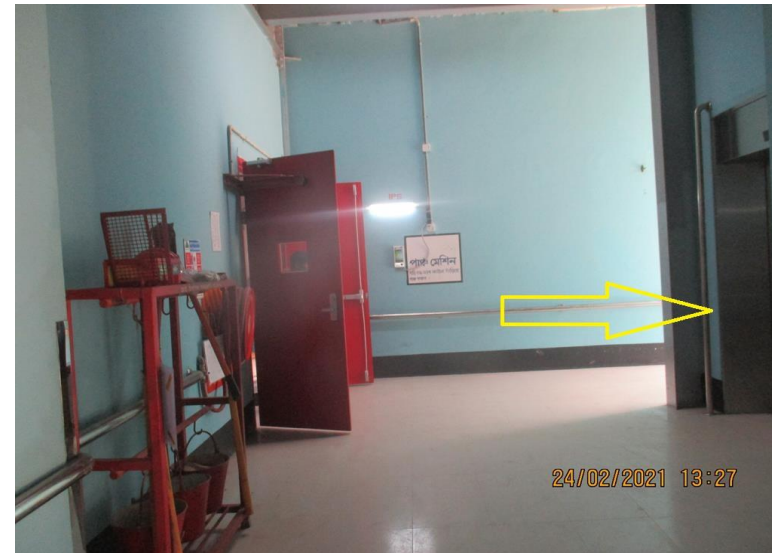
| F-31 | Fire Rated Construction | Elevator open directly inside of exit enclosure which is a violation of Accord Standard 6.14.3.<br>Location : Stair-1, B# 3- New Accessories Building | In new construction, elevators shall not open into an exit enclosure [Accord Building Standard 6.14.3].<br>So, rearrange the facility to provide separate enclosure for lifts. | 4 months |

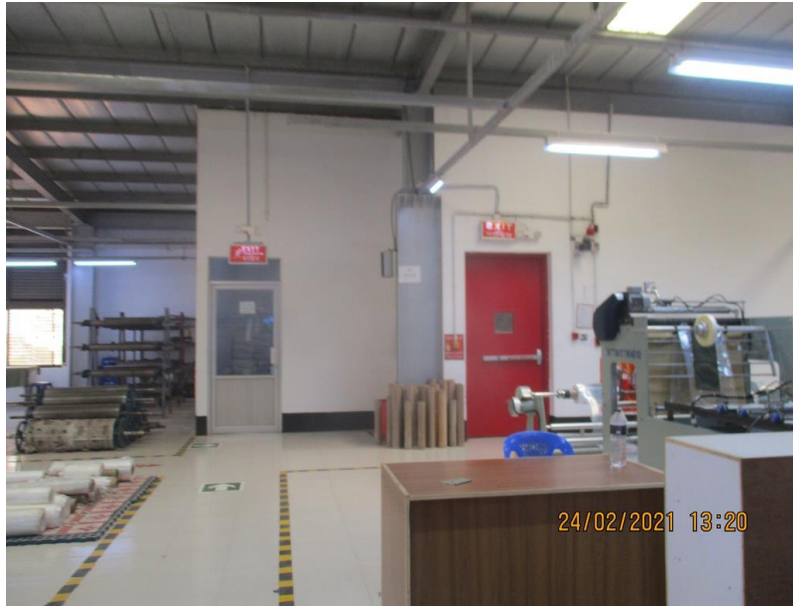
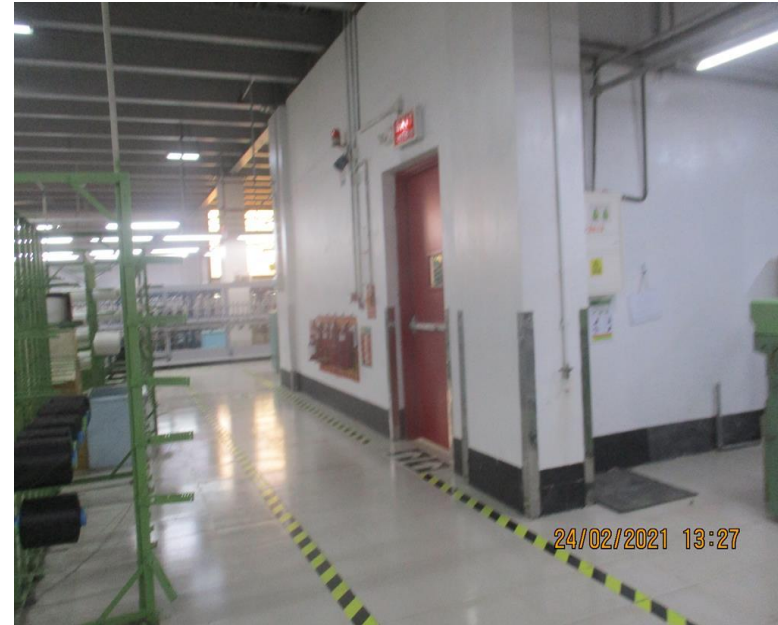
| F-32 | Fire Rated Construction | <p>The New Accessories in the newly constructed Building 3 is steel-composite type and the steel columns and girders has been found in exposed condition without any fire protection.</p> <p>Location : Building 3- New Accessories</p> | <p>New constructed building shall be type-1 or type-2 construction as per Table 3.2.4 of BNBC 2006. Provide required fire rating on the structural elements by following Section 4.4 and Table 4.4.1 of the Accord Standard or Table 3.3.1 and Table 4.1.1 from BNBC Part 4. Consult a qualified fire protection engineer to design the rated construction barriers in between two floors and in structural members.</p> | Within 6 months |

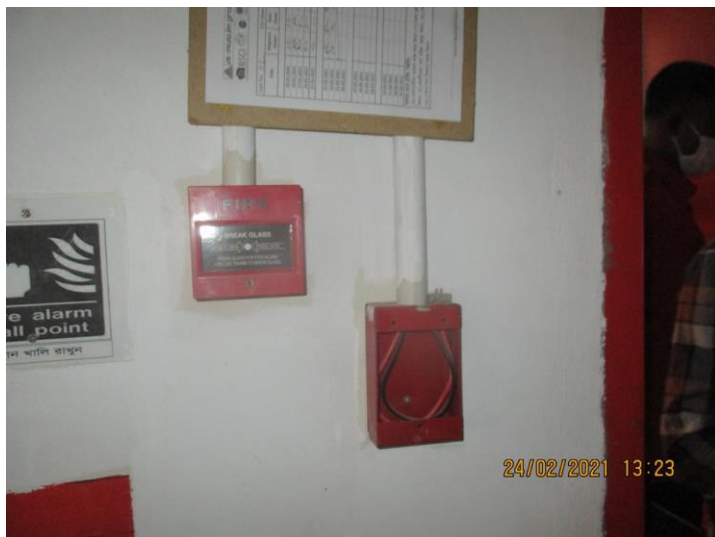
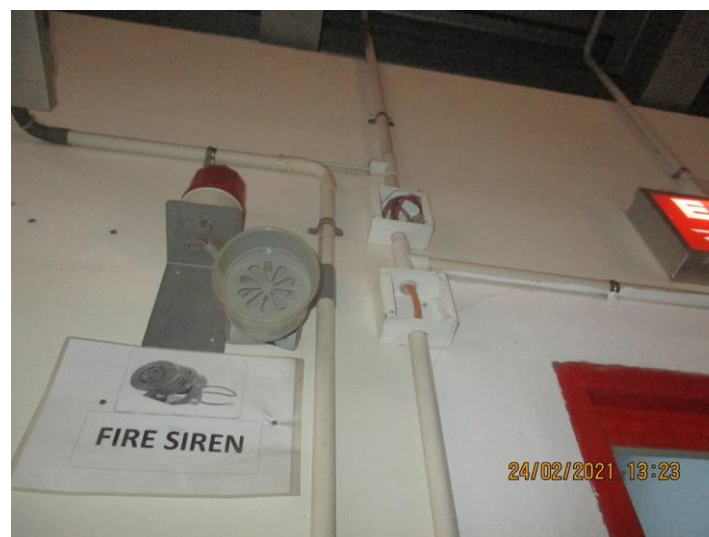
| F-35 | Fire Alarm & Detection system | The fire alarm system is antiquated, not a listed system and does not provide alarm and notification features consistent with acceptable standards.<br>Location: Building 3- New Accessories | Replace the fire alarm system with a listed automatic fire alarm system in accordance with NFPA 72. Submit drawings, equipment datasheets, certification and other relevant documentation to the RSC prior installation for review. | Design Review within 2 months and installation within 4 months. |

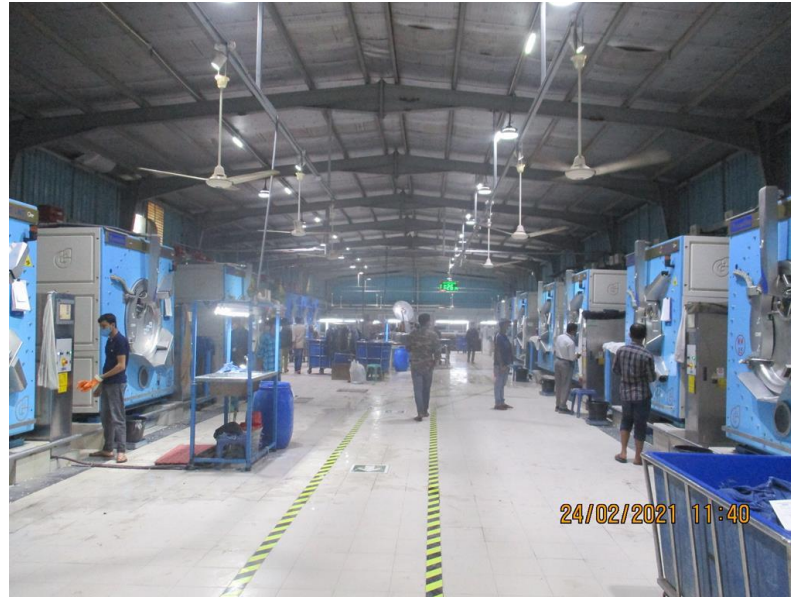
| SI No. | Category | Findings | Required Action | Remediation Time Frame |
|---|---|---|---|---|
| F-39 | Fire Rated Construction | The Acid Wash & Blech Mixing Area in the newly constructed Shed 1 is steel-composite type and the steel columns and girders has been found in exposed condition without any fire protection.<br>Location :Shed 1- Acid Wash & Blech Mixing Area | New constructed building shall be type-1 or type-2 construction as per Table 3.2.4 of BNBC-2006. Provide required fire rating on the structural elements by following Section 4.4 and Table 4.4.1 of the Accord Standard or Table 3.3.1 and Table 4.1.1 from BNBC Part 4. Consult a qualified fire protection engineer to design the rated construction barriers in between two floors and in structural members. | Within 6 months |

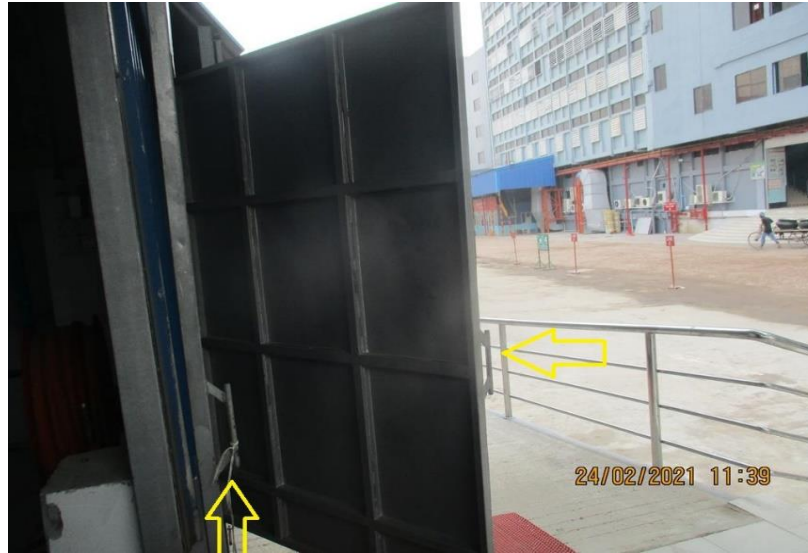
| F-40 | Means of Egress | Egress doors and gates with locking features are provided at building exits.<br>Location: Shed 1- Acid Wash & Blech Mixing Area | Remove locking features from all egress doors and gates. If locks are required for security reasons, utilize special door locking features complying with NFPA 101 and ACCORD standard 6.8.2. | Immediately |

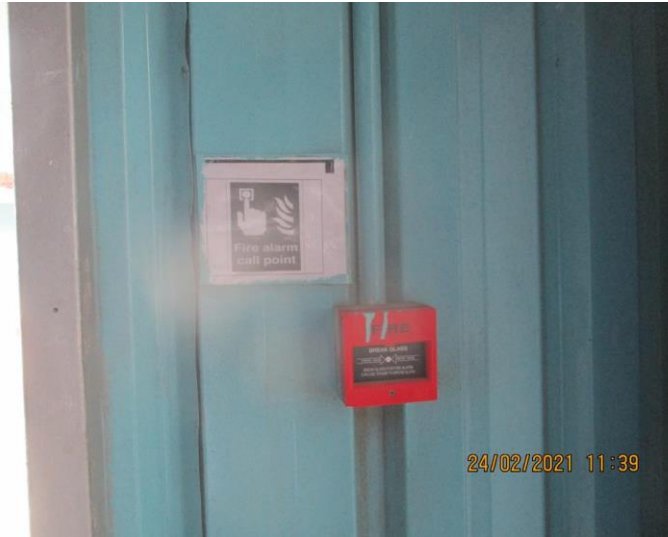
| F-41 | Fire Alarm & Detection system | <p>The fire alarm system is antiquated, not a listed system and does not provide alarm and notification features consistent with acceptable standards.</p> <p>Location: Shed 1- Acid Wash &amp; Blech Mixing Area</p> | <p>Replace the fire alarm system with a listed automatic fire alarm system in accordance with NFPA 72. Submit drawings, equipment datasheets, certification and other relevant documentation to the RSC prior installation for review.</p> | <p>Design Review within 2 months and installation within 4 months.</p> |
