INITIAL FIRE SAFETY INSPECTION REPORT

Factory Name: Mega Yarn Dyeing Mills Ltd. (Expansion) & Mega Fashion Wear Ltd.

Factory ID: 24157

ADDRESS: Sardagonj, Gabindabari, Kashimpur, Gazipur

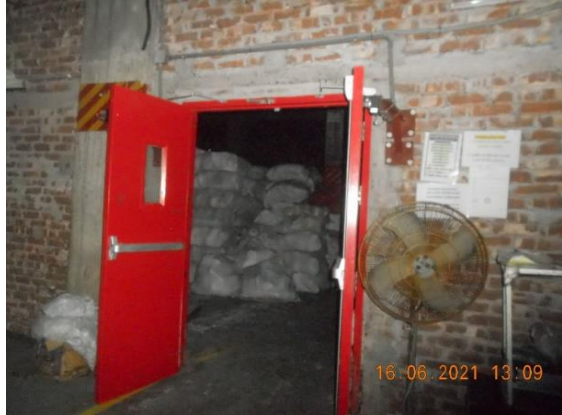
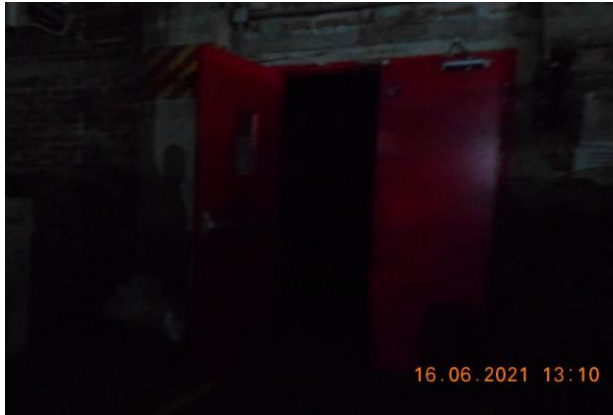
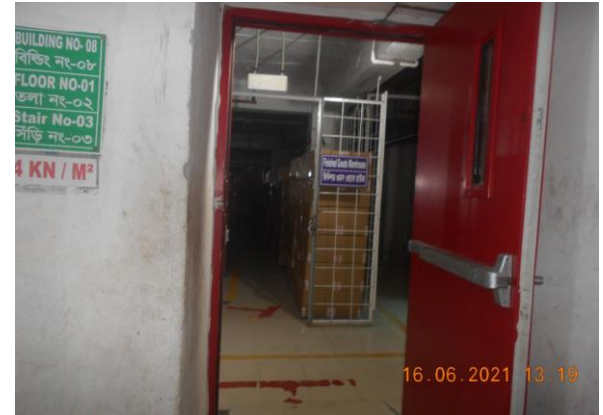
SI No.	Category	Findings	Required Action	Remediation Time Frame
1	Fire Rated Construction	Rooms used for storage of combustible materials are not separated from the surrounding occupancy/areas & floors. Location: Ground floor, 1st & 4th floor.	Rooms used for storage of combustible materials shall be separated from the surrounding occupancy with a minimum 1 hour construction.	Within 3 months

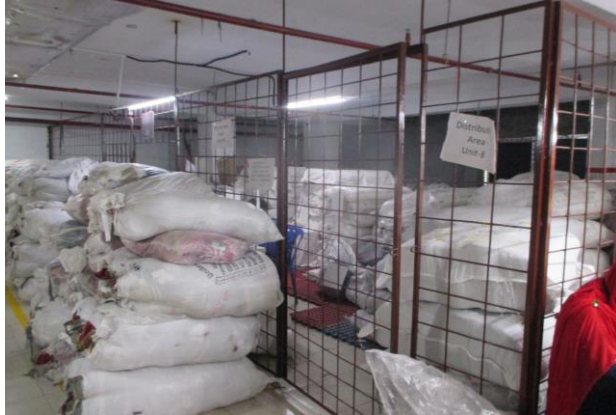
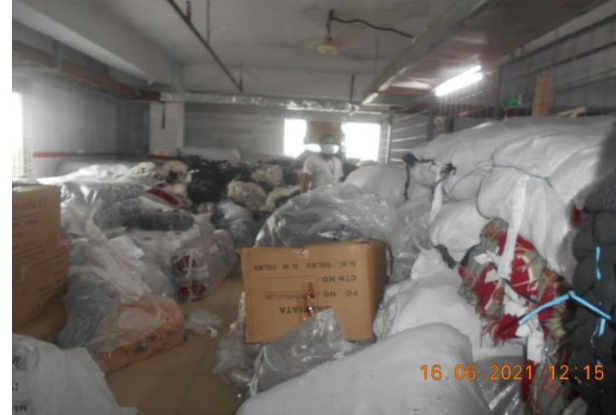
2	Fire Rated Construction	Areas used for combustible storage are not separated by fire-rated construction.	<p>Provide dedicated storage rooms separated by minimum 1-hr fire-rated construction.</p> <p>Where separate storage rooms are not feasible, provide defined storage areas and limit the storage arrangement as follows:</p> <ul style="list-style-type: none"> - Maximum height of 2.4m and maximum area of 23m² - If sprinkler protected: maximum height of 3.66m and maximum area of 93m² <p>Separate areas of unenclosed combustible storage by a minimum clear distance of 3m.</p>	Within 3 months
---	-------------------------	--	--	-----------------

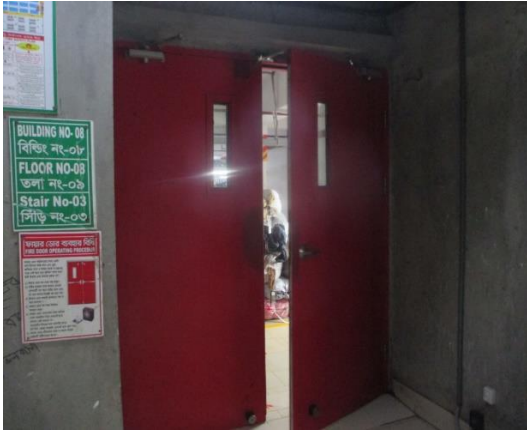
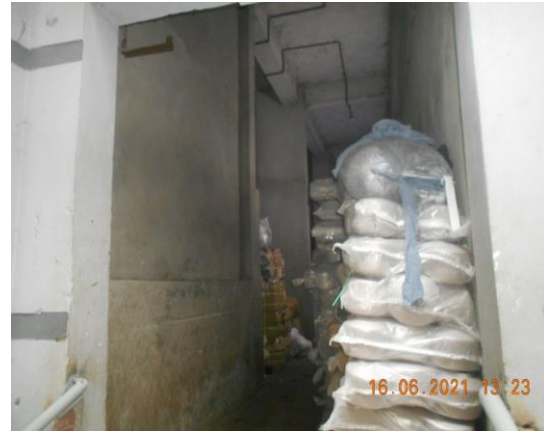
3	Fire Rated Construction	The exit stairs are not separated from other occupancy on each floor by fire rated construction.	<p>Separate the exit stairs from work areas and other building spaces on all floor levels by minimum 2-hr fire rated construction. Provide minimum 1.5-hr fire rated doors and seal all unprotected openings and penetrations to maintain the fire separation. The clearance under the bottom of a fire door shall be a maximum of 3/4 in. (19 mm). Ensure that all fire doors are self-closing and positive latching, and are provided with fire exit (panic) hardware where serving production floors or assembly occupancies. Provide vestibules to separate any storage areas. If fire doors are required to be held open for functional reasons, provide automatic closing devices tied to the fire alarm system. Once fire doors are installed, every door in a stair enclosure serving more than 5 stories shall be provided with reentry unless it meets ACCORD standard 6.8.3.1.</p>	Within 3 months

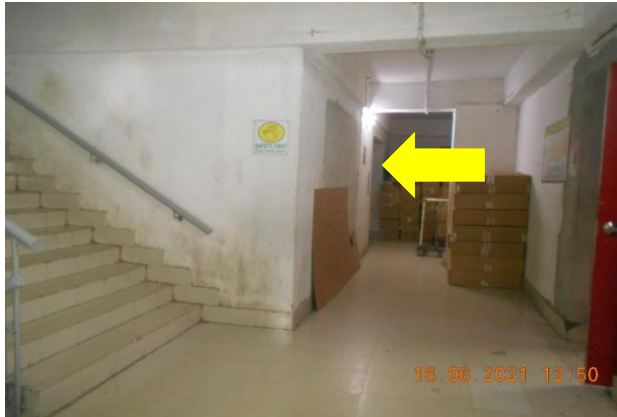
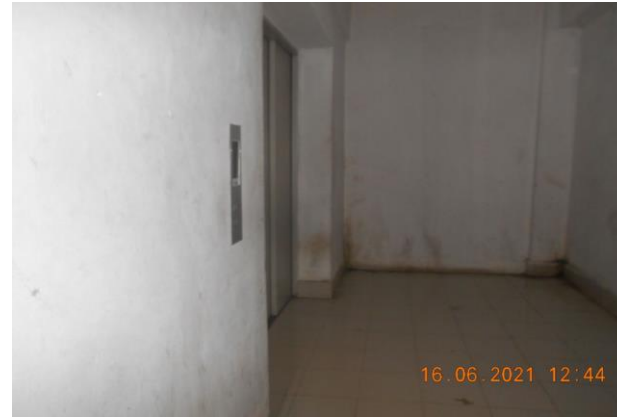
4	Fire Rated Construction	Elevator is open into exit stair enclosure. Location: Stair-3	Modify the elevator and stair enclosure arrangement in a way to satisfy Accord standard 6.14.3. Elevator shall not open into an exit enclosure.	Within 4 months
---	-------------------------	--	---	-----------------

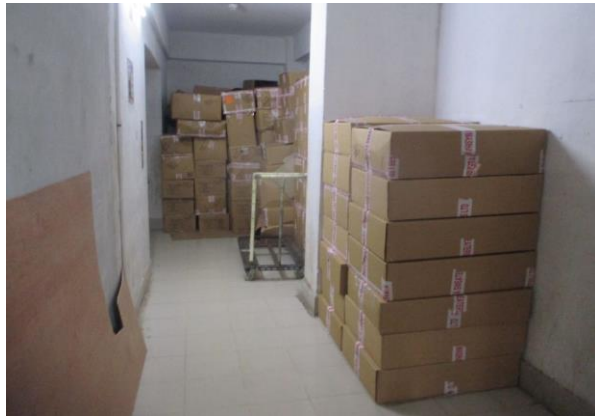
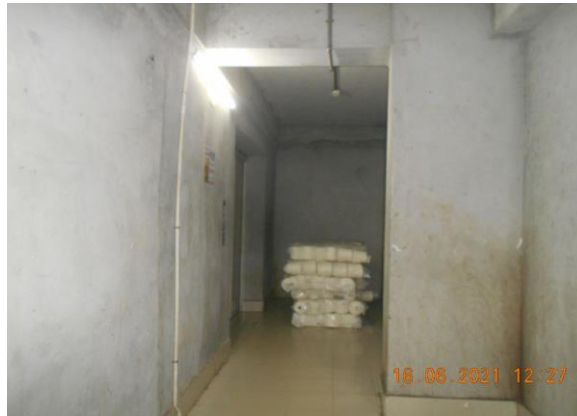
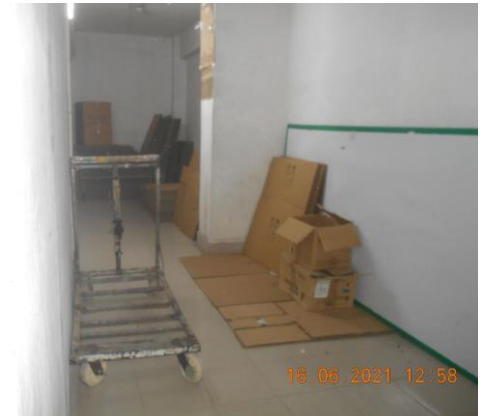
5	Egress	Storage was located in the exit stair. Location: Stair-3	Remove all storage from exit stairs.	Immediately
---	--------	---	--------------------------------------	-------------

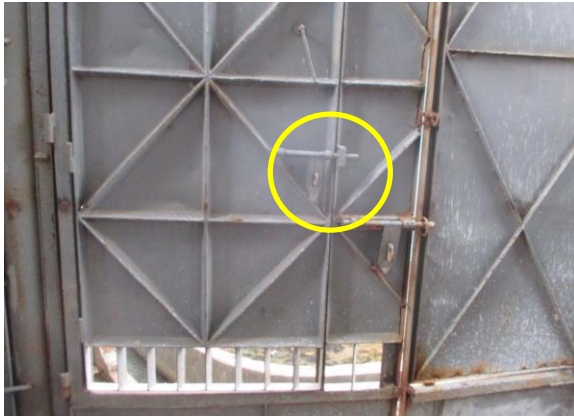
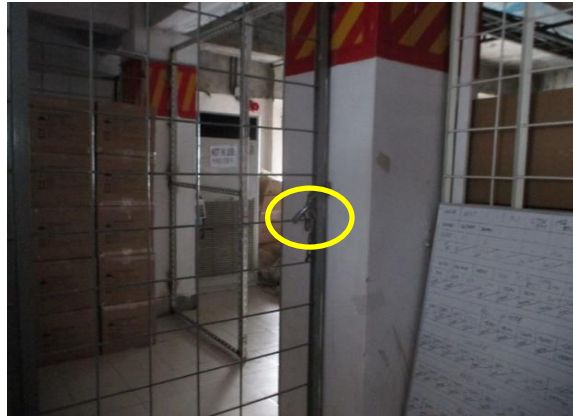
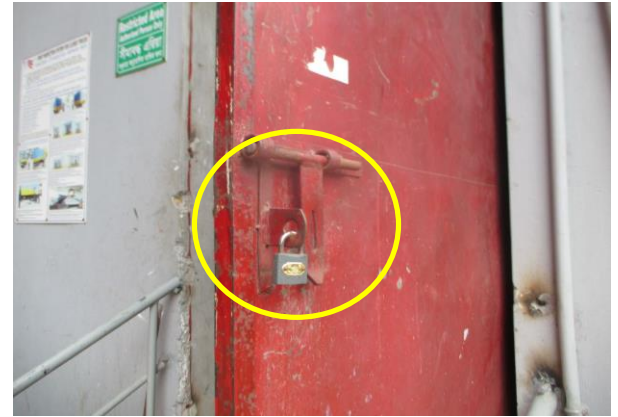
6	Egress	Doors along means of egress are provided with non compliant locking system. Location: 1st floor, Ground floor	<ol style="list-style-type: none"> 1. Remove all non compliant locking features from egress doors. 2. If locks are required for security reasons, utilize special door locking features complying with NFPA 101. 3. Doors may be locked where the latch and lock are disengaged with one motion where the occupant load does not exceed 49 persons. 4. Doors may be provided with locking hardware from the ingress side provided that a panic bar is installed on any door with an occupant load exceeding 49 persons. 	Immediately
---	--------	--	---	-------------

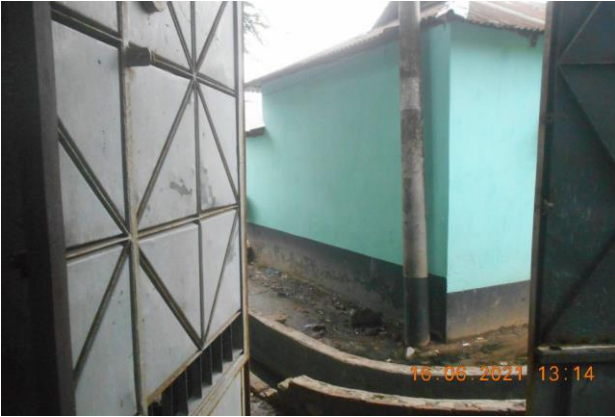
7	Egress	Egress door serving 50 or more occupants but does not swing in the direction of egress travel. Location: Ground floor main exit.	Modify swing direction of egress doors to the direction of egress travel. Doors serving an occupant load of more than 50 shall swing in the direction (out-ward) of egress travel .	Within 1 month

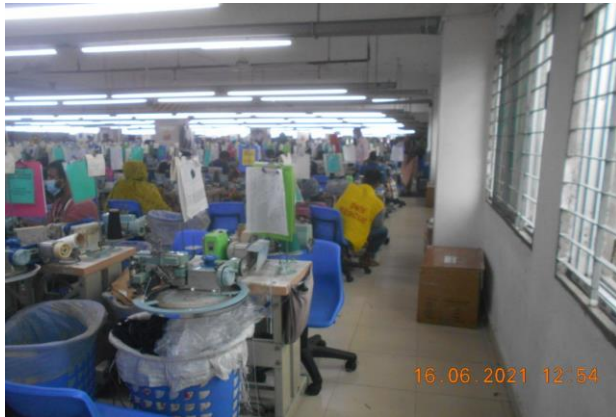
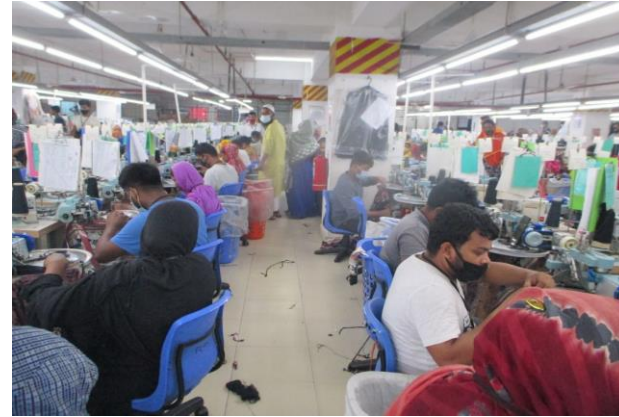
8	Egress	Aisles mark is missing and width of aisles is less than 0.9m (36-in.).	Aisles shall be provided with a minimum unobstructed clear-width of 0.9 m (36 in.).	Within 3 months

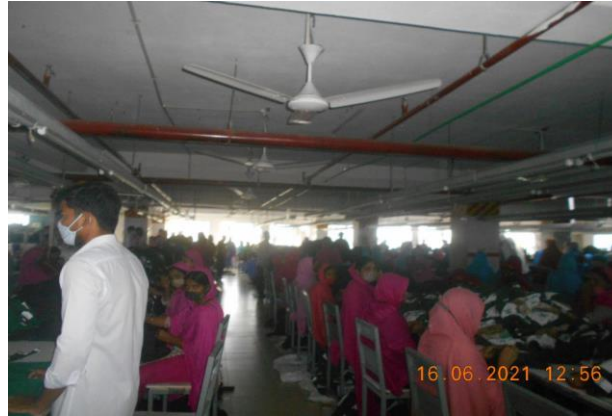
9	Egress Lighting	Based on the number and location of emergency lights observed, adequate illumination levels are not anticipated along egress routes.	Test the emergency lighting system on each floor and provide additional emergency fixtures to provide adequate illumination along the means of egress. Provide a minimum illumination of 10 lux at the floor level within exit stairs and exit discharge paths and minimum 2.5 lux along exit access aisles.	Within 3 months
---	-----------------	--	--	-----------------

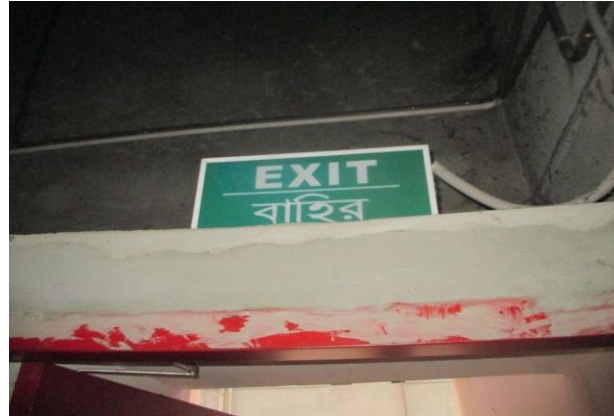
10	Egress Lighting	Exit signage not illuminated during testing (burned out, broken, etc.).	Regularly inspect all exit signage as per Accord standard and replace/install lights as needed to illuminate signs.	Within 1 month
----	-----------------	---	---	----------------

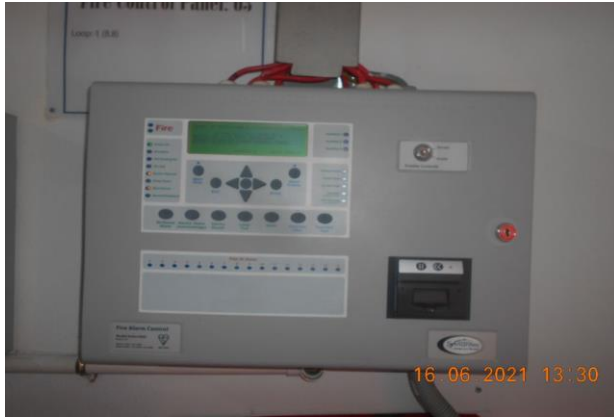
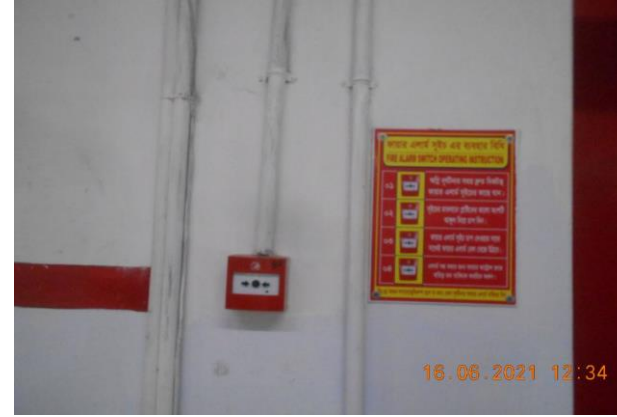
11	Inspection, testing, and maintenance of Emergency light and Exit Sign	Inspection, testing, and maintenance for the exit sign and emergency lighting system was not in accordance with The Accord standard.	Inspect, test and maintain the exit sign and emergency lighting system in the accordance with The Accord standard. Keep written records on-site.	Within 3 months
12	Fire Alarm & Detection System	Fire alarm & detection system installation requires detailed review to confirm compliance with NFPA 72 and ACCORD standards.	Configure the fire alarm system to initiate automatic occupant notification on all floor levels to facilitate whole-building evacuation upon any manual fire alarm station activation. Submit as-built drawings, testing records, equipment certification and other relevant documentation to the RSC for review and approval; modification (if required) shall have to done as per the reviewed design and standard.	Design within 2 months, installation /modification within 4 months

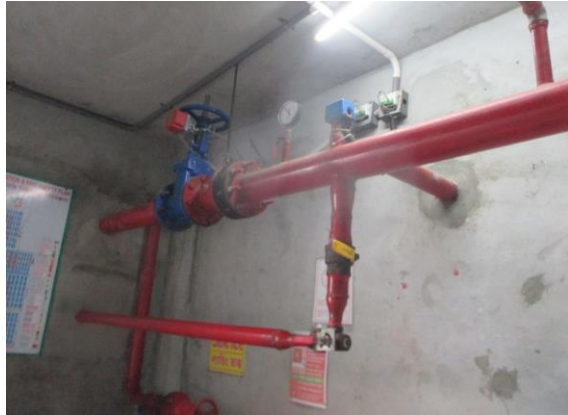
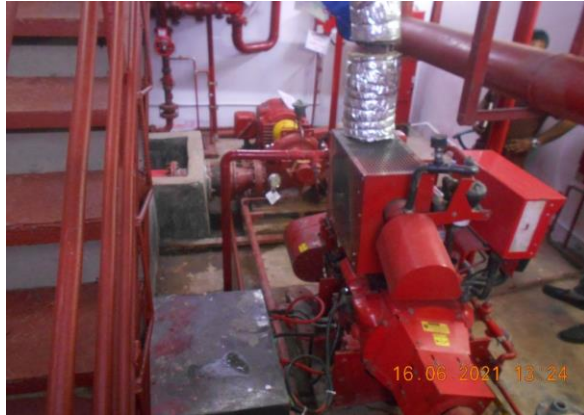
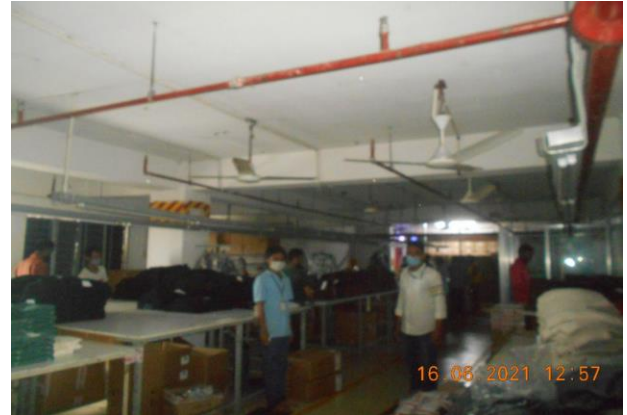
13	Inspection, Testing, and Maintenance of the Fire Detection & Alarm System	Inspection, testing, and maintenance for the fire alarm system is not in accordance with NFPA 72.	Inspect, test and maintain the fire alarm system, and keep written records on-site, in accordance with NFPA 72.	Within 1 month (After installation)
14	Fire Protection	Fire pump, water supply & sprinkler system installation requires detailed review to confirm compliance with NFPA 13, 14, 20, 22, 25 and ACCORD standards.	Submit as-built drawings, testing records, equipment certification and other relevant documentation to the RSC for review and approval; modification (if required) shall have to done as per the reviewed design and standard.	Design within 2 months, installation /modification within 6 months
